## 2014 Operations, Maintenance, and Monitoring Report

### Goose Point / Point Platte Marsh Creation (PO-33)

State Project Number PO-33  
Priority Project List 13

July 23, 2014  
St. Tammany Parish

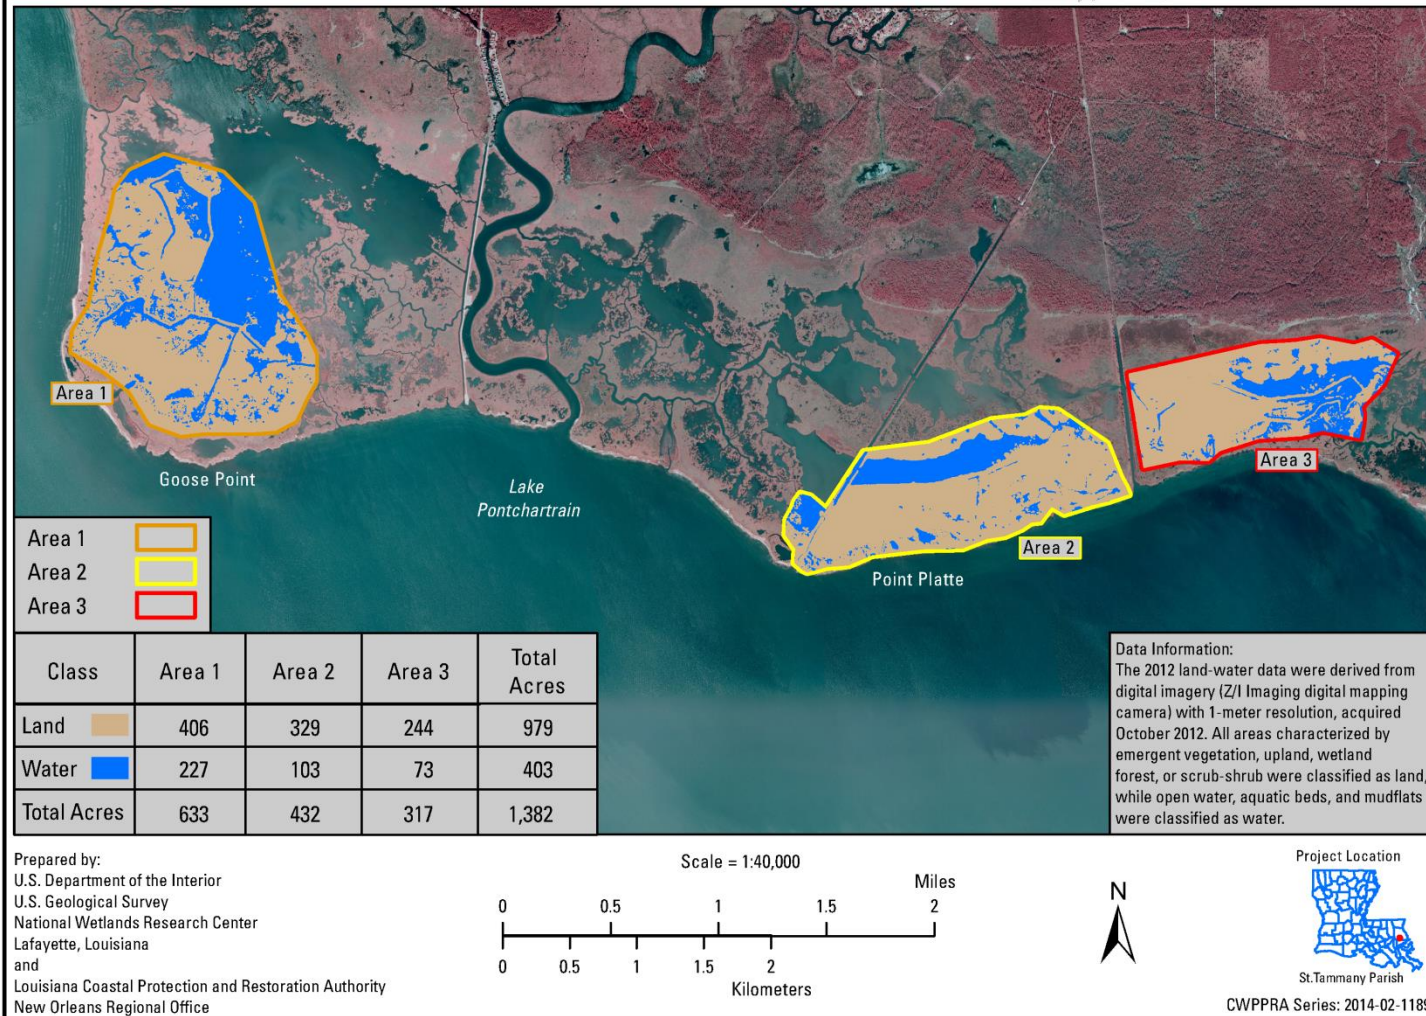
Land-water analysis of the 2012 aerial photography indicates that there are 979 ac of land and 403 ac of water within the 1,382-ac project area (70.8% land, 29.2 % water; Figure 4). The project area for PO-33 is divided into 3 areas which encompass the 5 marsh creation areas, as well as the marsh nourishment areas outside of the containment, and surrounding marsh and open water areas. Therefore, the project area is considerably larger than the marsh creation areas themselves.

**Figure 4.** Land-water analysis of 2012 aerial photography for the PO-33 project area.

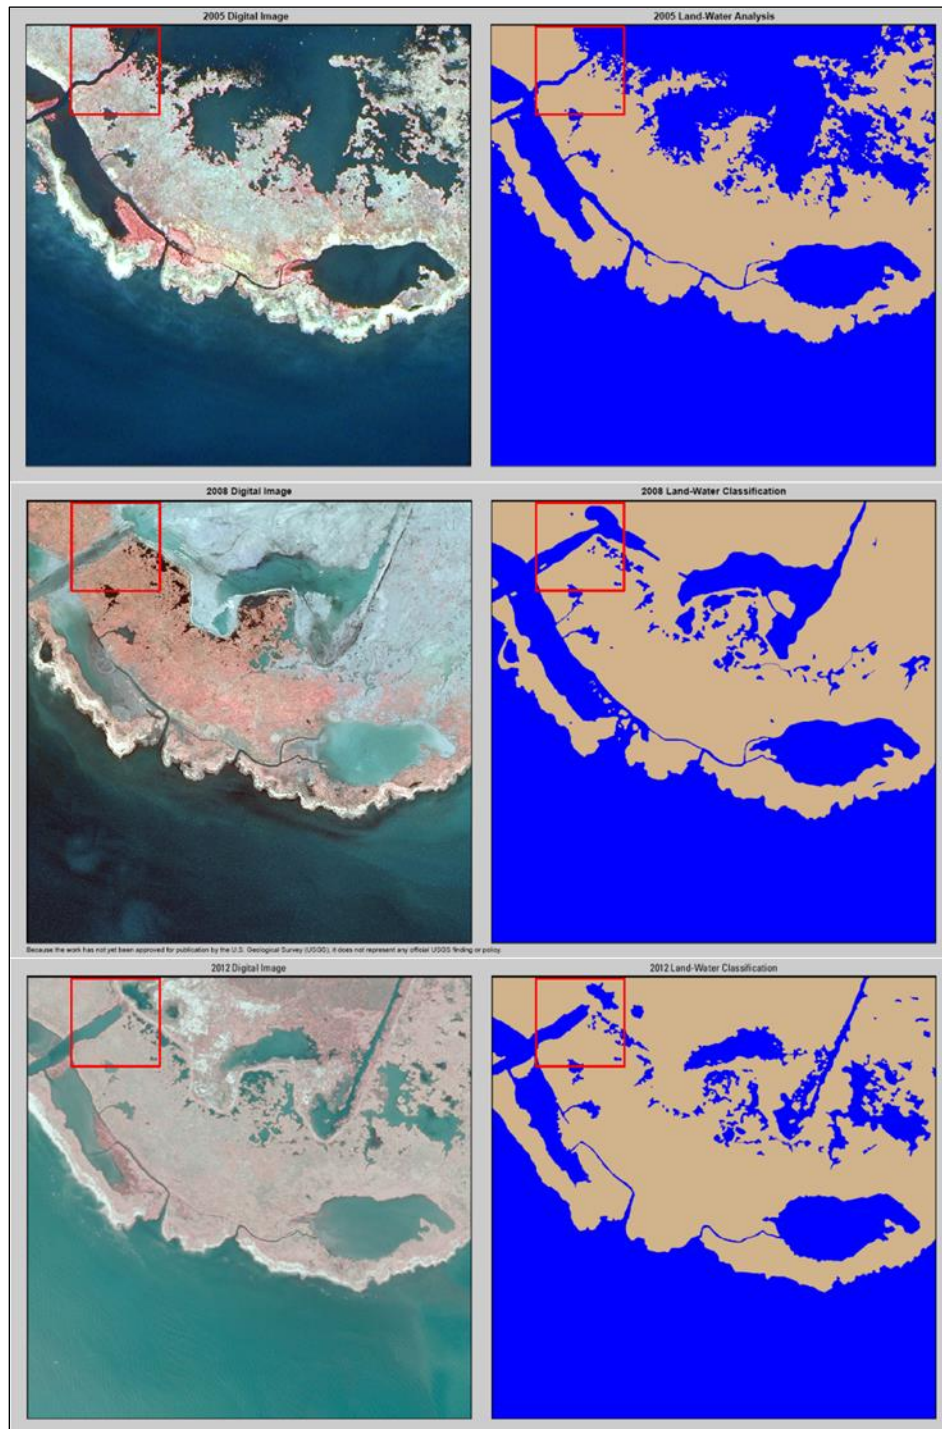
CRMS land-water analysis took place in 2005 (pre-construction), 2008 (during construction), and 2012 (post construction). The 1-km<sup>2</sup> areas for land-water analysis at CRMS0006 and CRMS3667 both capture portions of the PO-33 project. CRMS2854 did not receive any influence from the PO-33 project and will therefore serve as a reference for conditions in the surrounding area. The southern end of Area B is visible in the 2008 and 2012 aerial photography for CRMS0006 (Figure 6). Likewise, the eastern end of Area E is visible in the 2008 and 2012 aerial photography for CRMS3667 (Figure 7). In both cases, the 2008 photography acquired during project construction shows the extent of sediment brought into the area for marsh creation and nourishment.

**Figure 6.** Color infrared aerial imagery and land-water analysis of 1-km<sup>2</sup> area at CRMS0006 for years 2005 (top), 2008 (middle), and 2012 (bottom).

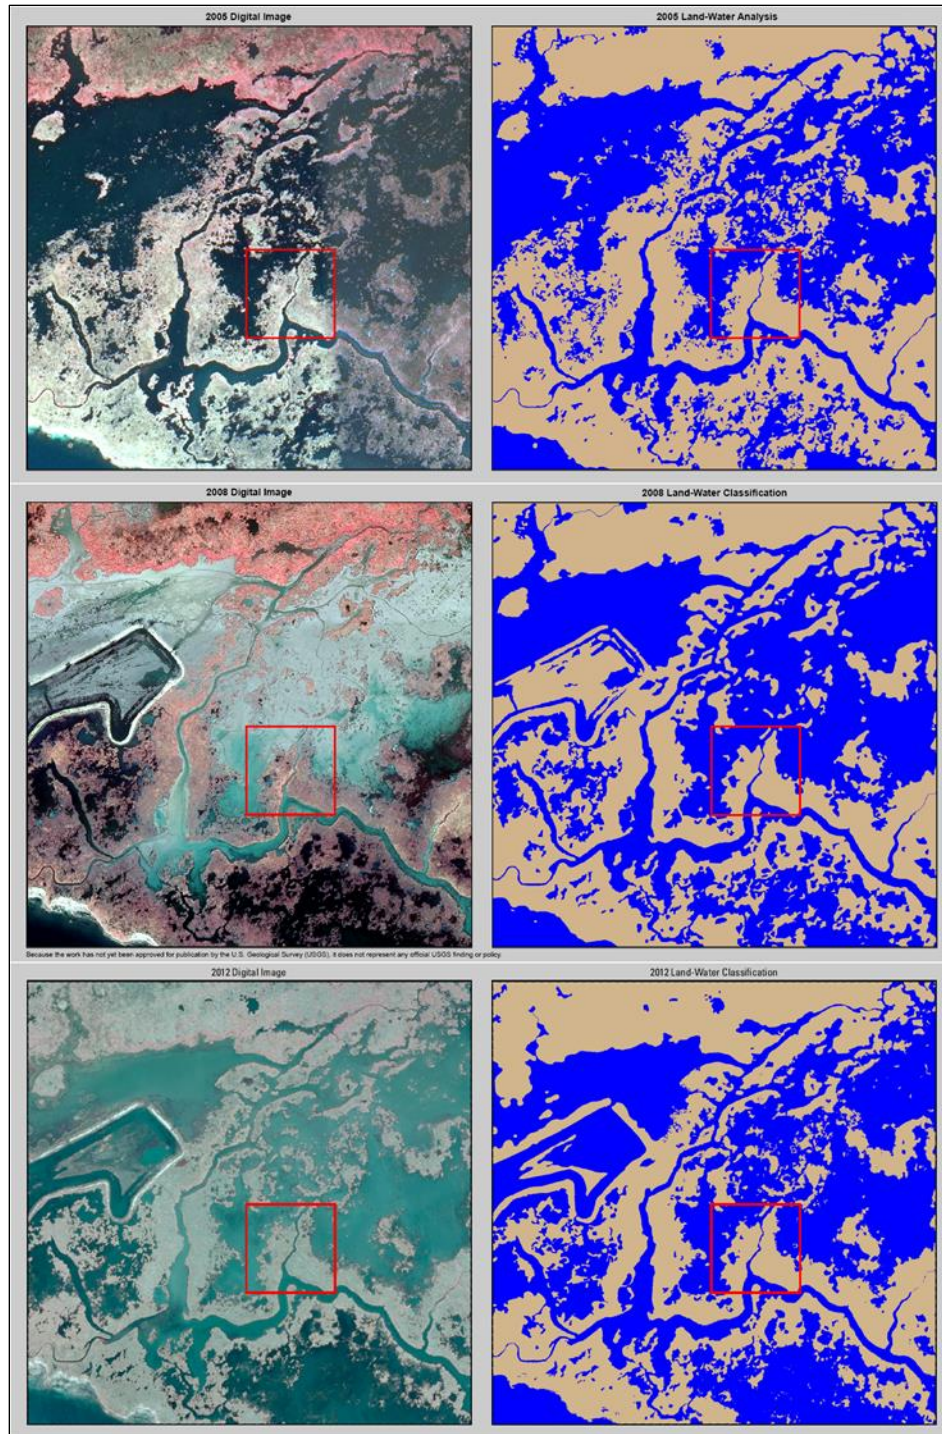
**Figure 7.** Color infrared aerial imagery and land-water analysis of 1-km<sup>2</sup> area at CRMS3667 for years 2005 (top), 2008 (middle), and 2012 (bottom).

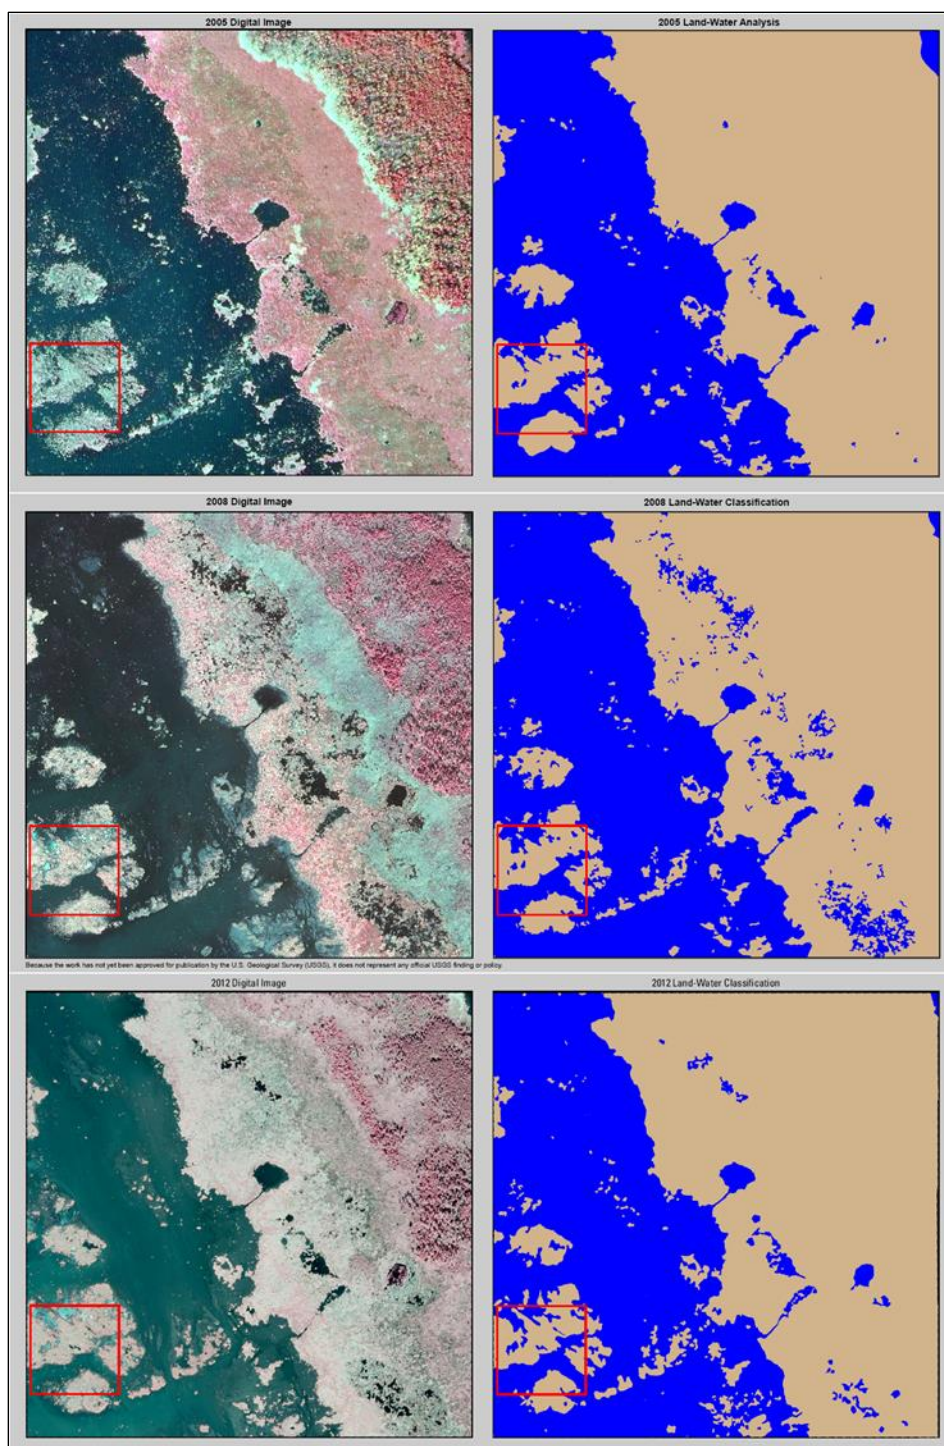
southeastern corner of the 1-km<sup>2</sup> area which is isolated from the project via a bayou that runs east-west below Area E and did not receive sediment from the project (Figure 5). Land-water ratios at CRMS2854 have remained relatively constant; decreasing slightly in 2008 and rebounding again in 2012 (Figure 8; Table 2).

**Figure 8.** Color infrared aerial imagery and land-water analysis of 1-km<sup>2</sup> area at CRMS2854 for years 2005 (top), 2008 (middle), and 2012 (bottom).
