## **2014 Operations, Maintenance, and Monitoring Report**

### **Boston Canal/Vermilion Bay Shoreline Stabilization Project (TV-09)**

State Project Number TV-09  
Priority Project List 2

June 2014  
Vermilion Parish

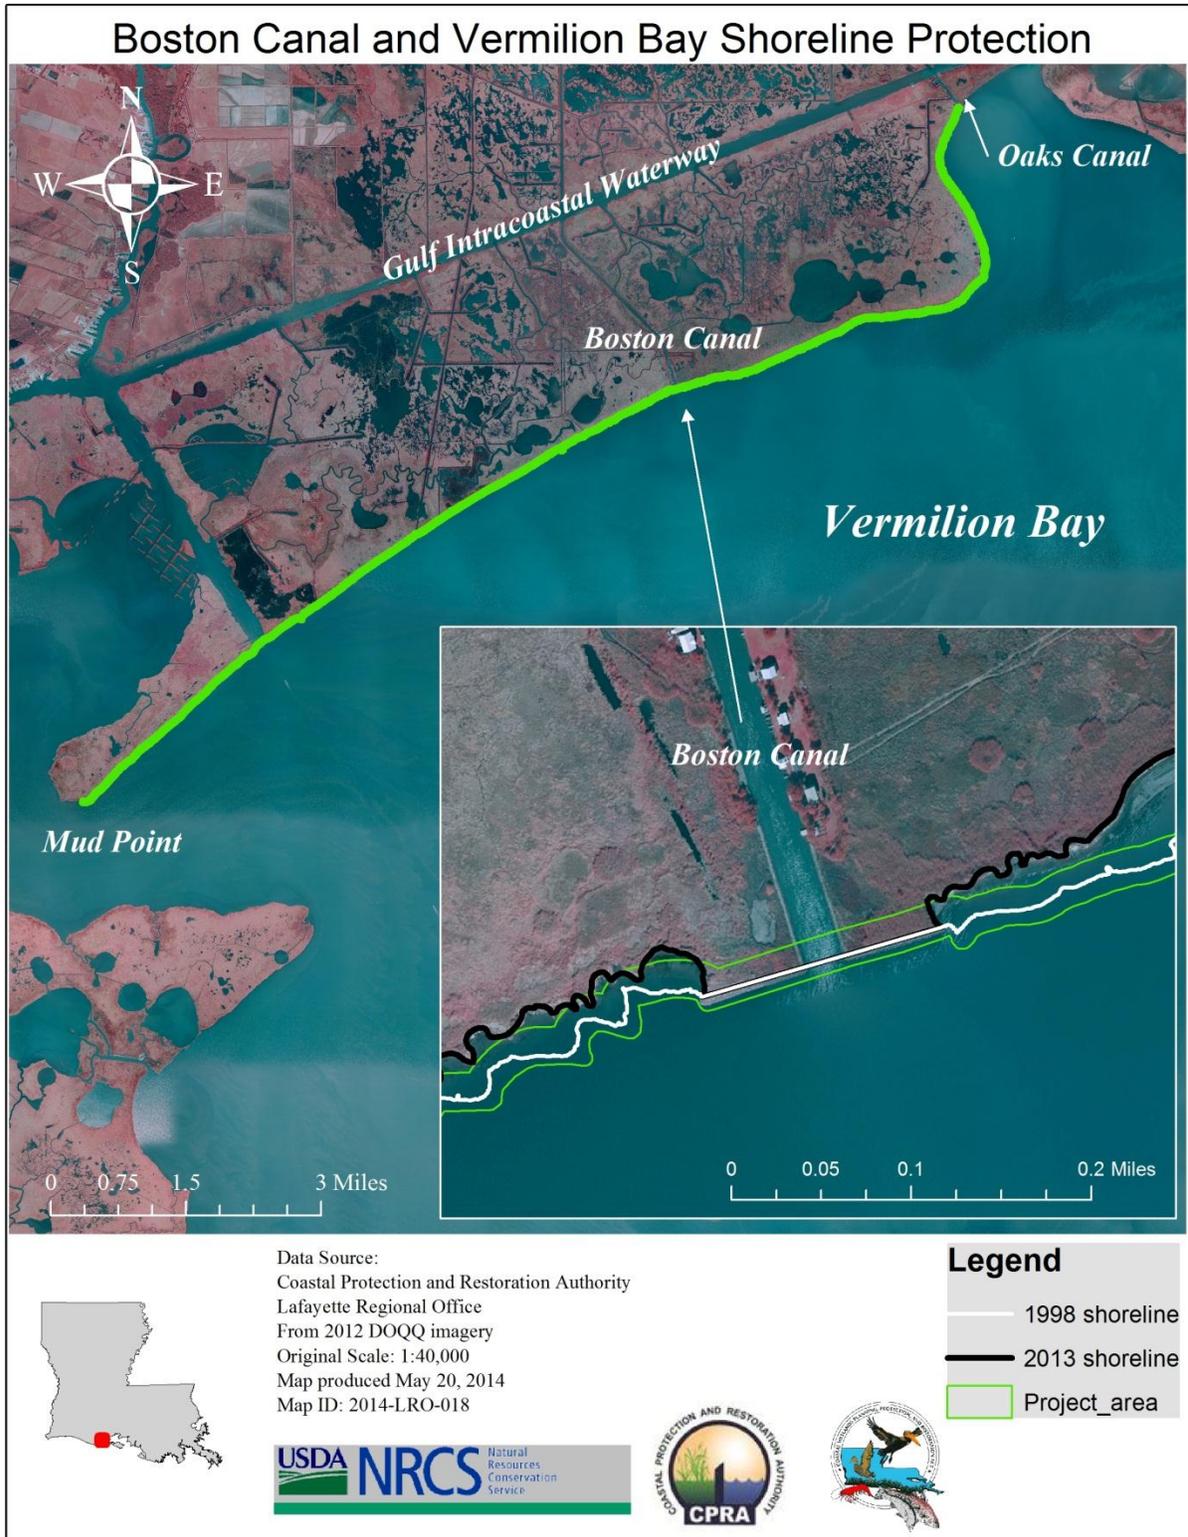
**Figure 1.** Boston Canal/Vermilion Bay Shoreline Stabilization (TV-09) project area with the 1998 and 2013 shorelines.

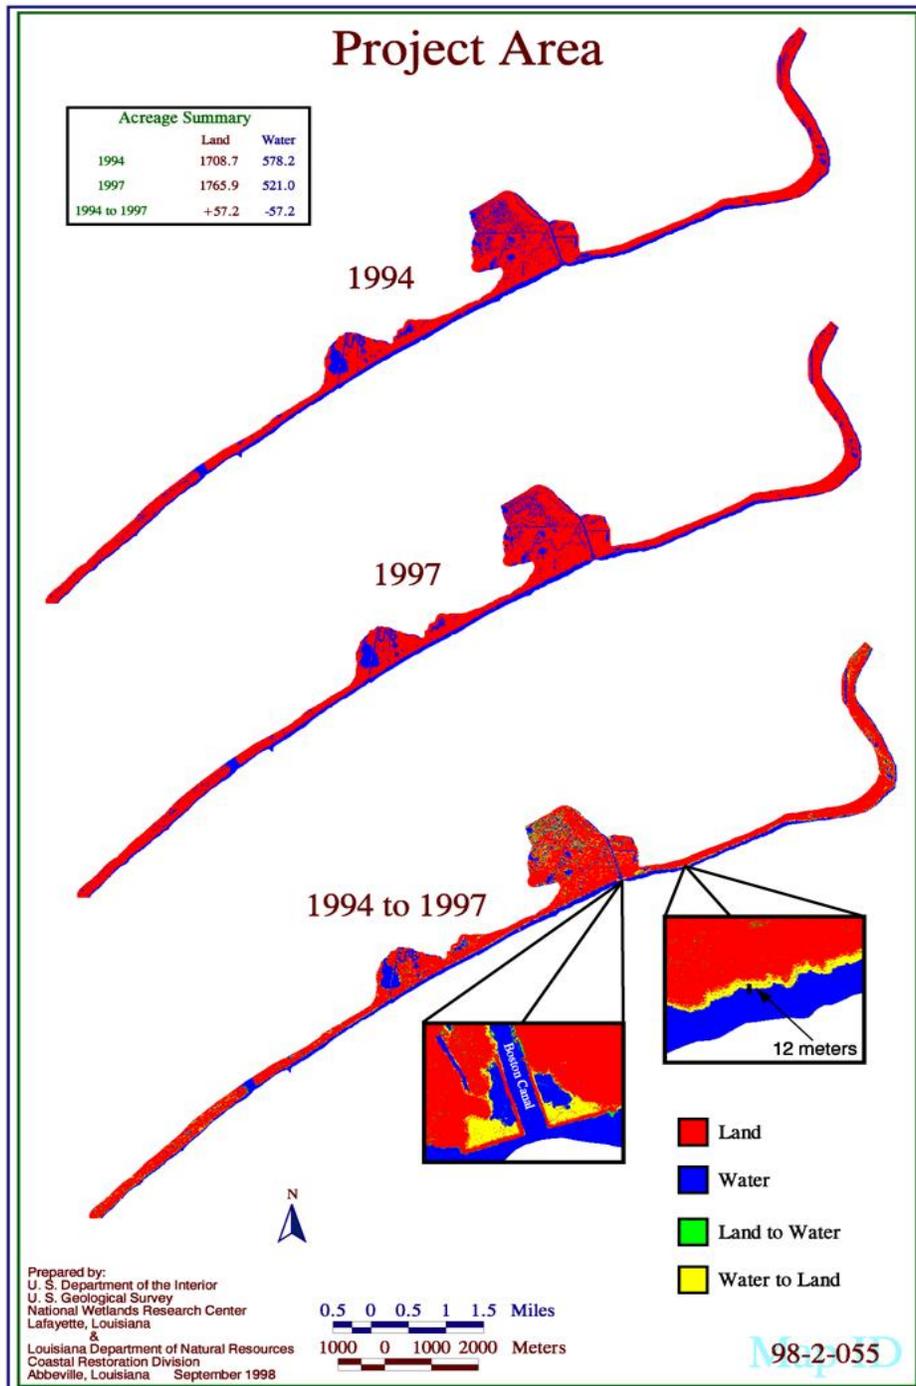
The 1994 to 1997 Land/Water analysis including the project area shows some land gain in the project area but also contains areas that were in the interior and not part of the project area and unrelated to project features (Figure 4). However there were gains in the areas behind the rock dikes and among the plantings on the bay shoreline. This pattern of shoreline progradation demonstrates the effective establishment of an intertidal *Spartina alterniflora* hedgerow (Figure 5). Though as of the 2013 shoreline survey, the project area has lost an average of one meter of land per year from 1998-2013 and this trend is likely to continue through the end of project life in 2015. The -1.0 m/y shoreline erosion rate is accelerating, the 2008-2013 period showed an average shoreline change of -2.0 m/y (Table 2). There were multiple storm events prior to and during this time period that likely impacted the planted hedgerows coverage and density contributing to this accelerated rate. A conservative estimate of the average shoreline loss of -1.0 m/y would equate to 20 meters along the 13 miles of planted coastline by 2015. This would yield a substantial acreage loss in terms of the project area. This shoreline erosion rate generates a land loss estimate of approximately 100 acres along the edge of Vermilion Bay from 1998 to 2013. This 100 acre loss represents approximately 50% of the project area. Based on regional scale analysis of satellite imagery (Thematic Mapper, 30 m<sup>2</sup> resolution) starting in 1985 (Figure 6) the percent land change from

Figure 4. Land water analysis including the Boston Canal Shoreline Stabilization (TV-09) project, highlighting the land gain behind the rock dike and the hedgerow along the shoreline from 1994 through 1997.

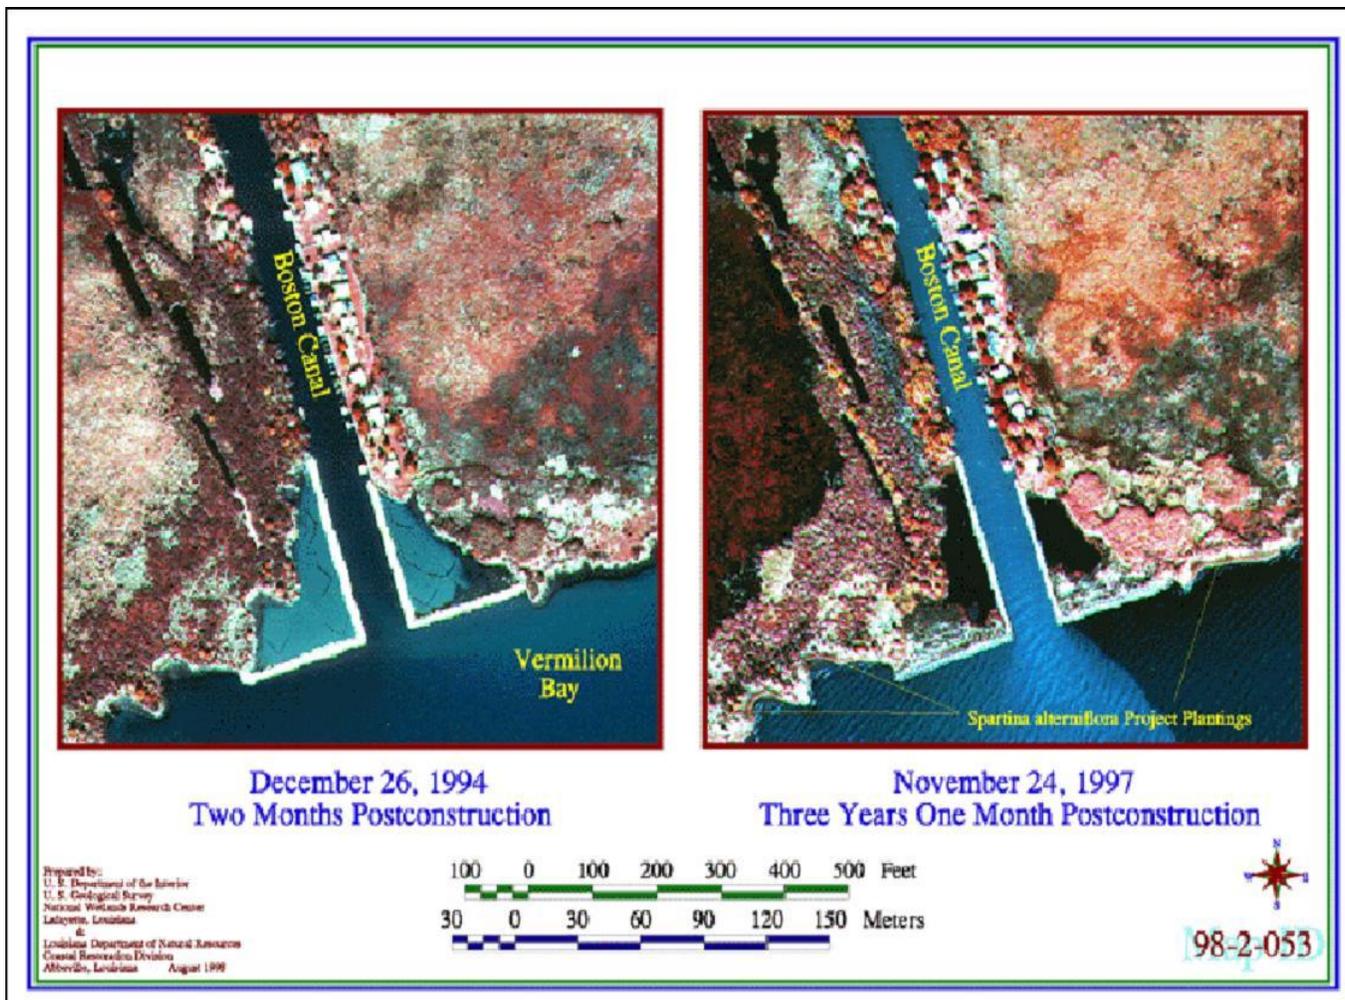
**Figure 5.** Aerial photography comparison of Boston Canal Shoreline Stabilization (TV-09) project at two month post construction in 1994 and three years post construction in 1997.

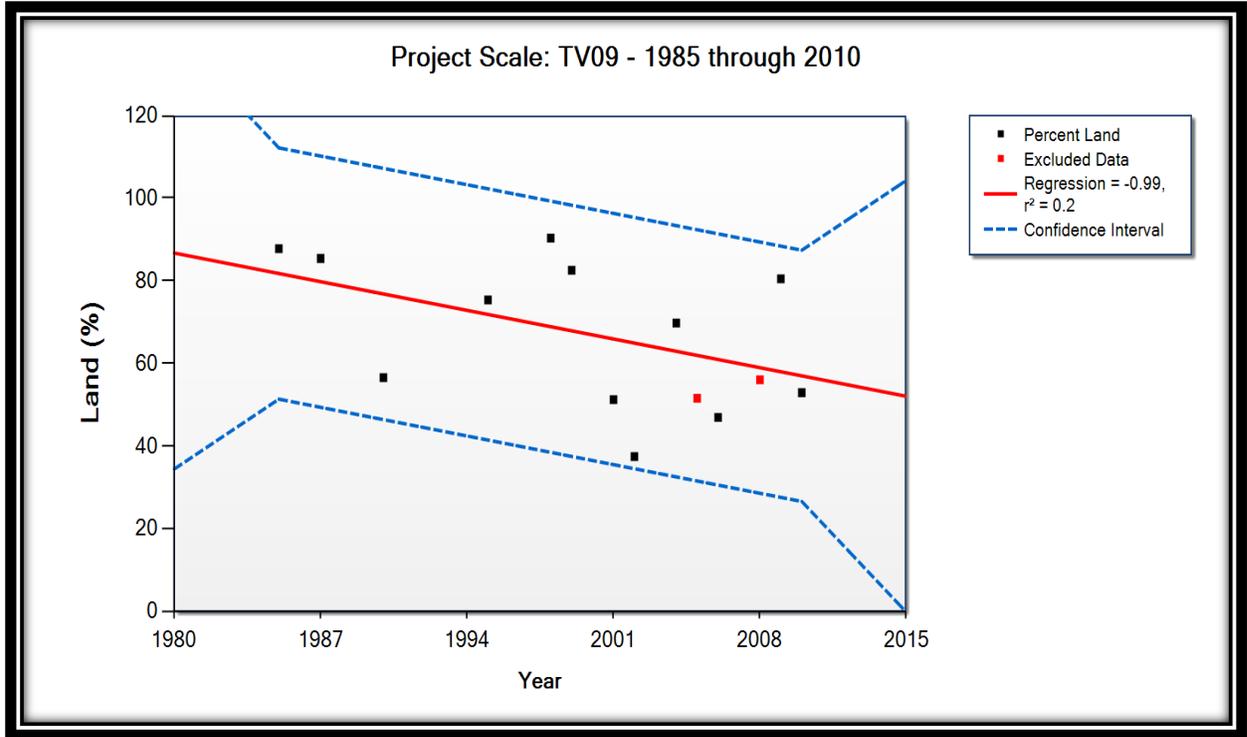
**Figure 6.** Land water analysis for Boston Canal Shoreline Stabilization (TV-09) project from 1980-2015, showing the land change trend for the project area of -1%/yr or -2 ac/yr.

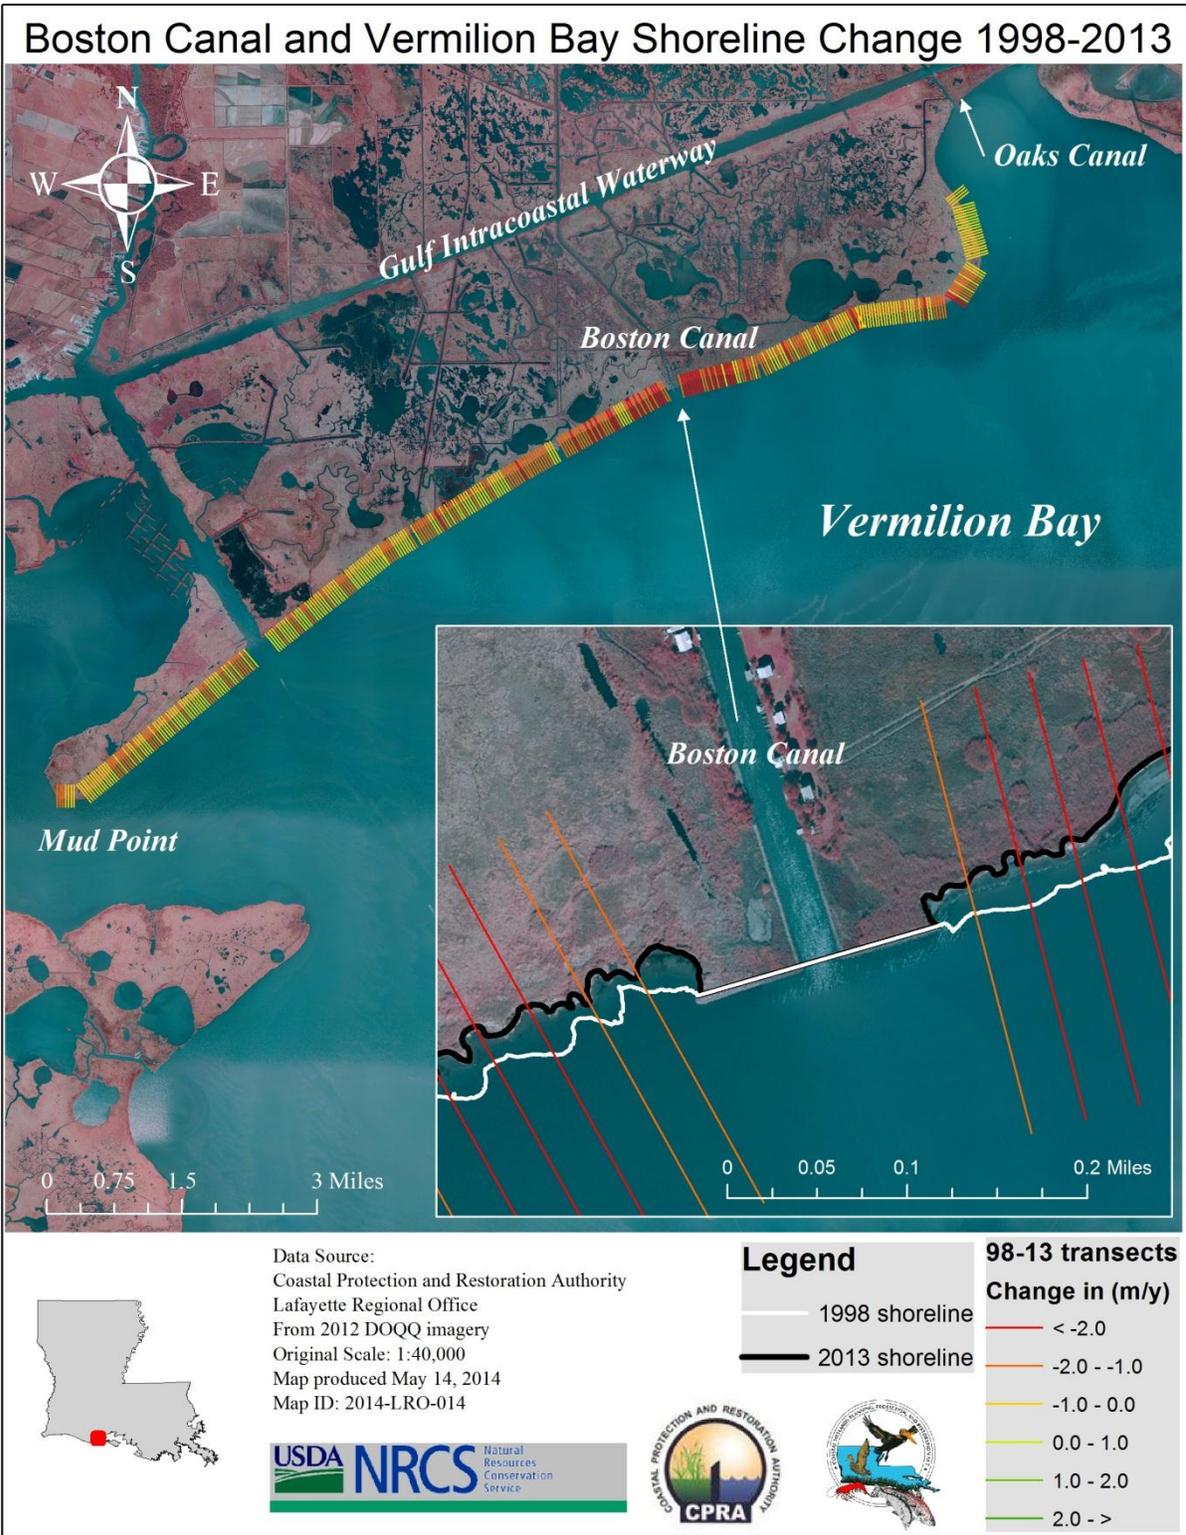
The project shoreline was mapped in 1998, 2001, 2004, 2008, and 2013. Over the 1998 to 2013 time frame the shoreline has retreated at -1.1 m/yr (-3.6 ft/y, Table 2) which is similar to the published pre project area rates in table 1 (Figure 14). A comparison of DGPS mapping of the 13.25 mile project shoreline from 1998 to 2001 indicates a progradational shoreline with an average gain of +0.5 m/yr (+1.6 ft/yr) (Figure 15). The vegetative plantings were installed in 1995 and considered full established by 1998. A comparison of the 2001 and 2004 shorelines show a high rate of shoreline loss likely due to the effects of Hurricane Lili in 2002 of -1.4 m/yr (-4.6 ft/yr) (Figure 16). In general the center of the project shoreline near Boston Canal has retreated at the highest rate as it is the most exposed section of the project to the prevailing southerly winds and is contiguous to the open waters of Vermilion Bay that stretch for over ten miles and extend into West Cote Blanche Bay. Erosion slowed from 2004-2008 even as it was adversely affected by multiple hurricanes over the same time frame. The average loss from this period was -1.0 m/yr (-3.3 ft/yr) (Figure 17). After the 2004-2008 survey period large areas of the project shoreline were devoid of the planted foreshore *Spartina alterniflora* hedgerow and the erosion rates subsequently increased over the next survey period. The 2008 to 2013 time period indicated average losses of -2.0 m/yr (-6.6 ft/yr) and loss near Boston Canal was prominent (Figure 18). During the 2013 mapping effort it was evident that nearly 50% of the project area contained no intertidal *Spartina alterniflora* and in some locations where it was present either cut banks or separations from the main shoreline was taking place further limiting the protective potential of this project feature (Figure 12). However there were still large areas of *Spartina alterniflora* in the intertidal zone between the existing marsh and Vermilion Bay along the project shoreline where losses are taking place (Figure 13). This is likely due to the *Spartina* hedgerow rolling backward in step with the existing marsh as the wave energy of the bay causes continued shoreline erosion. The rock dike at the confluence of Boston Canal and the Vermilion Bay shoreline has been extremely successful and maintenance free. The open water area behind the rock dike has build-up sediment and continues to vegetate over the previously exposed mud flats (Figures 19-20). Even though the plantings generally survived, their function to reduce the rate of shoreline erosion is not applicable; competition, herbivory, regular wave action, storms, and debris can cause the loss of large sections of plantings annually during the project life.

**Figure 14.** Overall shoreline position change for the TV-09 project using 1998 and 2012 differential global positioning system mapping data.

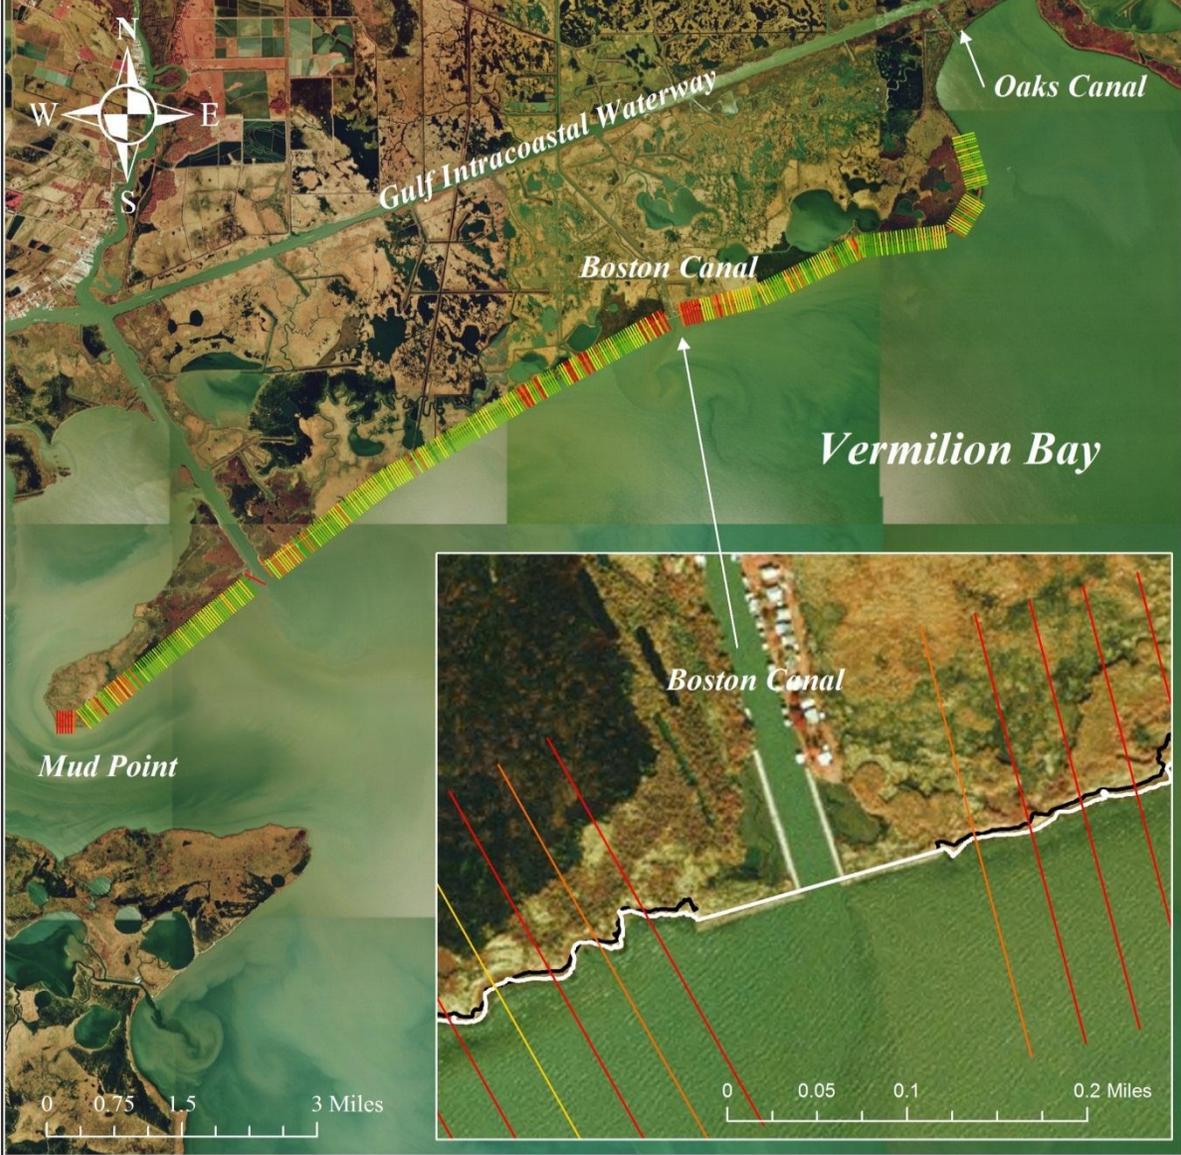
The initial monitoring results from 1998-2001 showed a progradation of +0.5 m/y (+1.6 ft/y) occurring along the project shoreline and net gain in acreage was likely achieved. Over the next two shoreline change measurement intervals hurricanes became a dominant force in reshaping coastal Louisiana. Hurricane Lili struck the Louisiana coast east of Vermilion Bay in 2002 followed by Hurricanes Rita in 2005 and Ike in 2008, all of which produced storm surge that caused extensive damage both locally and afar. It is certain that the wave energy from these storms produced and exacerbated some of the shoreline erosion and resulting acreage losses in the following data collection periods. Other moderate losses have occurred from *Eichhornia crassipes* (water hyacinth) mats and other wrack material thrown onshore from bay waters via wave action that smothered established vegetation. The now established *Spartina alterniflora* community has persisted in some areas, but along some sections of the shoreline where consistent loss has occurred, the hedgerow moves along with the shoreline edge to maintain occupation of its niche in the intertidal zone. This explains why there are still hedgerows existing well behind the remaining original monitoring posts.

**Figure 15.** Shoreline position change for the TV-09 project using 1998 and 2001 differential global positioning system mapping data.

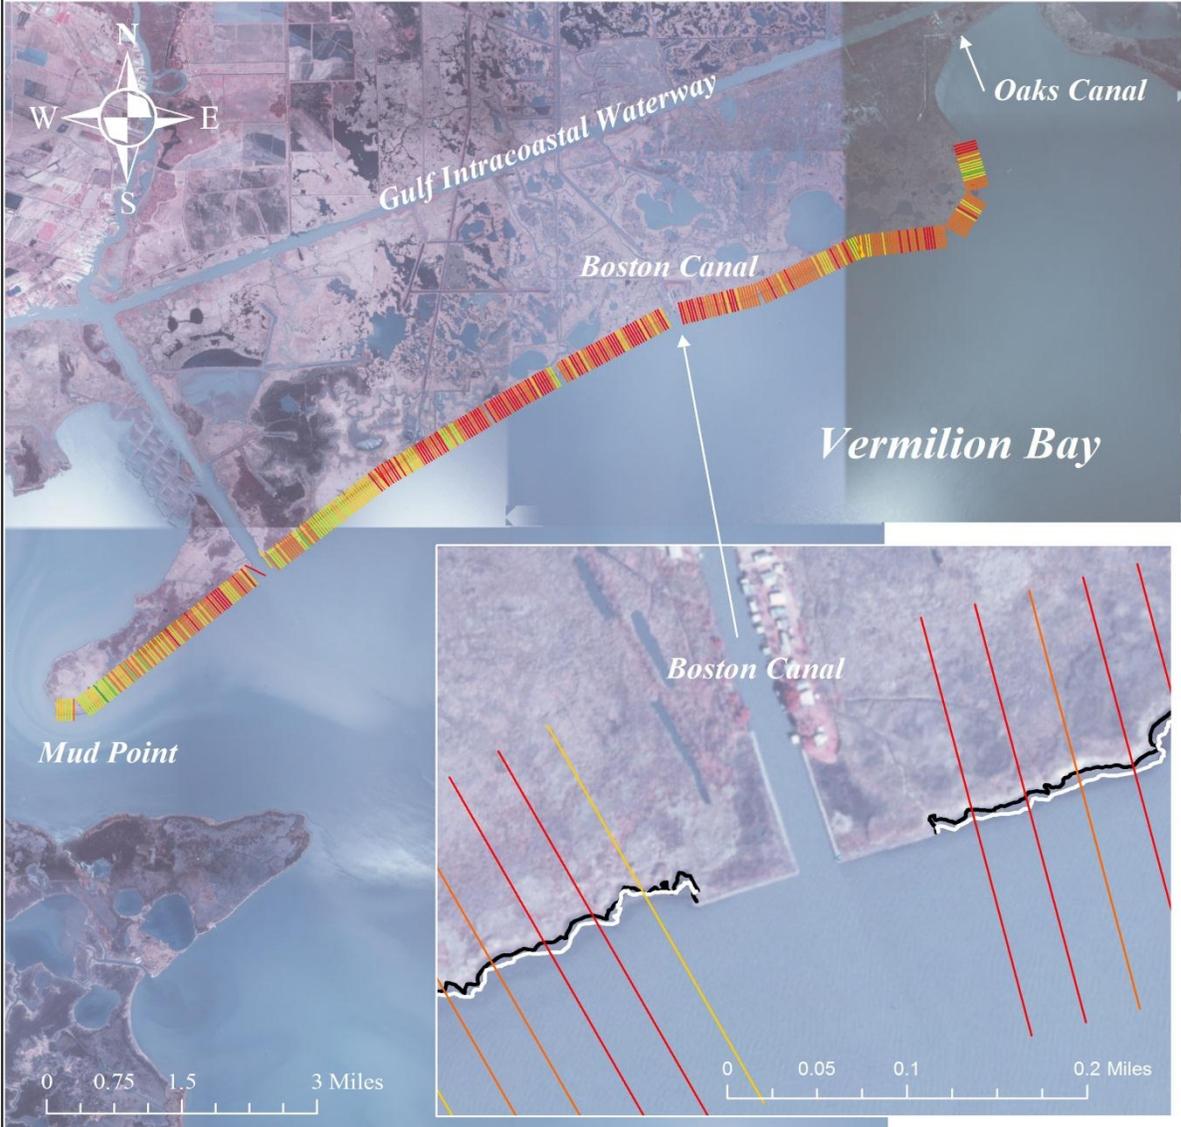
**Figure 16.** Shoreline position change for the TV-09 project using 2001 and 2004 differential global positioning system mapping data.

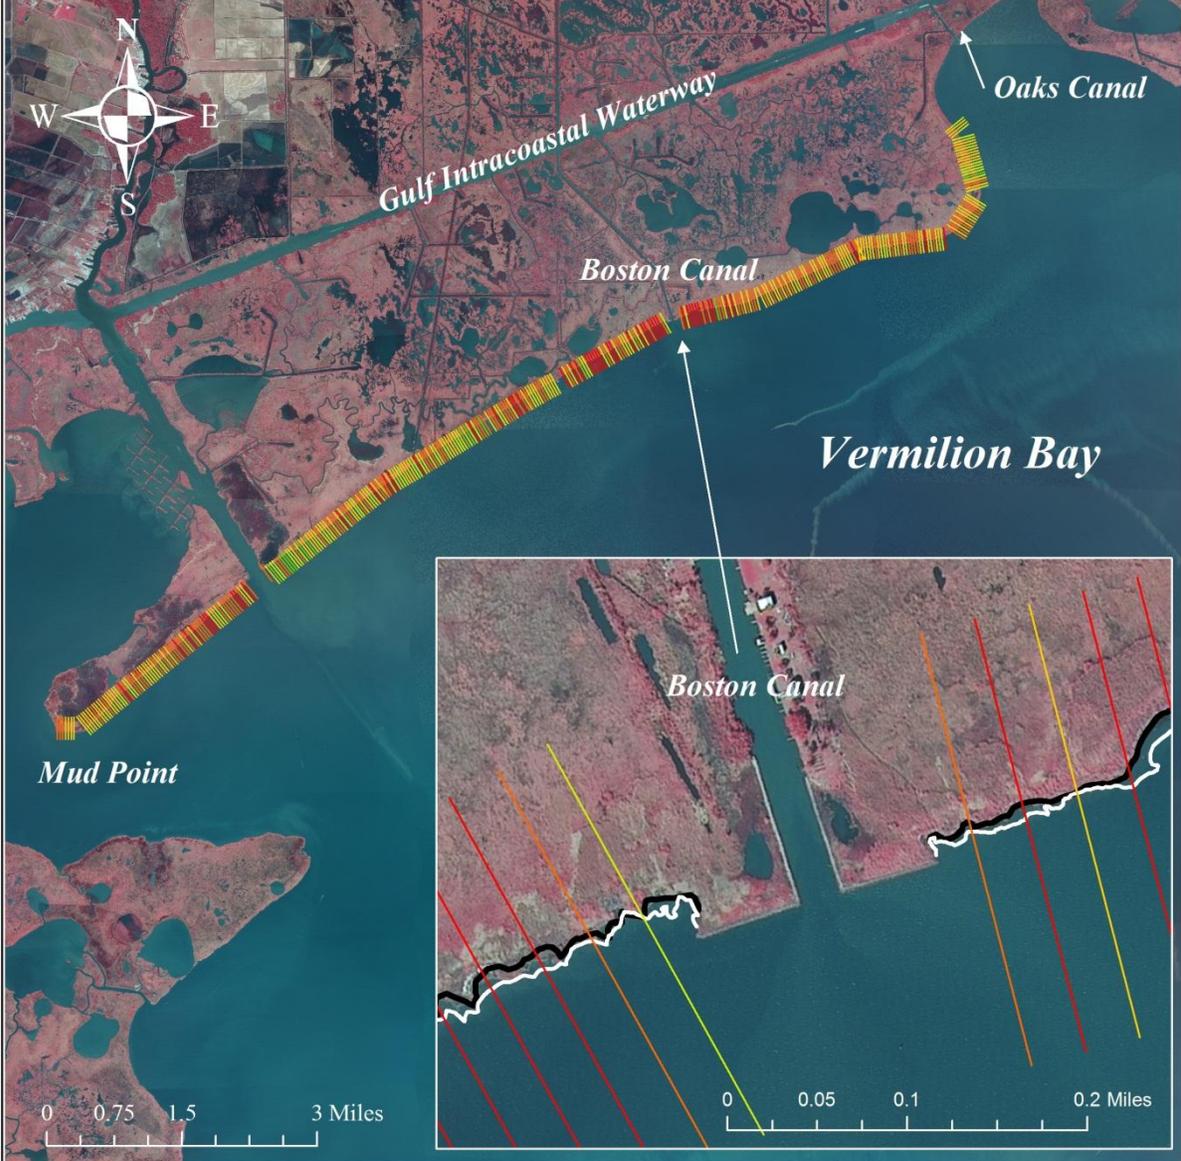
**Figure 17.** Overall shoreline position change for the TV-09 project using 2004 and 2008 differential global positioning system mapping data.

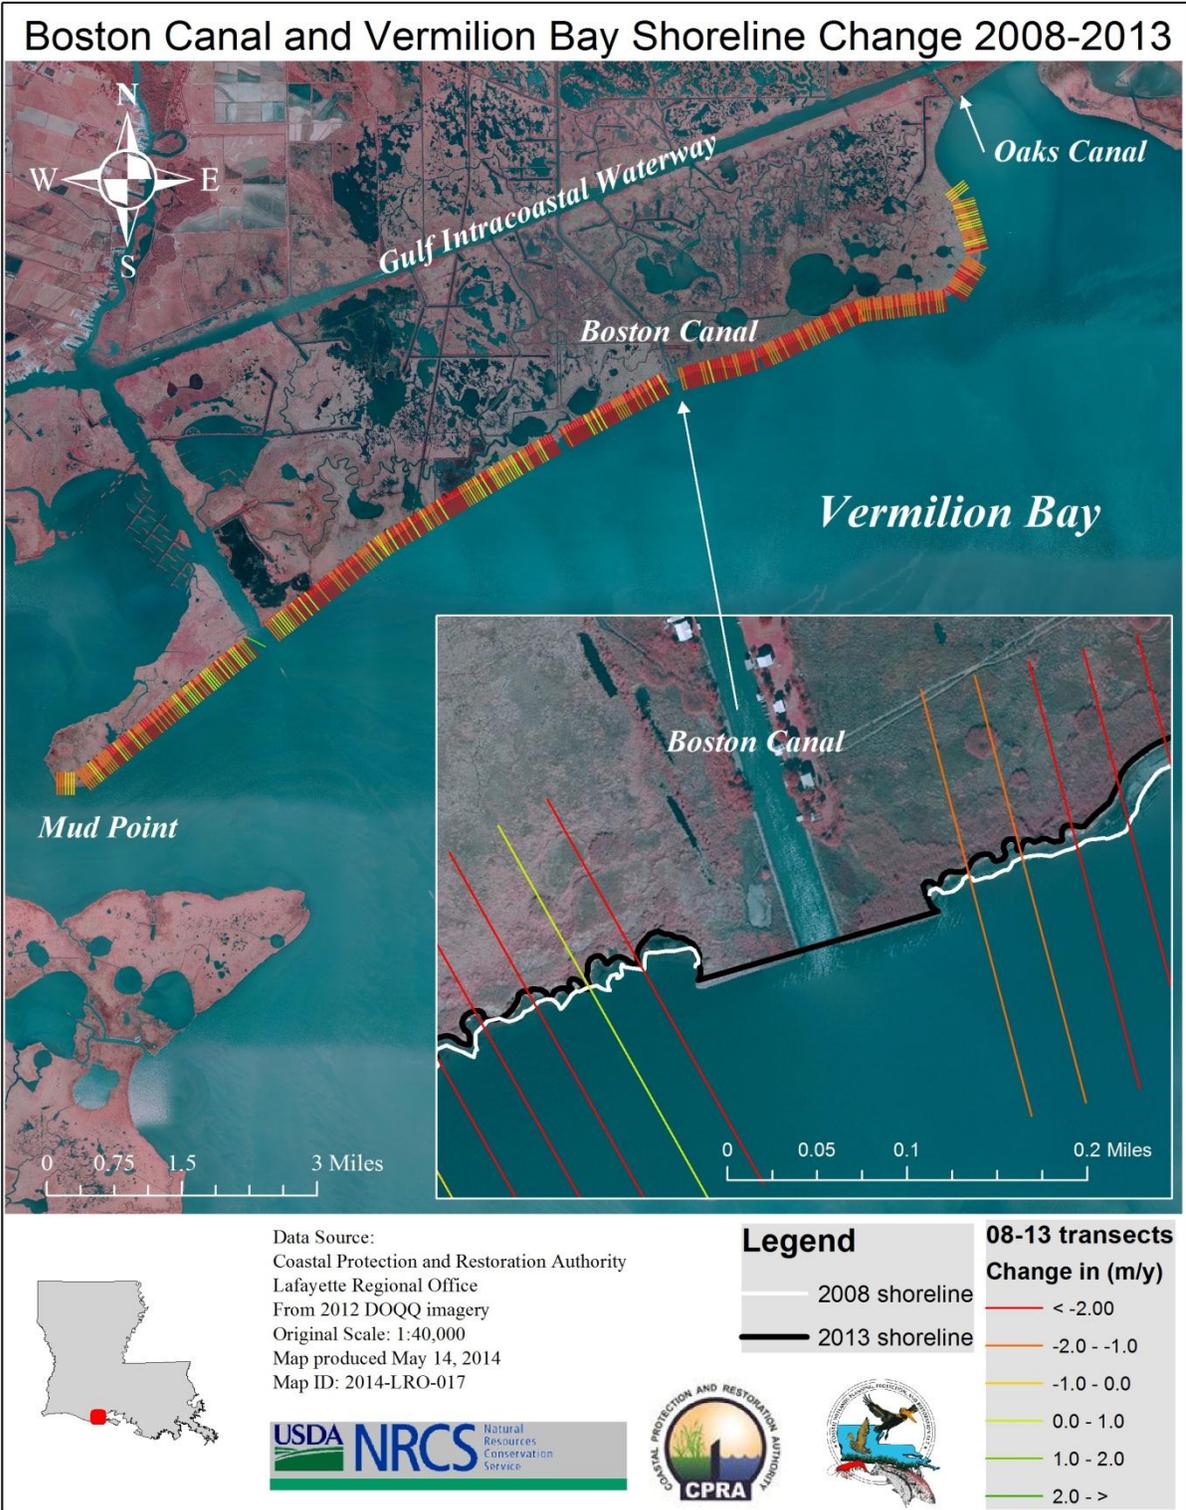
**Figure 18.** Shoreline position change for the TV-09 project using 2008 and 2013 differential global positioning system mapping data.

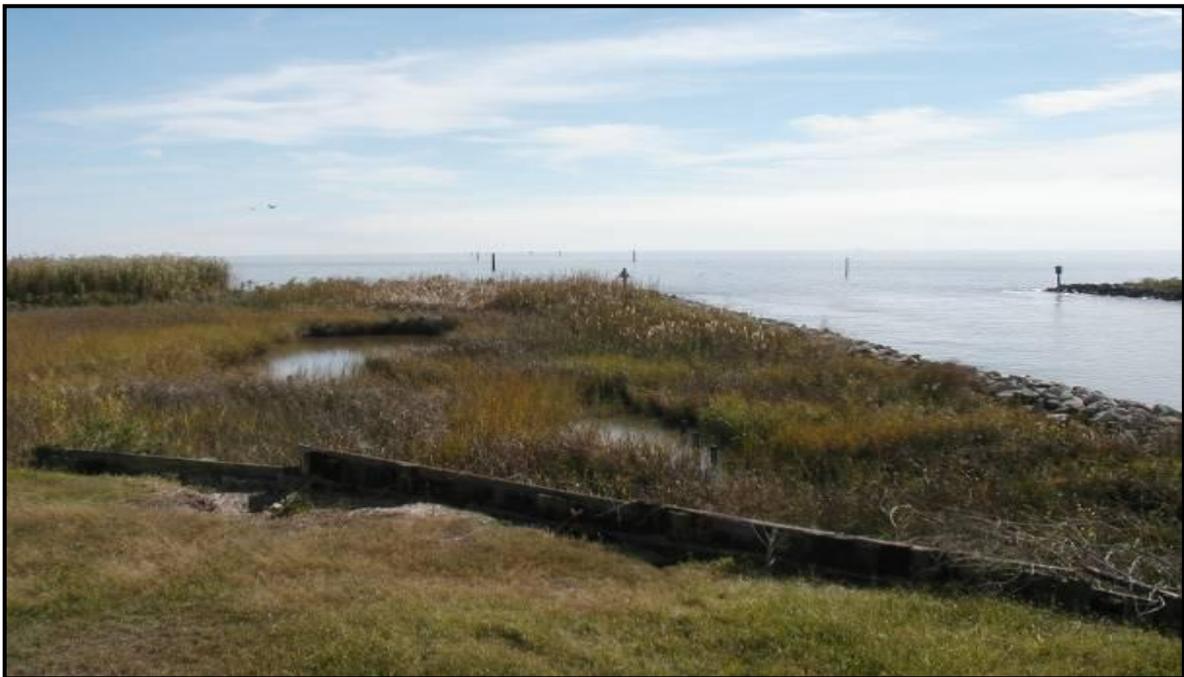
**Figure 20.** Boston Canal/Vermilion Bay Shoreline Stabilization Project behind the eastern rock dike November 9, 2004.
