## **2019 Operations, Maintenance, and Monitoring Report**

### **LAKE PORTAGE LAND BRIDGE PROJECT (TV-0017)**

State Project Number TV-17  
Priority Project List 8

November 2019  
Vermilion Parish

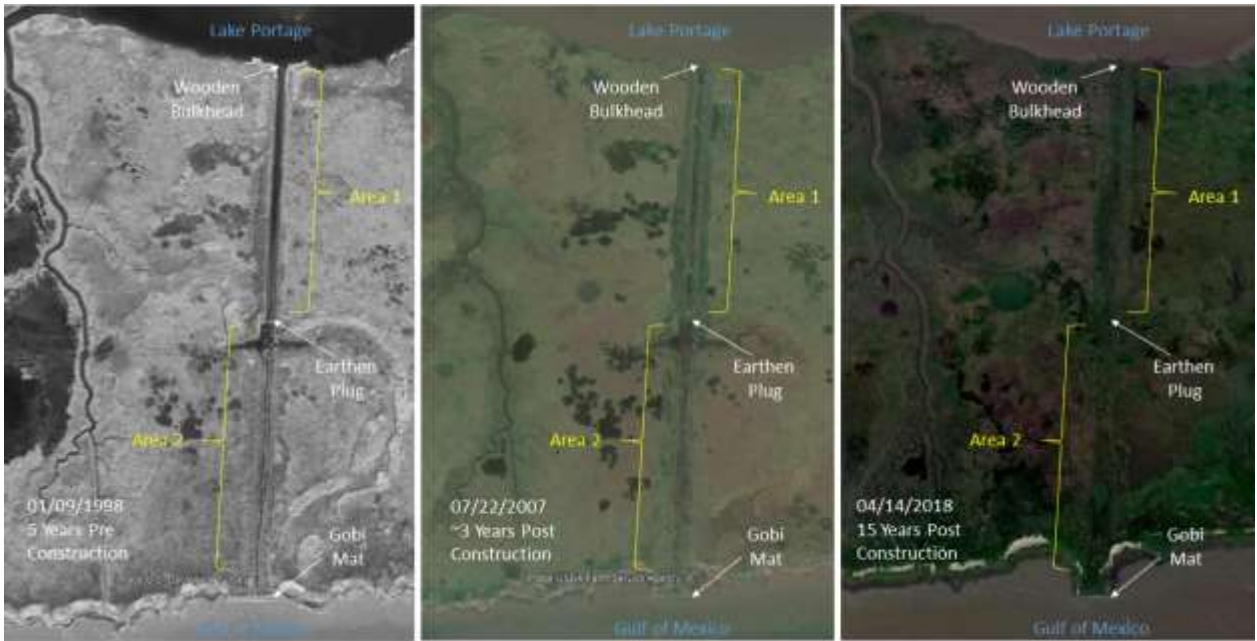
From an April 2005 vegetation survey (pers. comm. Cindy Steyer, USDA-NRCS), the northern portion of Area 1 was colonized predominantly by leafy three-square bulrush with trace *Calystegia sepium* (hedge bindweed) (Fig.2). The middle section of Area 1 was further along in succession and was slightly more diverse with leafy three-square bulrush sharing dominance with marshhay cordgrass and smooth cordgrass; saltgrass, morning glory, *Iva frutescens* (big leaf sumpweed), salt bush, and *Amaranthus* sp. also occurred in small to trace amounts. The higher portion of Area 1 approaching the earthen plug was slower to colonize (Fig. 2B). By April 2008, about 4 years after dredge placement, the Area 1 canal infill was 100 % vegetated as plants expanded naturally from the containment levees towards the center of the former pipeline canal (Fig. 3) (Pontiff 2008). Vegetation has remained intact as of 2018 (Fig. 2C).

**Figure 3.** A time series of aerial imagery of TV-0017 Areas 1 and 2 from 6 years preconstruction to 14 years post construction was obtained from GoogleEarth. The images show pre-existing features of the pipeline in white and the TV-0017 in-fill (Area 1) and nourishment (Area 2) areas.

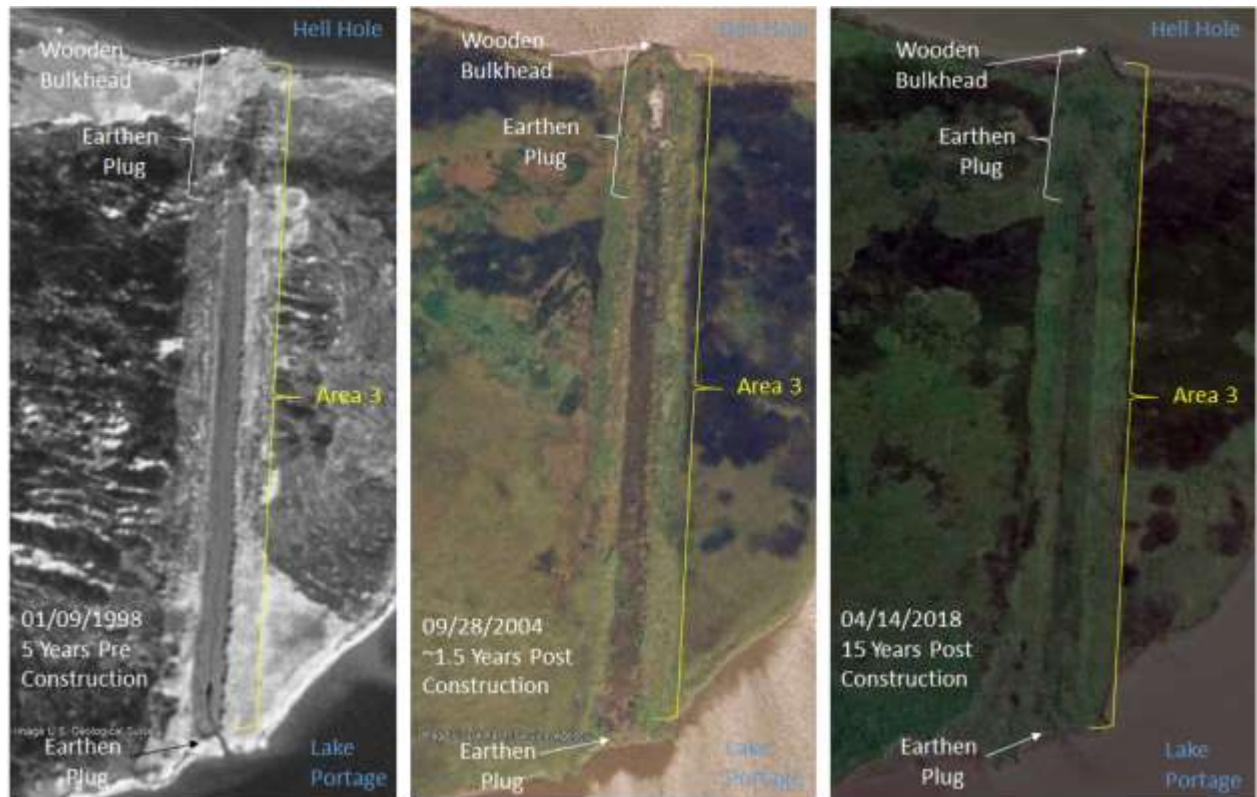
By April 2005, Area 3 had vegetated (Fig. 5) with very a robust community of smooth cordgrass, leafy three-square, and Roseau cane (Fig. 6). The northern portion of the Area 3 closer to the Hell Hole, which overtopped a pre-existing earthen plug and was higher vegetation, still had a bare patch by 2005 that completely vegetated by 2007 (Fig. 5). By 2013, Area 3 was completely vegetated aside from a small trennase connected to Lake Portage (Figs. 5 and 7).

**Figure 5.** A time series of aerial imagery of TV-0017 Area 3 from 5 years preconstruction to 15 years post construction was obtained from GoogleEarth. The images show pre-existing features of the pipeline and in white and TV-0017 in-fill area.

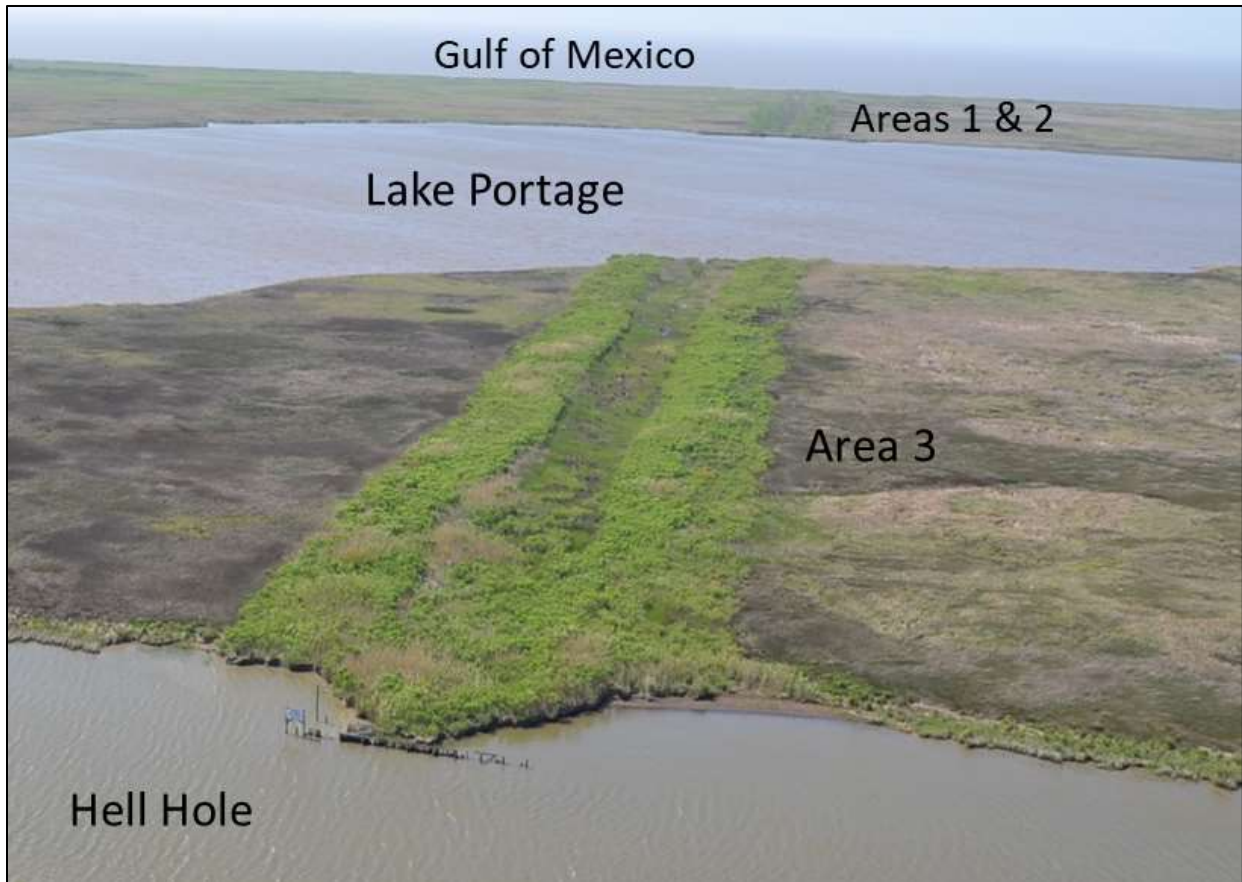
**Figure 7.** Oblique aerial photograph of Areas 3 (foreground) and 1 and 2 (background) in 2013. The picture is oriented by south at the top. Photograph courtesy of Louisiana Department of Wildlife and Fisheries.

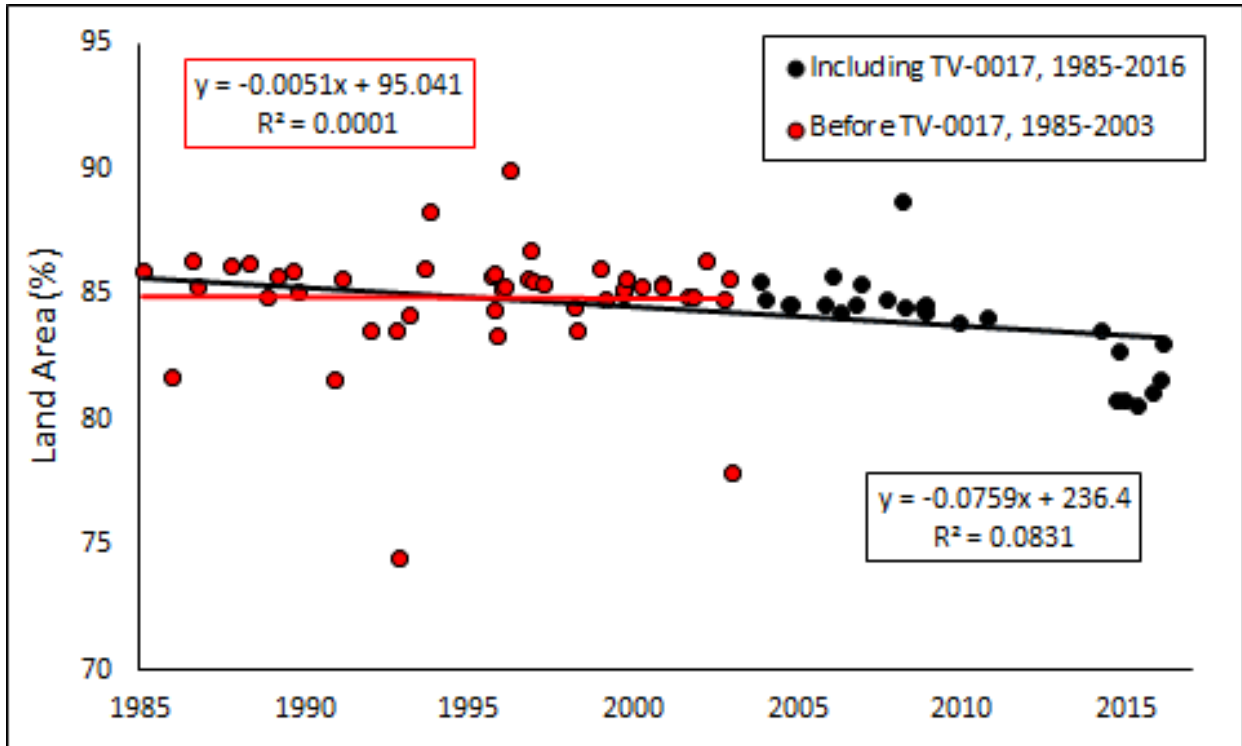
Although the infilled pipeline canal area completely vegetated within a few years after construction, land loss in the TV-0017 project area was 0.07 %/yr greater during the entire period of record (1985-2016) than prior to project construction (1985-2003) (Fig. 8). Much of the land change occurred along the shorelines. Based on a BICM report, the major shorelines along the north (Hell Hole) and south (Gulf of Mexico) of TV-0017 eroded 6.4 – 8.2 ft/yr, respectively, from 1998 – 2015 and 6.9 – 7.1 ft/yr, respectively from 2004 – 2012 with localized shoreline losses up to 20 ft/yr (Byrnes et al. 2018). In addition, Lake Portage and associated bayous have expanded into the marsh during the project life.

**Figure 8.** Hyper-temporal analysis of land area from satellite imagery for TV-0017. Time periods include TV-0017 (1985-2016, black symbols and linear regression line) and before TV-0017 (red symbols and linear regression line) (CPRA 2019; <http://cims.coastal.louisiana.gov>. Accessed 22 July 2019).
