COLE'S BAYOU MARSH RESTORATION PROJECT (TV-63) PROJECT COMPLETION REPORT

Project: Cole's Bayou Marsh Restoration Project

State Project No.: TV-63

By: Sellers & Associates, Inc.

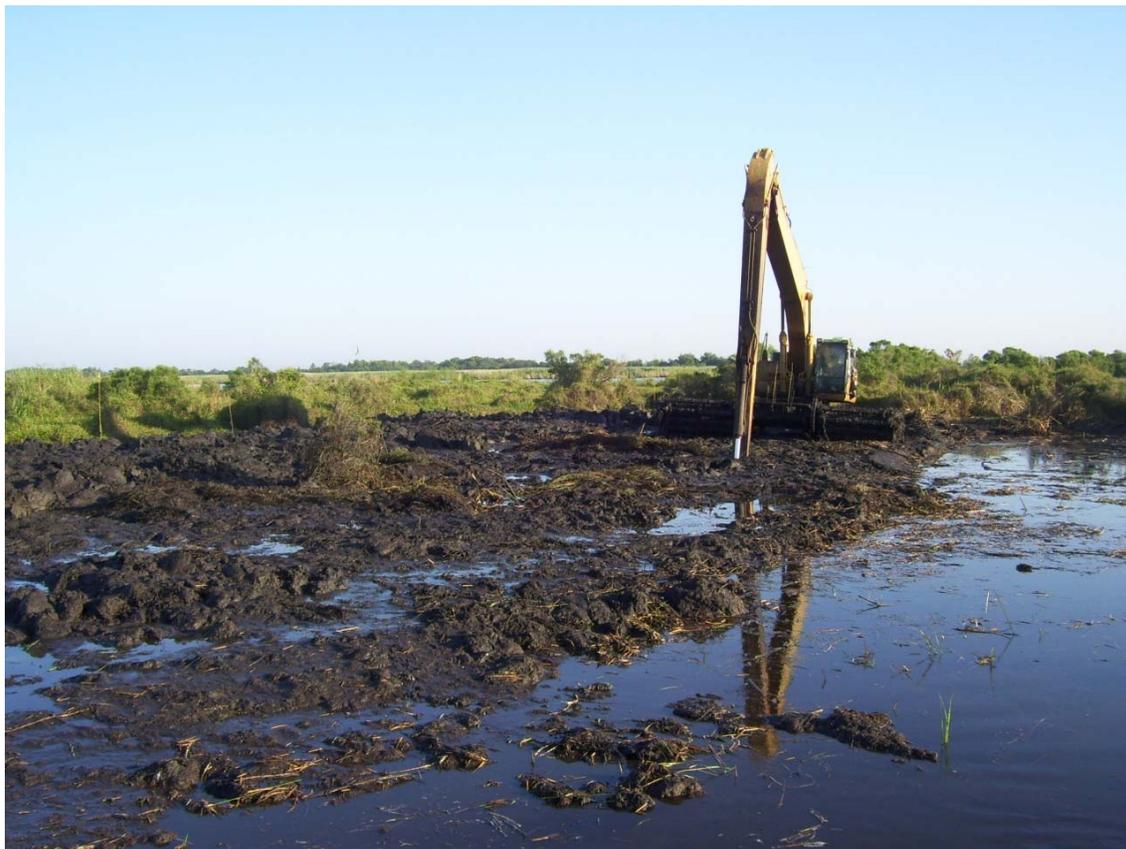
Figure 1: ECD 1 Construction

Construction of the ECD for MCA 1 began on September 11, 2018. The ECD was constructed with a typical section of 5' crest width at elevation +3.0' to +4.0' (armored ECD at elevation +3.5' to +4.0) with side slopes of 4:1. The material used to construct ECD 1 was not suitable to construct the dike to the target elevation in one lift. Therefore, Wilco constructed a base for the ECD and allowed it to consolidate before constructing a second lift to bring the ECD within the required vertical tolerance. Borrow material was taken from inside MCA 1 to allow for the hydraulically dredged sediment to fill the voids created from the ECD construction. ECD 1 totaled 5,887 linear feet. The ECD was protected with articulated concrete block mats and geotextile fabric from St. 23+95 to St. 35+73.

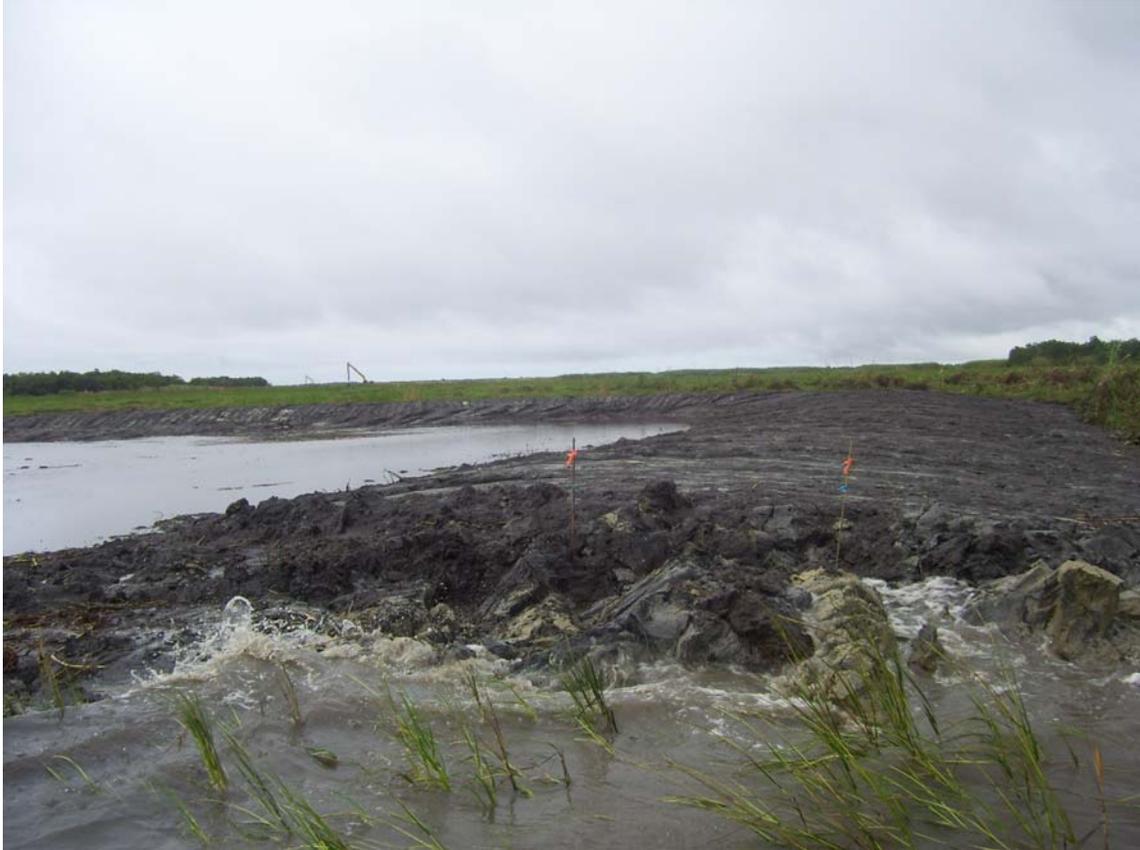
Figure 3: Earthen Containment Dike 2

GLDD began discharging marsh fill material into MCA 2 on December 9, 2018. Two weir boxes were installed at MCA 2 to dewater the area. Both weir boxes were placed along the southeastern reach of ECD 2 to allow decanted water to be discharged into the marsh nourishment area. Stop logs were added and removed in the weir boxes as required to allow for dewatering while preventing marsh fill material from exiting through the weir boxes.

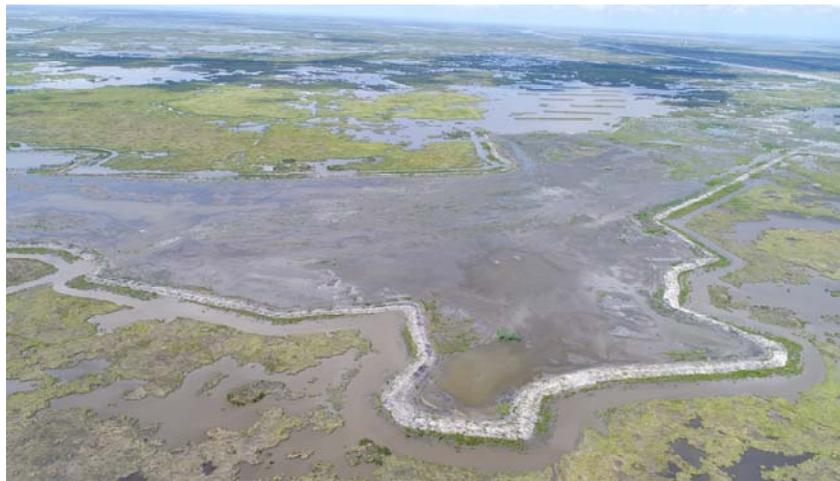
Figure 4: MCA 3 Aerial (taken June 2019)

Marsh Creation Area 3 was the last and largest MCA constructed in the Cole's Bayou Marsh Restoration Project. ECD 3 geometries included 5' crest widths, crest heights of +3.5' to +4.5', and side slopes of 4:1. The construction of ECD 3 required borrow material to be taken from outside and inside of MCA 3 as shown on the construction plans. GLDD began discharging marsh fill material into MCA 3 on January 19, 2019.

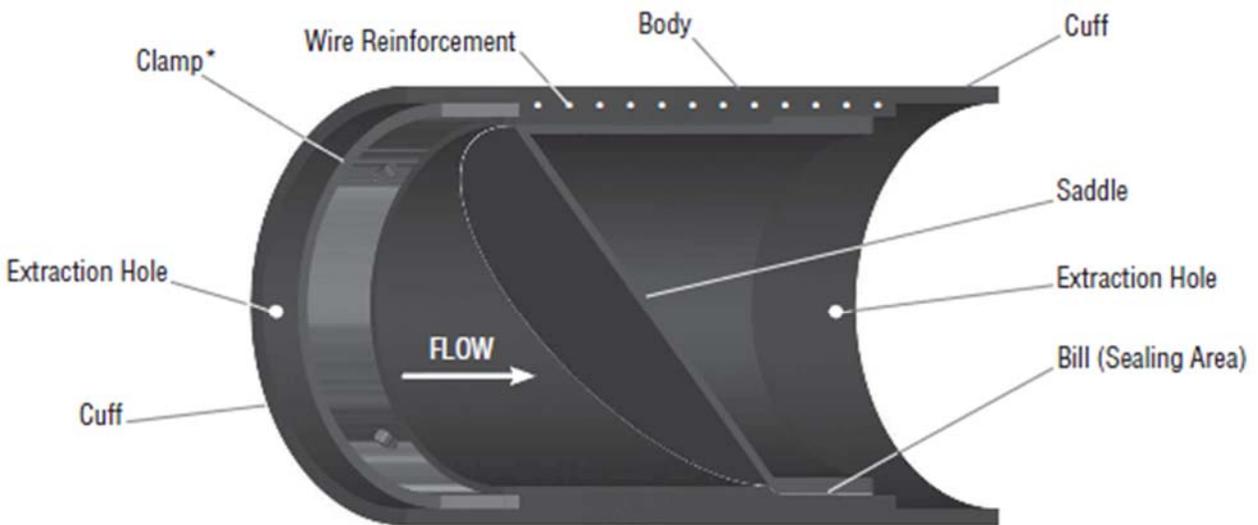
Figure 5: Red Valve inline check valve

The installation process for the Red Valve inline check valve shown below required the valve to be fastened inside the pipe using a minimum of two 304 stainless steel expansion clamps. Corrugations in the CMP around the inline check valve were then filled with grout to create a seal between the valve and the pipe. In occasional instances when the expansion clamps could not be secured in the CMP, they were allowed to be through bolted.

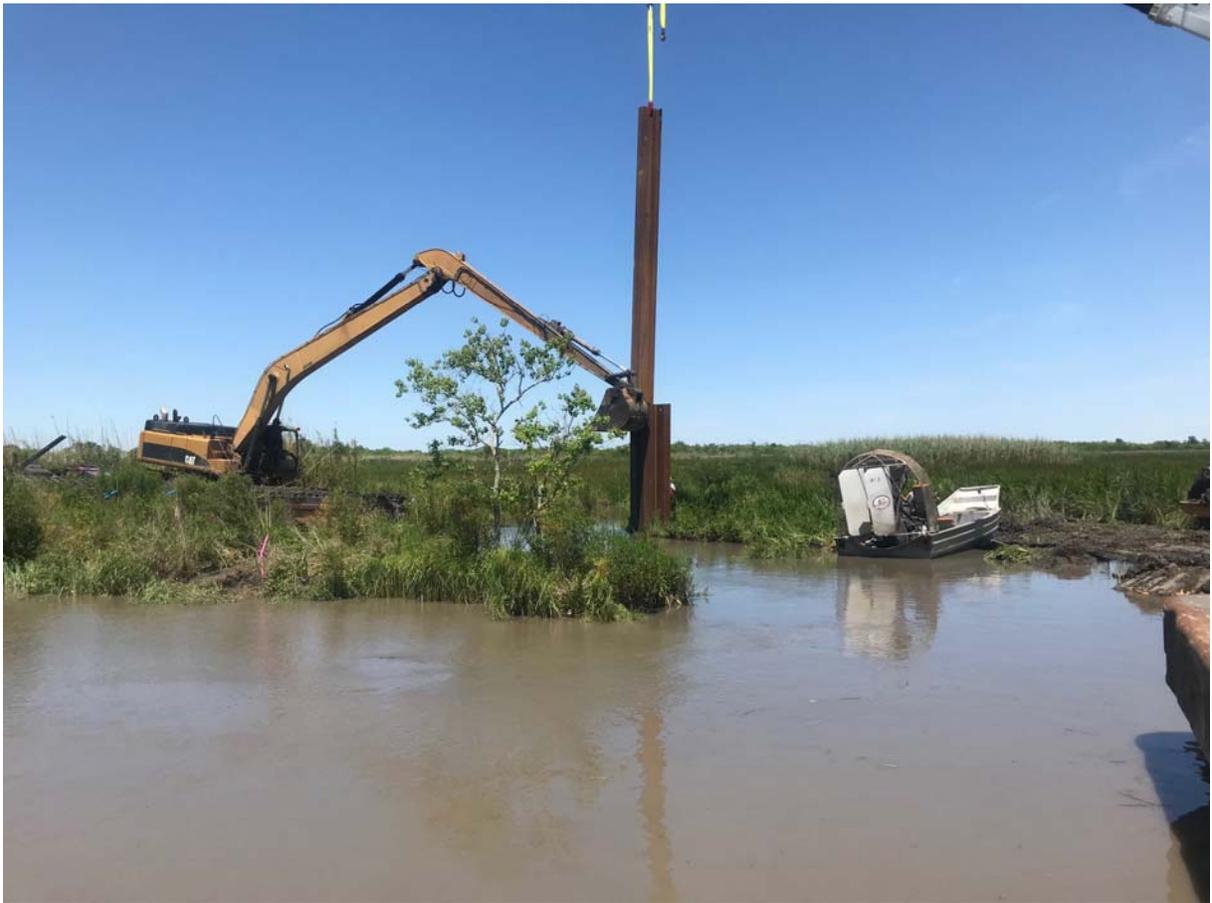
Water Control Structure 3 included the installation of one 42" corrugated metal pipe containing a Red Valve inline check valve. The check valve is located at the intake of WCS 3. Steel sheet piles were erected around WCS 3 to dewater the area. The change in site conditions between the design survey and pre-construction survey required Wilco to use the steel sheet piles in lieu of an earthen dam to effectively dewater the construction area.

Figure 16: Steel Sheet Piles being set at WCS 3 (5/14/2019)

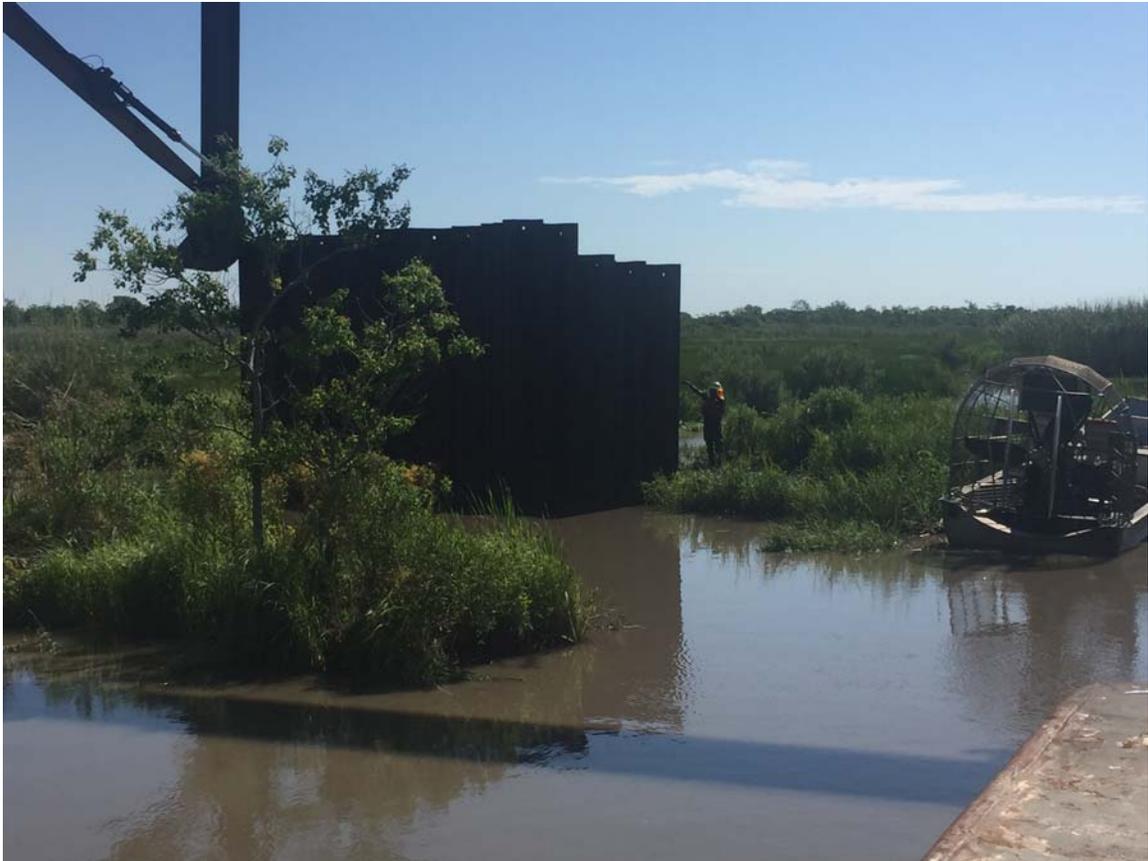
Figure 17: Steel Sheet Piles being set at WCS 3 (5/15/2019)

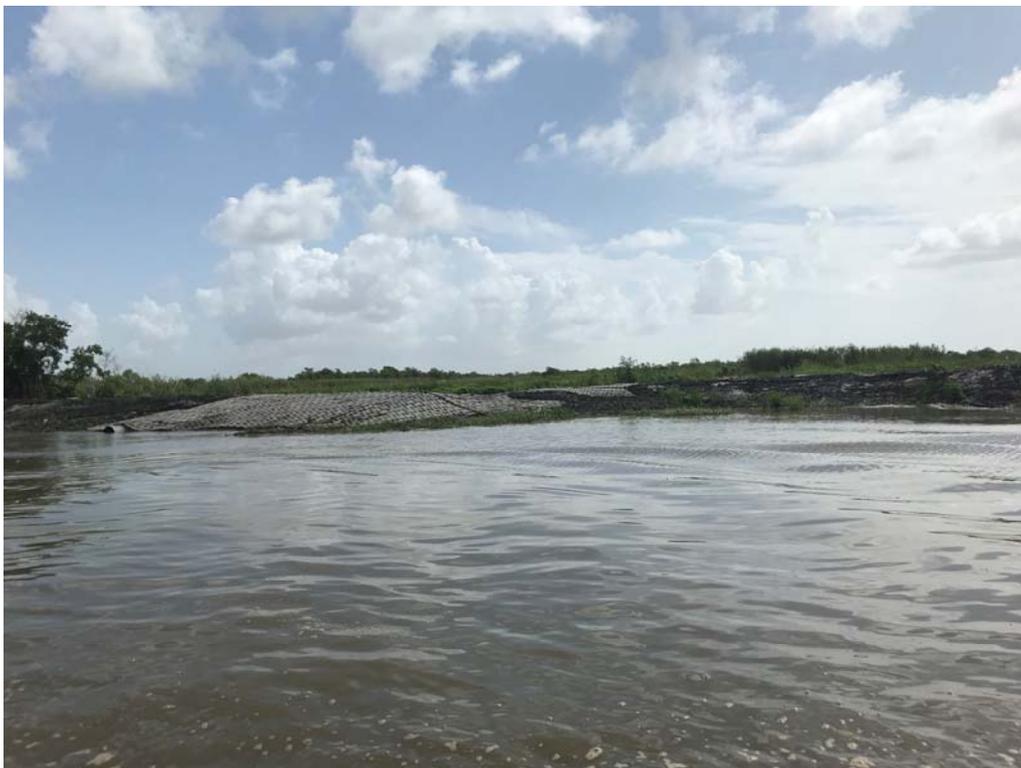
Figure 20: WCS 3 and EP 3 (8/21/2019)

In addition to the WCS an earthen plug (EP 3) was constructed. The earthen plug was located south of WCS 3 and was designed with a target as-built elevation of 2.5'. WCS and EP 3 were constructed using borrow material excavated from the adjacent canal. The original construction plans did not include ACB mats to be installed at EP3. The layout of the WCS 3 ACB mats was expanded to encapsulate EP 3 to mitigate concerns of the EP washing out. The maximum as-built constructed elevation of EP 3 is 4.3'. The sequence of construction for WCS 3 and EP 3 is depicted in Figures 16 – 21.

An additional item included in Change Order No. 4 tasked Wilco with reconstructing EP 6 due to the erosion evident at the site (described in Section 3.6 and Figure 37). In addition to the reconstruction of EP 6, Wilco then installed geotextile fabric and ACB mats at EP 6. Geotextile fabric and ACB mats were also added to EP 3 to prevent erosion.

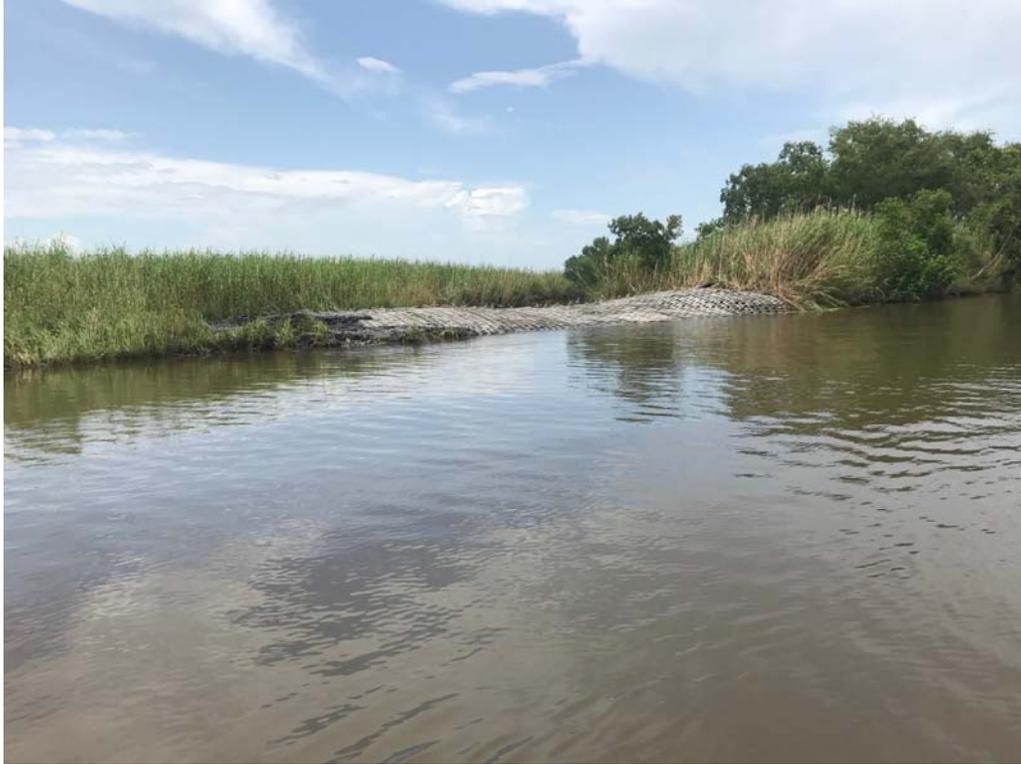
Figure 38: EP 6 (8/8/2019)

EP 6 presented various challenges, similar to EP 3. EP 6 continuously settled and degraded after initial construction was complete (degradation shown in Figure 37). Animals (alligators crossing), Hurricane Barry, boats crossing, water level fluctuation and tidal flushing contributed to the erosion and degradation of the plug. To ensure the structural stability of EP 6, it was rebuilt and protected with geotextile fabric and ACB mats through Change Order No. 4. The design target elevation of EP 6 was 2.5', while the as-built elevation varies from 2.5' – 3.3'. EP 6 was constructed using material excavated from the adjacent canal.

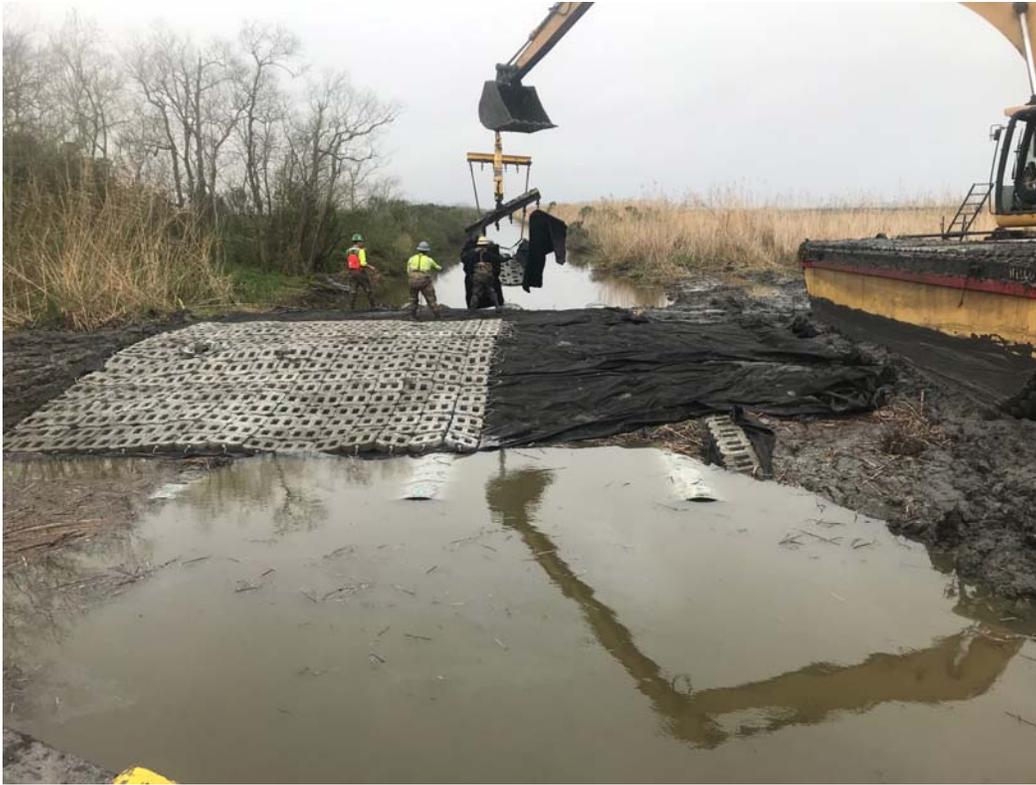
Figure 63: WCS 9 Construction (2/23/2019)
