**Coastal Protection and Restoration
Authority (CPRA)**

2022 Operations, Maintenance, and Monitoring Report

Sediment Trapping at the Jaws (TV-15)

State Project Number TV-15
Priority Project List 6

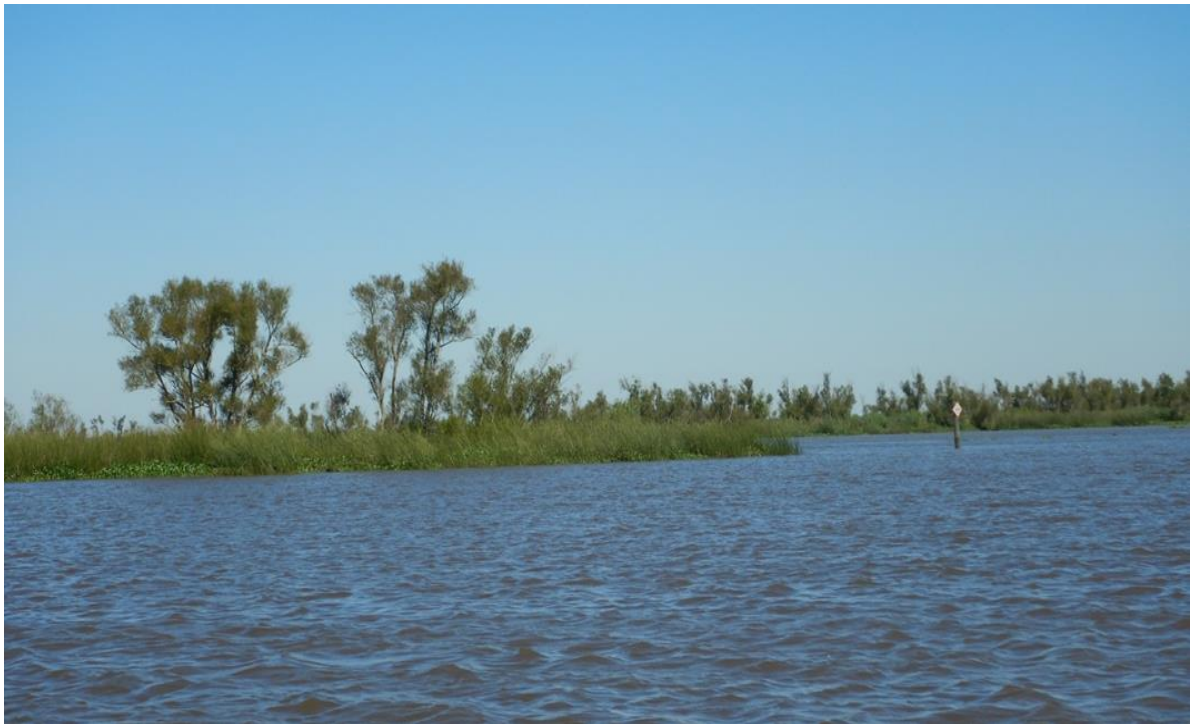
Figure 3d. Sediment Trapping at the Jaws (TV-15) the same location near the end of the projects 20 year economic life post 2020 hurricane season on 9-2021.

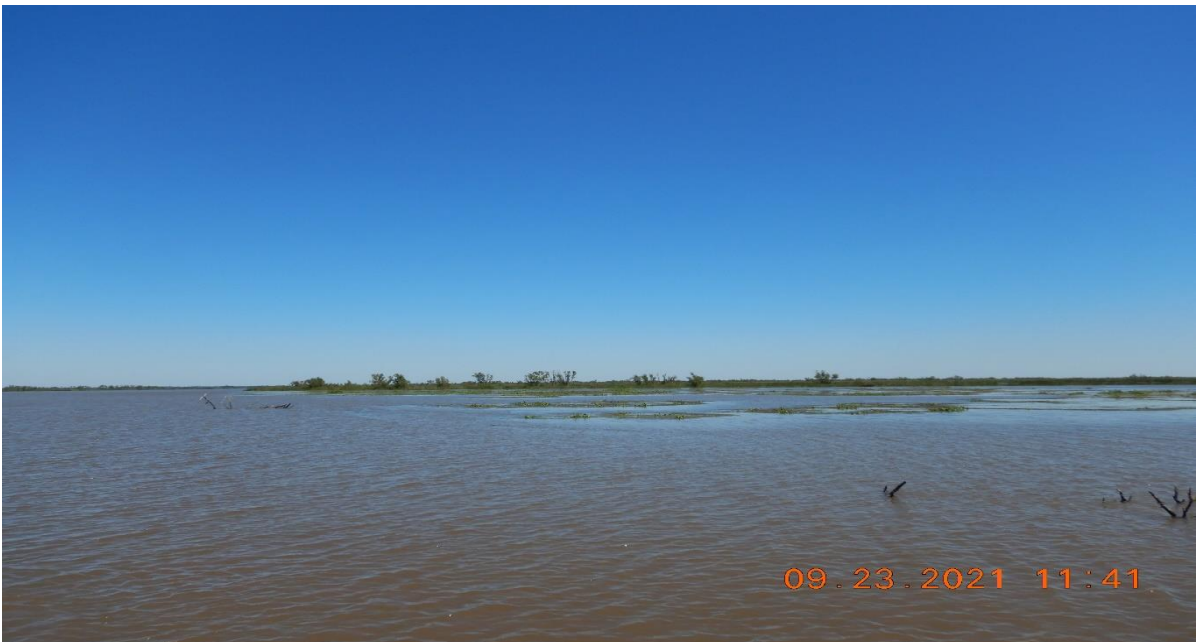
Figure 15. Sediment Trapping at the Jaws (TV-15) on 9-2021, with extensive beds of *Potamogeton diversifolium* and *Najas guadalupensis* seen growing in vast areas interspersed in the project area, covering multiple acres.

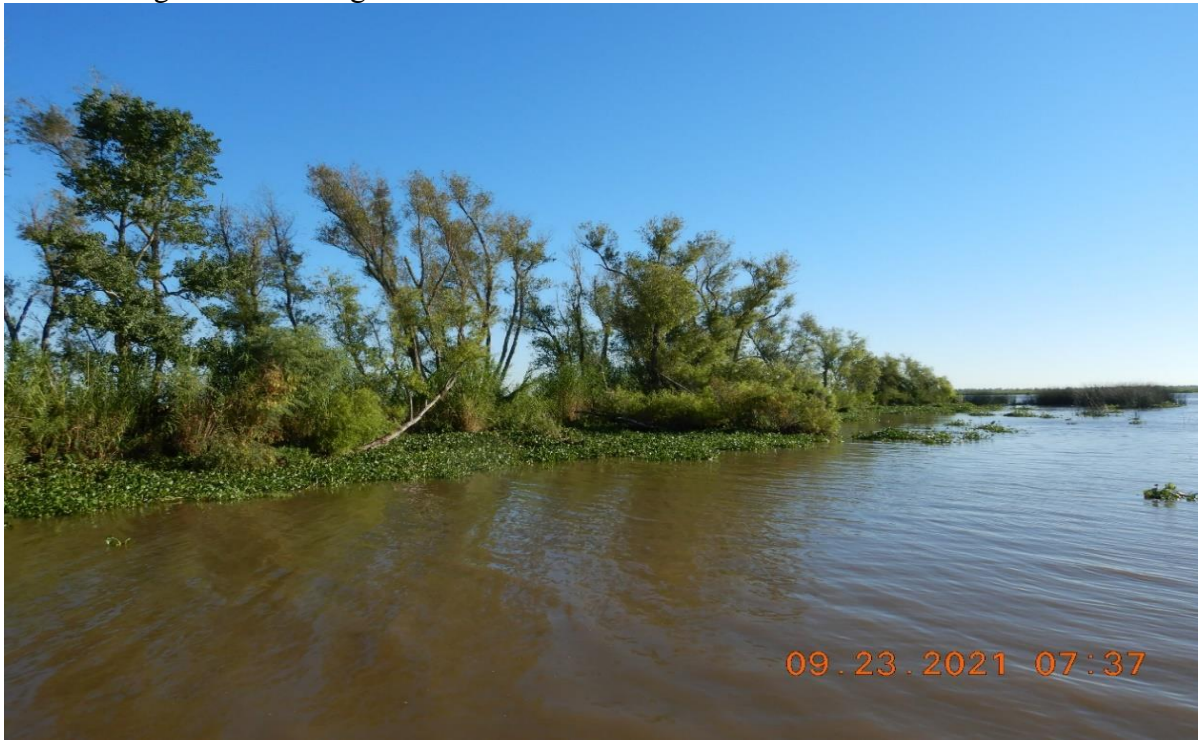
Figure 18. Sediment Trapping at the Jaws (TV-15) photo of a typical terrace as it transitions from higher to lower elevation, left to right. This generally occurs traveling southwest through the project area.

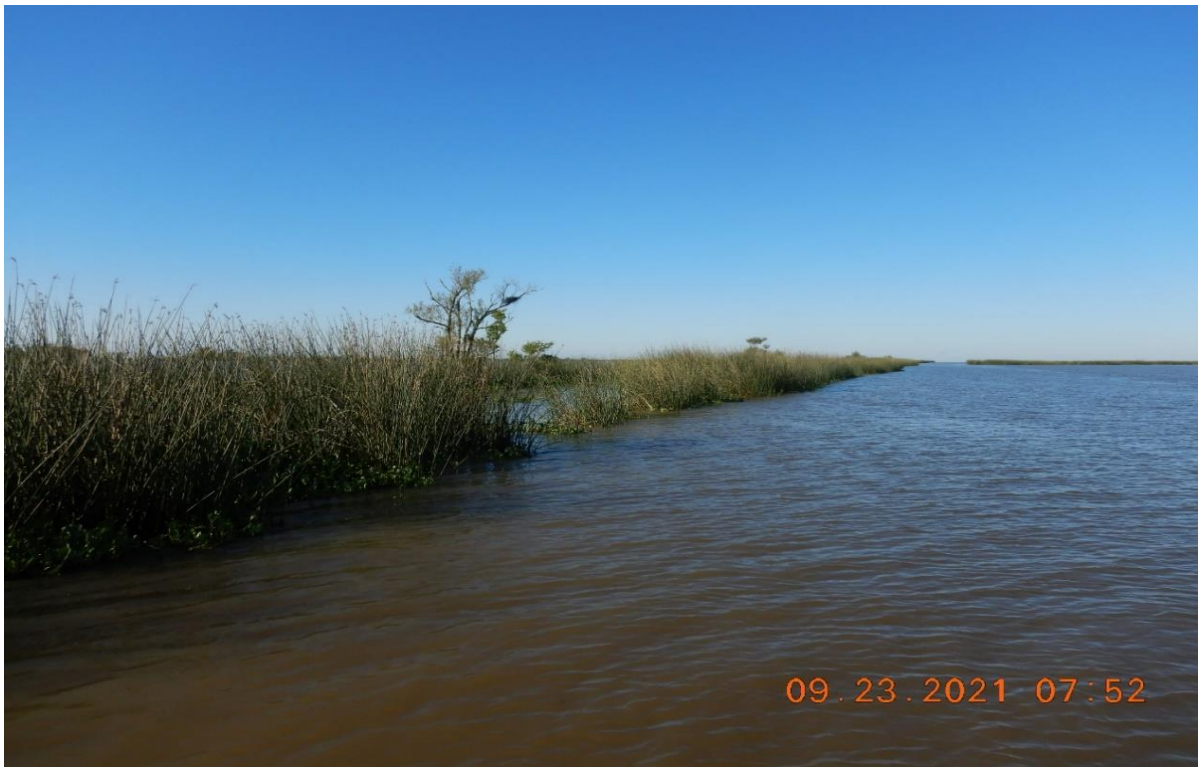
Figure 19 Sediment Trapping at the Jaws (TV-15) photo of a typical terrace as it transitions from higher to lower elevation, left to right. This generally occurs traveling southwest through the project area.

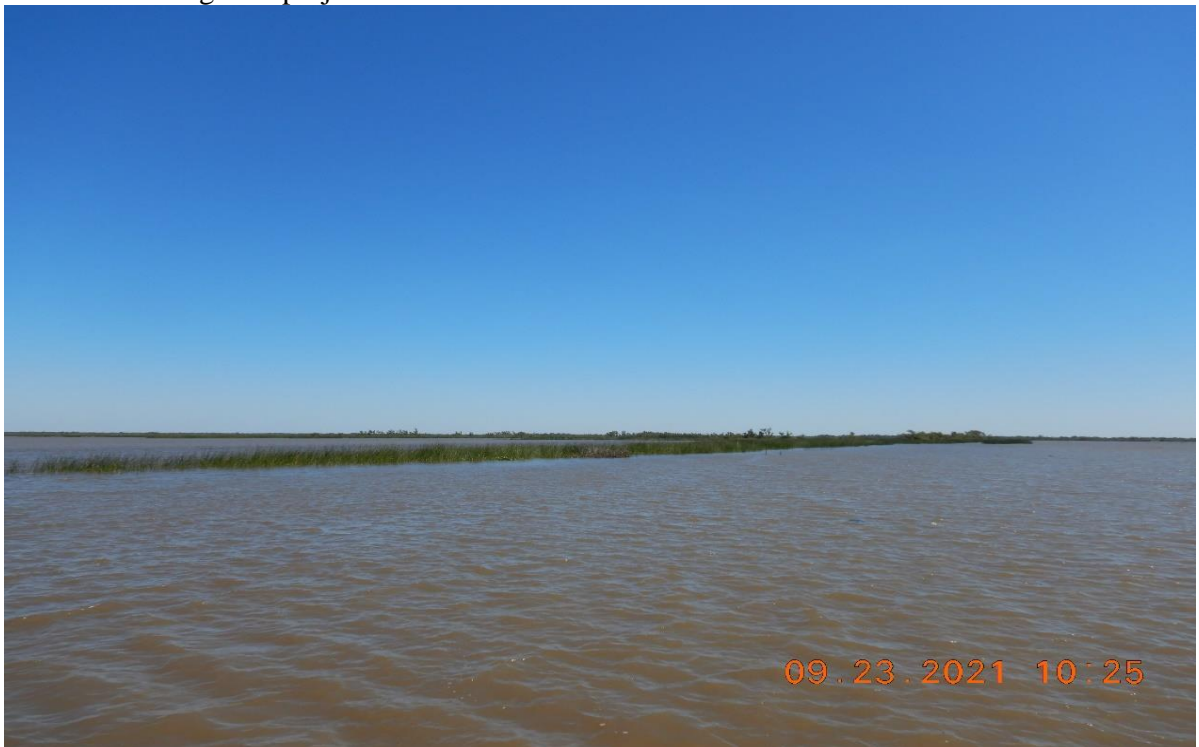
Emergent vegetation data was collected on the terraces post construction in Sept 2021. The total cover of emergent vegetation at differing relative elevations was utilized to determine what elevation's effect of species composition and quantity was over the project life. Vegetation quickly became established on all elevations of the terraces including the planted *Schoenoplectus californicus* on the terrace edge. In general, terrace vegetation types have been stable over the project life with *Salix nigra* (23%) dominating the higher point bar terrace crowns and *Schoenoplectus californicus* (69%) consistently filling the land water interface niche and spreading into deeper waters (Figure 17). However, this does not indicate the succession that has taken place in the vegetative species present and their dominance. The middle elevation of the terraces or transitional area between the water and the crown contained the least cover during the 2021 survey likely due to three factors. First, the nature of this relative elevation is transitional and annual and seasonal variability could select for new species. During this recent survey, *Schoenoplectus californicus* (14%) was the dominant species, likely due to years of high water and recent storm events. Also this relative elevation on the terrace slope was generally in the wave break zone during average storm and frontal passages leading to both erosive damage and smothering via FAV's, mainly *Eichhornia crassipes* (Figure 18). In general the terrace's northern most portions were higher supporting woody vegetation which, as the terrace stretched out away from the main channel, transitioned into *Schoenoplectus californicus* monocultures in deep water, rarely appearing subaerial (Figure 19). These stands eventually gave way to isolated pockets of the vegetation before diminishing to open water where the terraces had either eroded, subsided too deeply beneath the water, or both. (Figure 20).

Figure 20. Sediment Trapping at the Jaws (TV-15) photo of a typical terrace as it transitions from higher to lower elevation, right to left. This generally occurs traveling southwest through the project area.
