**Coastal Protection and Restoration
Authority (CPRA)**

2024 Operations, Maintenance, and Monitoring Report

Cole's Bayou Marsh Restoration

State Project Number TV-0063
Priority Project List #21

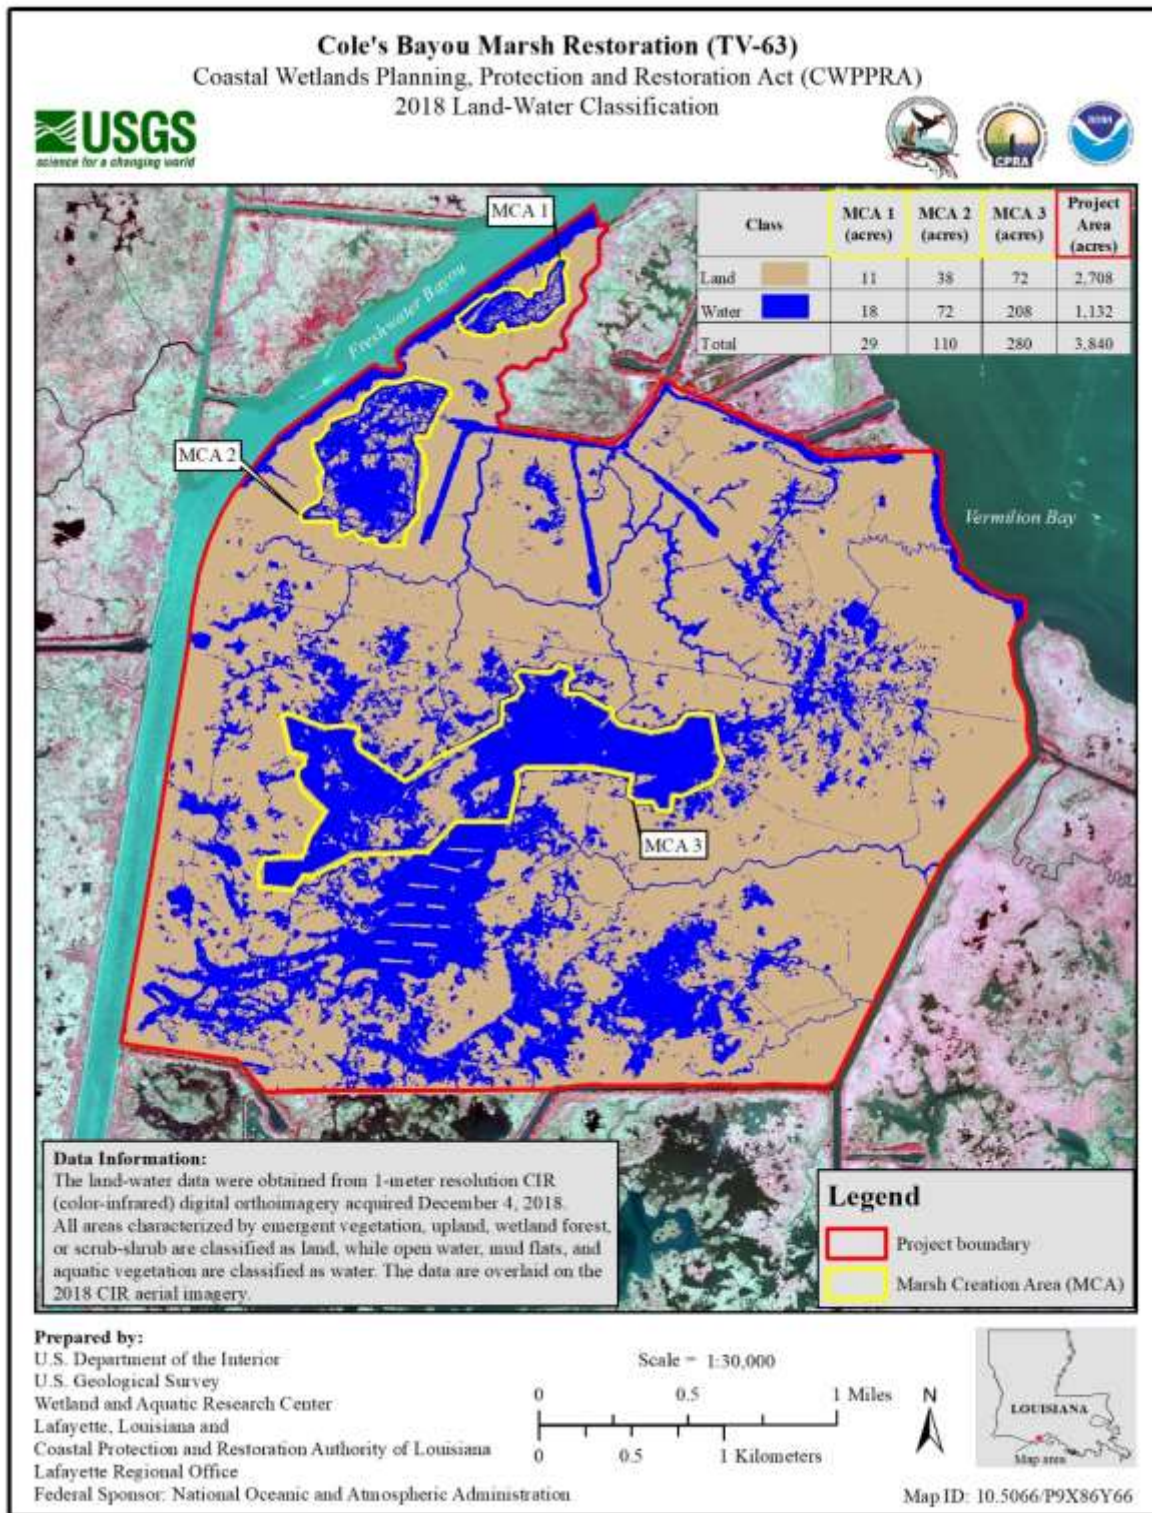
Land:water analysis was completed for the 2018 pre-construction aerial photography (Figure 2). Results indicated 37.93% land and 62.07% water within MCA 1, 34.55% land and 65.45% water within MCA 2 and 25.71% and 74.29% water within MCA 3. Overall, the project area was 70.50% land and 29.51% water prior to construction. Future analyses will determine land/water ratios in the project area through time as the marsh creation areas settle.

Figure 2. Cole's Bayou Marsh Restoration (TV-63) project 2018 land/water analysis pre-construction.

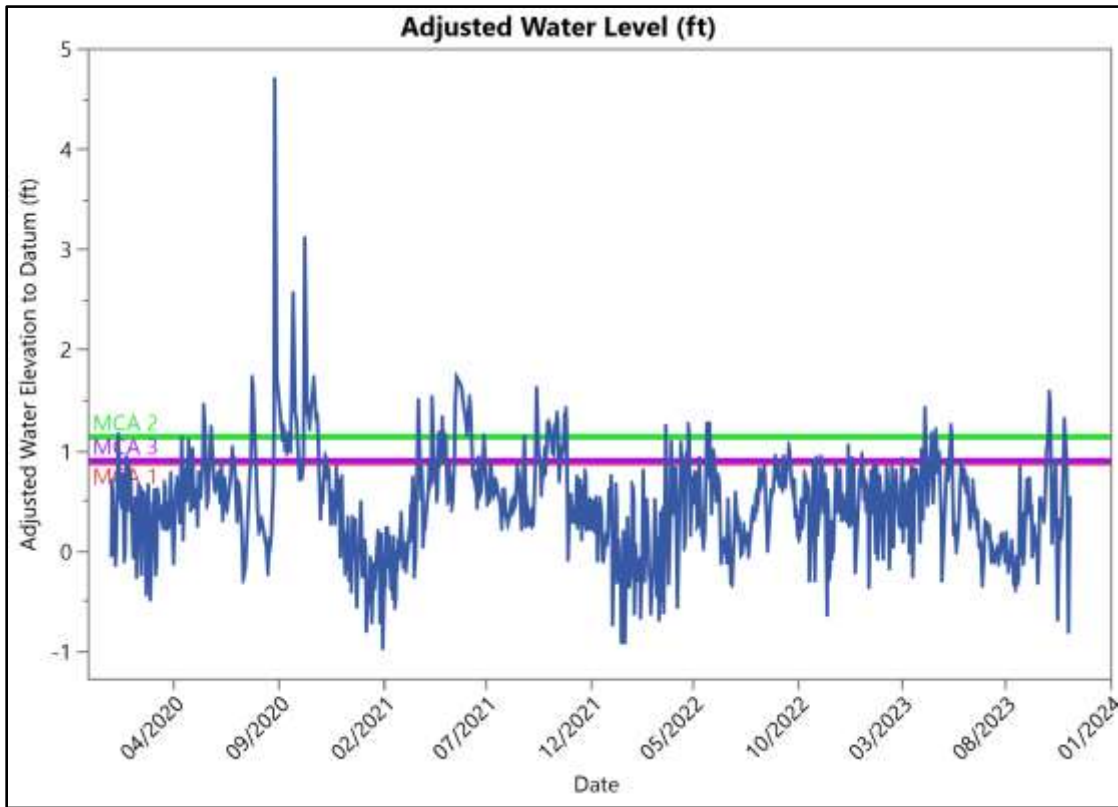
When comparing water elevation to datum to the marsh platform elevation (Figure 4), all three MCA's are in the upper region of the tidal frame. MCA 2 experiences less inundation being slightly higher than MCA 1 and 3.

Figure 4. 2018-2024 adjusted water elevation to datum from CRMS0618 compared to 2023 settled elevations at the TV-63 marsh creation areas. The average height of MCA 1 (red), MCA 2 (green) and MCA 3 (purple) all shown on the maps.

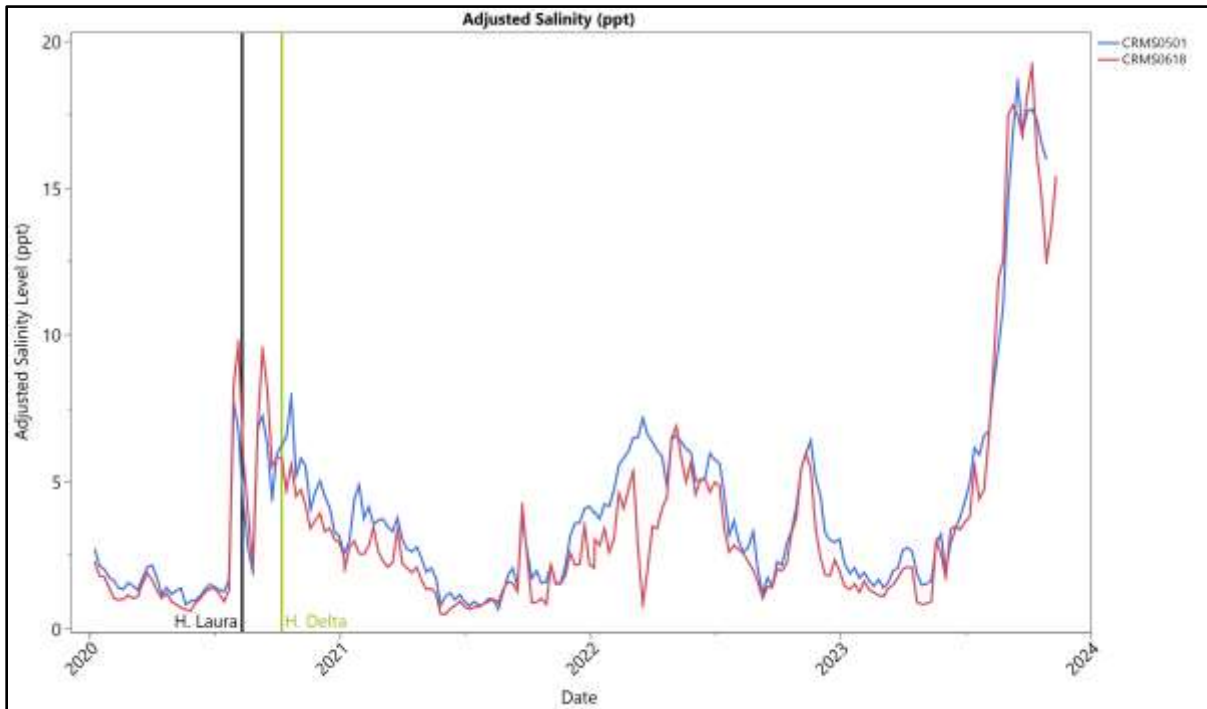
The reference CRMS sites also recorded salinity levels throughout 2023 (Figure 5). Salinities throughout the first half of 2020 were typically less than 2 ppt in the marshes where the reference sites are located. Following Hurricanes Laura and Delta, salinities spiked to over 10 ppt at the sites. Salinities were slower to recede than water levels following the storms and were still slightly elevated by the end of 2020. Salinities dropped and remained low throughout 2021 with only a slight uptick due to Hurricane Nicholas that made landfall in southeast Texas in September. Salinities stayed relatively low averaging around 4 ppt through 2022. In late 2023 we saw a large spike in salinity that was the result of a prolonged severe drought that kept salinities elevated through early 2024.

Figure 5. Hourly salinity levels from January 2020 through October 2023 of the reference CRMS sites. Data was taken from CIMS Data portal.

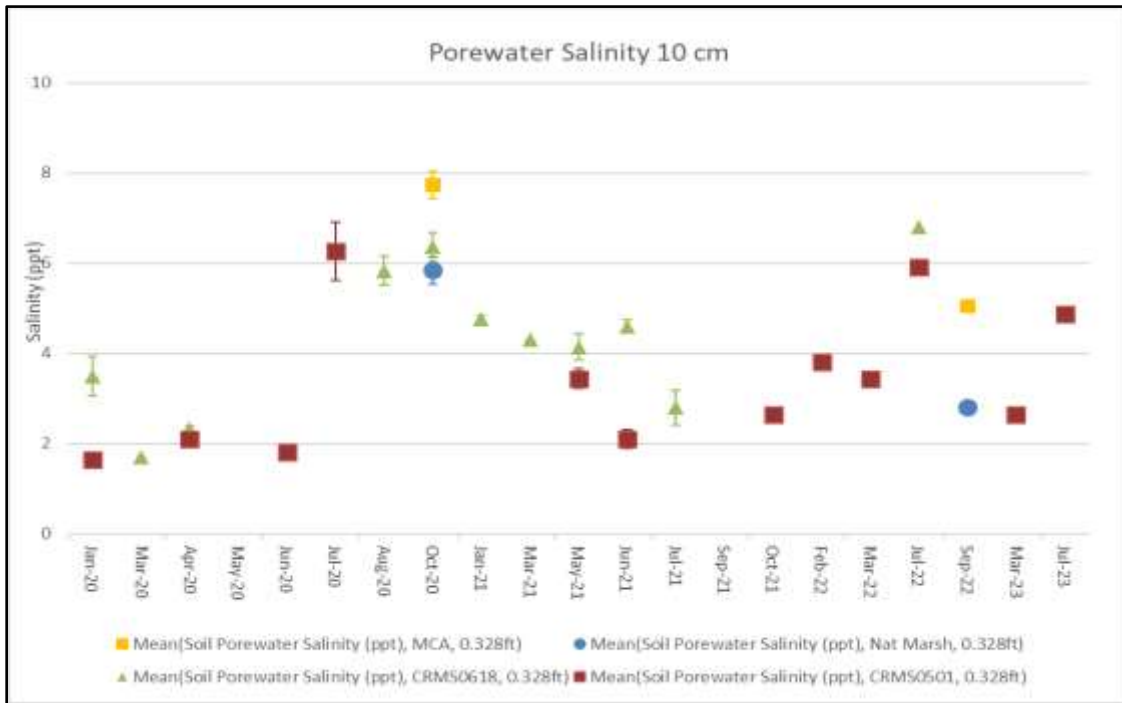
Interstitial water salinity was collected in the TV-63 project area (Figures 6 and 7). Porewater salinities in the marsh creation areas ranged from 6-8 ppt, which fall within the intermediate to slightly brackish range. Salinities in the natural marsh (pre-existing marsh in the project area) were similar at ~6ppt at both 10 and 30 cm, indicating the salinity of the borrowed sediments was similar to the existing surrounding marsh. After the two major hurricanes of 2020 (H. Laura and H. Delta) soil salinities dropped until the end of 2021, then rose back into the 4 – 6 ppt in response to the drought of 2022-23. This trend is seen in both the created marsh and in the natural marsh areas.

Figure 6. Porewater salinities within the TV-63 marsh creation areas, natural marsh and select CRMS sites from January 2020 to July 2023 at 10 cm below the soil surface. Error bars represent standard error.

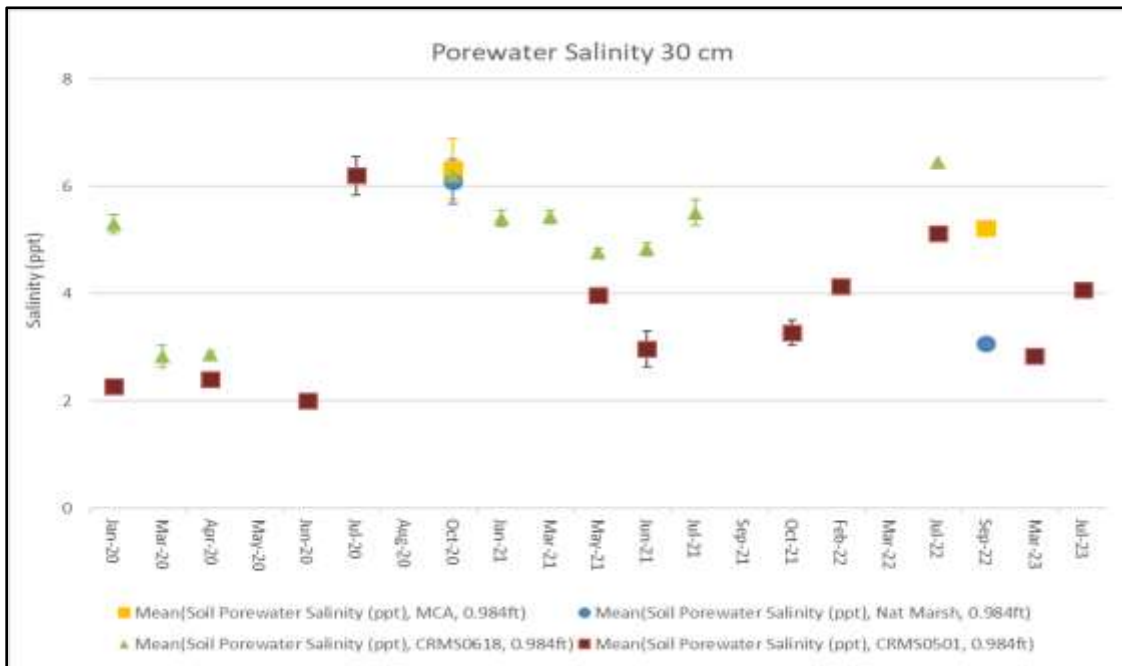
Figure 7. Porewater salinities within the TV-63 marsh creation areas, natural marsh and select CRMS sites from January 2020 to July 2023 at 30 cm below the soil surface. Error bars represent standard error.

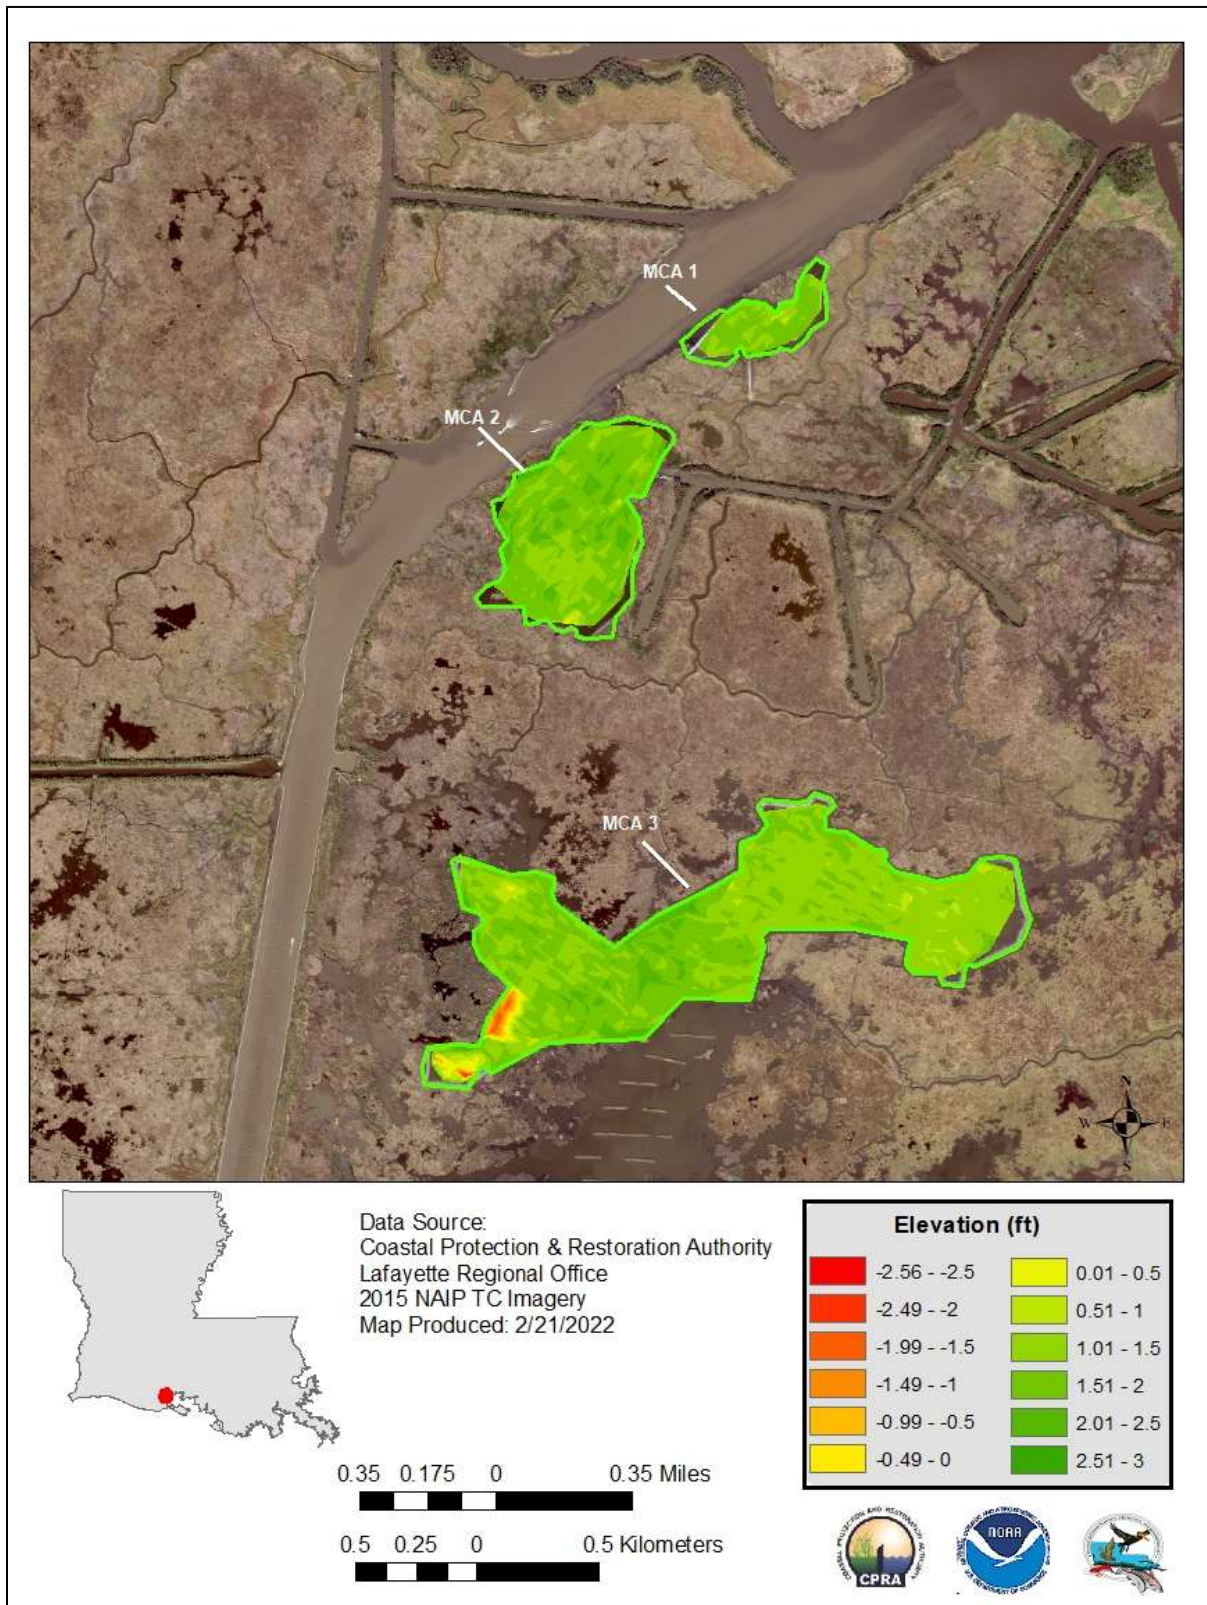
Figure 11. Elevation grid models for the TV-63 marsh creation fill areas from the December 2020 Survey.

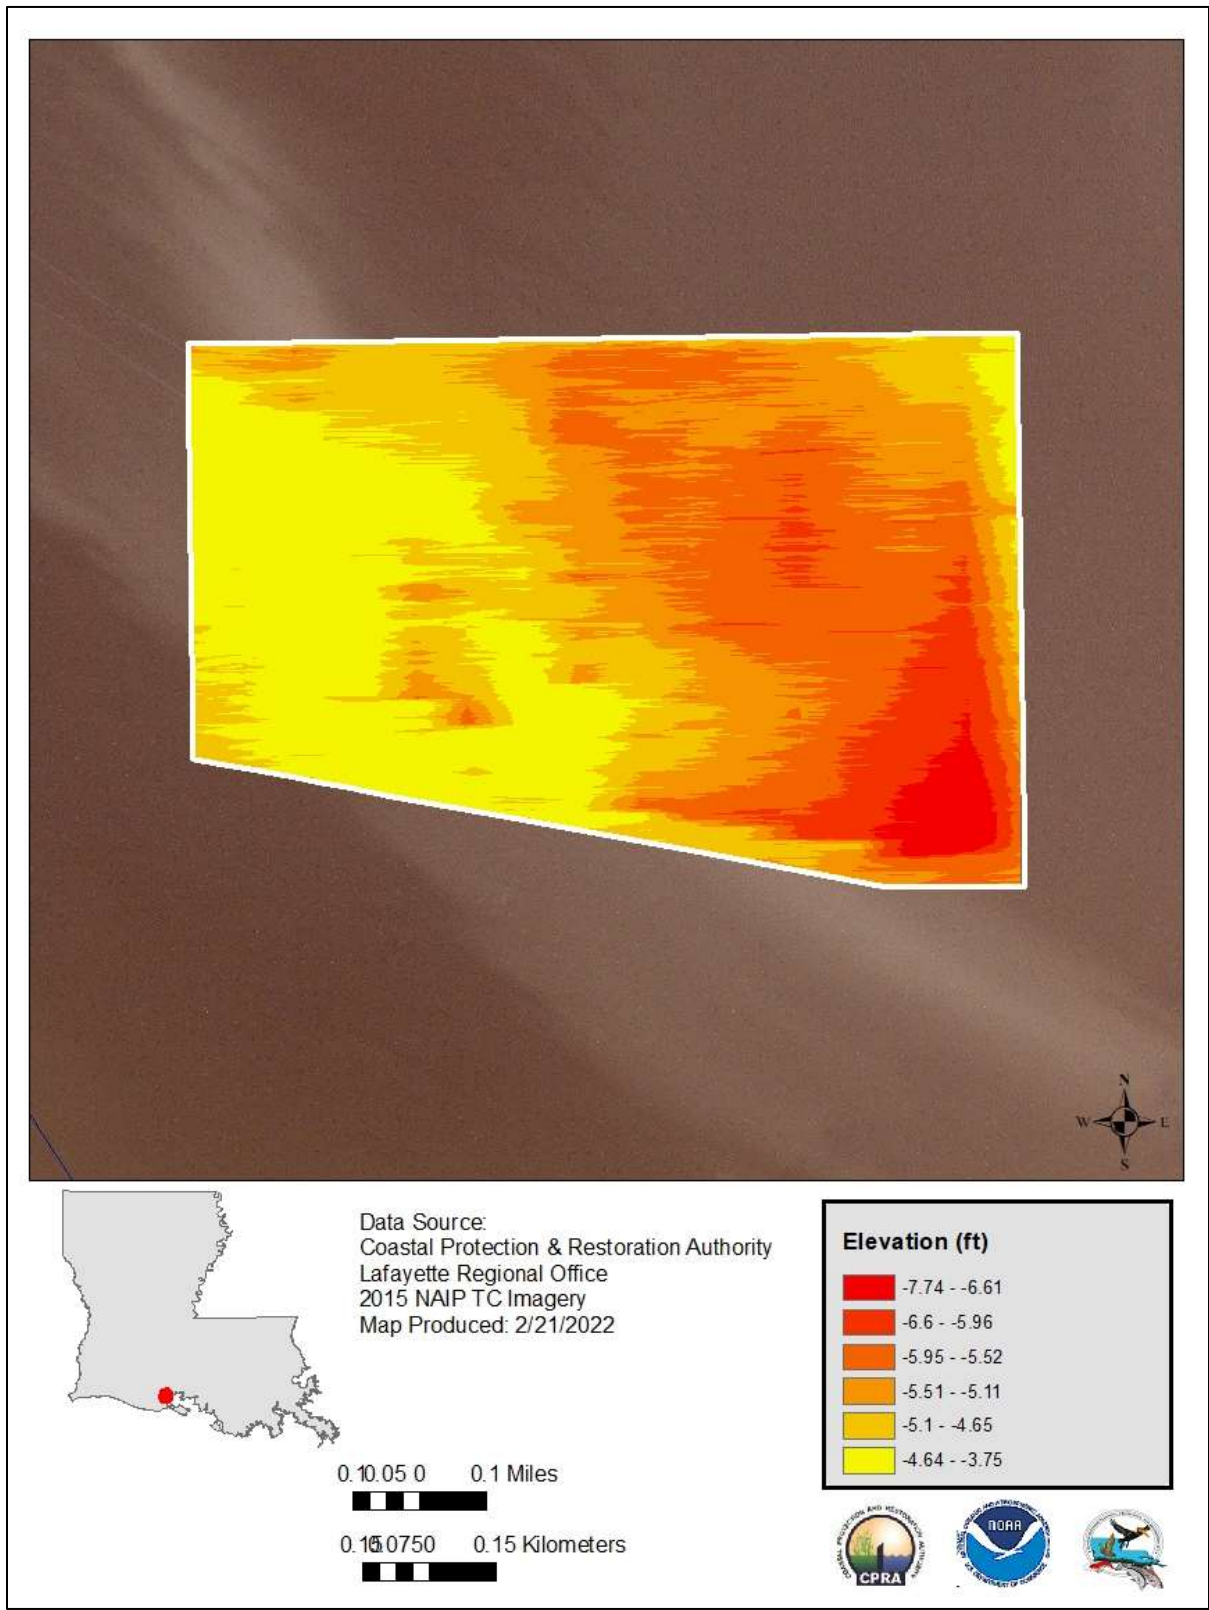
Bathymetric surveys of the borrow area within Little Vermilion Bay were completed at the time of the as-built survey in August 2019 and one year post-construction in December 2020 (Figure 13). Average elevation in the borrow area at the time of the as-built survey was around -7 ft. Significant infilling occurred in the first year following construction. Average elevation increased by ~2ft to -5.15 ft. More significantly, the minimum elevation increased from -18.52 ft to -7.75 ft. Depths within the borrow area increase from west to east with the deepest portion in the southeast corner. In the 2023 survey, the borrow area saw further infilling to an elevation of -4.99 ± 0.002 ft. on average. The borrow area saw an increase of 0.151 ft. between the 2020 and the 2023 survey but a measurable decrease in growth due to encroaching on local water bottom average elevations of around -4 – -6 ft. (Figure 14). Future bathymetric surveys, with the next scheduled for late 2025, will further document the infilling of the borrow area through time.

Figure 13. Elevation grid model for the TV-63 borrow area from the December 2020 Survey.

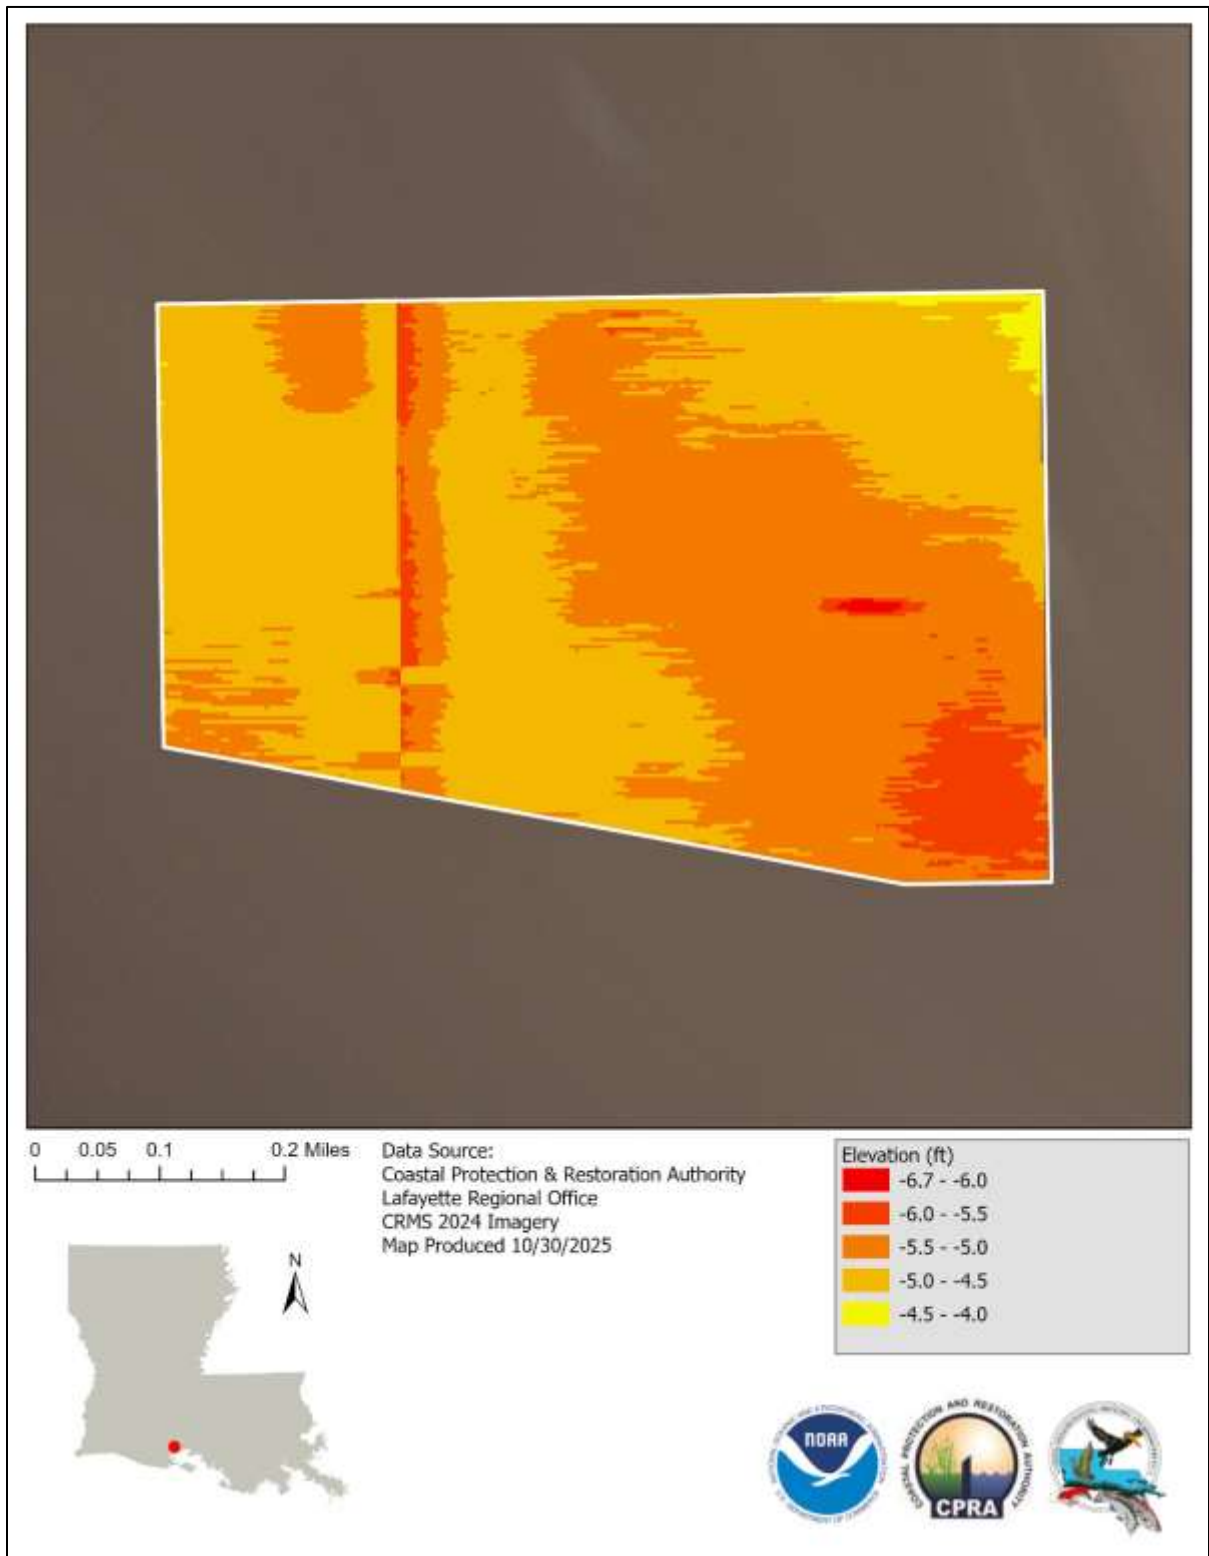
Figure 14. Elevation grid model for the TV-63 borrow area from the June 2023 Survey.

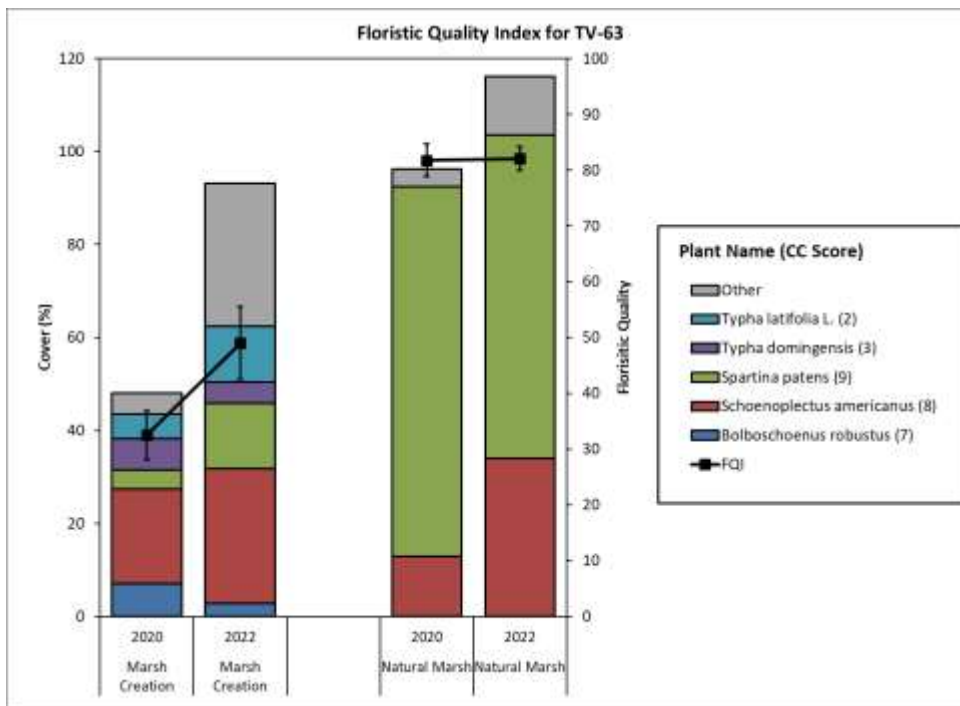
Figure 15. Percent coverage and floristic quality index of species collected from the TV-63 marsh creation and natural marsh areas in 2020 and 2022. The Coefficient of Conservatism (CC) scores represent the quality of individual species from 1 to 10 where 1 represents disturbance species and 10 indicates stable species.

The project area saw the FQI increase in overall total plant coverage in the MCAs (Fig 15). We saw an increase of more than 30% between the first vegetation survey in 2020 and the second one that was completed in 2022. Project areas are typically vegetated around year three post construction of the MCA. TV-63 was completed in 2019 and a majority vegetated before 2022. As mentioned we saw low coverage percentages in the MCA area in 2020 with the area mainly being composed of *Schoenoplectus americanus*, *Bolboschoenus robustus* and both species of *Typha*. We didn't see an increase in the main vegetation seen between 2020 and 2022 other than a boom in the percentage of *Spartina patens*, along with an increase in multiple smaller flora species which were classified in the Other portion of the percentage. In addition, the eastern section of MCA3 saw significant vegetation colonization compared to the 2020 survey (Figure 18).

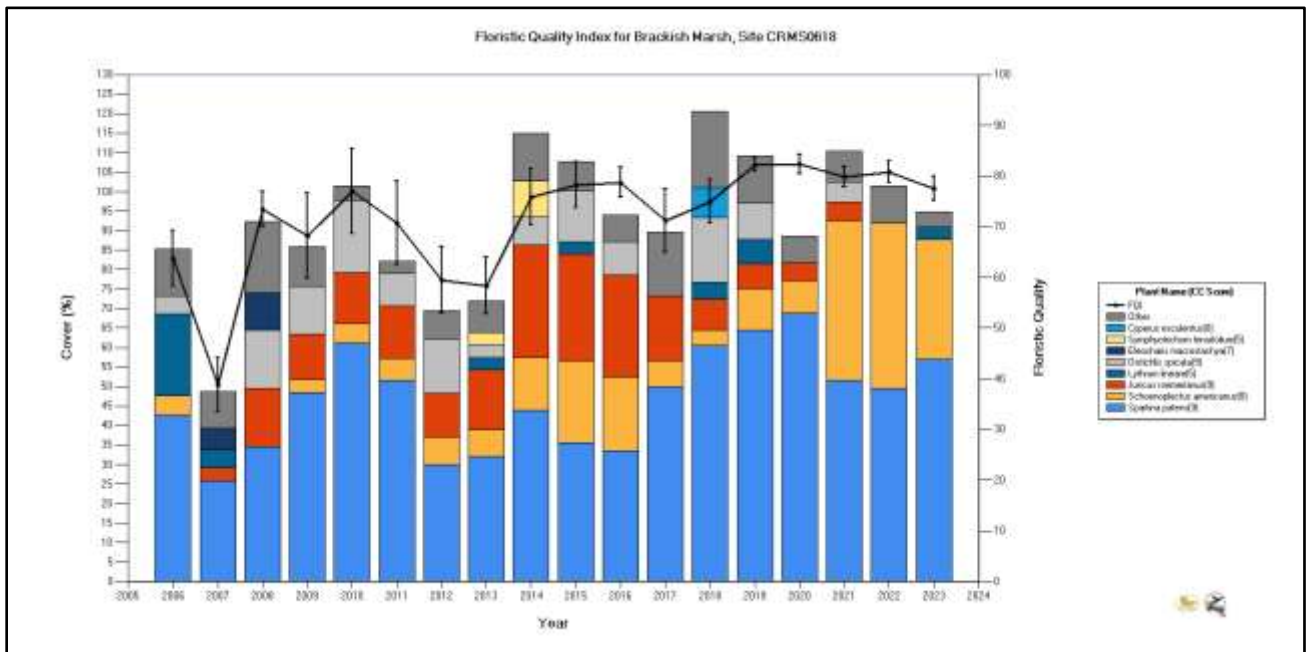
CRMS0618 is located within a managed marsh across Freshwater Bayou from the project, but has a similar species assemblage to the project area (Figure 19). The site is dominated by *S. patens* and *S. americanus* but is classified as brackish, due to the presence of *Distichlis spicata* and *Juncus roemerianus*. The site saw a drop in cover in 2020 but rebounded in 2021 due to an increase in *S. americanus*, even though the cover of *S. patens* dropped slightly. This is a positive sign that the busy hurricane season of 2020 did not have lasting impacts on the vegetation of the area. For the 2021 survey we saw a boom of *Schoenoplectus americanus* that took over as one of the main species in the area alongside *S. patens* that historically has thrived in the area. The same trend was observed through 2023 at CRMS618; *Schoenoplectus americanus* and *Spartina patens* were together as the majority of flora in the area. CRMS0501 is located within a brackish marsh south of the project area that is unmanaged and has a direct connection to Freshwater Bayou (Figure 20). This site didn't see the drop in cover during 2020 that CRMS0618 did, but saw a slight decrease in 2021. The drop in cover is primarily related to a reduction in the fresher species *T. latifolia*, *V. Luteola* and *Ipomoea sagittata* with an increase in *B. robustus*. After 2021 the CRMS site saw an increase in total cover through 2022 due to increased growth of *Schoenoplectus americanus* and *S. patens* in the 2022 vegetation season. Again, a jump in total cover was recorded due to the appearance of *Vigna luteola* across the CRMS site in 2023.

Figure 19. Percent coverage and floristic quality index of species collected from CRMS0618 2006-2023. The Coefficient of Conservatism (CC) scores represent the quality of individual species from 1 to 10 where 1 represents disturbance species and 10 indicates stable species.
