**State of Louisiana
Coastal Protection and Restoration Authority**

2015 Annual Inspection Report

**BAYOU CHEVEE SHORELINE
PROTECTION (PO-22)**

State Project Number PO-22
Priority Project List 5

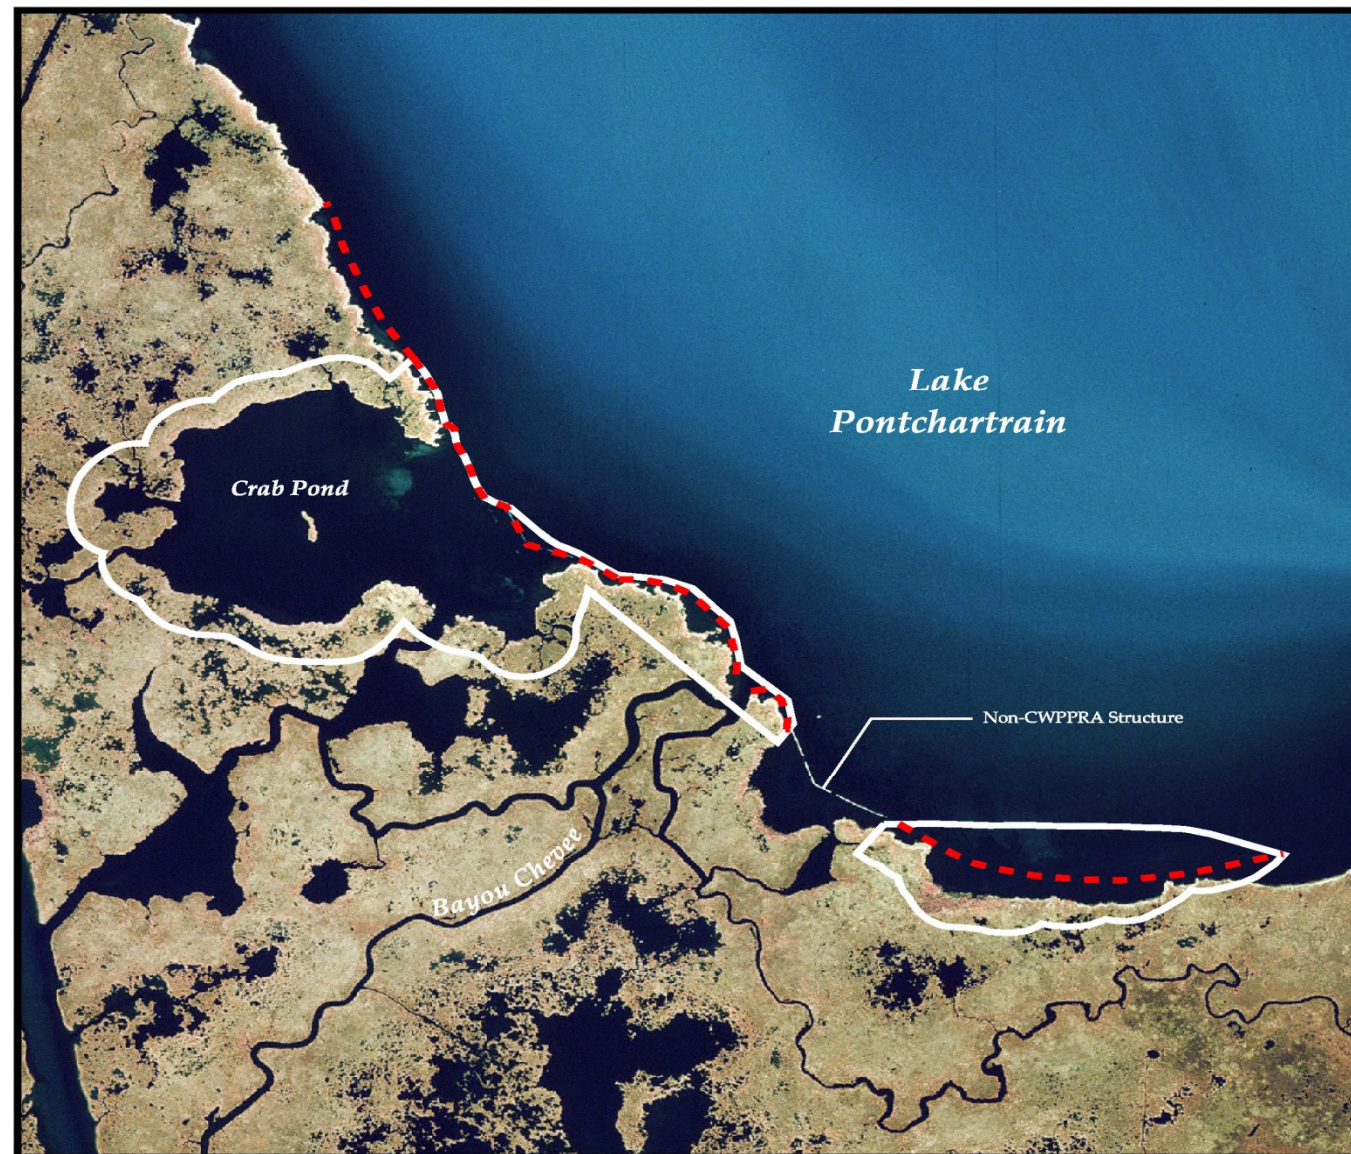
Project Features Map

Bayou Chevee Shoreline Protection (PO-22)

Construction of the Bayou Chevee project was completed on December 7, 2001. The project is divided into two areas, the North Cove area and the South Cove area (Appendix A). The rock dike protects both areas from shoreline erosion.
