**2004 Operations, Maintenance,  
and Monitoring Report**

**Pecan Island Terracing**

State Project Number ME-14  
Priority Project List 7

May 2004  
Vermilion Parish

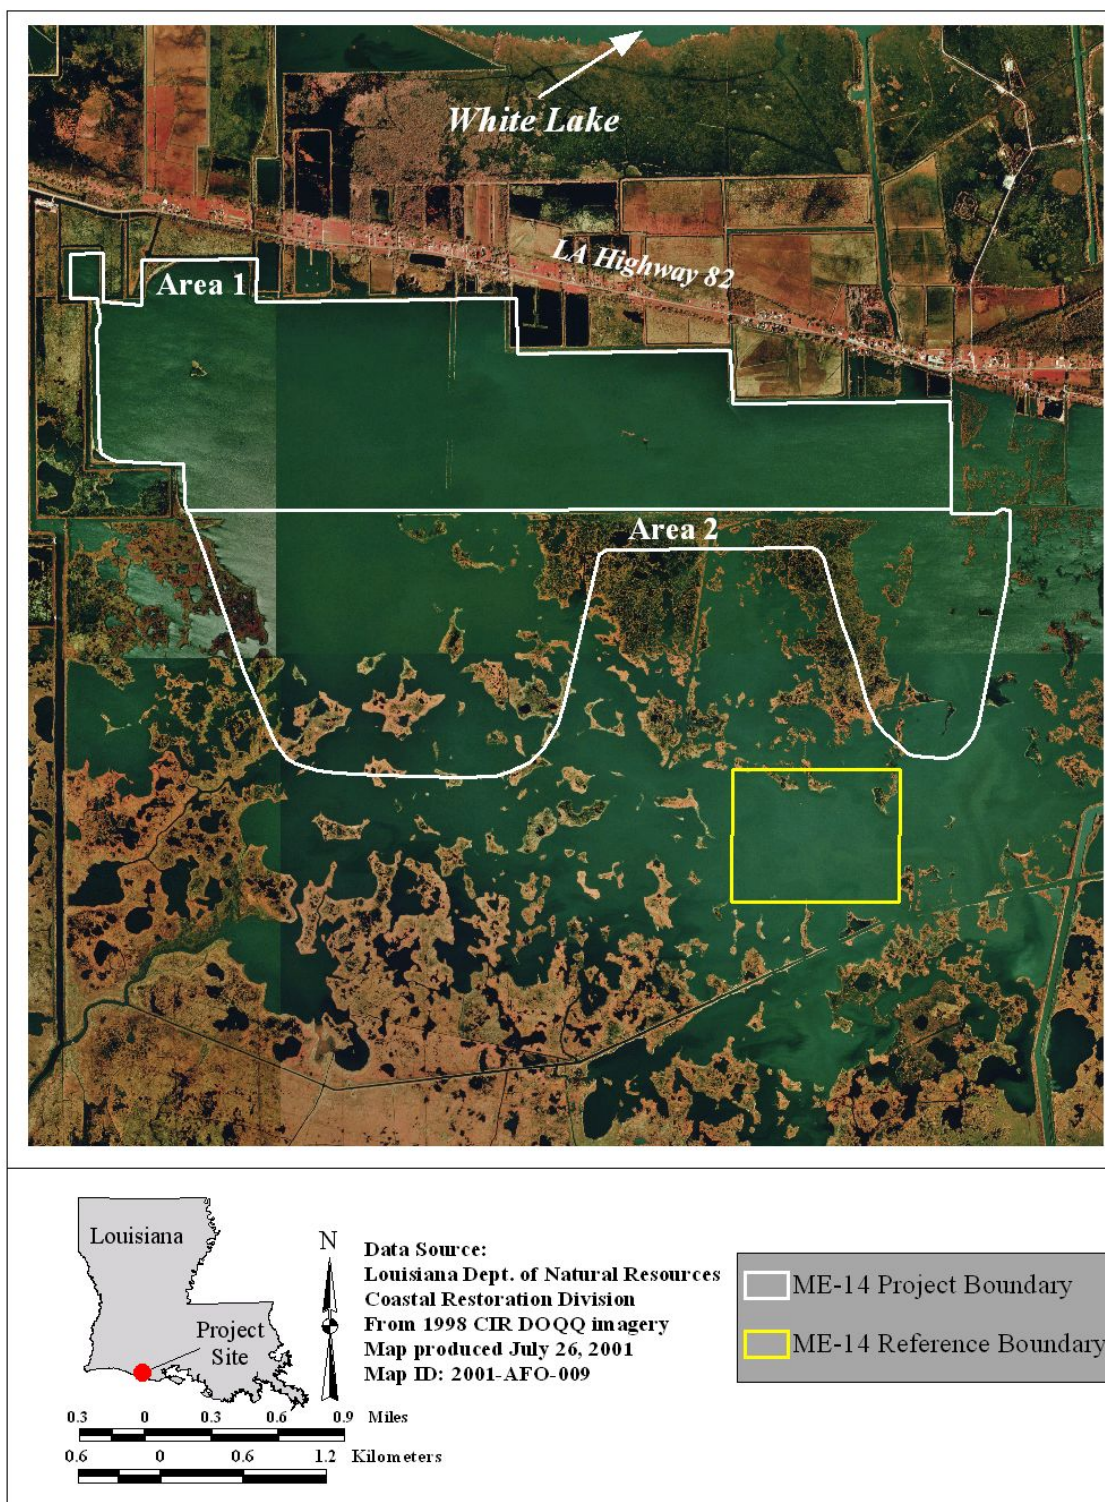
**Figure 1.** Pecan Island Terracing (ME-14) project and reference area boundaries.

The Pecan Island Terracing (ME-14) project is located five miles north of the Gulf of Mexico just south of Pecan Island and Hwy 82 in the Lakes Sub-basin of the Mermentau Basin, Vermilion Parish, Louisiana (figure 1). The total project area comprises 3,753 acres (1,519 ha) of brackish marsh and open water. Area 1 is primarily open water and was formerly pasture land of approximately 1,938 acres (784 ha). Area 2 consists of 1,715 acres (694 ha) of brackish marsh and open water.

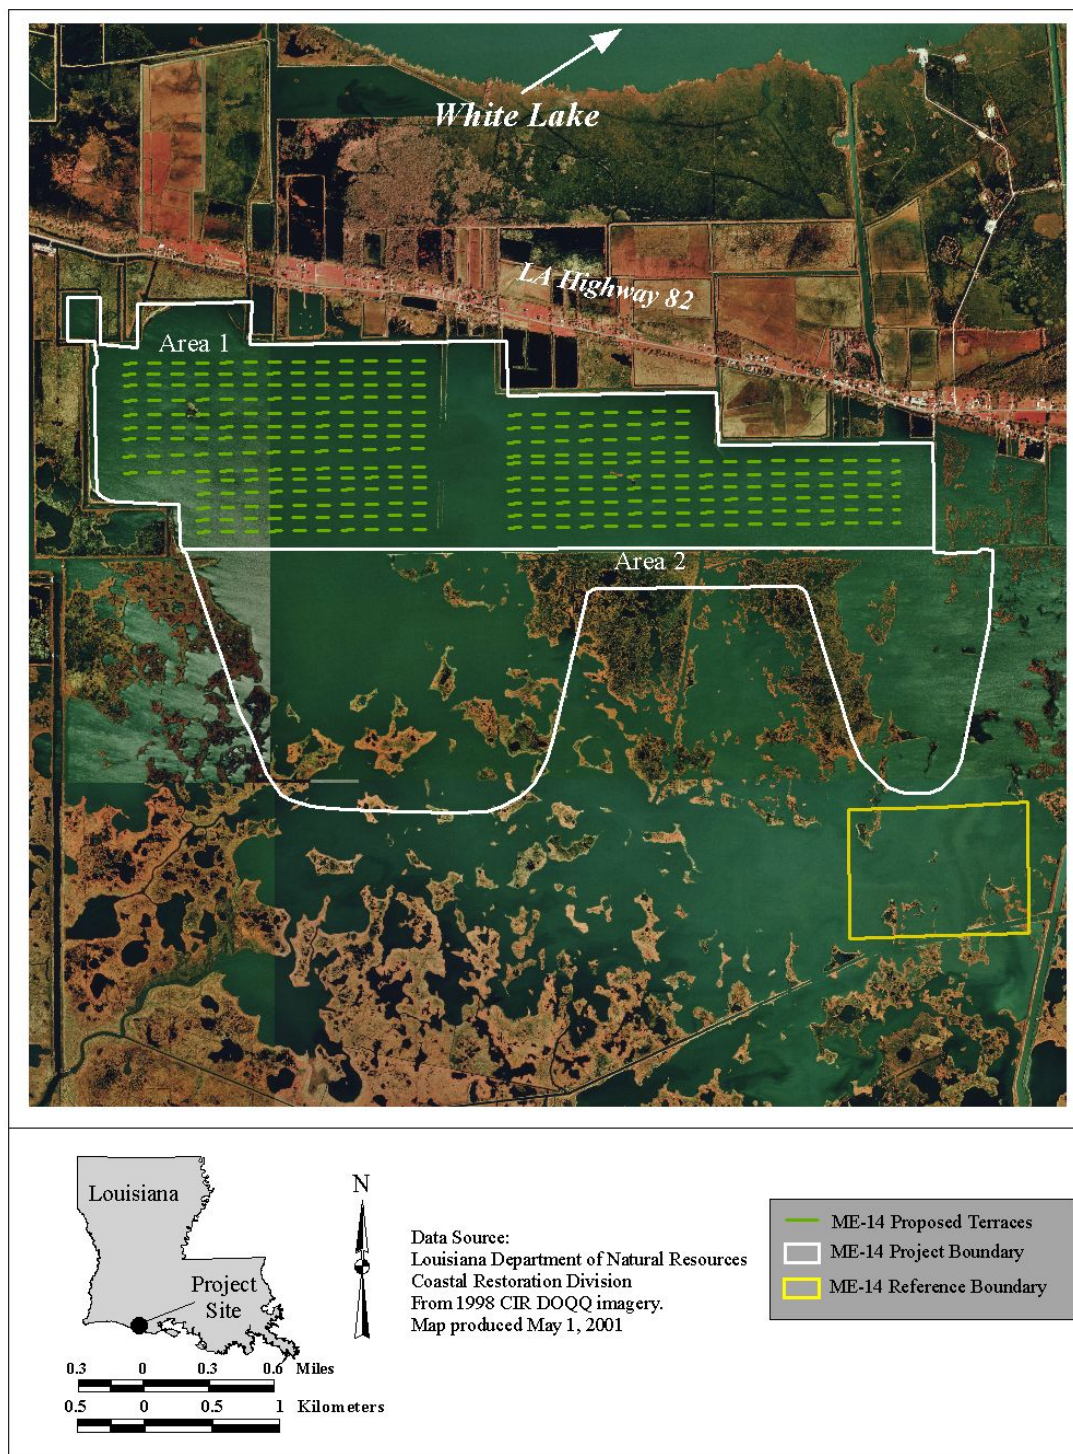
**Figure 2.** Pecan Island Terracing (ME-14) location of terraces.

The project features include construction of 197,000 linear feet (60,046 m) of terraces in 500 ft (152.4 m) sections with a 50 ft (15.24 m) break between each terrace, creating approximately 344 terraces (figure 2). Terraces run east to west in a staggered gap formation (figure 3). The terraces were constructed by depositing borrow material with a 40 ft (12.19 m) berm for a terrace with 4:1 side slopes and a top width of 10 ft (3.04 m). Initial constructed elevation was approximately 3.75 ft (1.14 m) NAVD88 which in 5 years should have a final settled elevation approximately 1 ft above marsh elevation. The dredged material was deposited such that the terrace's side slopes were 4:1 to conform to the natural angle of repose for the bottom soil. Breaks were constructed to permit water to move in and out of the interior, which may facilitate the settling of suspended soil particles (figure 3). *Spartina alterniflora* (smooth cordgrass) plugs were planted every five linear feet on both sides of terrace.

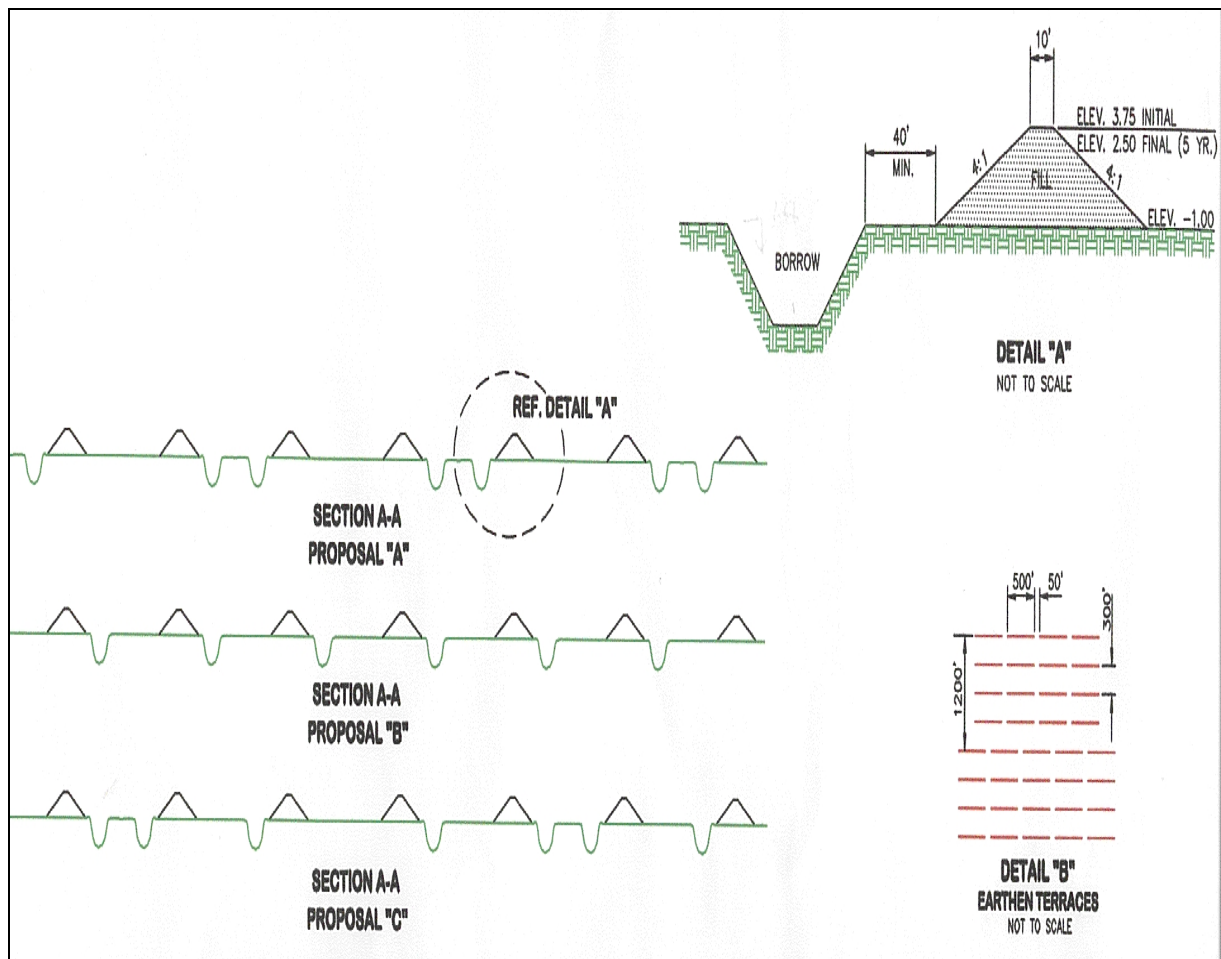
**Figure 3.** Pecan Island Terracing (ME-14) schematic of terraces.

Initial observations have determined that the typical section of the earthen terraces for the Pecan Island Terrace Creation Project (ME-14) consisting of a 10 ft. crown width constructed to (+) 3.75 ft NAVD88 with 4:1 side slopes along with the 300 ft. spacing between terraces has been effective in reducing wind fetch and allowing colonization of plants. The constructed height of (+) 3.75 ft NAVD88 was per recommendations of the Geotechnical Report for the soil type within the project area and is anticipated to settle to (+) 2.5 ft NAVD88 within five (5) years.

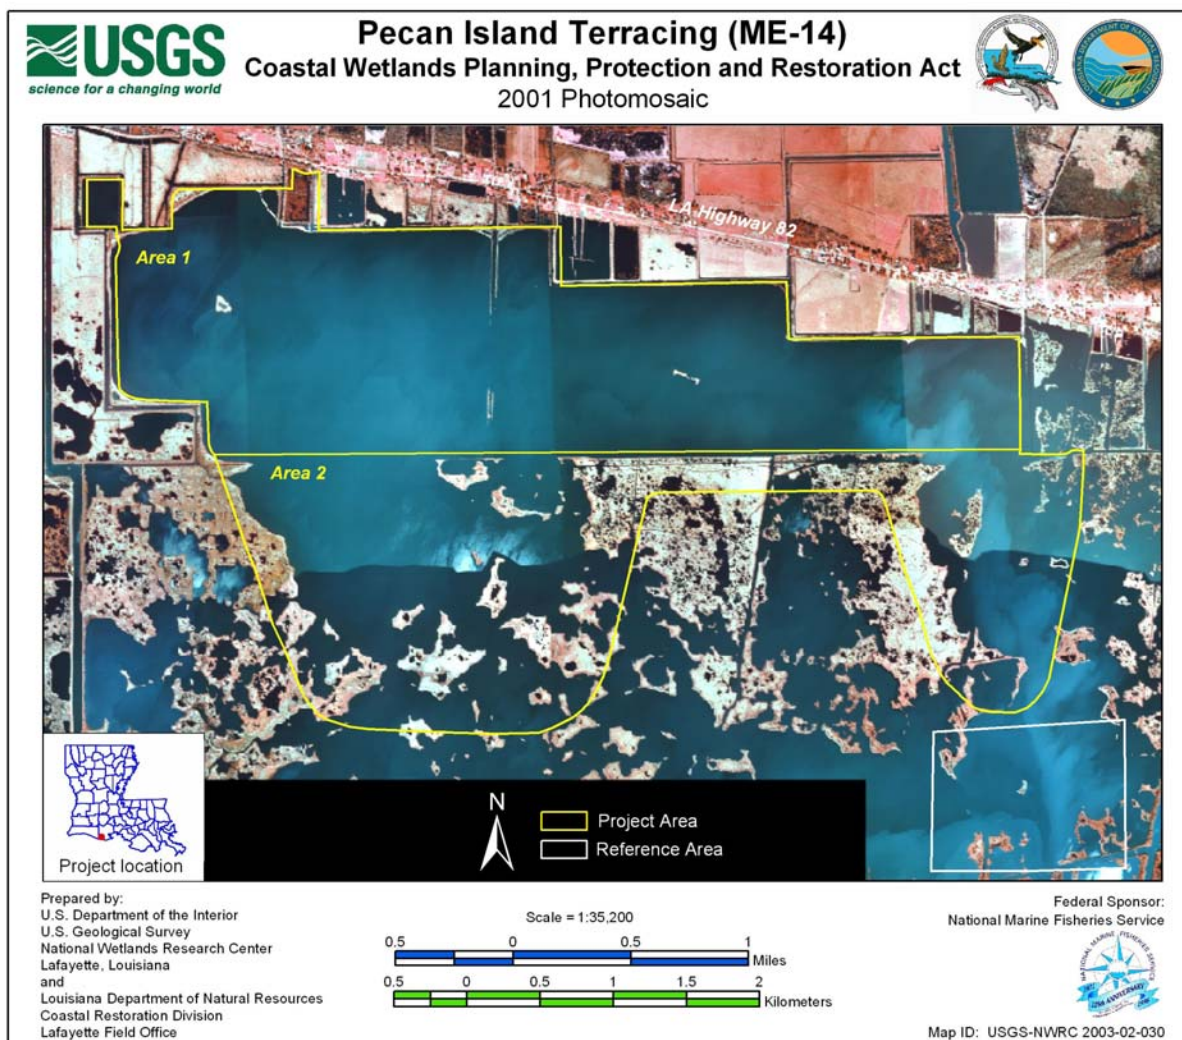
**Figure 4.** Pecan Island Terracing (ME-14) GIS photomosaic of the project and reference area.

To document land to open-water ratios and marsh loss/gain rates in Area 1 and Area 2, near-vertical color infrared aerial photographs (1:12,000) were obtained in 2001 prior to construction, and will be obtained in 2004, and 2017. Imagery will be delineated to classify all land in the project and reference areas as either (1) preexisting wetlands, (2) vegetated and non-vegetated terraces, and (3) non-terrace, newly developed wetlands (i.e., those that develop in open water areas between the terraces or adjacent to the preexisting perimeter levees). The original photographs were checked for flight accuracy, color correctness, and clarity and were subsequently archived. Aerial photographs were scanned, mosaicked, and georectified by USGS/NWRC personnel according to standard operating procedures.

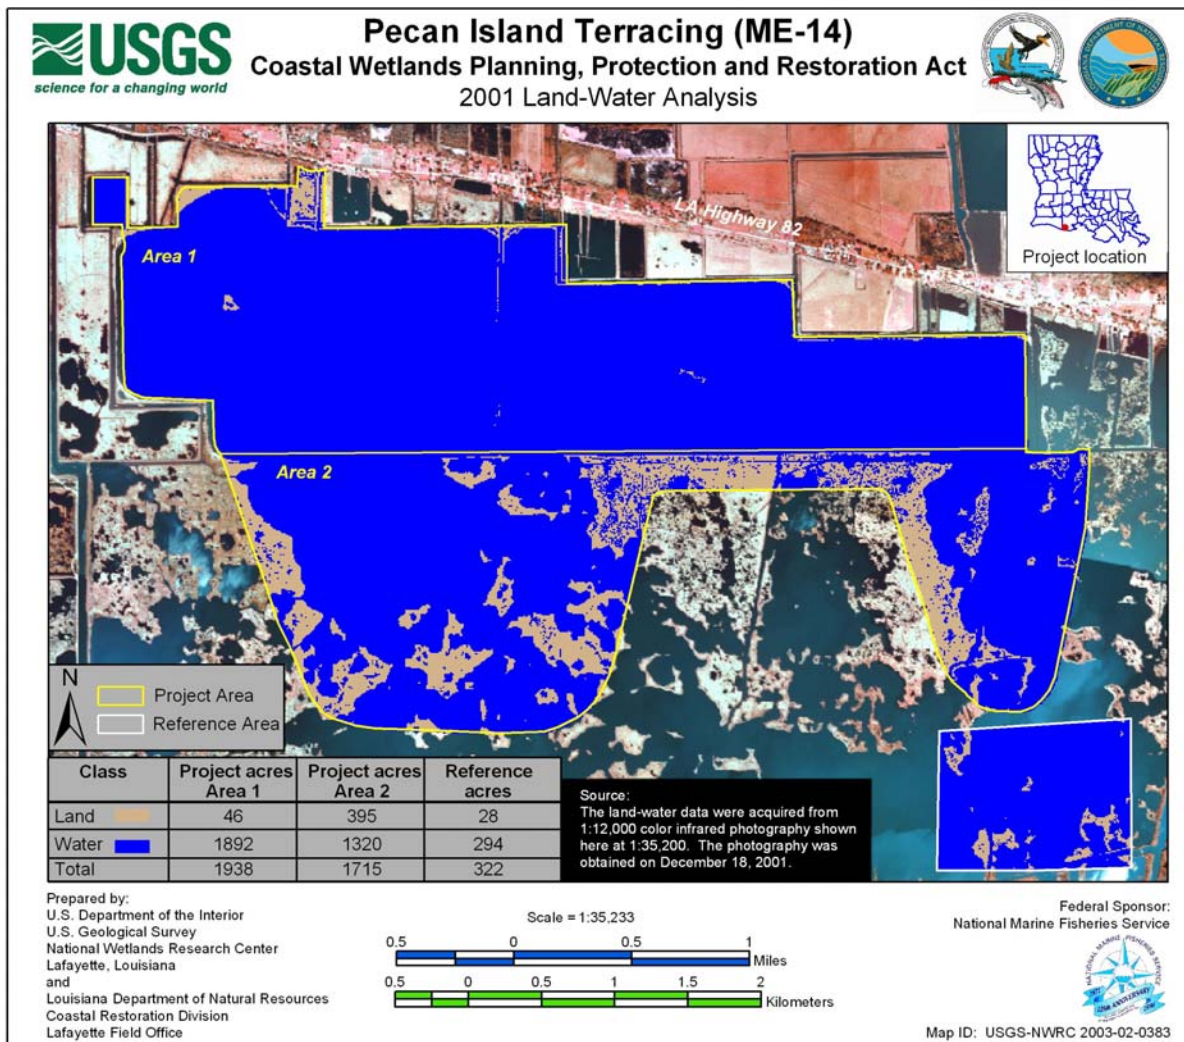
**Figure 5.** Pecan Island Terracing (ME-14) GIS Land/Water analysis of the project and reference area.

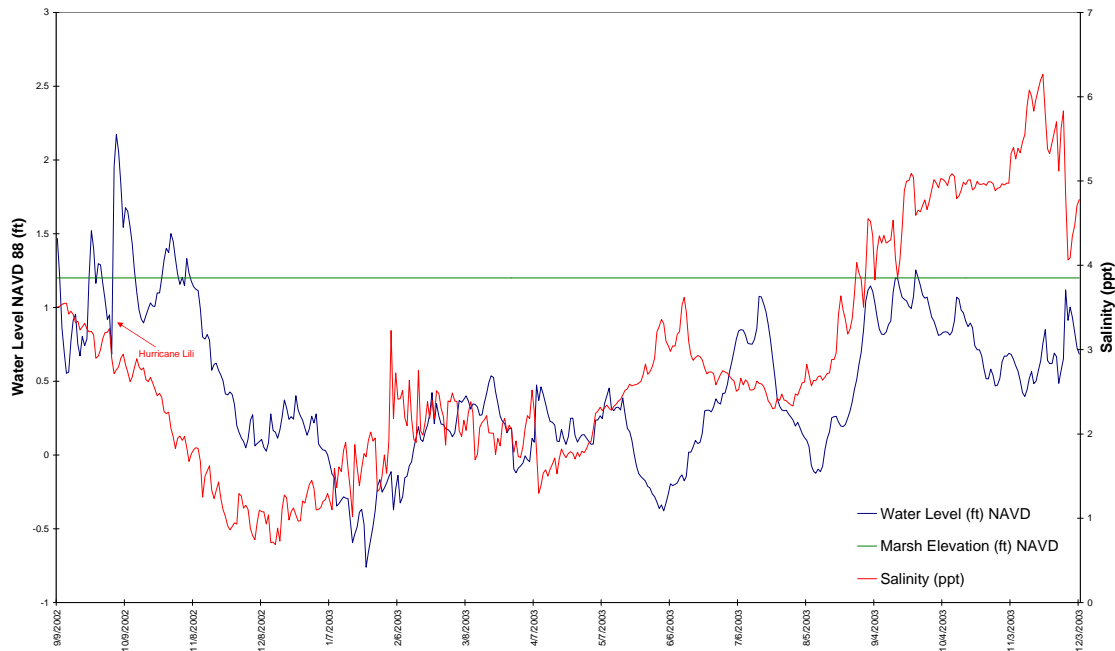
Project Station ME14-01 (9/9/02 - 12/3/03)  
Salinity and Water Level Data

**Figure 6.** Daily mean salinity and water level at Station ME14-01 in the Pecan Island Project area during 2002 and 2003. A water level reading above the marsh elevation line signifies that the marsh is flooded.

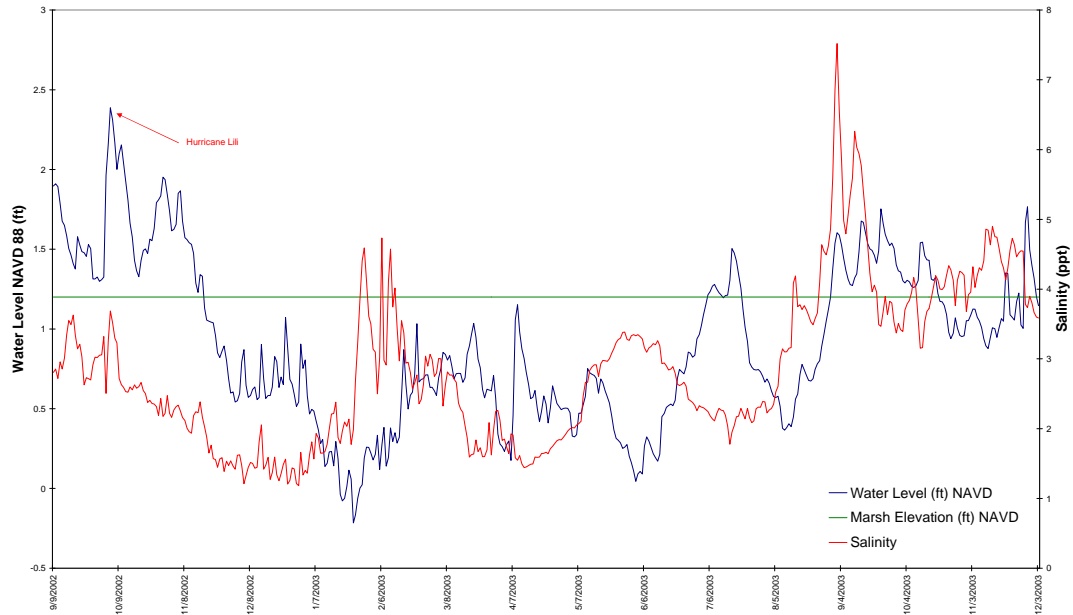
Project Station ME14-02R (9/9/02 - 12/3/03)  
Salinity and Water Level Data

**Figure 7.** Daily mean salinity and water level at station ME14-02R in the Pecan Island Project area during 2002 and 2003. A water level reading above the marsh elevation line signifies that the marsh is flooded.

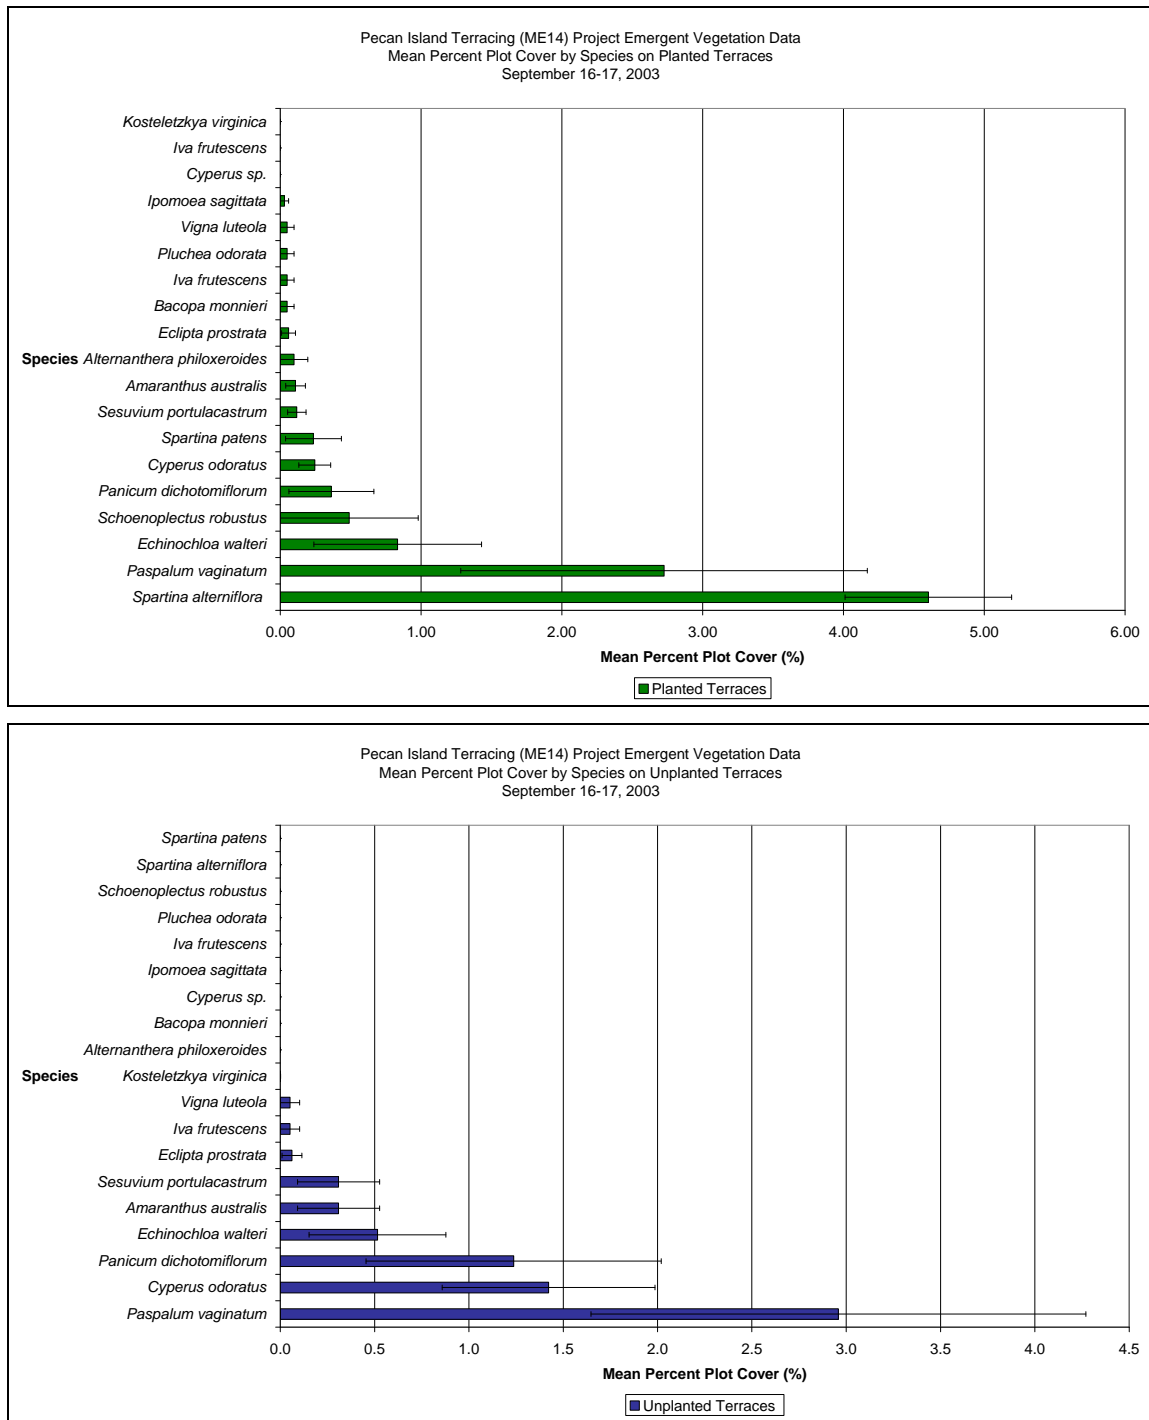
**Figure 8.** Mean % cover of selected species across all 4m<sup>2</sup> plots within the ME14 project area on the planted and reference unplanted terraces.

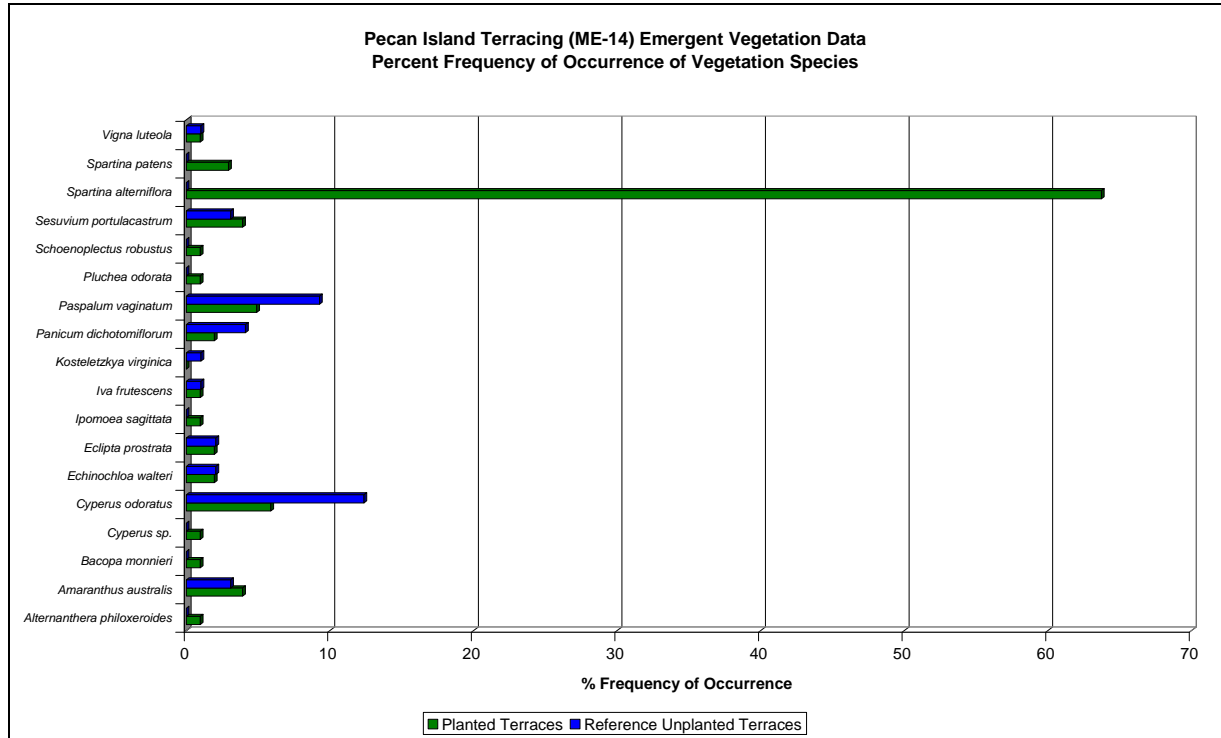
**Figure 9.** Pecan Island Terracing (ME-14) % frequency of occurrence of emergent vegetation by species on terrace planted with *Spartina alterniflora* vs. unplanted terraces.

Although the project has been constructed for only 3 months, both planted and unplanted terraces were quickly colonized by natural vegetation including, but not limited to, *Paspalum vaginatum*, *Cyperus odorata*, *Panicum dichotomiflorum*, *Echinochloa walteri*, *Amaranthus australis*, *Sesuvium portulacastrum*, *Spartina patens*, *Eclipta prostrata*, *Iva frutescens*, *Vigna luteola* and *Kosteletzkya virginica*. Early plant colonization was predominately on the slopes of the terraces. Vegetation noticed on the crown of terraces not planted nor sampled was identified as *Sesbania drummondii*.

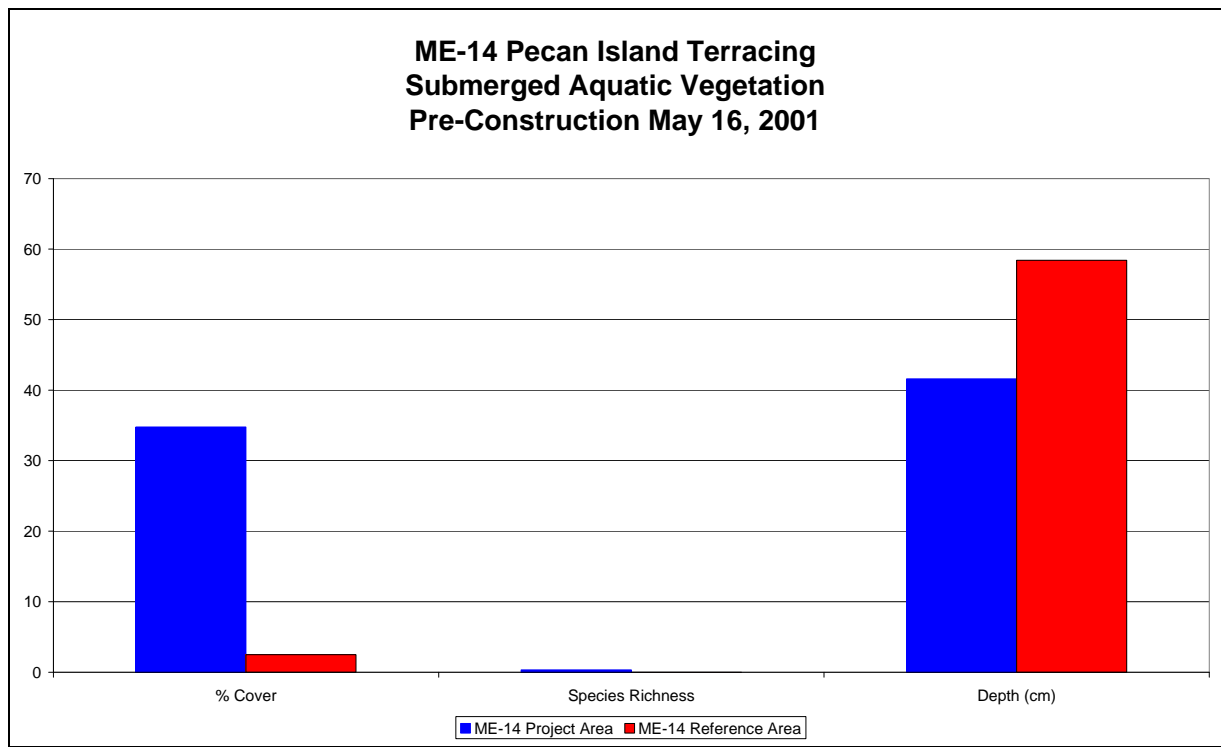
**Figure 10.** Pecan Island Terracing (ME-14) submerged aquatic vegetation % cover, species richness, and water depth. Species consisted of one unknown alga.

Species of submerged aquatic vegetation consisted of one unknown alga. Salinity and water level data were not collected at the time of sampling. Lack of SAV may be attributed to the long fetch associated with the large body of shallow open water, high water levels or extremes in salinity variability. Also, wind driven waves may increase turbidity due to re-suspension of unconsolidated bottom sediments.
