**2004 Operations, Maintenance,
and Monitoring Report**

**BRADY CANAL HYDROLOGIC
RESTORATION**

State Project Number TE-28
Priority Project List 3

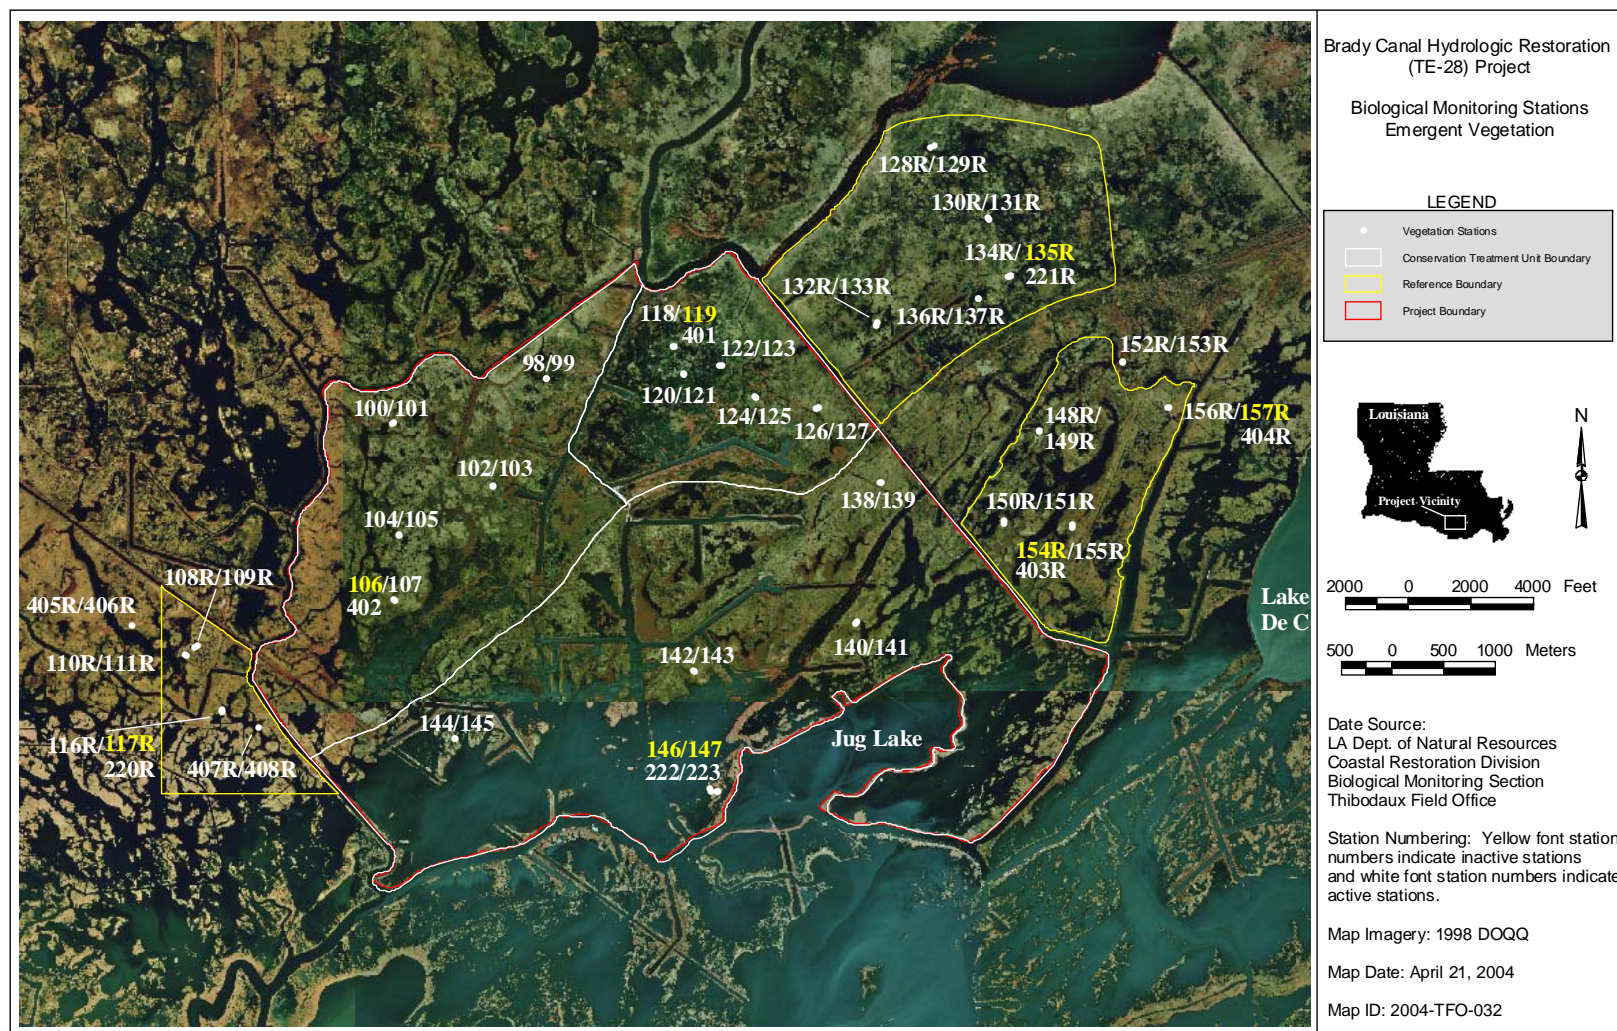
Figure 3: Location of emergent vegetation stations for the Brady Canal Hydrologic Restoration (TE-28) project.

Species richness and relative abundance are evaluated in the project and reference areas using the Braun-Blanquet method (Mueller-Dombois and Ellenberg 1974). Five stations were chosen within each CTU and reference area and replicate samples are collected at each station (Figure 3). Relative abundance will be documented in permanent plots to allow revisiting over time. Sites were sampled once in 1996 (pre-construction), 1999 (as-built), and in 2002 (post-construction) and will be sampled in 2004, 2006, 2009, 2012, and 2015 (post-construction).

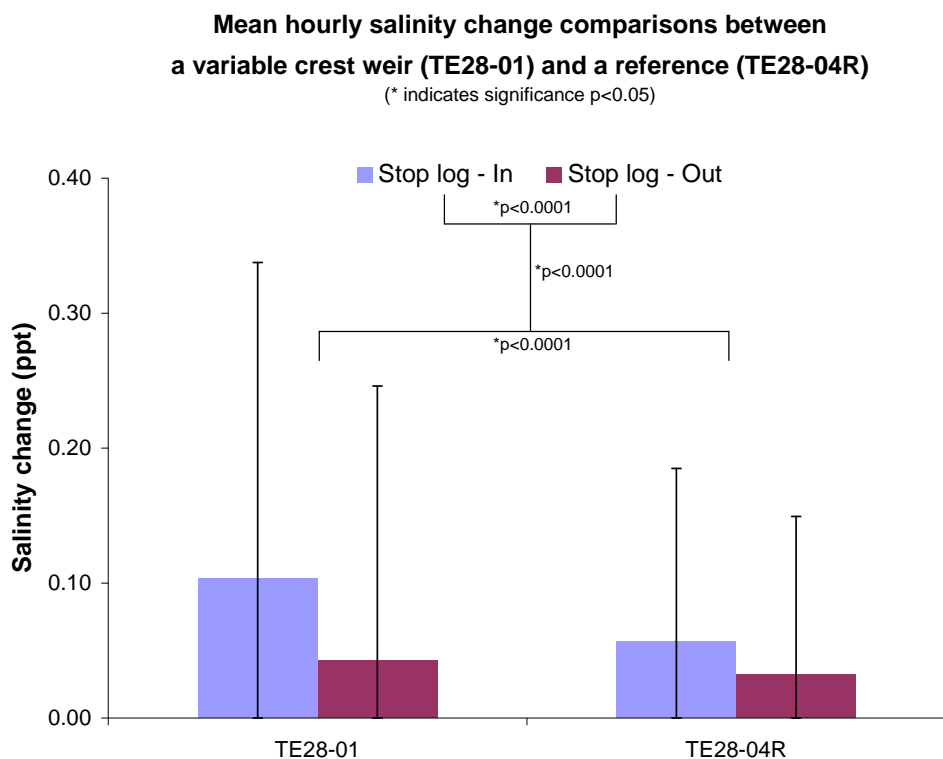
Figure 9: Mean salinity change comparison \pm standard deviation between a continuous recorder station located near a variable crest weir structure inside the marsh (TE28-01) and a continuous recorder located in a bayou (TE28-04R) in the near vicinity of the structure but are not affected by the structure. Stop logs – in (September 15, 2002 – March 18, 2003 and September 10, 2003 – October 28, 2003) and stop logs – out (April 11, 2002 – September 15, 2002 and March 18, 2003 – September 10, 2003) were used to determine the affects of the weir on the variability of the salinity.

Because station TE28-01 showed a significant increase in the mean hourly salinity change (Figure 8), the data for this station and its paired reference station were analyzed for operational structure affects. This station is located in the interior of the marsh where a variable crested weir was constructed as a part of the project feature. This structure is numbered site 14 in figure 1. Since the operation of the structure did not begin until April 2002, the data used for this analysis began with the first structure manipulation (April 11, 2002) and stopped with the latest available data (October 28, 2003) that has been processed for accuracy. Briefly, the operations plan for this structure calls for stop logs to be removed in March and added in September. For detailed structure operations refer to the operations activity section of this document. Results indicate that there is a statistical significance ($p < 0.05$) between the stations, stop log position, and the interaction between the stations and

Using a GLM, tests were performed between the structure and reference area, the positions of the stop logs, and the interaction between the structure and stop logs. The results (Figure 9) show significance between all three. Since the results have shown a significant difference between the structure and reference area and the position of the stop logs as well as the interaction between the structure and the stop logs, we can conclude that the structure does not effect the hourly salinity change.

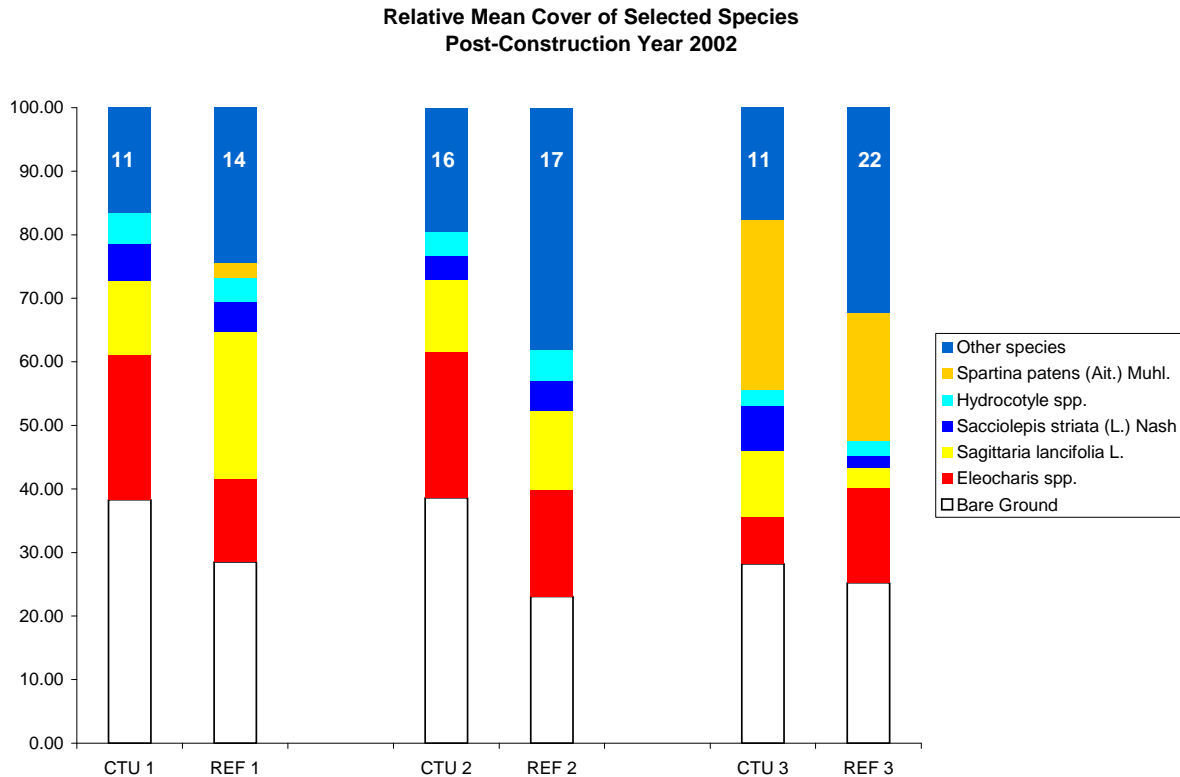
Figure 16: The relative mean cover of five selected emergent vegetation species at the Brady Canal Hydrologic Restoration (TE-28) project during the October 2002 post-construction sampling period.

Only two species had greater than ten percent relative mean cover in two different areas of the reference area in 2002. *Schoenoplectus americanus* had a relative mean cover of 11.02 in reference area #3, and *Leersia hexandra* had a relative mean cover of 14.24 in reference area #2.
