**2004 Operations, Maintenance,
and Monitoring Report**

**Replace Sabine Refuge Water Control
Structures at Headquarters Canal,
West Cove Canal, and Hog Island
Gully**

State Project Number CS-23
Priority Project List 3

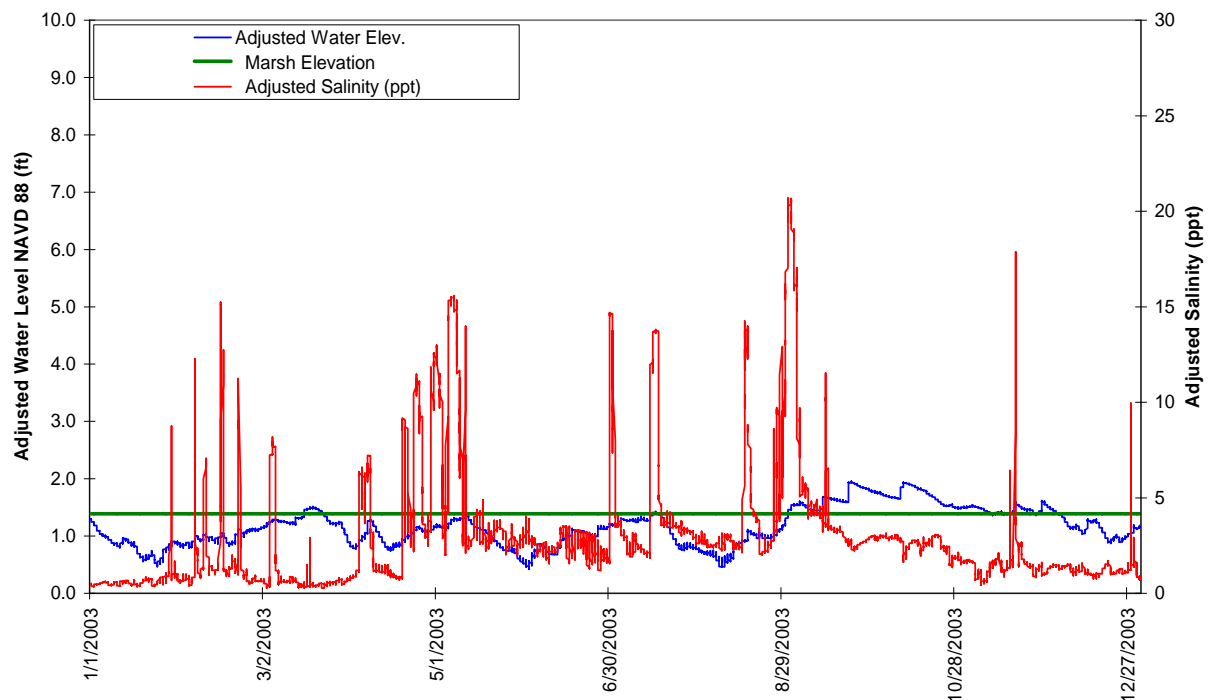
Station CS23-03 (1/1/03 – 12/31/03)
Salinity and Water Level Data

Figure 7a-b. Hourly salinity and water level at station CS23-03 in the Sabine Structure Replacement (CS-23) project area. A water level reading above marsh elevation indicates that the marsh is flooded.

Salinity data was collected hourly at seven stations (figure 4) associated within the CS-23 project and reference areas (Figures 5a-b to 11a-b).

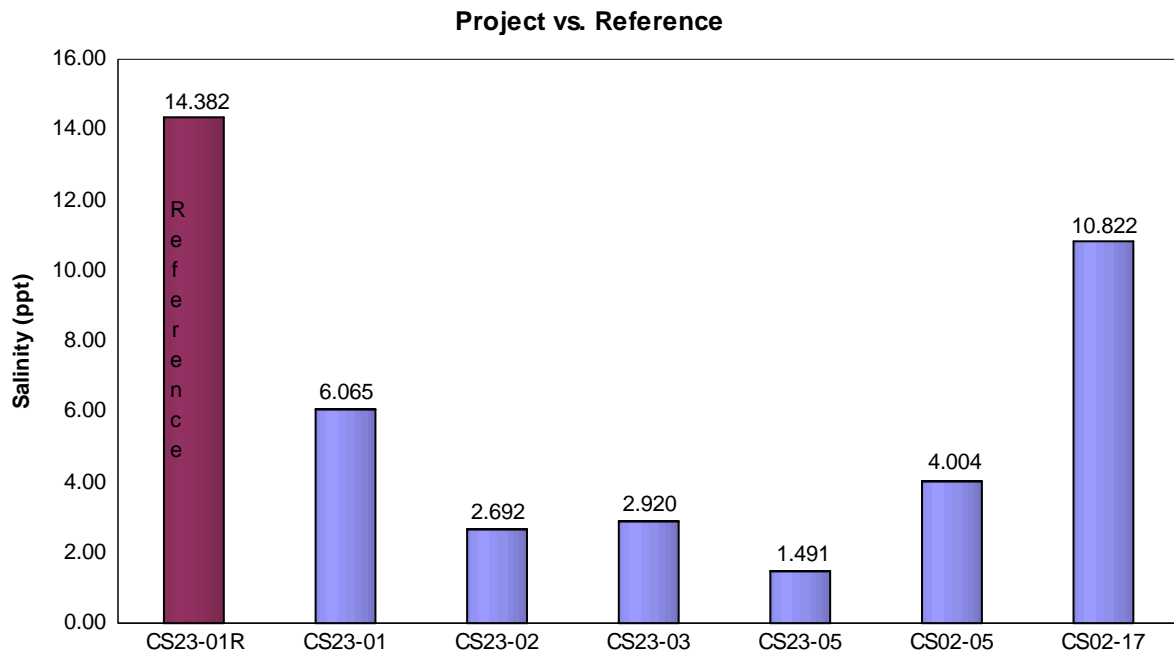
Figure 12. Yearly means derived from weekly means of salinity (ppt) at 7 continuous recorder stations located in the Sabine Structure Replacement (CS-23) project and reference areas from period 1/1/03 – 12/31/03.

Hourly data were combined at each station to derive a daily means value. Weekly means were then calculated from the daily means. Yearly means were derived from the weekly means associated with each station (figure 12). Salinity was not significantly different ($P < 0.001$) at stations CS23-01 and CS02-05. However significant differences did occur ($P < 0.005$) at stations CS23-02, CS23-03, CS23-05 ($p = < .001$) and CS02-17 ($p = 0.0010$).

Electrical problems caused the electric motors to overheat on the Hog Island Gully and West Cove structures after the initial installation, and the structures are not fully operational at this time. Due to the inability to operate the structures correctly, salinity and water level spikes have occurred, although less frequently than preconstruction. Yearly mean salinities derived from the weekly means were also lower within the project area when compared to the reference area (figure 12).

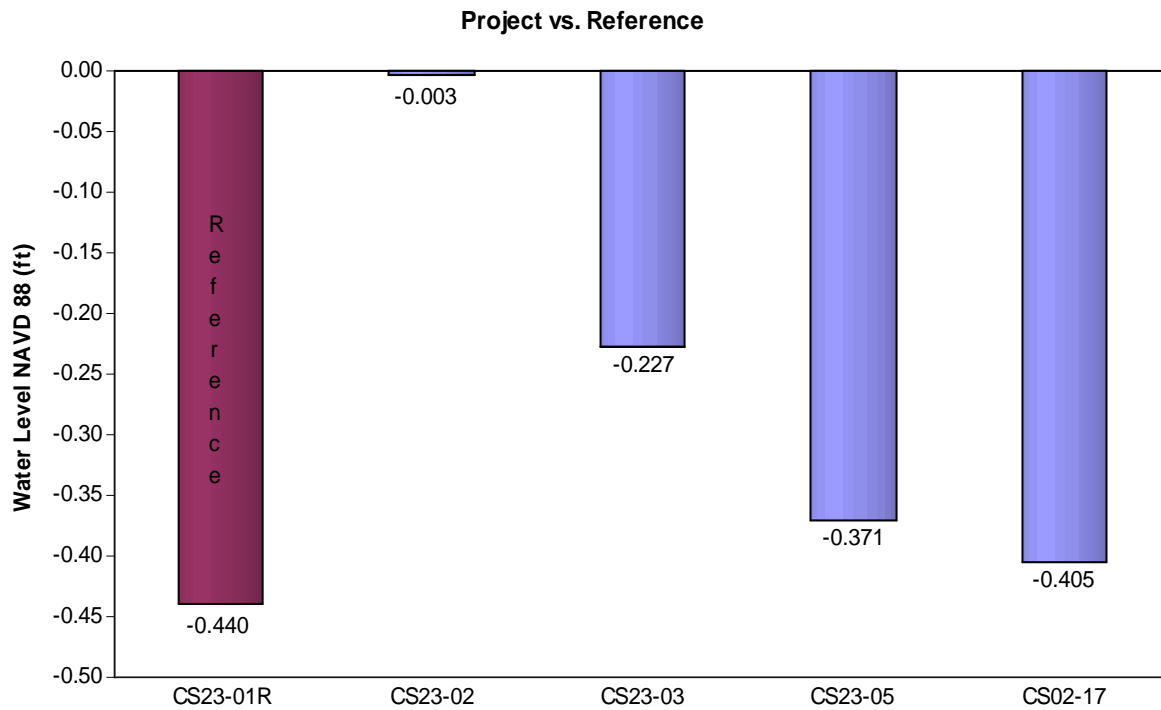
Figure 14. Yearly means derived from weekly means of water levels NAVD 88 (ft) at 5 continuous recorder stations located in the Sabine Structure Replacement (CS-23) project and reference areas for period 1/1/03 – 12/31/03.

Water level NAVD 88 (ft) data were collected hourly at five stations associated within the CS-23 project and reference areas. Water circulation patterns relative to incoming tidal flows are depicted in figure 13. Hourly data were combined at each station to derive daily mean values. Weekly means were then calculated from the daily means. Yearly means were then calculated from the weekly means associated with each station. Water levels relative to marsh elevations were calculated to determine yearly marsh inundation rates for the sampling period. The reference station CS23-01R was compared to the project stations for yearly marsh inundation. Water levels were not significantly different ($P < 0.0001$) at stations CS02-17 and CS23-05. However, significant differences did occur ($P < 0.005$) at stations CS23-02 and CS23-03, (figure 14). Water levels remained well below the average marsh elevation of 1.41 ft for the 1/1/03 -12/31/03 period.
