**2003 Operations, Maintenance,
and Monitoring Report**

**BRADY CANAL HYDROLOGIC
RESTORATION**

State Project Number TE-28
Priority Project List 3

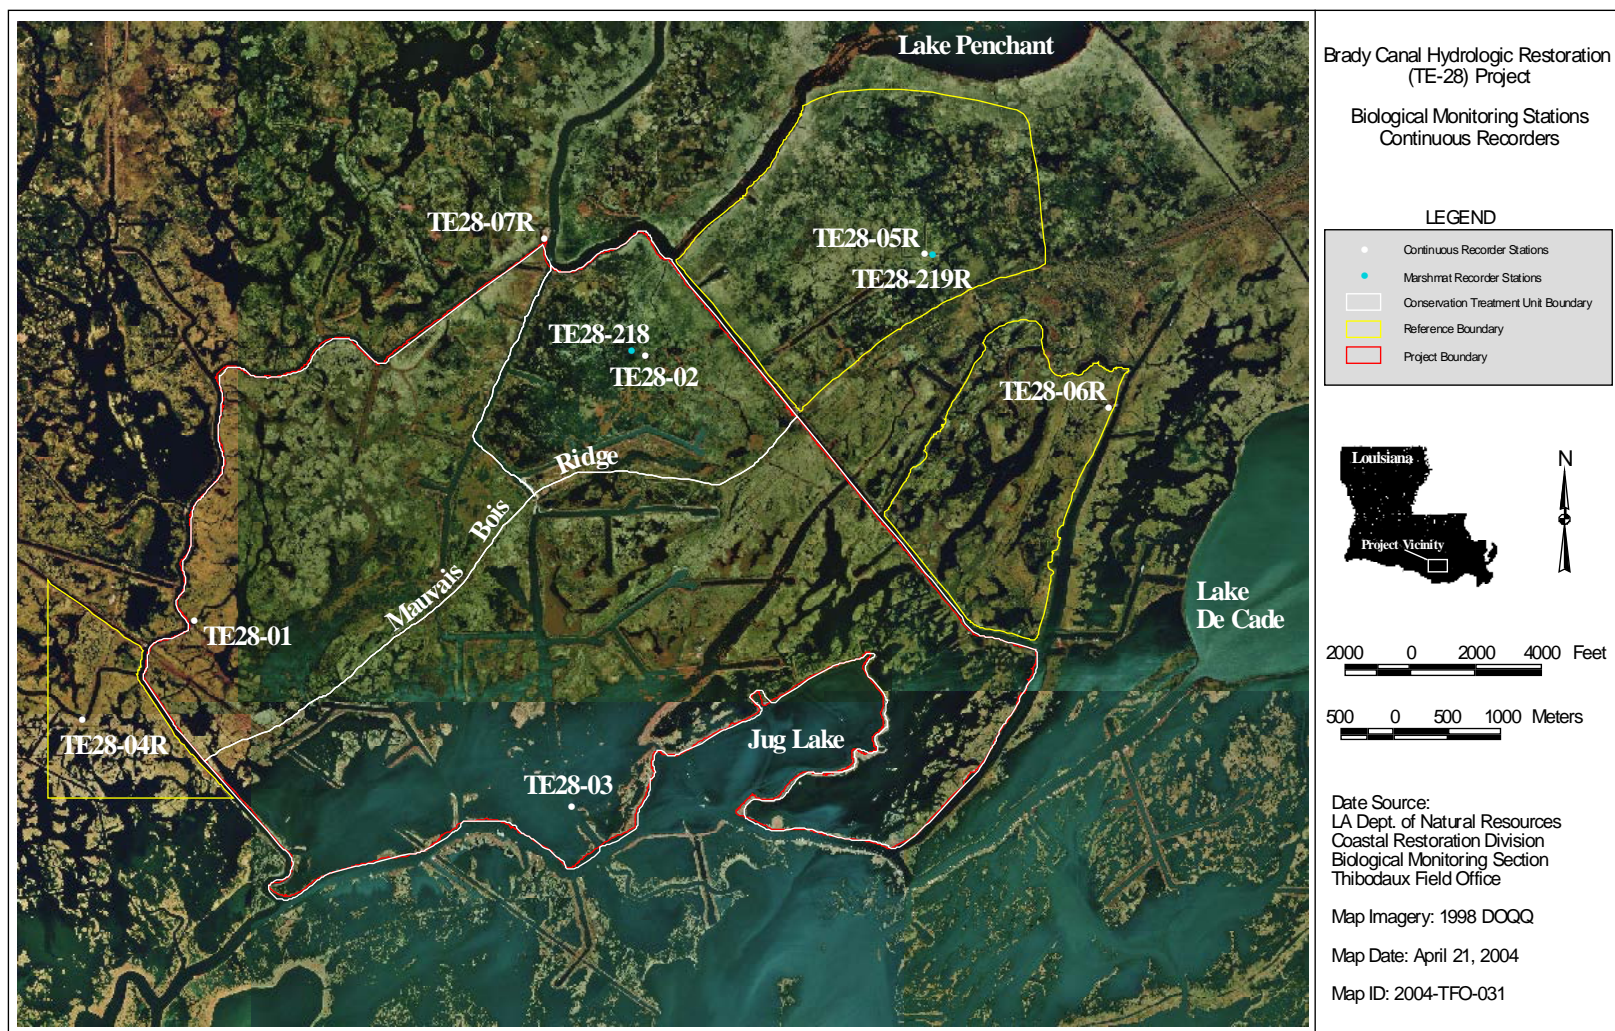
Figure 2: Location of continuous salinity and water level recorders in the Brady Canal Hydrologic Restoration (TE-28) project.

To monitor salinities one continuous recorder is located in each CTU and reference area (Figure 2). One additional recorder is located outside the project area on Bayou Penchant where Brady Canal begins near a water control structure. Discrete salinities are measured monthly at five sites within each CTU and reference area. Salinity data has been collected

To monitor water level variability, one continuous recorder is located within each CTU and one recorder is located in each reference area (Figure 2). One additional recorder is located outside the project area on Bayou Penchant near a water control structure. Mean daily water level variability and duration and frequency of flooding will be compared between pre-construction and post-construction and also between project and reference areas. Water level data was collected from 1997-2000 (pre-construction) and 2000-2003 (post-construction), and will be collected through 2004.

To monitor marsh mat movement, one continuous recorder is located within CTU #2 and one recorder located in the paired reference area #2 (Figure 2). Mean daily water level variability and duration and frequency of flooding of floating marshes are determined for pre-construction vs. post-construction comparisons and also project vs. reference comparisons. Marsh mat movement data was collected from 1998-2000 (pre-construction) and 2000-2003 (post-construction) and will be collected through 2004 (post-construction).

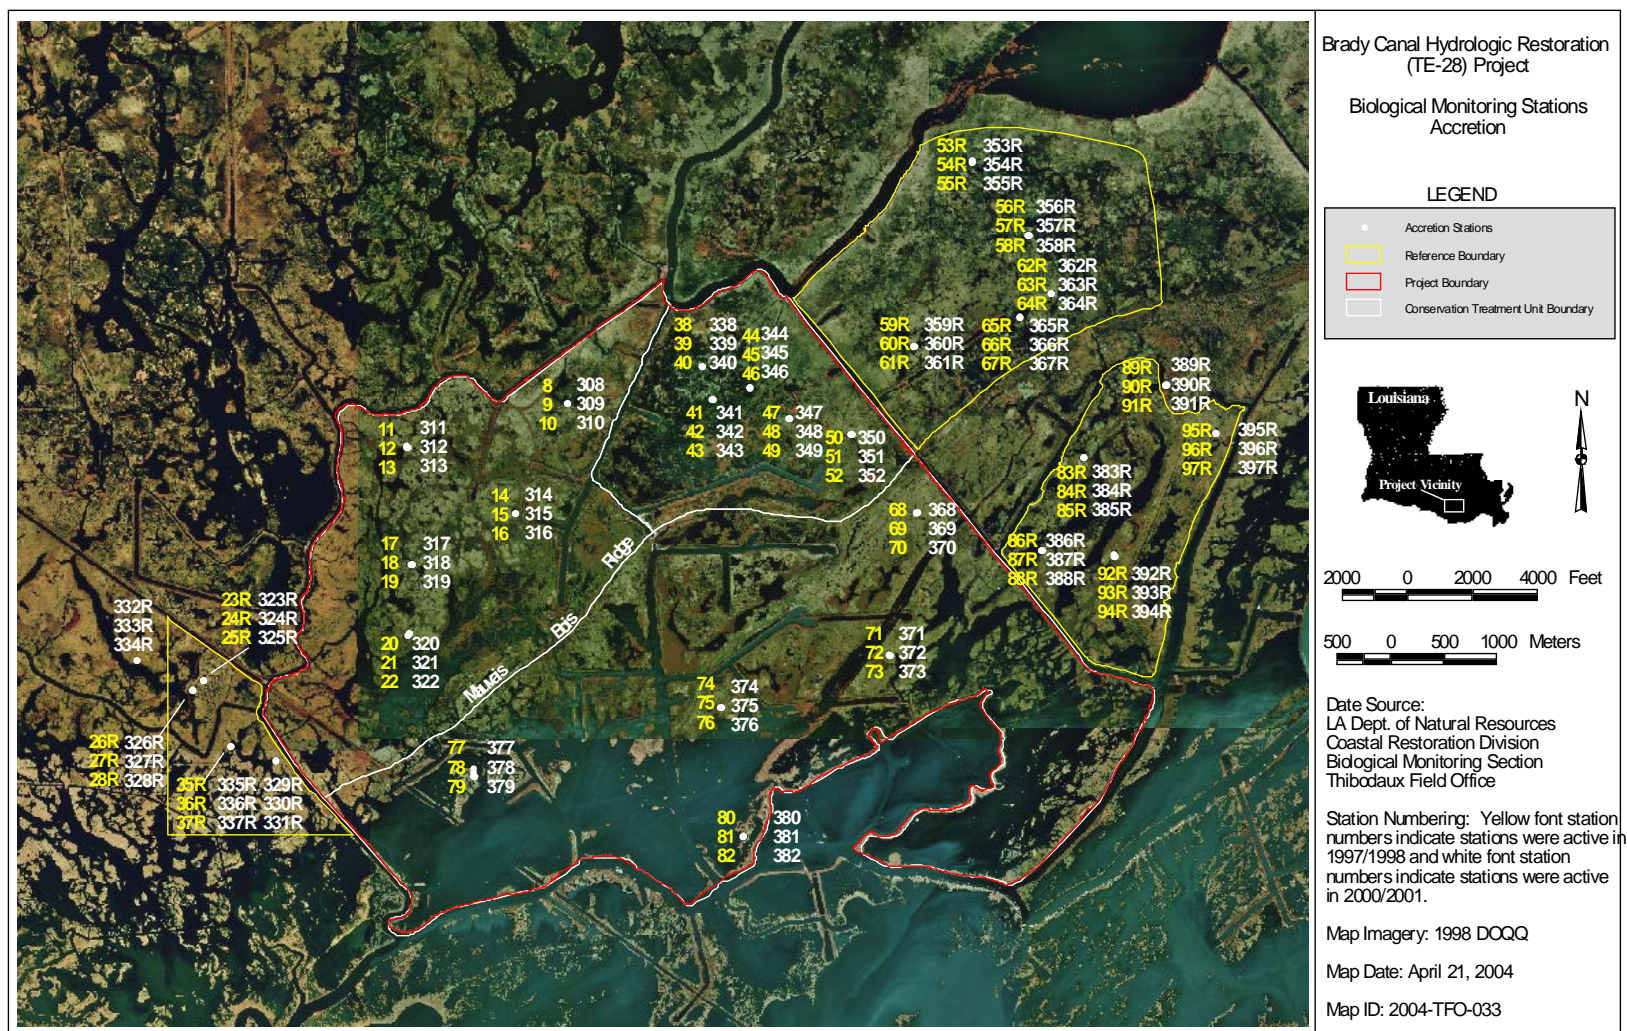
Figure 4: Location of accretion stations for the Brady Canal Hydrologic Restoration (TE-28) project.

Vertical accretion is determined in triplicate at each of the five representative stations within each CTU and reference area using techniques described in Steyer et al. (1995). The location of vertical accretion sites corresponds with the location of vegetation sampling sites (Figure 4). Sites were sampled in 1997/1998 (pre-construction), and in 2000/2001 (post-construction), and will be sampled in 2004, 2006, 2009, 2012, and 2015 (post-construction).

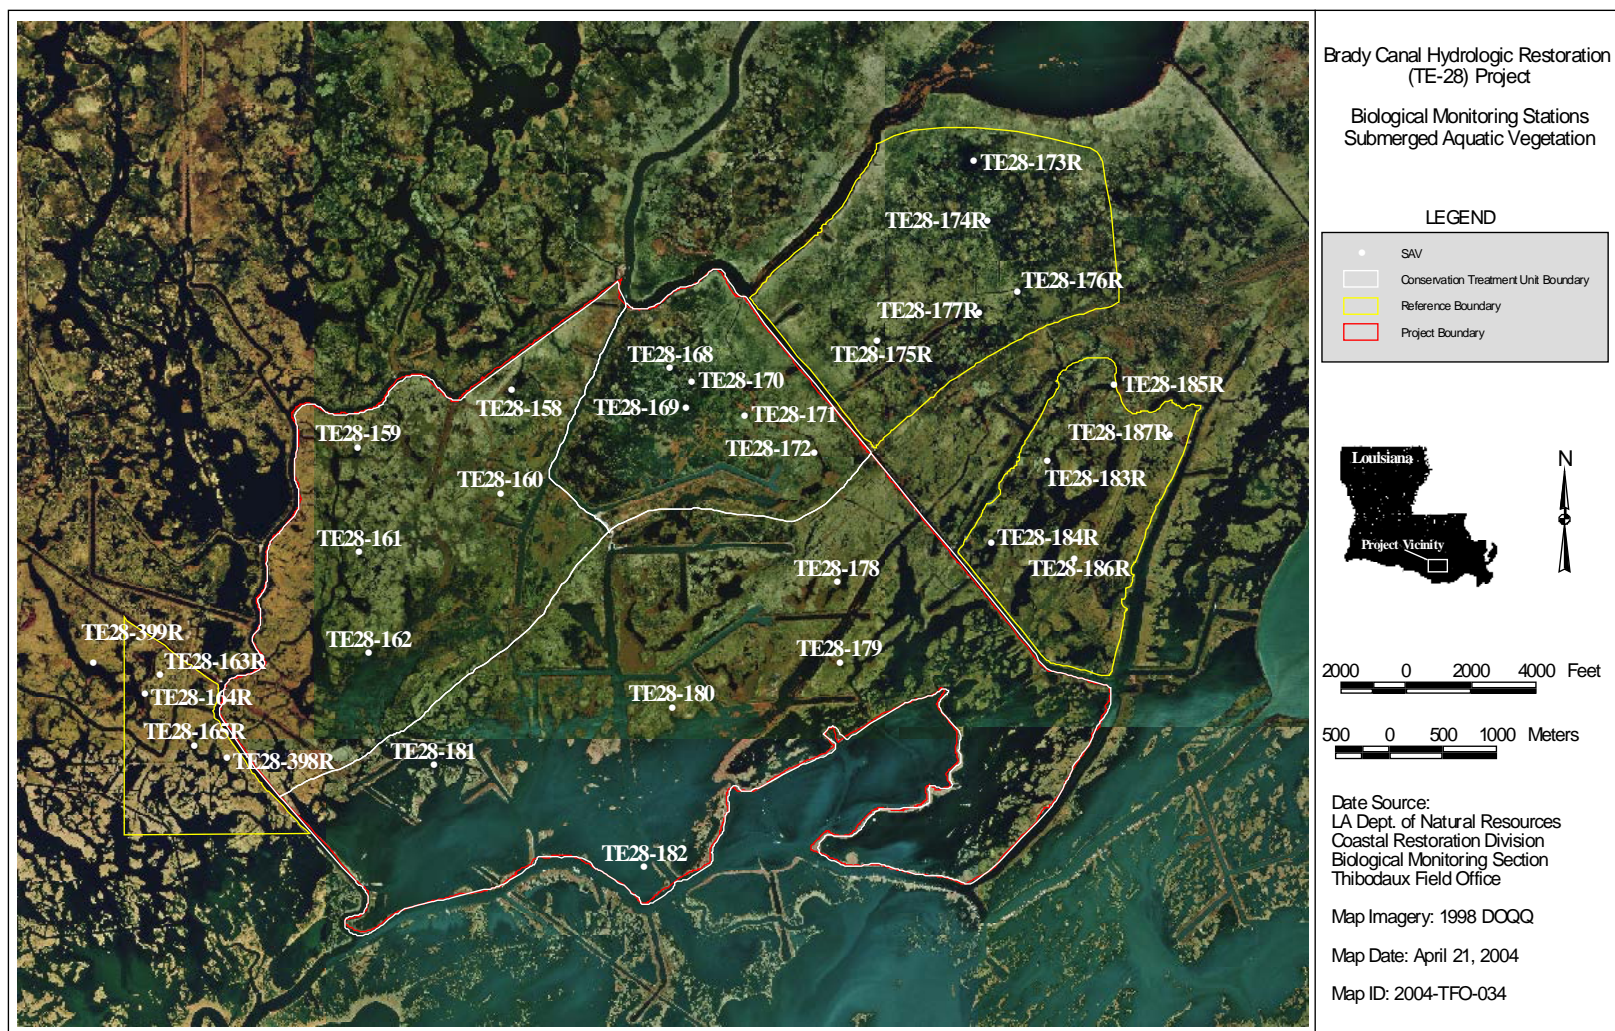
Figure 5: Location of submerged aquatic vegetation stations for the Brady Canal Hydrologic Restoration (TE-28) project.

The frequency of occurrence of SAV was compared between project and reference areas. Within the project (by CTU) and reference areas (Figure 5), 5 ponds were sampled during the Fall (October or November) in 1996 and 1999 (pre-construction) and in 2002 (post-construction) and will be sampled in 2006, 2012, and 2015 (post-construction). Methods described in Nyman and Chabreck (in press) will be used to determine the frequency of occurrence of SAV. Within each pond sampled, the presence/absence of SAV is determined at a minimum of 20 random points. Frequency of occurrence is determined for each pond from the number of points at which SAV occurred and the total number of points sampled. When SAV occurs at a point, the species occurring will be listed.

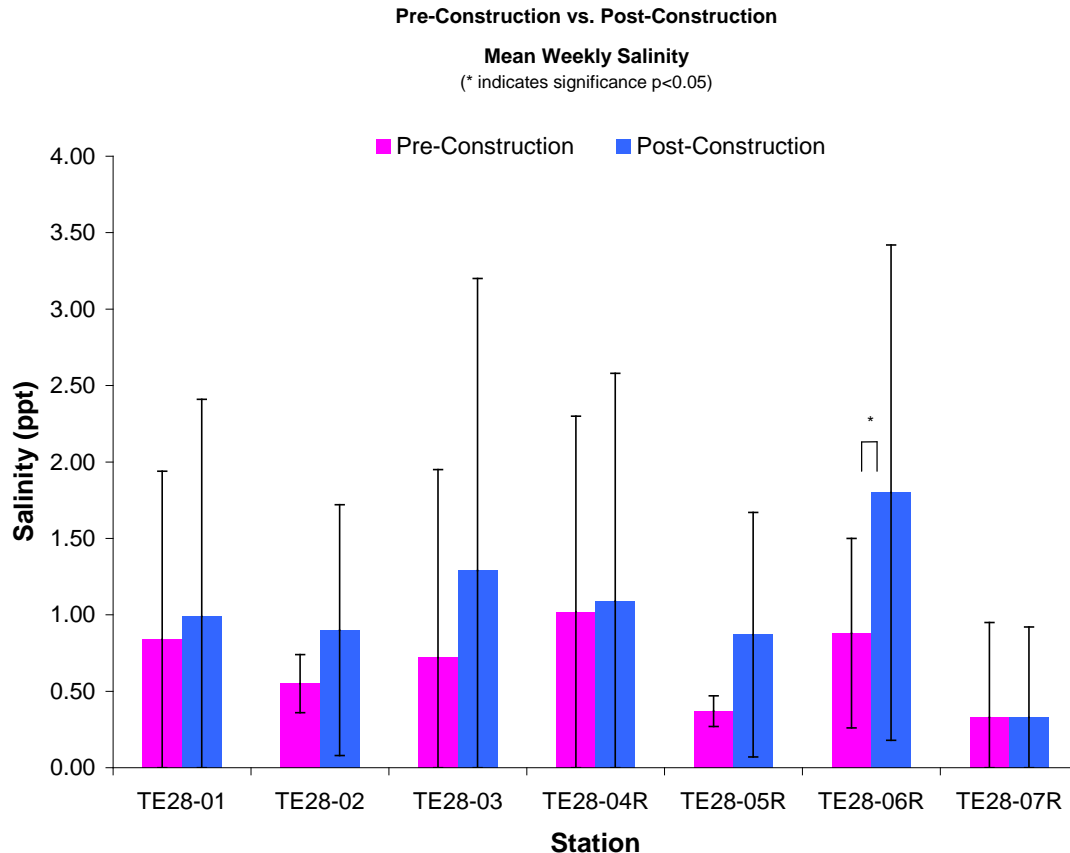
Figure 6: Mean weekly salinity \pm standard deviation have shown an increase at all stations associated with the Brady Canal Hydrologic Restoration (TE-28) project; however, only station TE28-06R has had a significant increase.

Figure 6 shows the mean weekly salinity concentrations at each continuous recorder station have increased except for station TE28-07R between the pre- and post-construction data; however, only station TE28-06R has shown a significant ($p < 0.05$) increase. Examining the figure also shows that the post-construction period experienced a higher degree of variability indicated by the standard deviation bars. When the interactions between all the stations and the time periods were analyzed, the results showed a significant increase in the salinity between the pre-construction (0.67ppt) and the post-construction (1.04ppt) time periods. This indicates that the entire region where the continuous recorders are located is increasing in

salinity. Although the differences may be statistically significant, the biological response may not reflect the significance since the classification for both periods are within the brackish oligosaline category (0.5 – 5.0ppt).

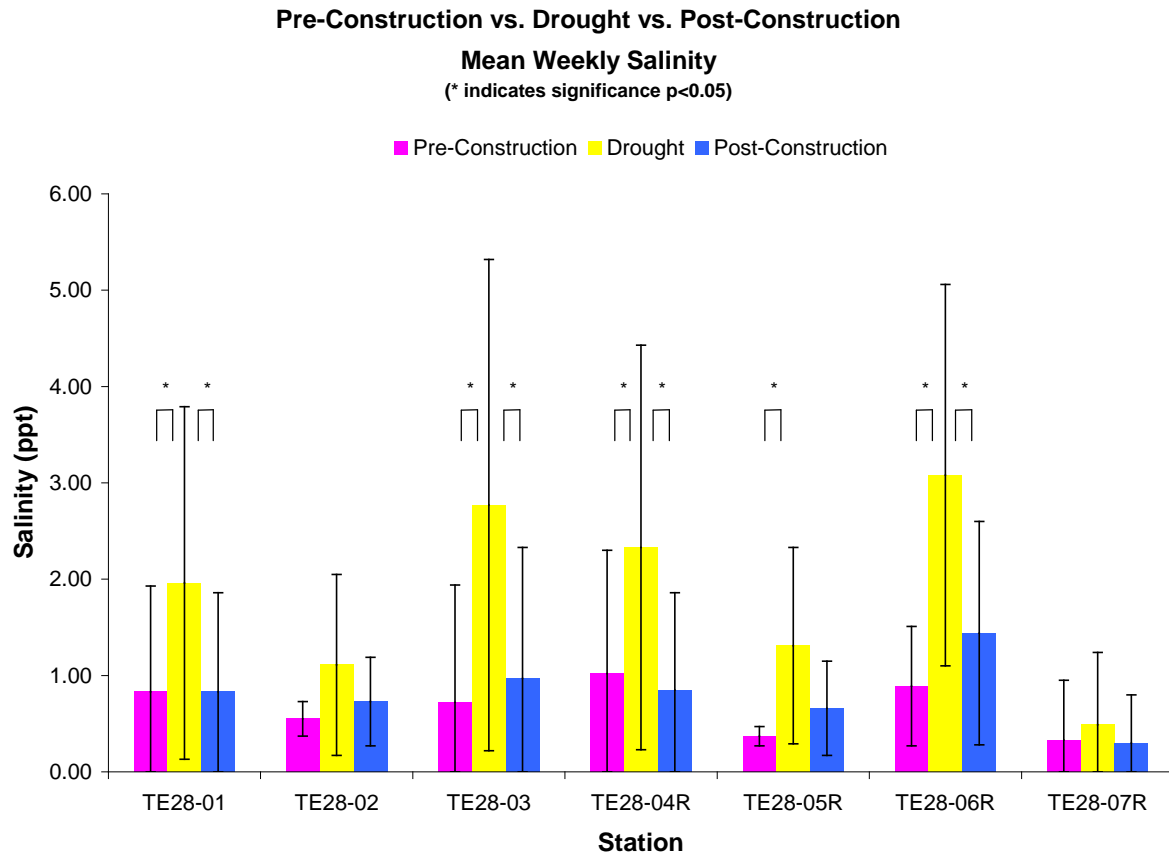
Figure 7: Mean weekly salinity \pm standard deviation showing the effects of the drought as recorded at each continuous recorder in the Brady Canal Hydrologic Restoration (TE-28) project.

post-construction and drought, but no stations were significantly different between the pre- and post-construction periods when the drought data was removed. Therefore, the drought had a significant influence on the area; however, the project did not show a statistical significance between the pre- and post-construction data. Figure 7 shows the specific results of the GLM test with respect to the weekly means.

Even though the drought data has been removed from the post-construction data, the continuous recorders in the project area show an increase in the mean weekly salinity readings as well as an increase in the standard deviation. The increase may not be statistically or biologically significant; however, any time salinity begins to rise in an area concerns are warranted.

period occurred during a severe drought that lowered water levels (Figure 11) and increased salinities (Figure 7) throughout the area. Because of these conditions the marsh experienced little or no flooding which would have deposited mineral sediment on the surface. More importantly, it is believed that freshwater floating marshes, such as those in the project area, depend heavily on the production of biomass to sustain their ability to increase vertically. During this period, the lack of marsh flooding and increase in salinity concentrations may have reduced the productivity of the plants thereby reducing the marshes ability to vertically accrete. During the sampling period, the marker horizon (feldspar) was still visible on the surface 9-12 months after plot establishment.

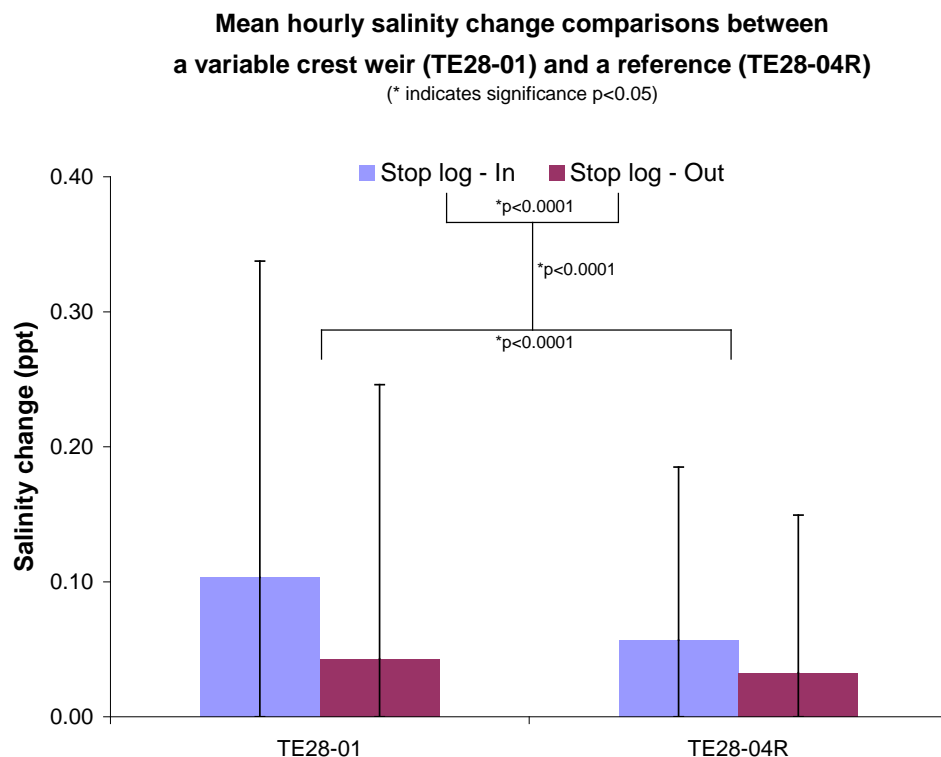
Figure 9: Mean salinity change comparison \pm standard deviation between a continuous recorder station located near a variable crest weir structure inside the marsh (TE28-01) and a continuous recorder located in a bayou (TE28-04R) in the near vicinity of the structure but are not affected by the structure. Stop logs – in (September 15, 2002 – March 18, 2003 and September 10, 2003 – October 28, 2003) and stop logs – out (April 11, 2002 – September 15, 2002 and March 18, 2003 – September 10, 2003) were used to determine the affects of the weir on the variability of the water levels.

Using a GLM, test were performed between the structure and reference area, the positions of the stop logs, and the interaction between the structure and stop logs. The results (Figure 9) show significance between all three. Since the results have shown a significance between the structure and reference area and the position of the stop logs as well as the interaction between the structure and the stop logs, we can conclude that the structure does not effect the hourly salinity change.

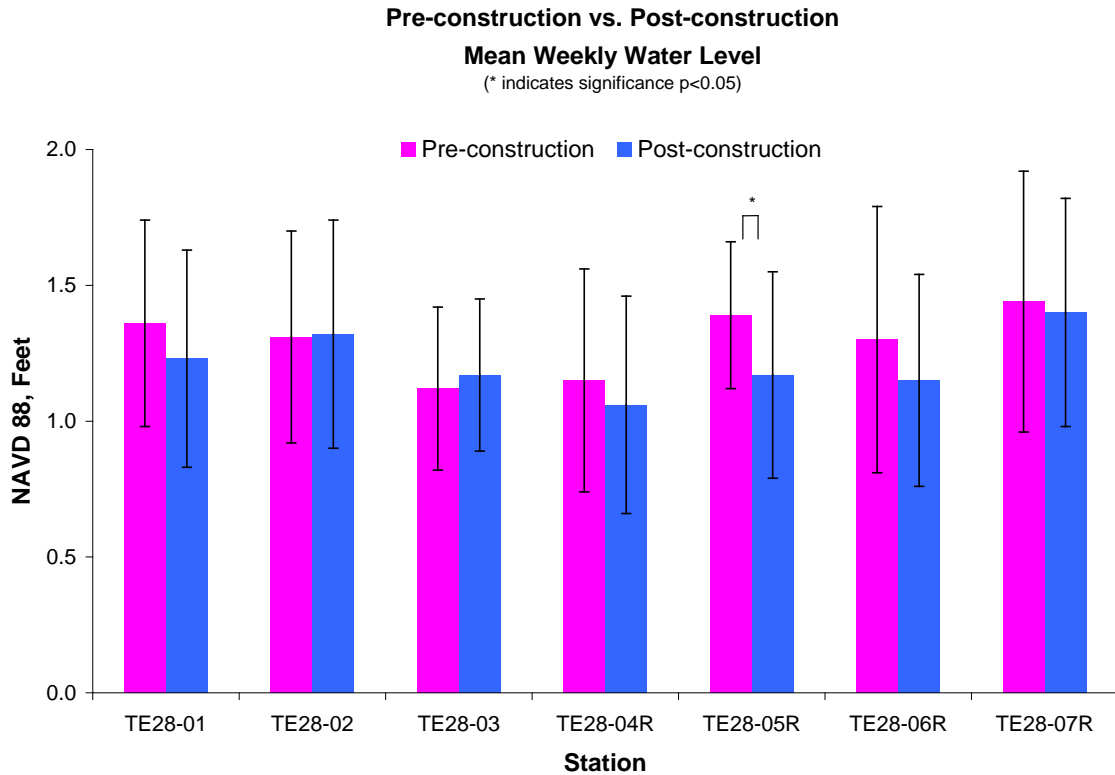
Figure 10: Mean weekly water level \pm standard deviation at each of the continuous recorder stations associated with the Brady Canal Hydrologic Restoration (TE-28) project during pre-construction (March 1997 – August 1999) and post-construction (July 2000 – October 2003) periods.

Figure 10 shows all four reference stations and one project station (TE28-01) having a decrease in mean water levels after the completion of the project features. A test for significance among the pre- and post-construction weekly means resulted in only one station (TE28-05R) being statistically significant ($p < 0.05$). Combining the water elevations within the project and reference areas and comparing the pre- and post-construction water levels reveal the water elevation in the project area did not change (1.27 ft, NAVD 88) while the reference area decreased (1.27 to 1.21 ft, NAVD 88).

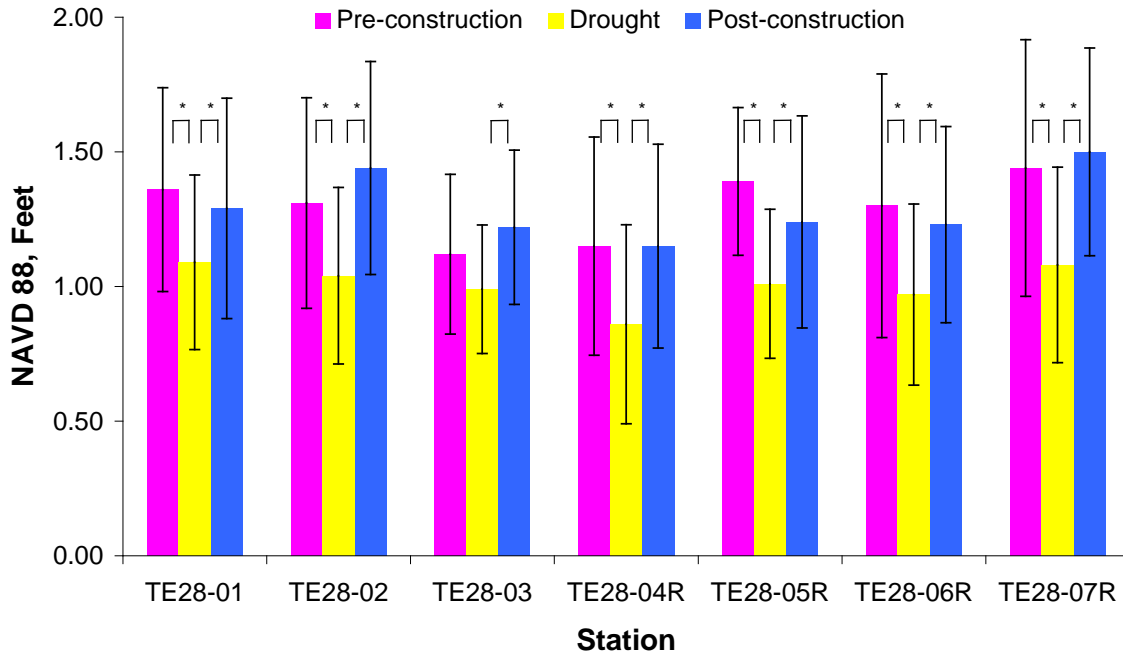
**Pre-construction, Drought, and Post-construction
Mean Weekly Water Elevation**

(*indicates statistical significance $p < 0.05$)

Figure 11: Mean weekly water elevation at each continuous recorder station with respect to pre-construction (1997 – August 1, 1999), the drought (August 1, 1999 – June 5, 2001), and post-construction (June 5, 2001 – October 28, 2003) at the Brady Canal Hydrologic Restoration (TE-28) project.

With respect to the drought data, the water level was lower at all stations throughout the area and statistically significant between pre-construction verses drought and post-construction verses drought data except at station TE28-03. Test between the pre- and post-construction data with the drought data removed showed no statistical significance at any station; however, the mean water levels had increased at two project stations and one reference station (figure 11).

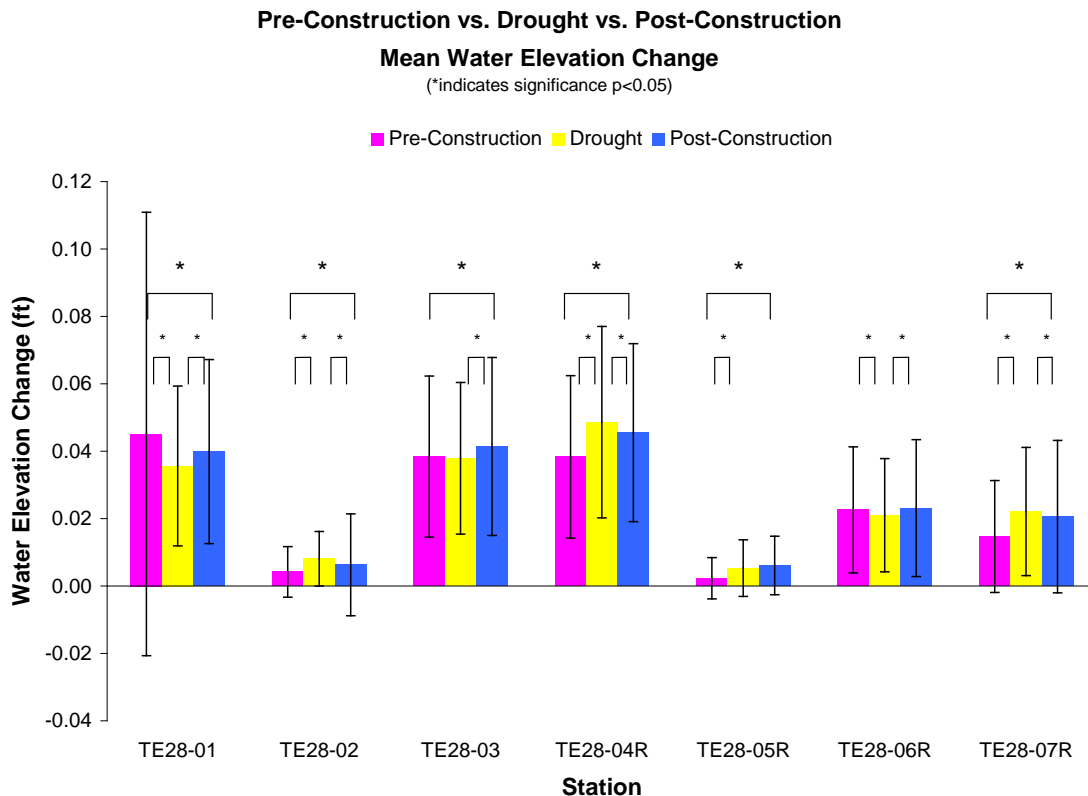
Figure 12: Mean hourly water level change \pm standard deviation at each of the continuous recorder stations associated with the Brady Canal Hydrologic Restoration (TE-28) project during pre-construction (March 1997 – July 2000) and post-construction (July 2000 – October 2003) periods.

Hourly water level changes were calculated at each station (Figure 12). A comparison of pre-verses post-construction, pre-construction verses drought, and post-construction verses drought data shows a significant difference at six of the seven stations. Of the seven stations, only one station (TE28-01) showed a significant decrease in the mean hourly water level change.

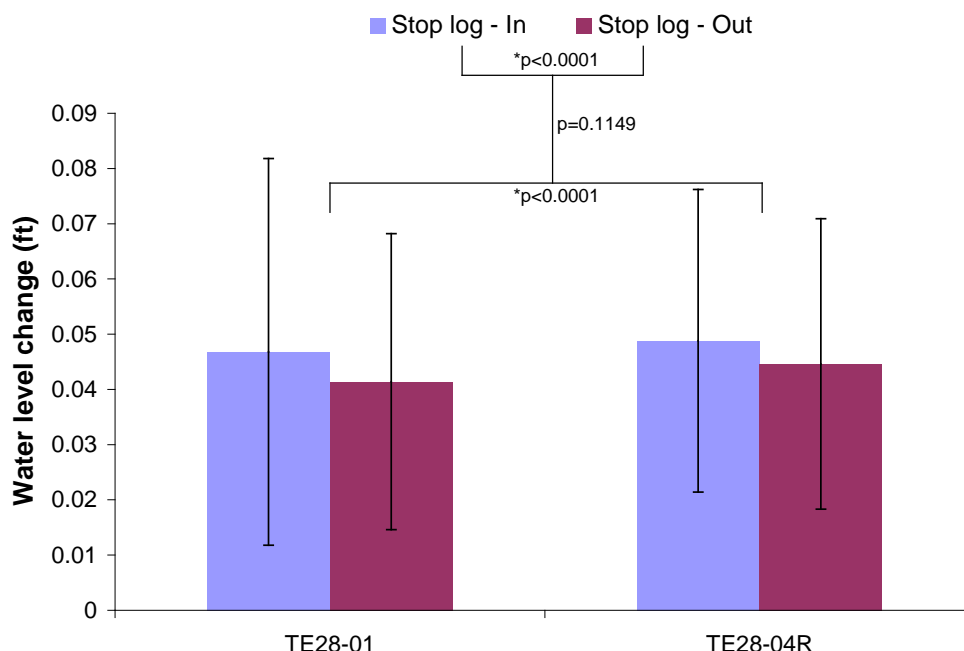
Mean hourly water level change comparison between a variable crest weir (TE28-01) and a reference (TE28-04R)

(* indicates significance $p < 0.05$)

Figure 13: Mean water level change \pm standard deviation comparison between a continuous recorder located near a variable crest weir structure inside the marsh (TE28-01) and a continuous recorder located in a bayou (TE28-04R) in the near vicinity of the structure but not affected by the structure. Data used for this analysis included stop logs – in (September 15, 2002 – March 18, 2003, and September 10, 2003 – October 28, 2003) and stop logs – out (April 11, 2002 – September 15, 2002 and March 18, 2003 – September 10, 2003) to determine the affects of the weir on the variability of the water levels.

Using the water level change data, the data for stations TE28-01 and TE28-04R were analyzed even further to investigate the effects of the variable crest weir structure near TE28-01 on the water level change. The data were separated by “stop logs in” and “stop logs out.” Since the structure was not operated until April 2002, all data prior to this date were not used in the analysis. The results showed a significant difference between the two stations and the stop log position; however, there was no significant difference between the interaction of the stop log and stations (figure 13). Consequently, the project feature(s) have not affected the variability of the water level at this particular station.

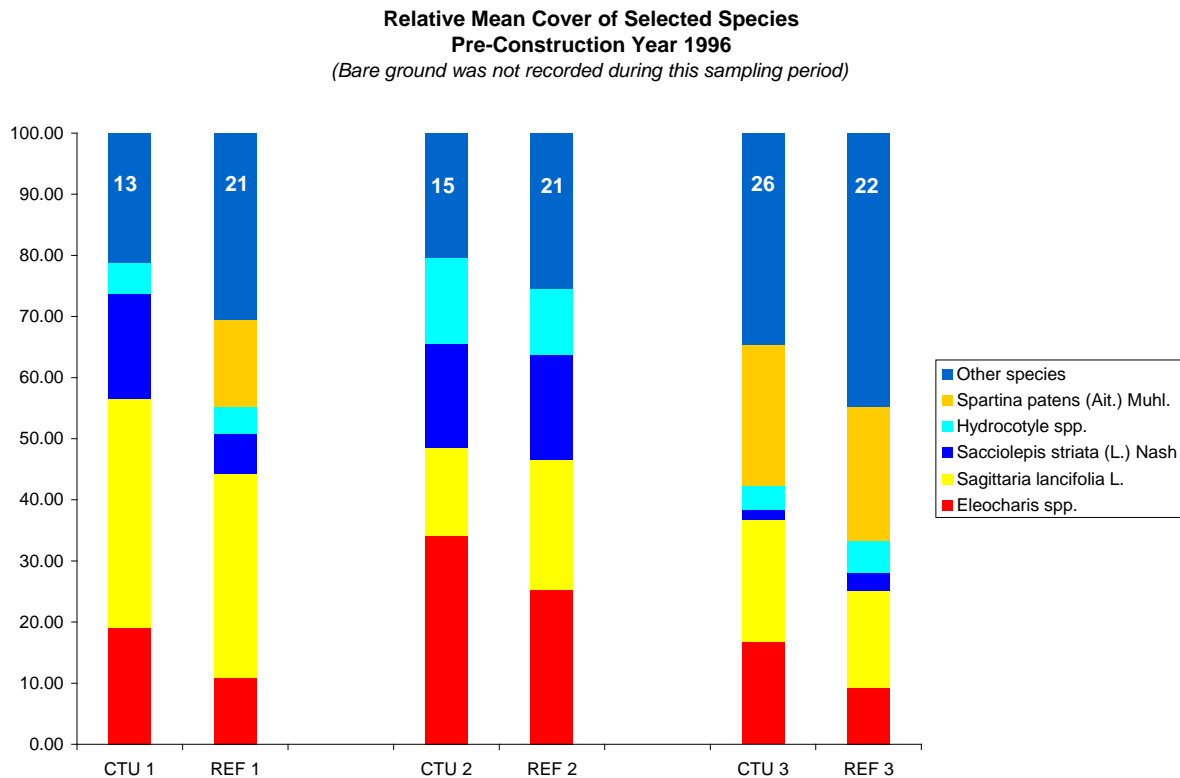
Figure 14: The relative mean cover of five selected emergent vegetation species at the Brady Canal Hydrologic Restoration (TE-28) project during the September 1996 pre-construction sampling period.

Within the other species category for the 1996 pre-construction sampling period, there were three other species that were present in an area with over ten percent relative mean cover; however, they were only present in one or two of the six areas. In reference area #1 *Vigna luteola* had a relative mean cover of 11.56. In CTU #3, *Vigna luteola* had a relative mean cover of 12.49. In reference area #3, *Polygonum hydropiperoides* had a relative mean cover of 19.92.

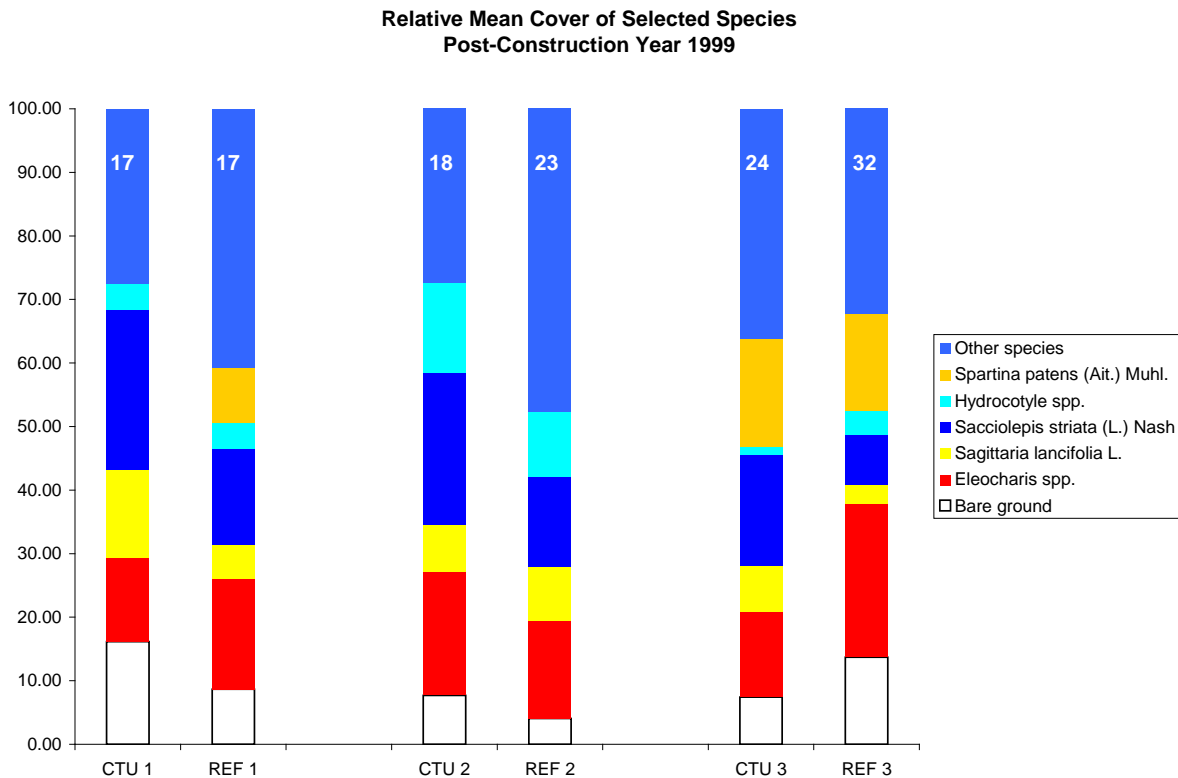
Figure 15: The relative mean cover of five selected emergent vegetation species at the Brady Canal Hydrologic Restoration (TE-28) project during the September 1999 post-construction sampling period.

Within the other species category for the 1999 post-construction sampling period, there were two other species that were present in an area with over ten percent relative mean cover; however, they were only present in two out of the six. In reference area #1 and CTU #3, *Schoenoplectus pungens* had a relative mean cover of 10.84 and 11.08, respectively. In CTU #2 and reference area #2, *Leersia hexandra* had a relative mean cover of 10.28 and 21.52, respectively.

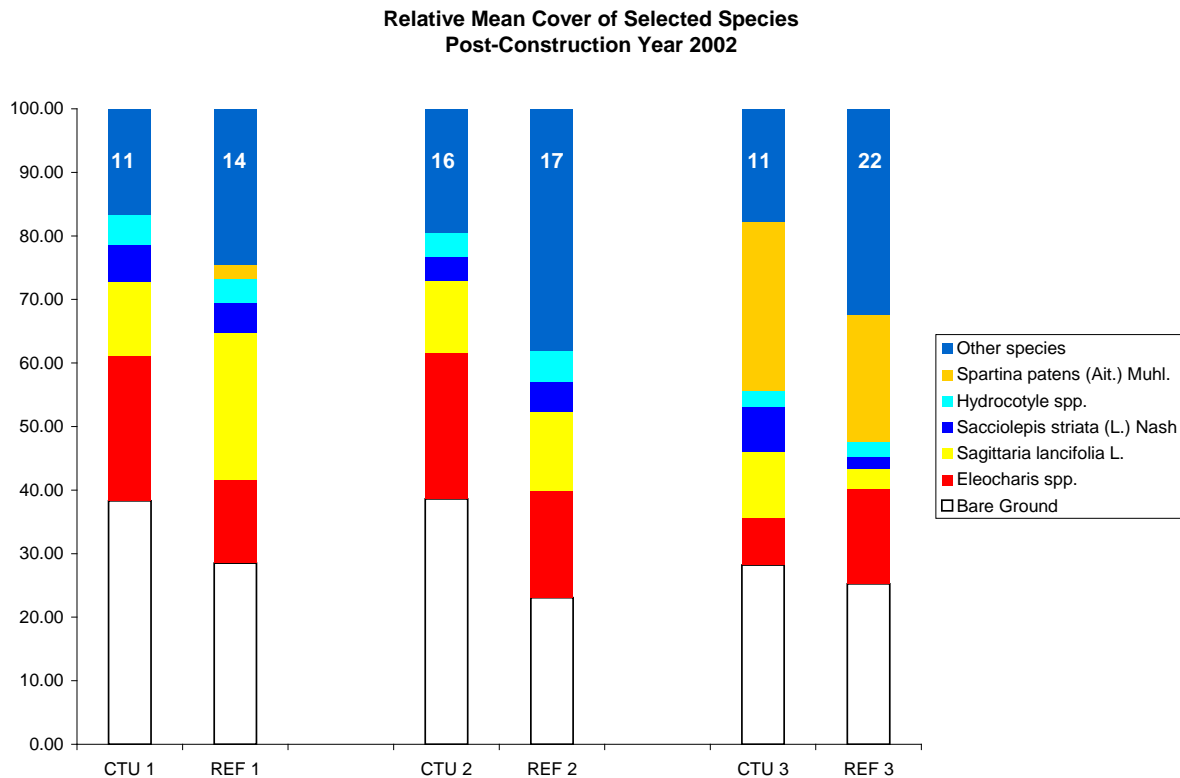
Figure 16: The relative mean cover of five selected emergent vegetation species at the Brady Canal Hydrologic Restoration (TE-28) project during the October 2002 post-construction sampling period.

Only two species had greater than ten percent relative mean cover in two different areas of the reference area in 2002. *Schoenoplectus americanus* had a relative mean cover of 11.02 in reference area #3, and *Leersia hexandra* had a relative mean cover of 14.24 in reference area #2.

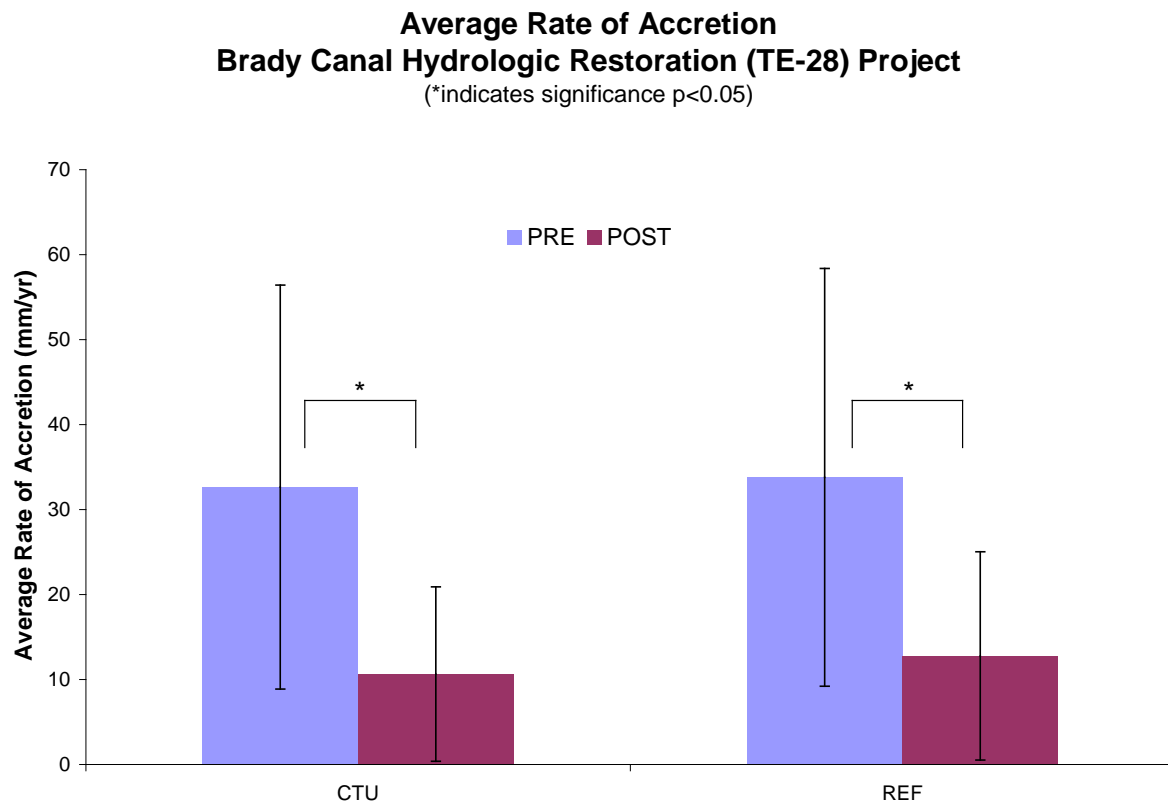
Figure 17: Average rate of accretion \pm standard deviation showing significance between pre- and post-construction time periods in the conservation treatment unit (CTU) and reference area (REF).

Figure 17 shows that the rate of vertical accretion within the project area has decreased significantly ($p < 0.05$) from the pre-construction sampling to the post-construction sampling. The decrease in accretion can be attributed to environmental conditions that the project and reference areas experienced during the sampling period. The post-construction sampling

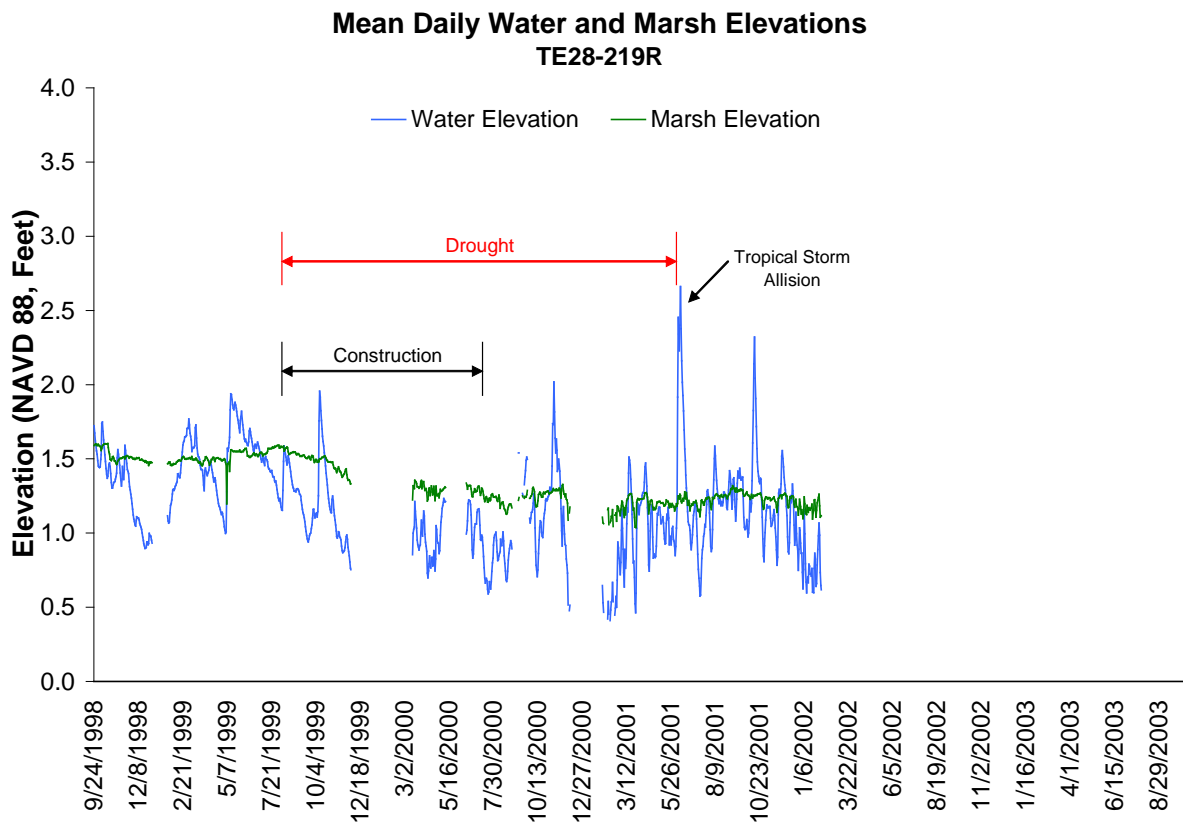
Figure 19: Mean daily water and marsh elevations in reference area two at the Brady Canal Hydrologic Restoration (TE-28) project.

Figures 18 and 19 show the mean daily water and marsh surface elevations in CTU #2 and reference area #2. These graphs show the vertical movement of the water and marsh surface as well as the depth and duration of flooding. In January 2002, a decision was made to remove the marsh mat equipment at station TE28-219R which is the reference site since the marsh was not showing a comparable response to the changing water levels. Attempts were made to re-locate the instrumentation; however, a site was not found.

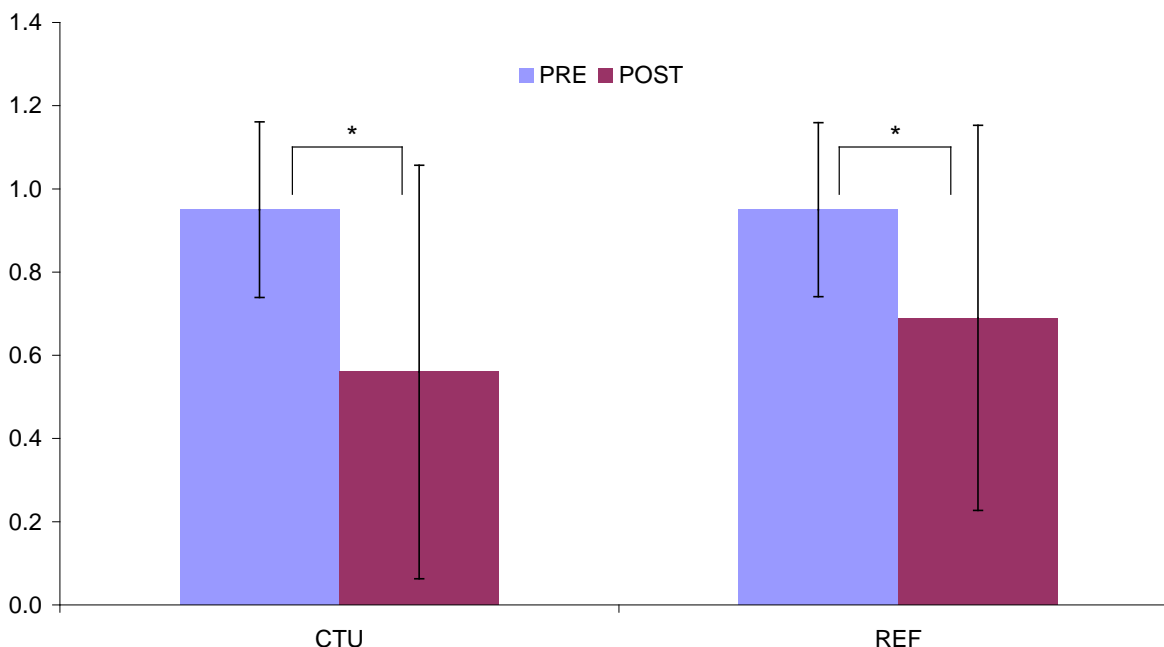
Relative Frequency of Occurrence for Submerged Aquatic Vegetation

(*indicates significance $p < 0.05$)

Figure 20: Relative frequency of occurrence for submerged aquatic vegetation \pm standard deviation significance between the pre- and post-construction time periods in the conservation treatment unit (CTU) and reference area (REF).

The frequency of occurrence of submerged aquatic vegetation within the project area has decreased from the pre-construction sampling period to the post-construction sampling (figure 20). Although it has decreased significantly, this decrease can be explained by the passing of Hurricane Lili prior to the post-construction sampling. This hurricane passed just weeks before the scheduled sampling period and affected the submerged aquatic vegetation as well as the emergent vegetation. During the pre-construction sampling period, the dominant species included *Ceratophyllum demersum*, *Najas guadalupensis*, *Nuphar lutea*, and *Nymphaea mexicana*. During the post-construction sampling period, the dominant species included *Ceratophyllum demersum* and *Nymphaea mexicana*.
