**2008 Operations, Maintenance,
and Monitoring Report**

**Caernarvon Diversion Outfall
Management**

State Project Number BS-03a
Priority Project List 2

September 1, 2009
Plaquemines Parish

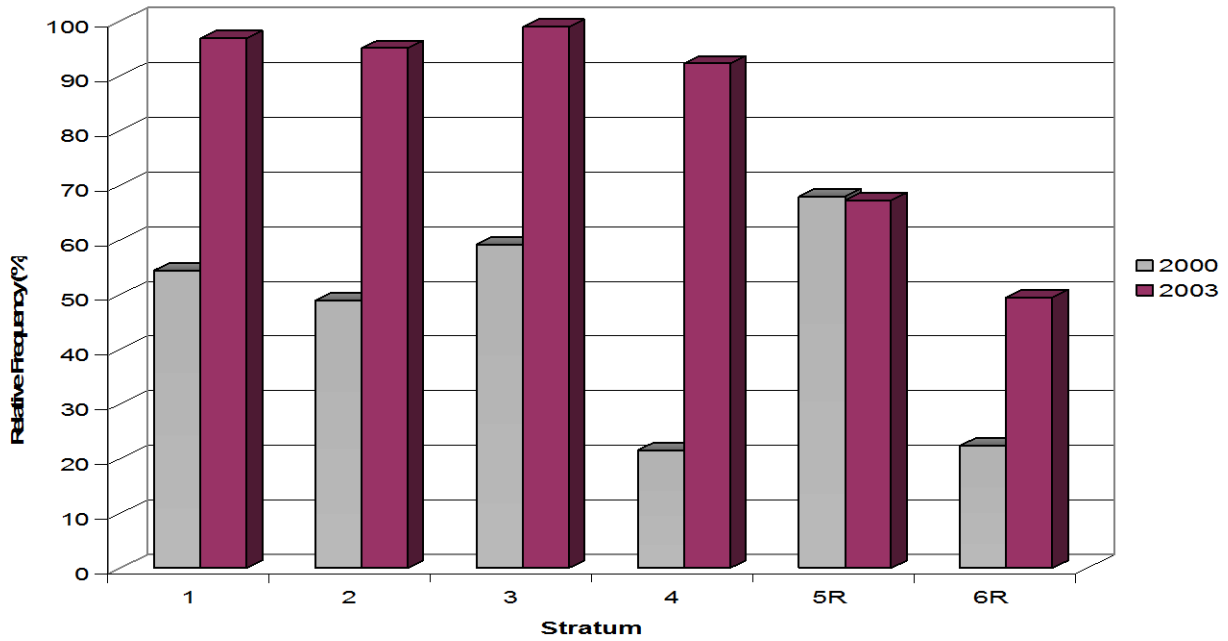
Figure 32. Relative frequency (%) of all submerged aquatic vegetation species combined across two transects within two ponds per stratum of the Caernarvon Diversion Outfall Management (BS-03a) project and reference areas in April 2000 and 2003.

Relative frequency of SAV increased dramatically across all strata, except 5R, from the sampling period in 2000 to the sampling period of 2003 (figure 32). All project area strata had empty sample percentages less than 10, and strata 6R showed a decrease of 19% occurrence of empty samples (table 5). All strata showed an increase in species diversity with at least one species of plant being observed in all strata that was not present in the 2000 survey. As was seen with emergent vegetation data, the dramatic increase of SAV may not be fully attributable to project effects because pre-construction data were taken during a drought.
