APPENDIX B

Mississippi River Borrow Area Geotechnical Survey

The Mississippi River Borrow Area Geotechnical Survey (Survey) was completed in support of the Preliminary Design Phase for the Riverine Sand Mining / Scofield Island Restoration Project (Project). The Project is sponsored by the Louisiana Department of Natural Resources (LDNR), State of Louisiana Office of Coastal Protection and Restoration (OCPR) and NOAA Fisheries. The Project design is funded and authorized in accordance with the provisions of the Coastal Wetlands Planning, Protection and Restoration Act (CWPPRA) (16 U.S.C.A., Sections 3951-3956) and has been approved by the Public Law 101-646 Task Force. The Project's CWPPRA designation is BA-40.

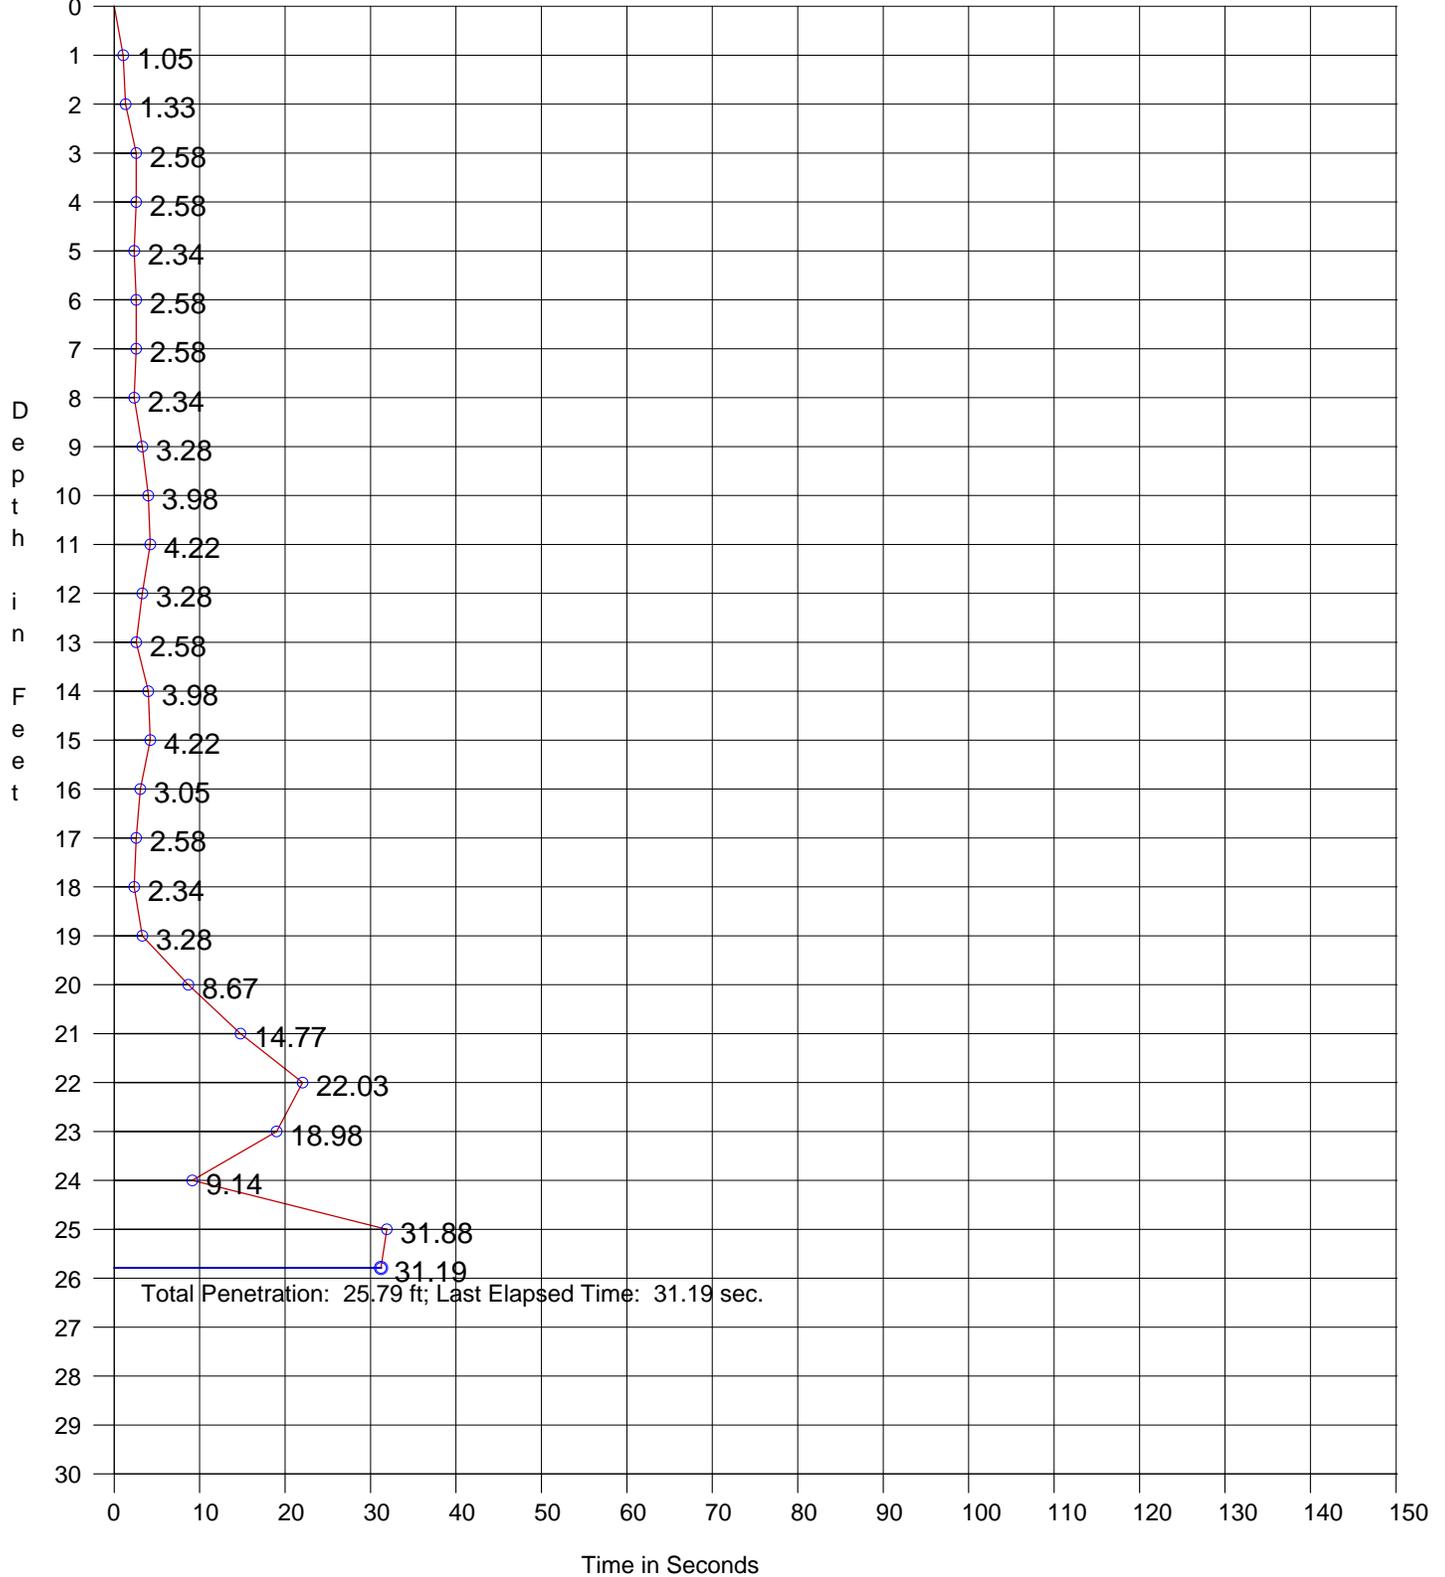
Penetration Graph for Core No. MRB-VC-08-02, Run 1

Lat: 29d24.6954'
Long: 089d36.1119'
Datum:

Date: 12/19/2008
Start Time: 12:02:05 PM
End Time: 12:09:27 PM

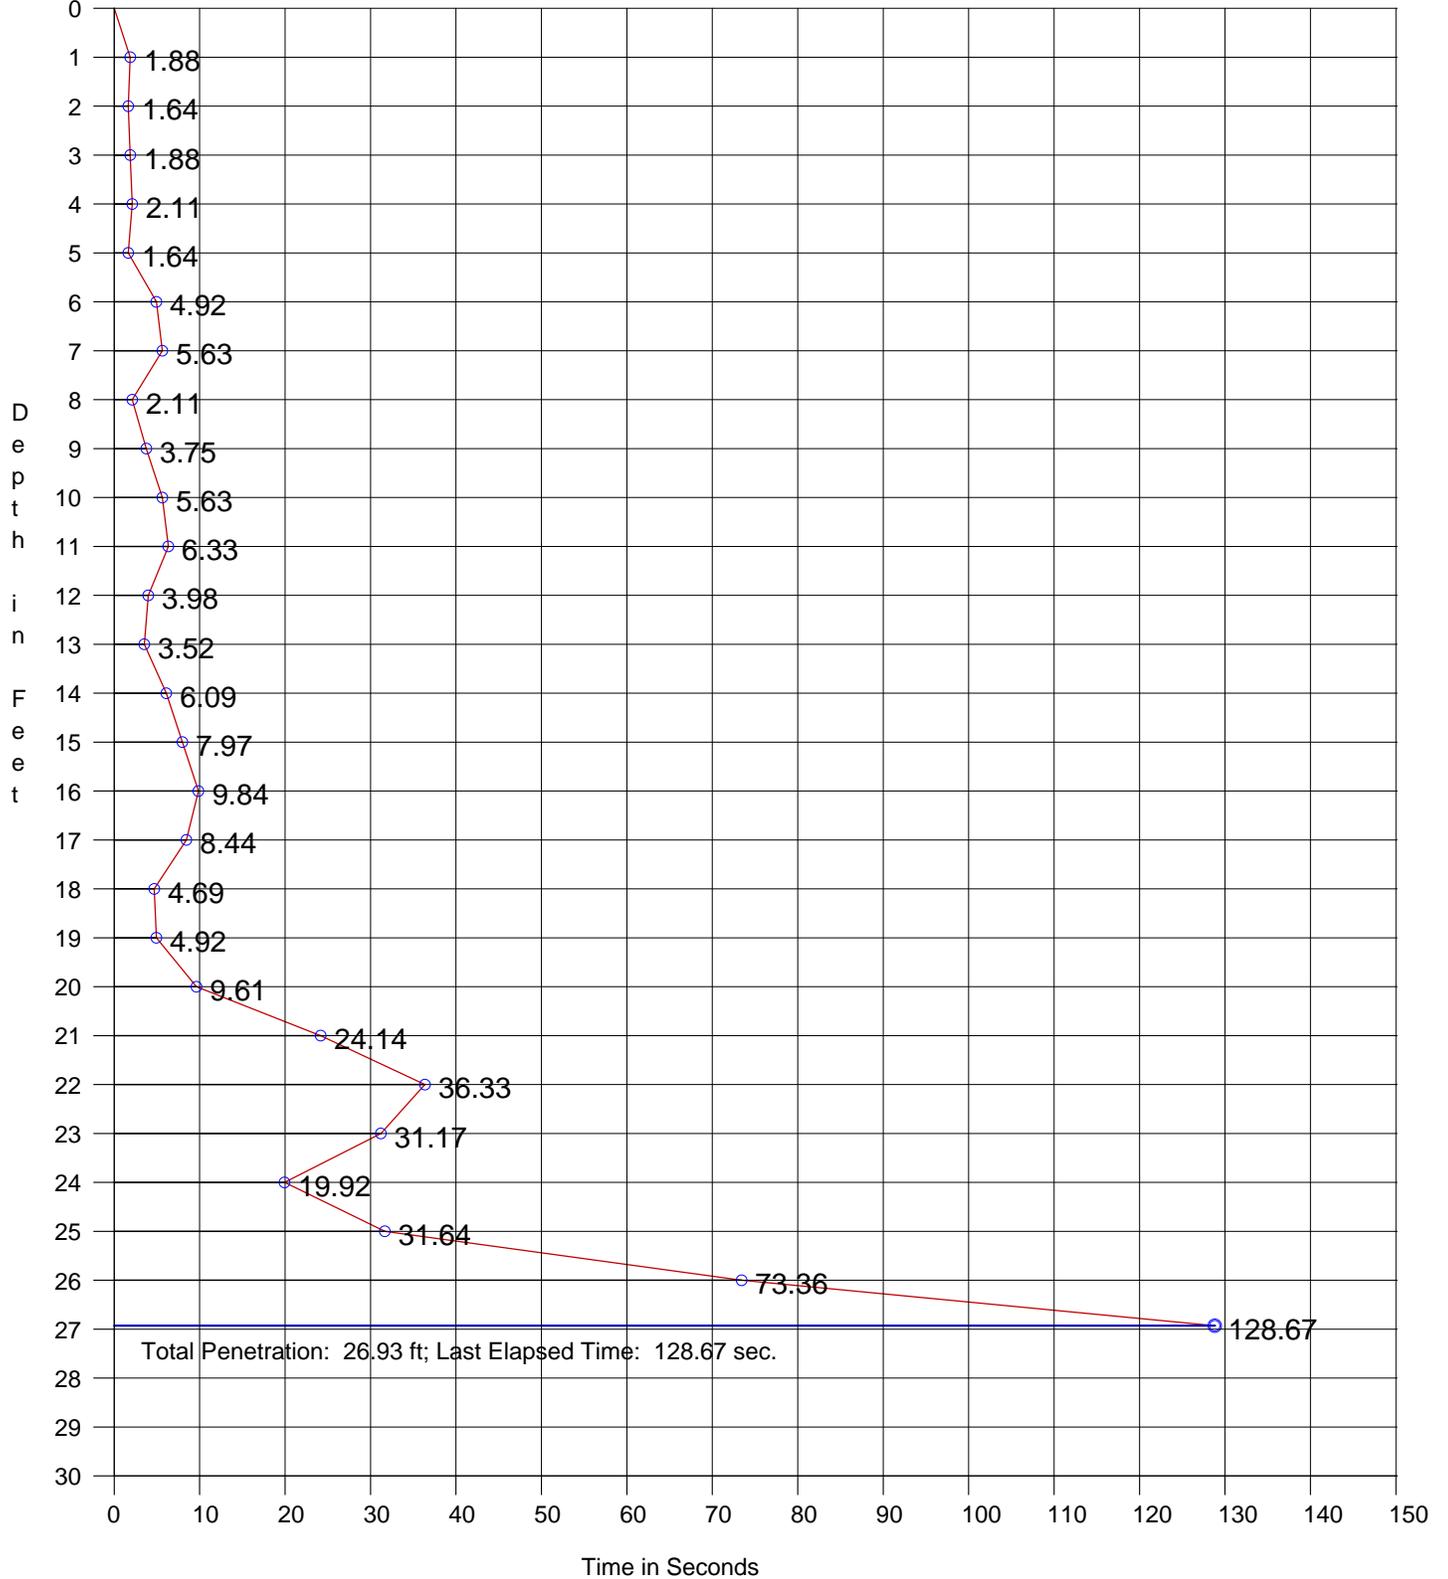
Penetration Graph for Core No. MRB-VC-08-04, Run 1

Date: 12/20/2008
Start Time: 1:55:00 PM
End Time: 1:58:04 PM

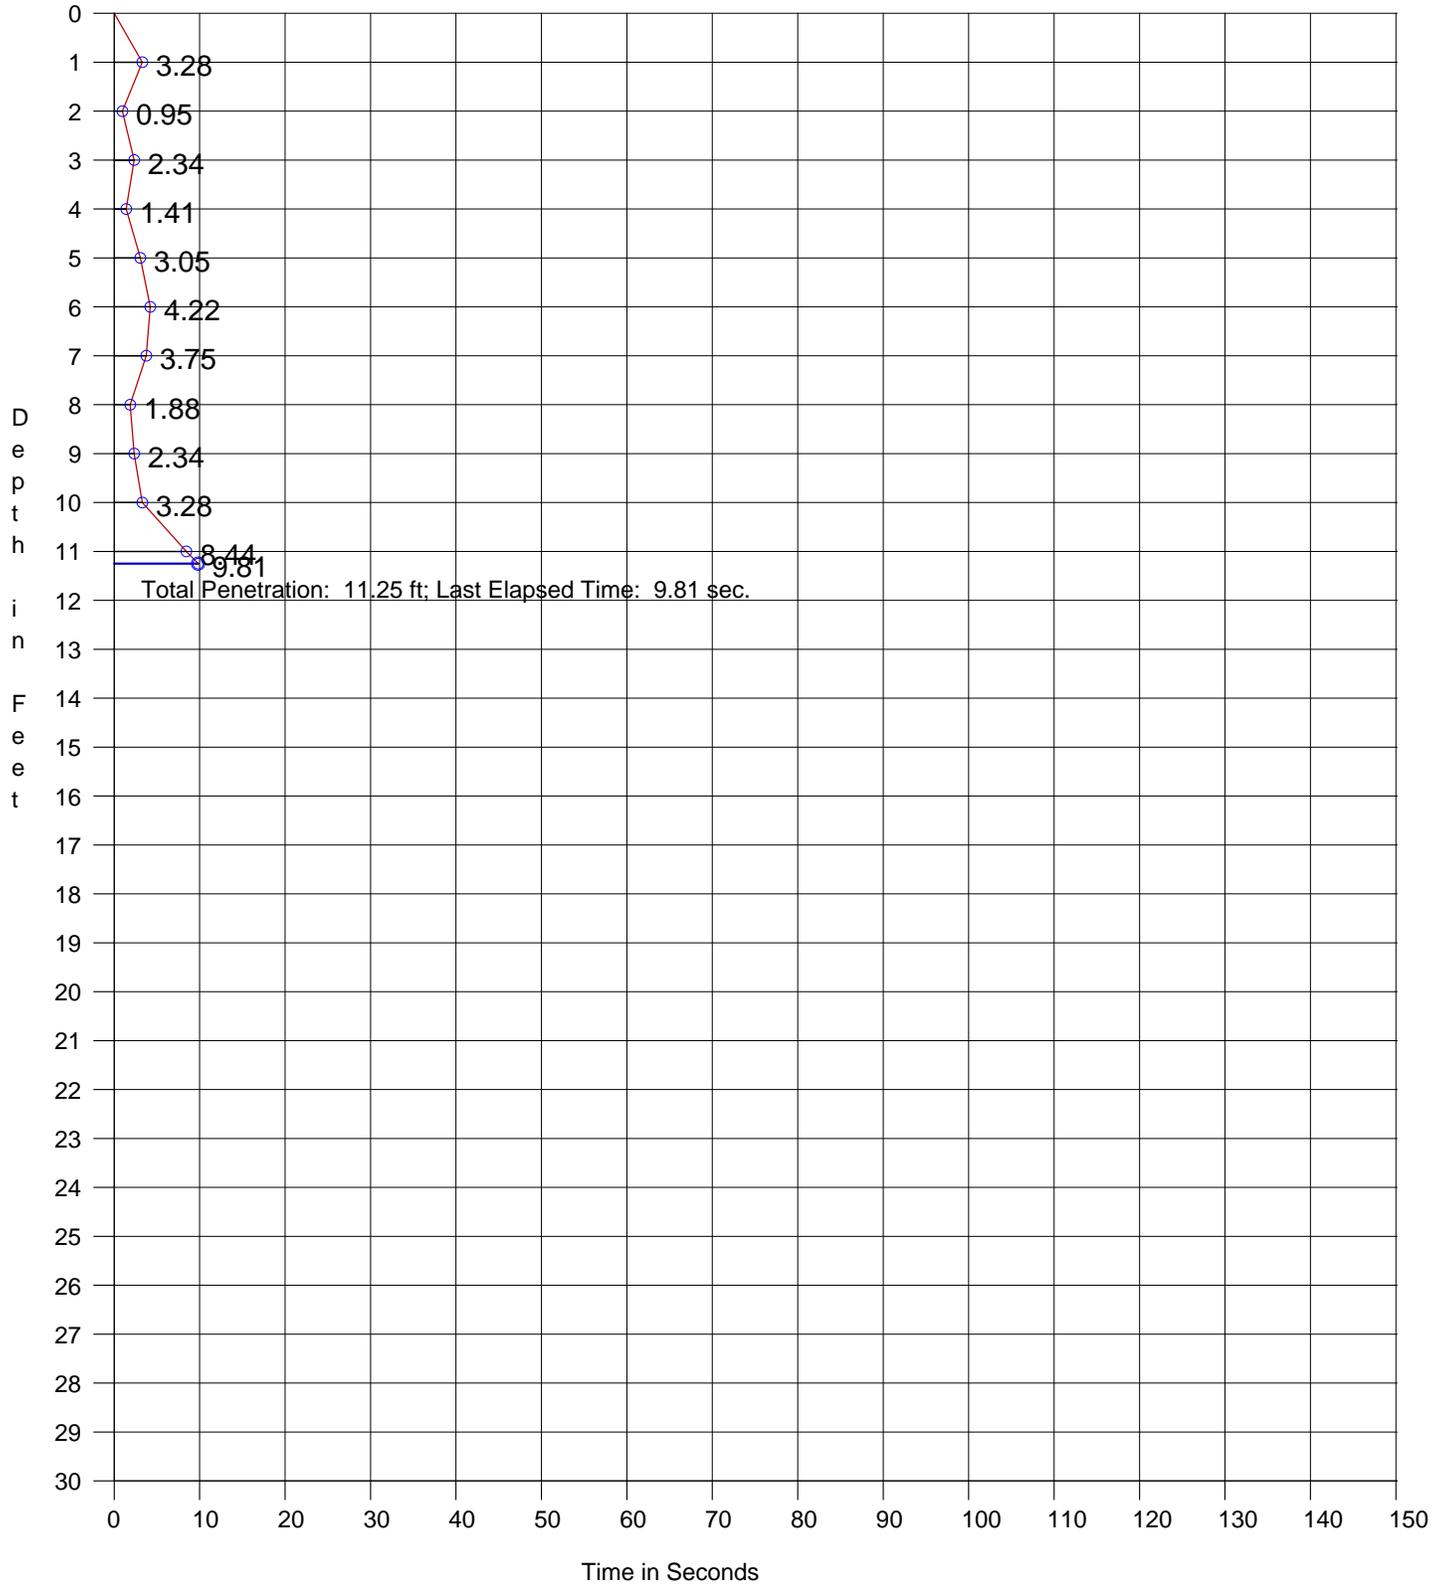
Penetration Graph for Core No. MRB-VC-08-05, Run 1

Comment: Rig pulled over. pipe broke

Date: 12/19/2008
 Start Time: 1:17:26 PM
 End Time: 1:22:12 PM

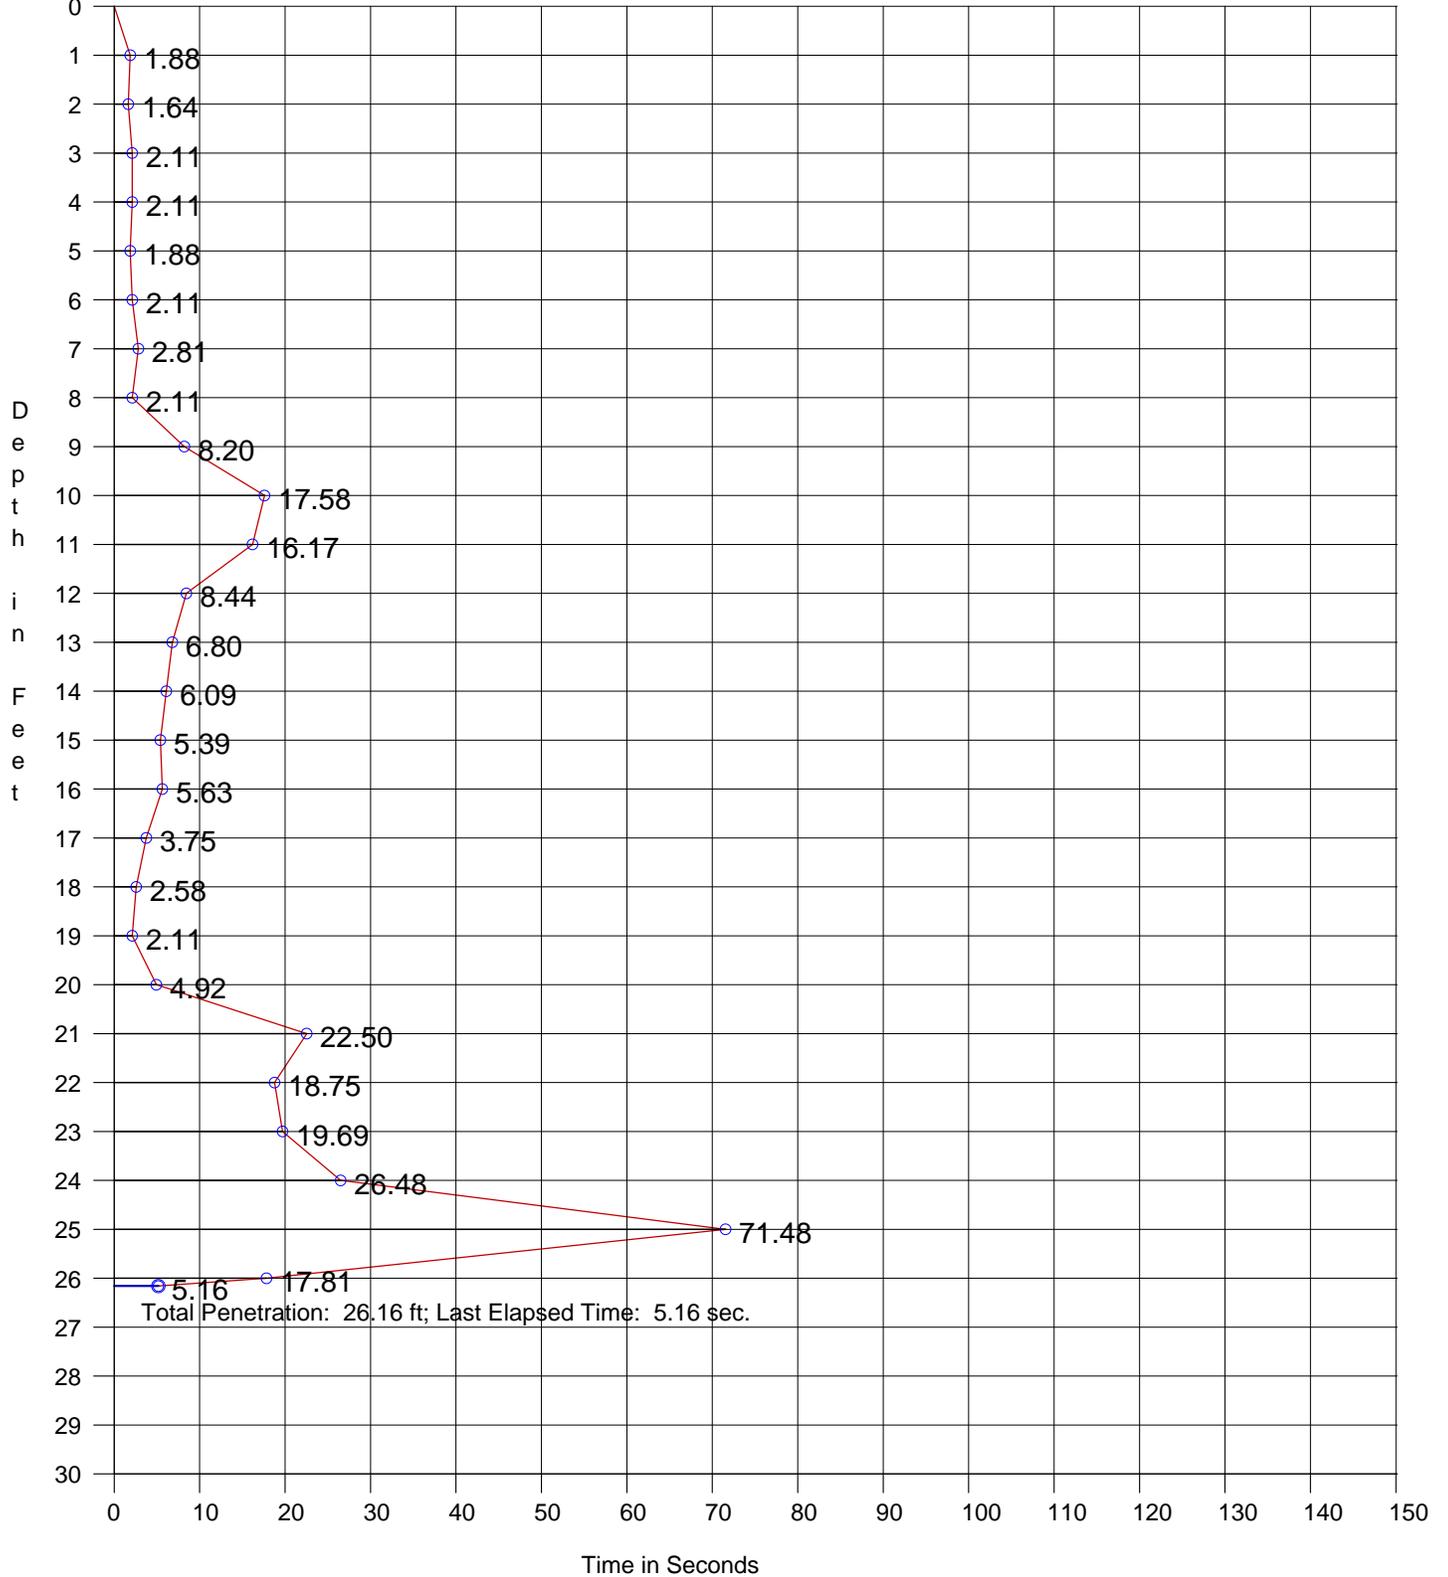
Penetration Graph for Core No. MRB-VC-08-06, Run 1

Date: 12/19/2008
 Start Time: 3:12:24 PM
 End Time: 3:15:15 PM

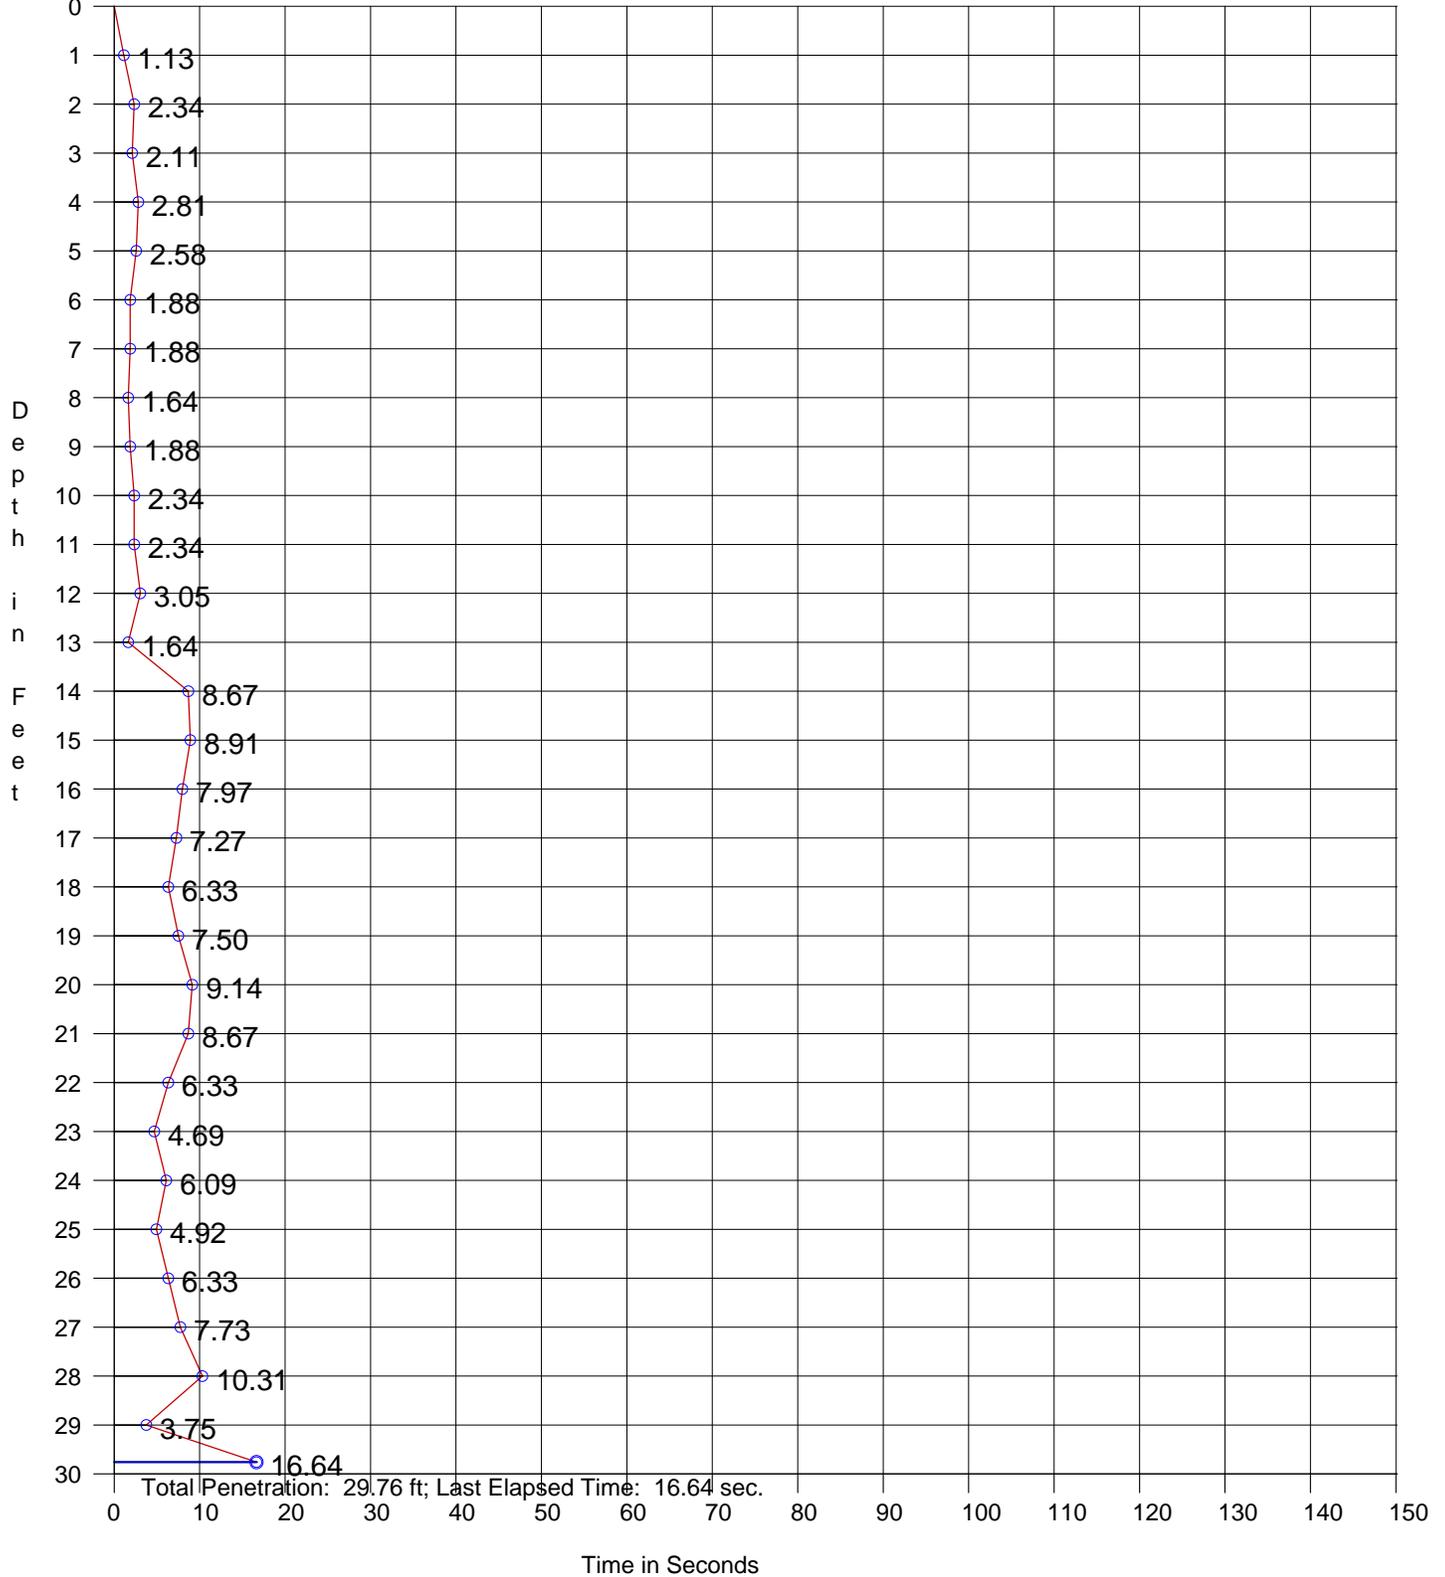
Penetration Graph for Core No. MRB-VC-08-07, Run 1

Date: 12/19/2008
 Start Time: 10:27:00 AM
 End Time: 10:34:47 AM

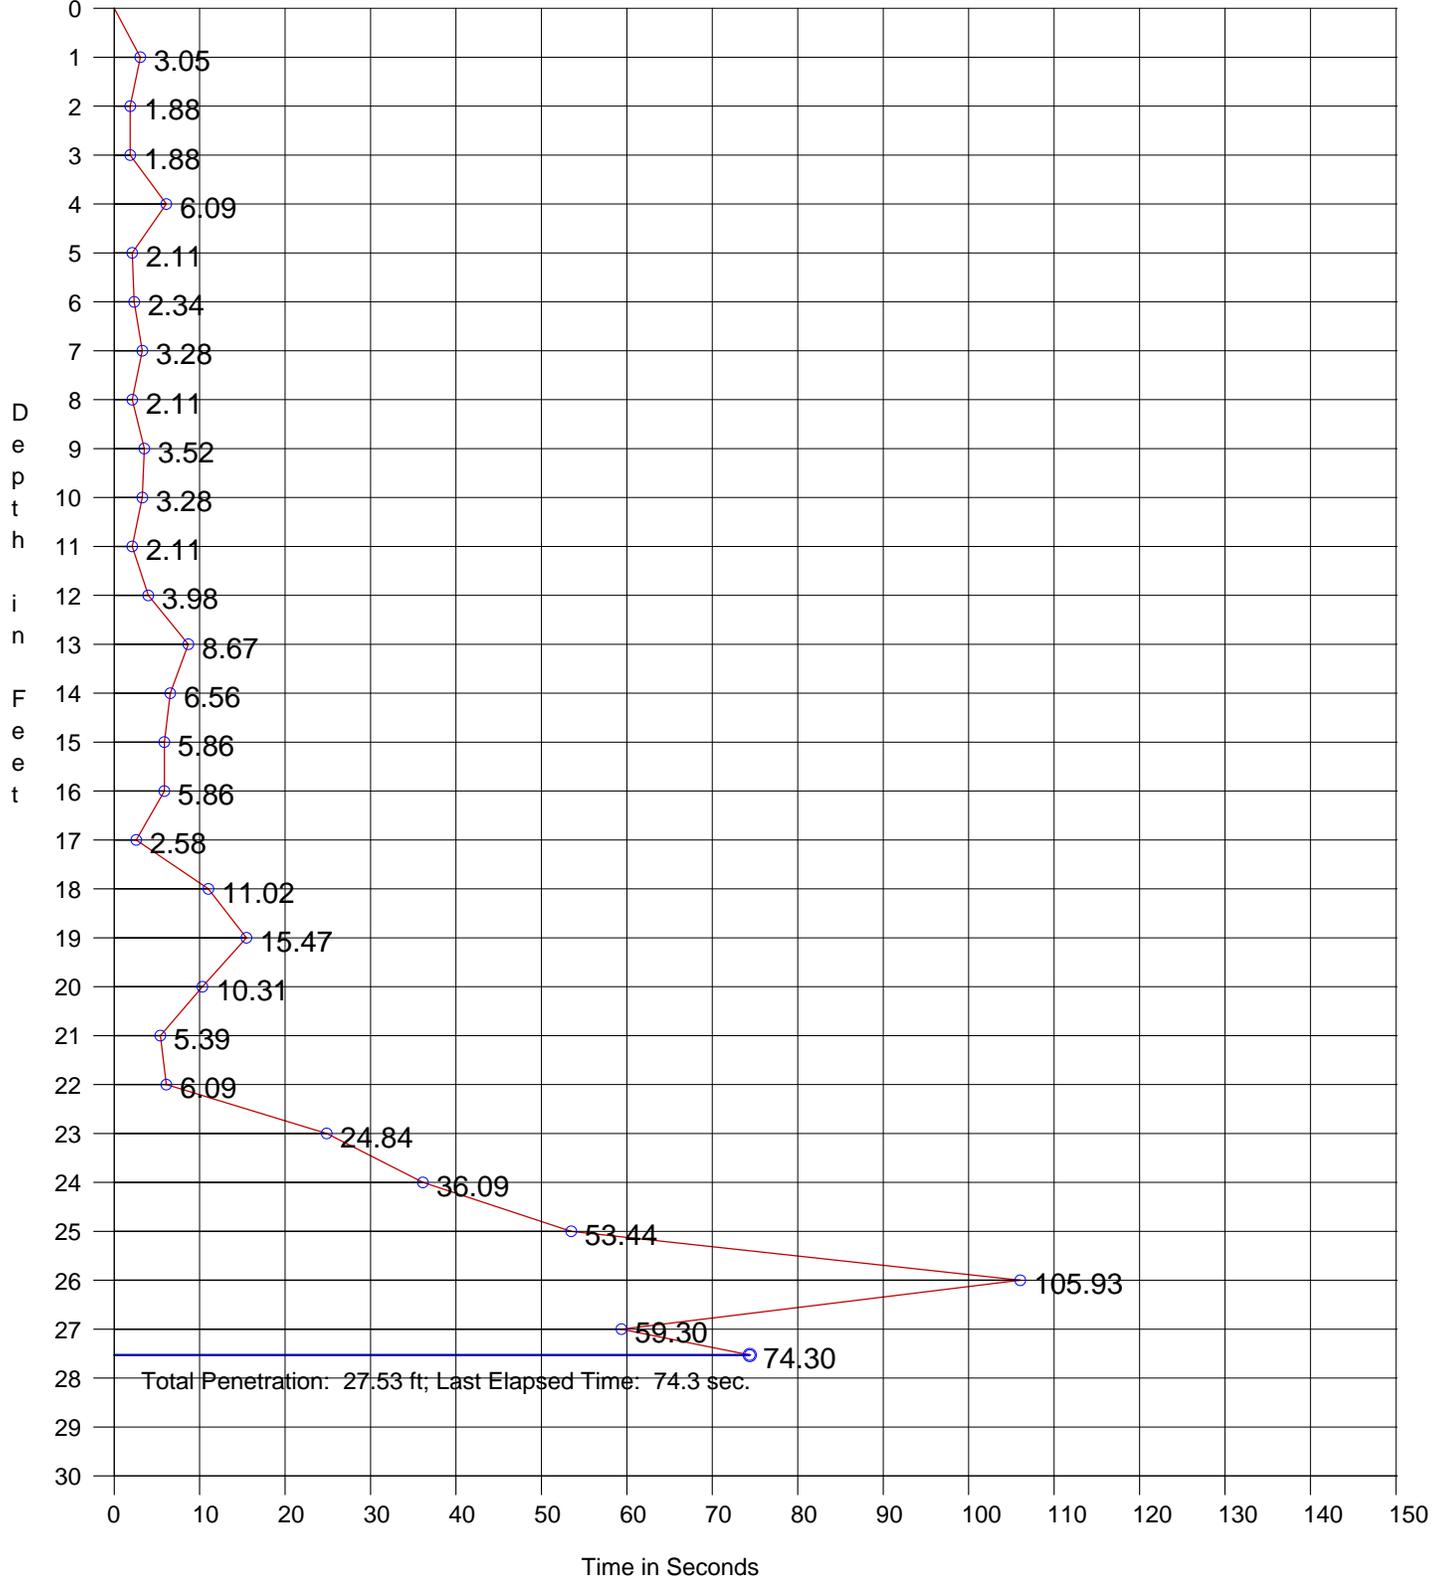
Penetration Graph for Core No. MRE-VC-08-05, Run 1

Date: 12/18/2008
 Start Time: 3:23:01 PM
 End Time: 3:26:42 PM

Recovery was at least 80 percent on all cores except MRE-08-05, where only 70 percent of the core was recovered. The upper portion of targeted area was penetrated very quickly, indicating the presence of very soft silts or clays. Since these types of sediment are not compatible with the sands needed to restore Scofield Island, no additional actions were taken to collect samples past the refusal depth.

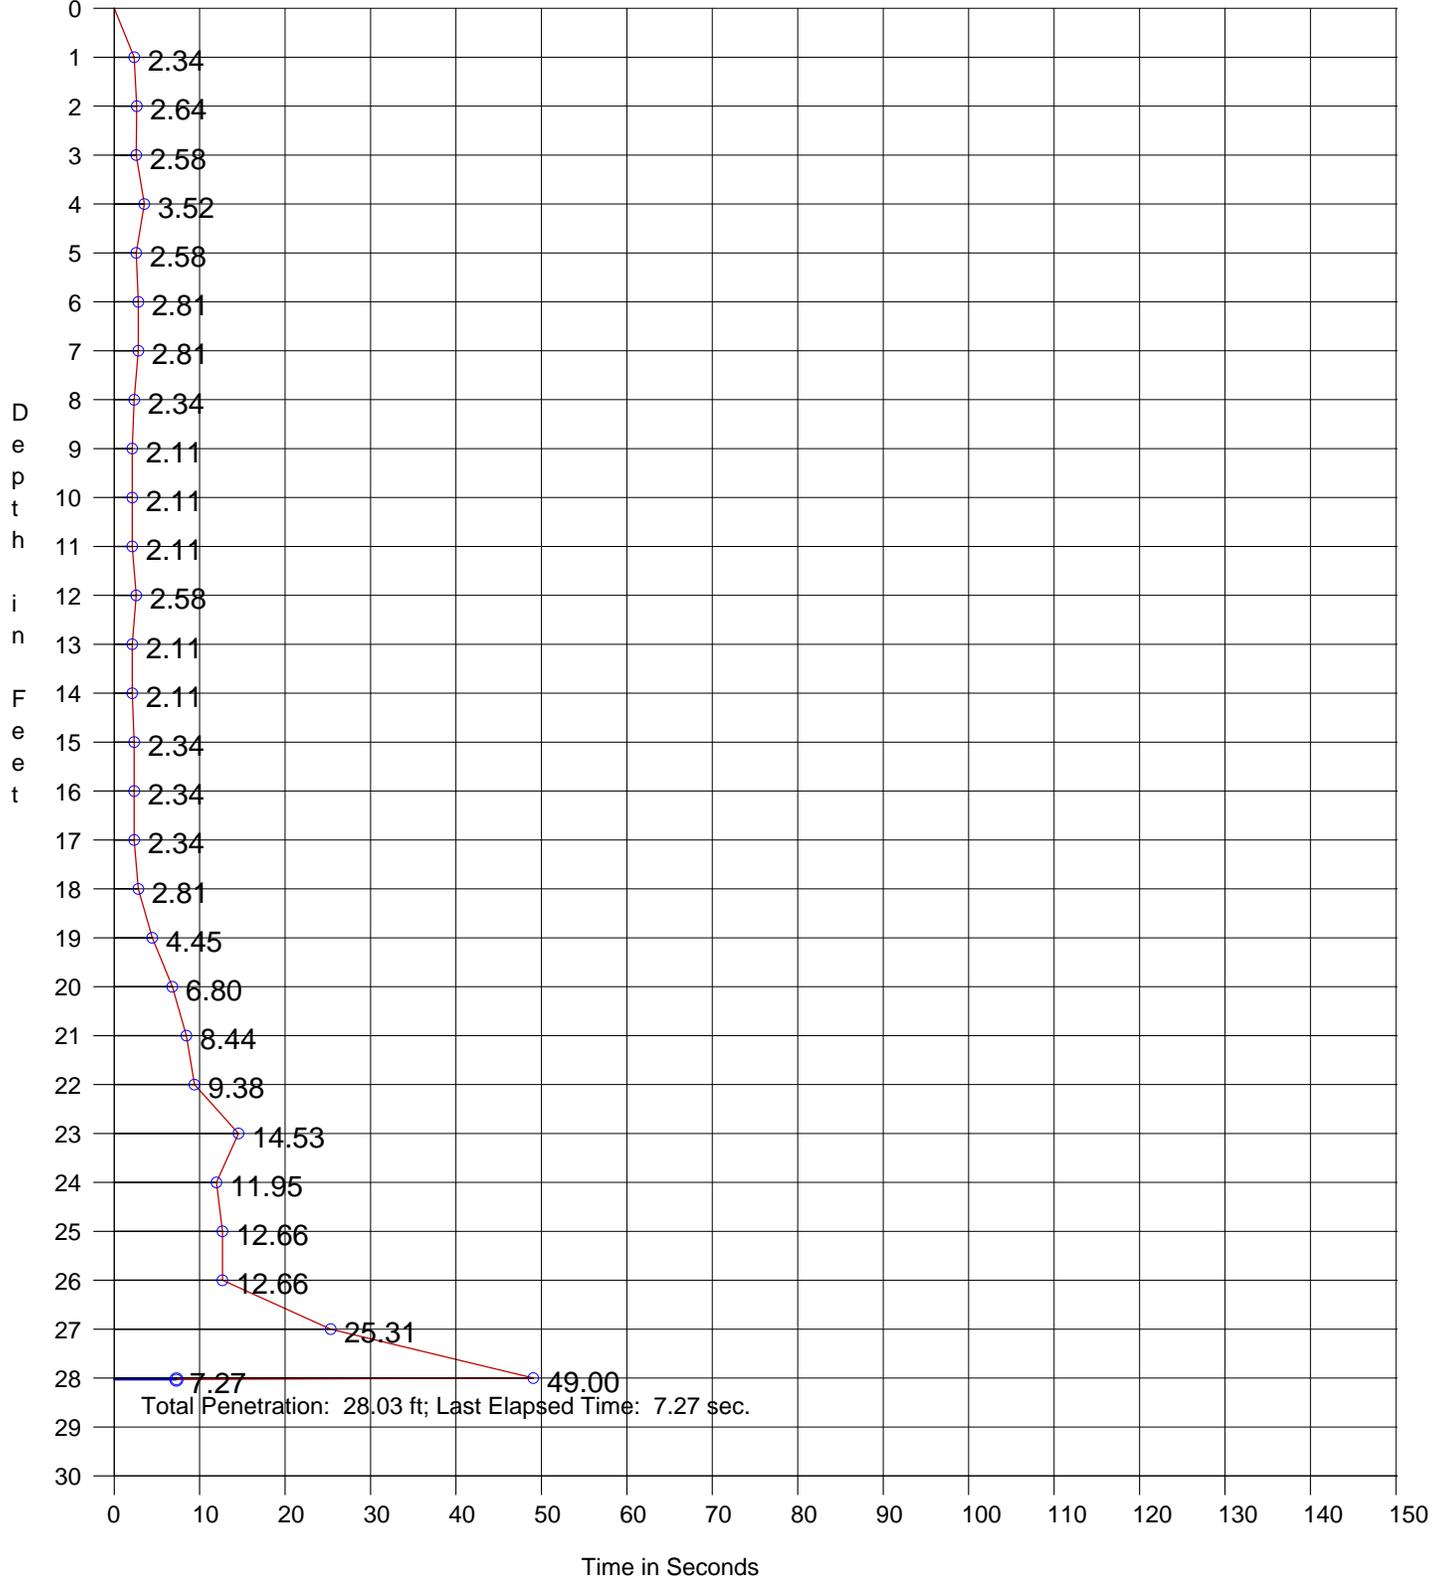
Penetration Graph for Core No. MRE-VC-08-07, Run 1

Date: 12/17/2008
Start Time: 5:20:36 PM
End Time: 5:23:43 PM

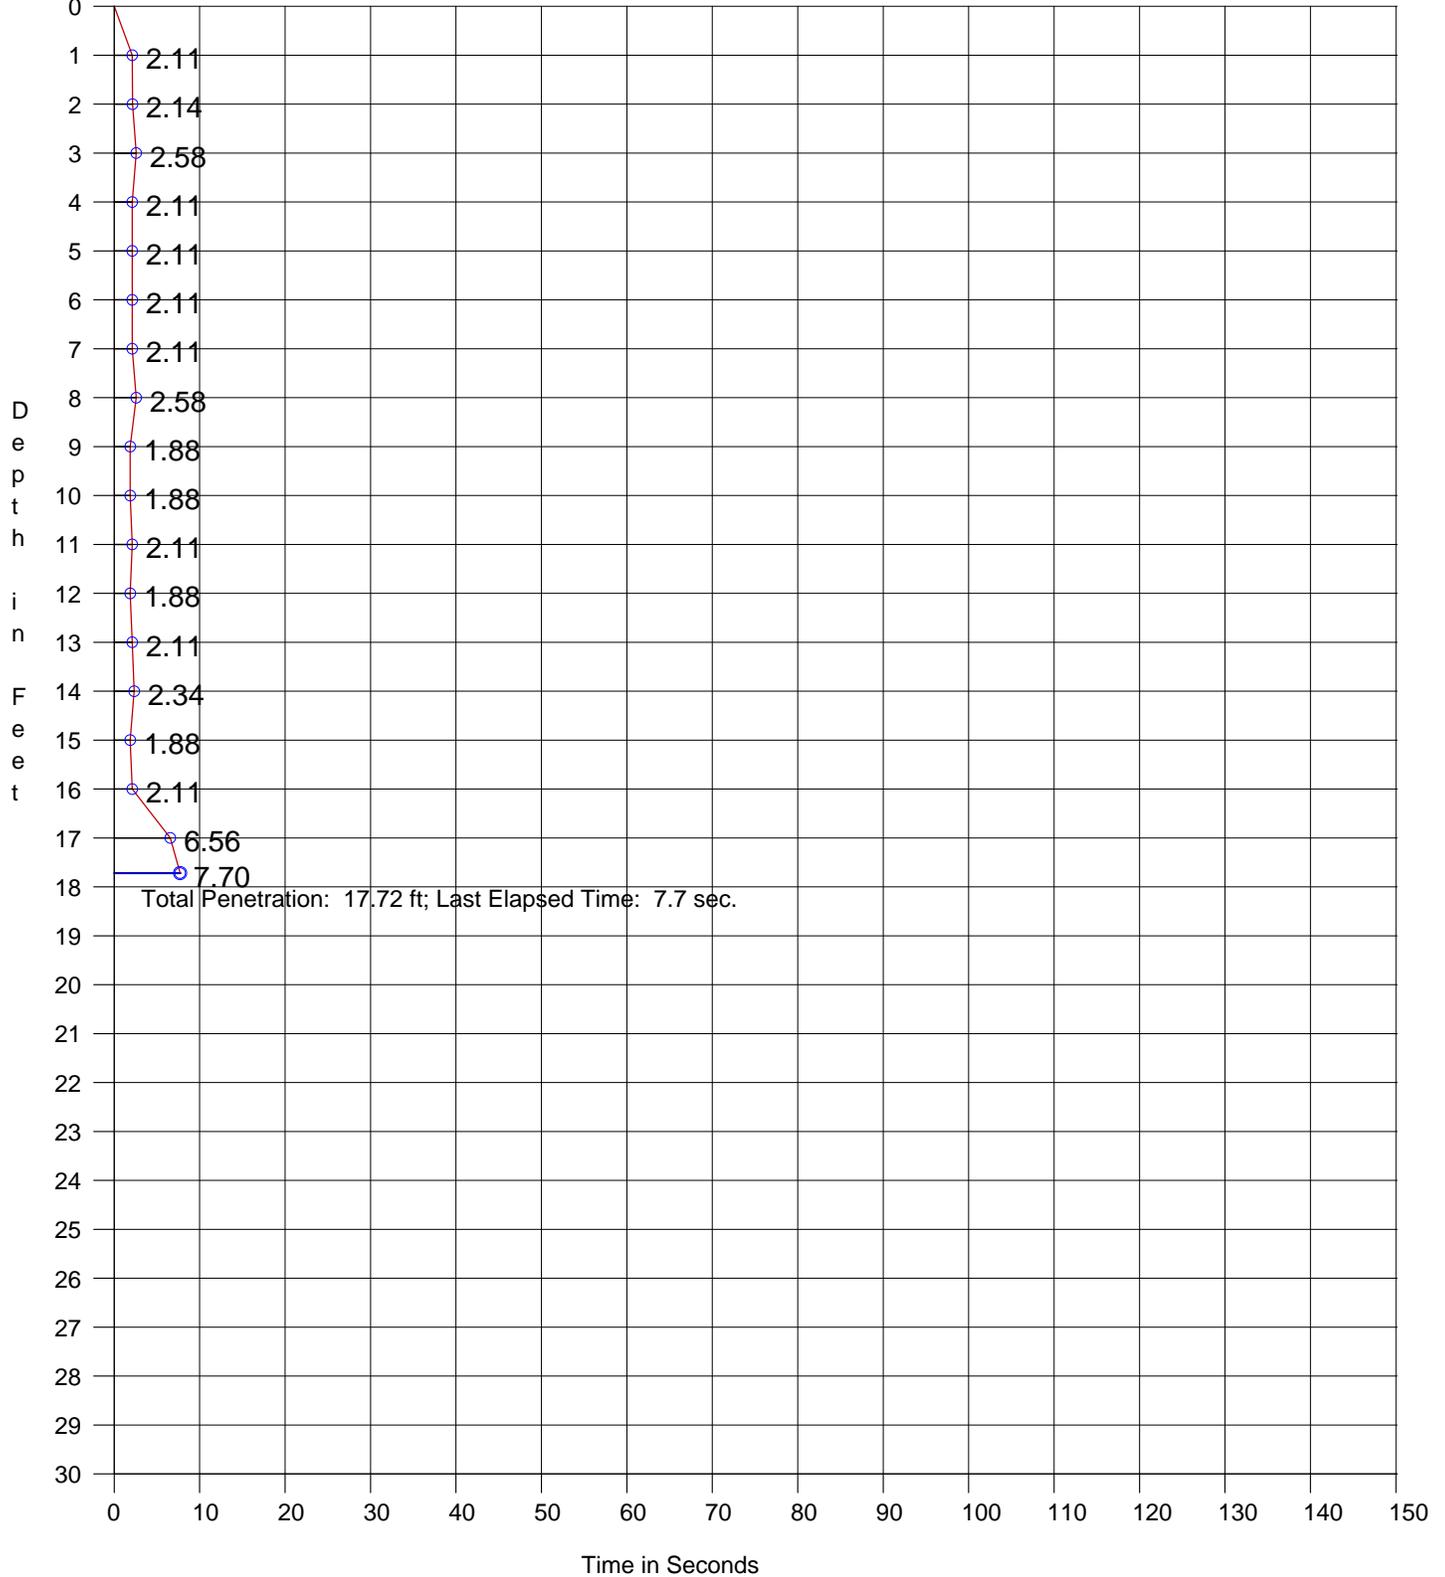
Penetration Graph for Core No. MREVC-08-08, Run

Date: 12/18/2008
 Start Time: 2:32:55 PM
 End Time: 2:34:47 PM

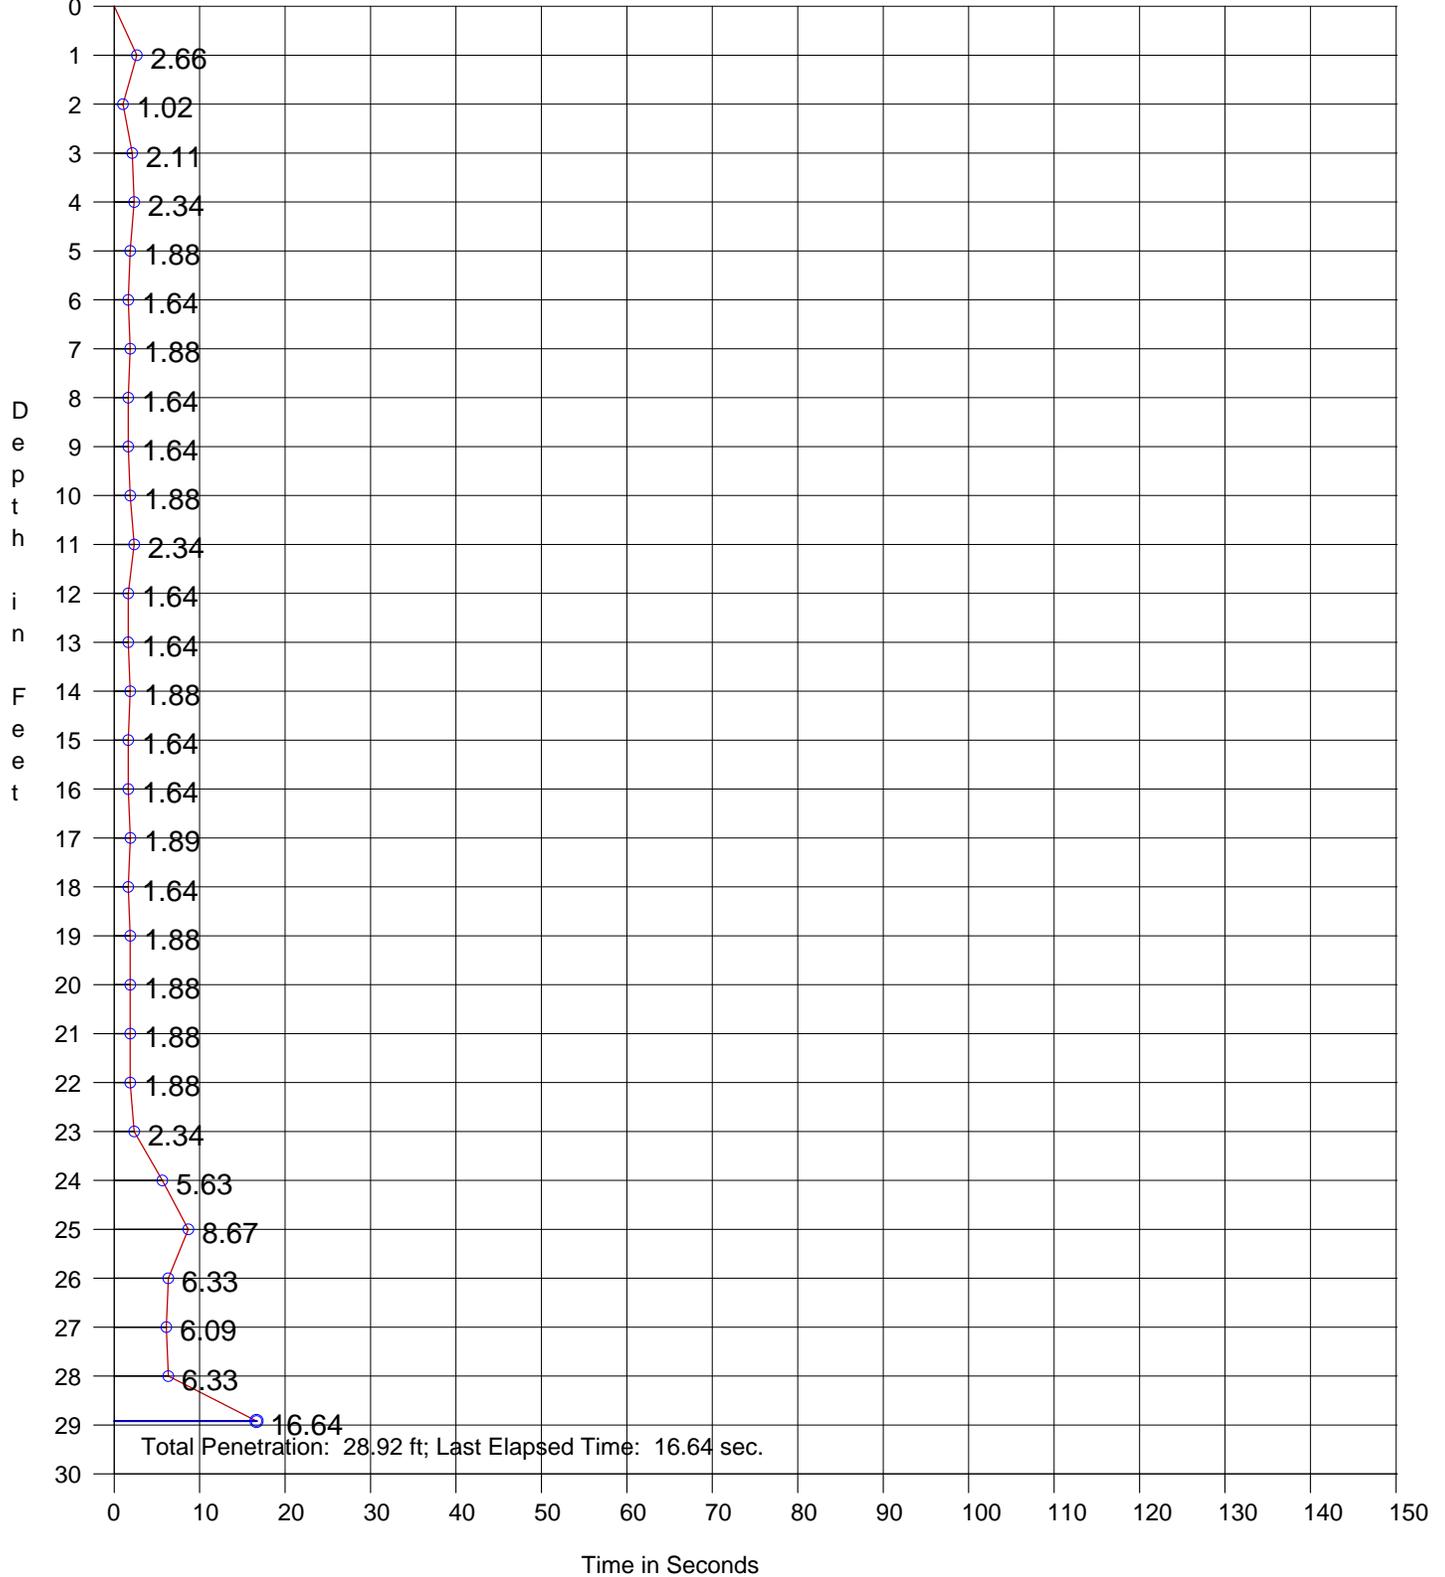
Penetration Graph for Core No. MRE-VC-08-09, Run 1

Date: 12/17/2008
Start Time: 1:12:05 PM
End Time: 1:14:50 PM
