APPENDIX B

Mississippi River Borrow Area Geotechnical Survey

The Mississippi River Borrow Area Geotechnical Survey (Survey) was completed in support of the Preliminary Design Phase for the Riverine Sand Mining / Scofield Island Restoration Project (Project). The Project is sponsored by the Louisiana Department of Natural Resources (LDNR), State of Louisiana Office of Coastal Protection and Restoration (OCPR) and NOAA Fisheries. The Project design is funded and authorized in accordance with the provisions of the Coastal Wetlands Planning, Protection and Restoration Act (CWPPRA) (16 U.S.C.A., Sections 3951-3956) and has been approved by the Public Law 101-646 Task Force. The Project's CWPPRA designation is BA-40.

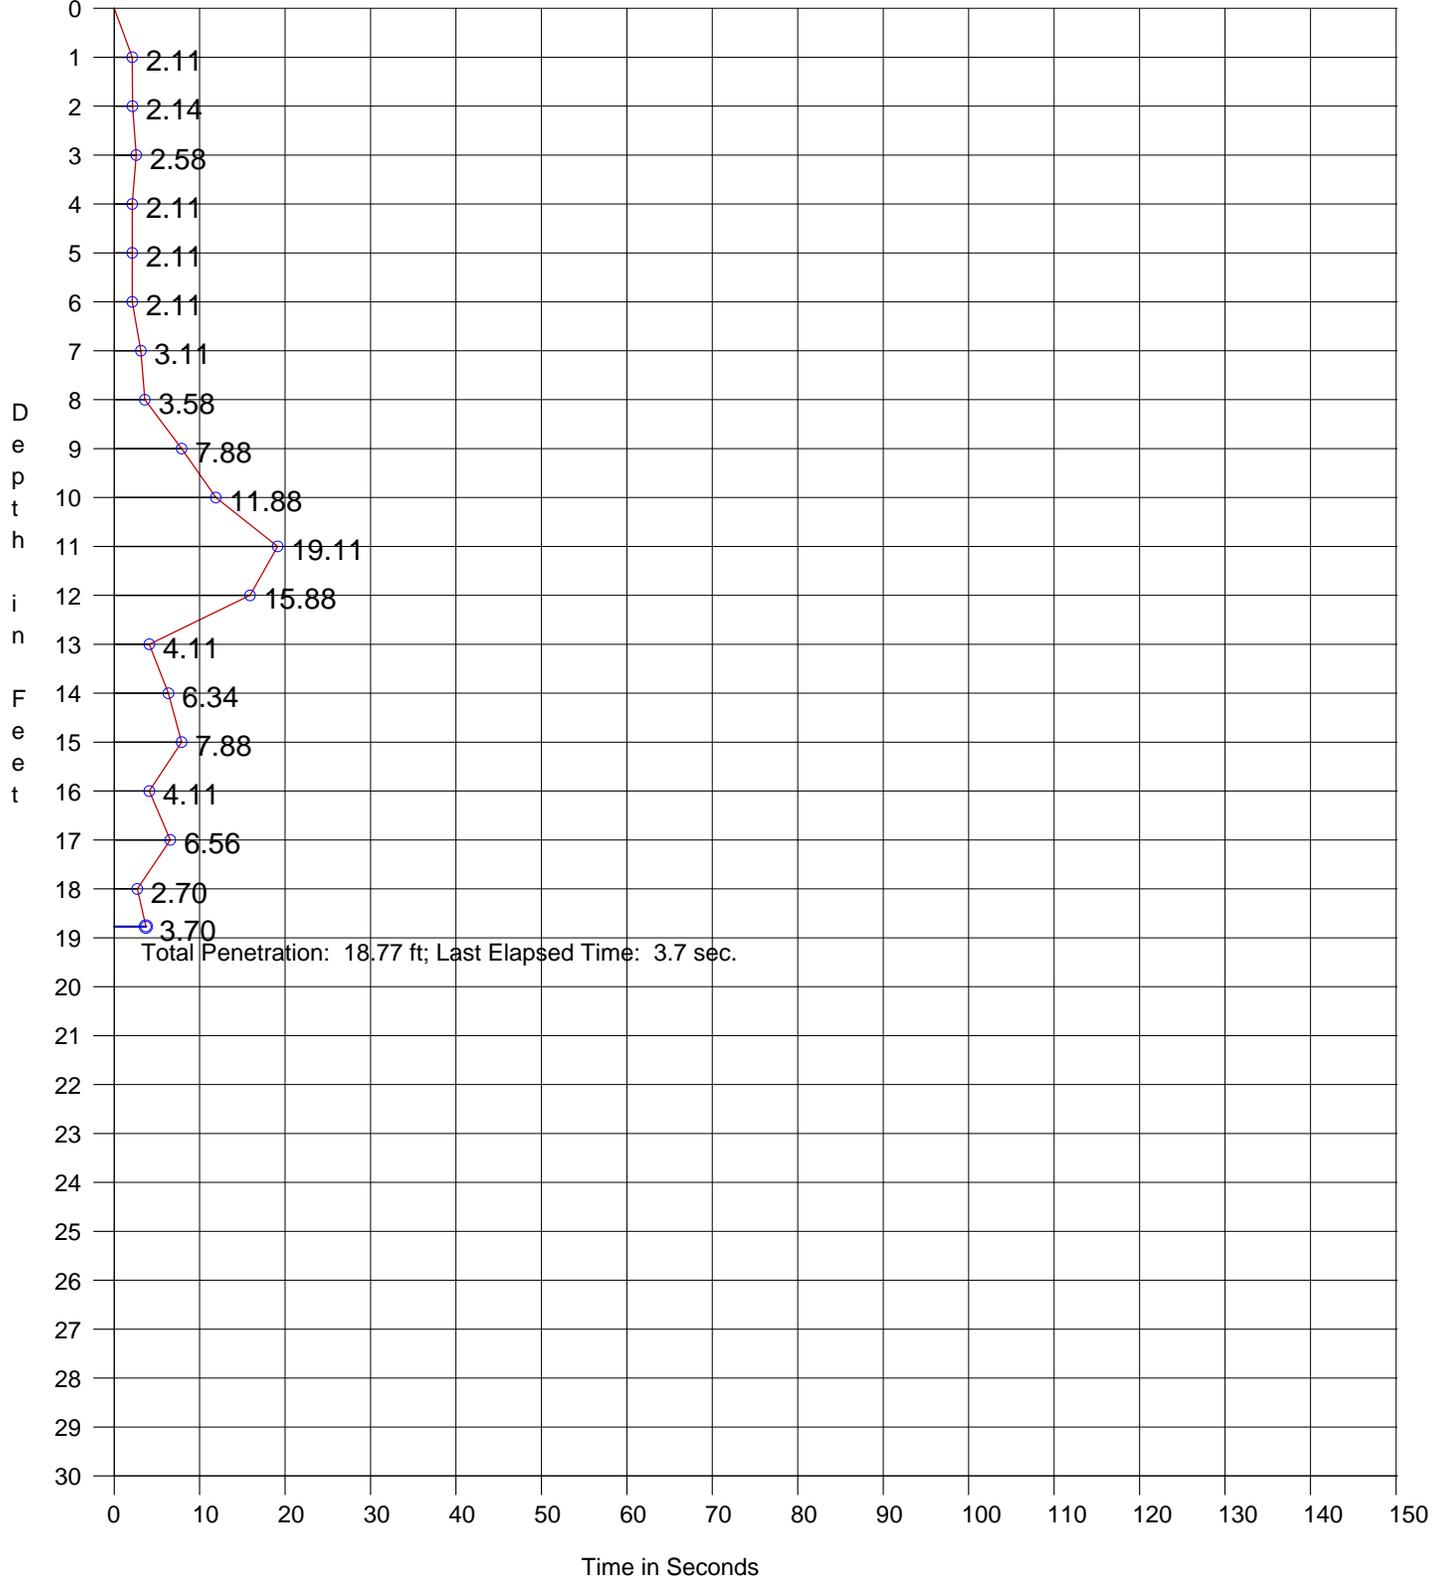
Penetration Graph for Core No. MRE-VC-08-10, Run 1

Date: 12/17/2008
Start Time: 3:39:40 PM
End Time: 3:41:52 PM

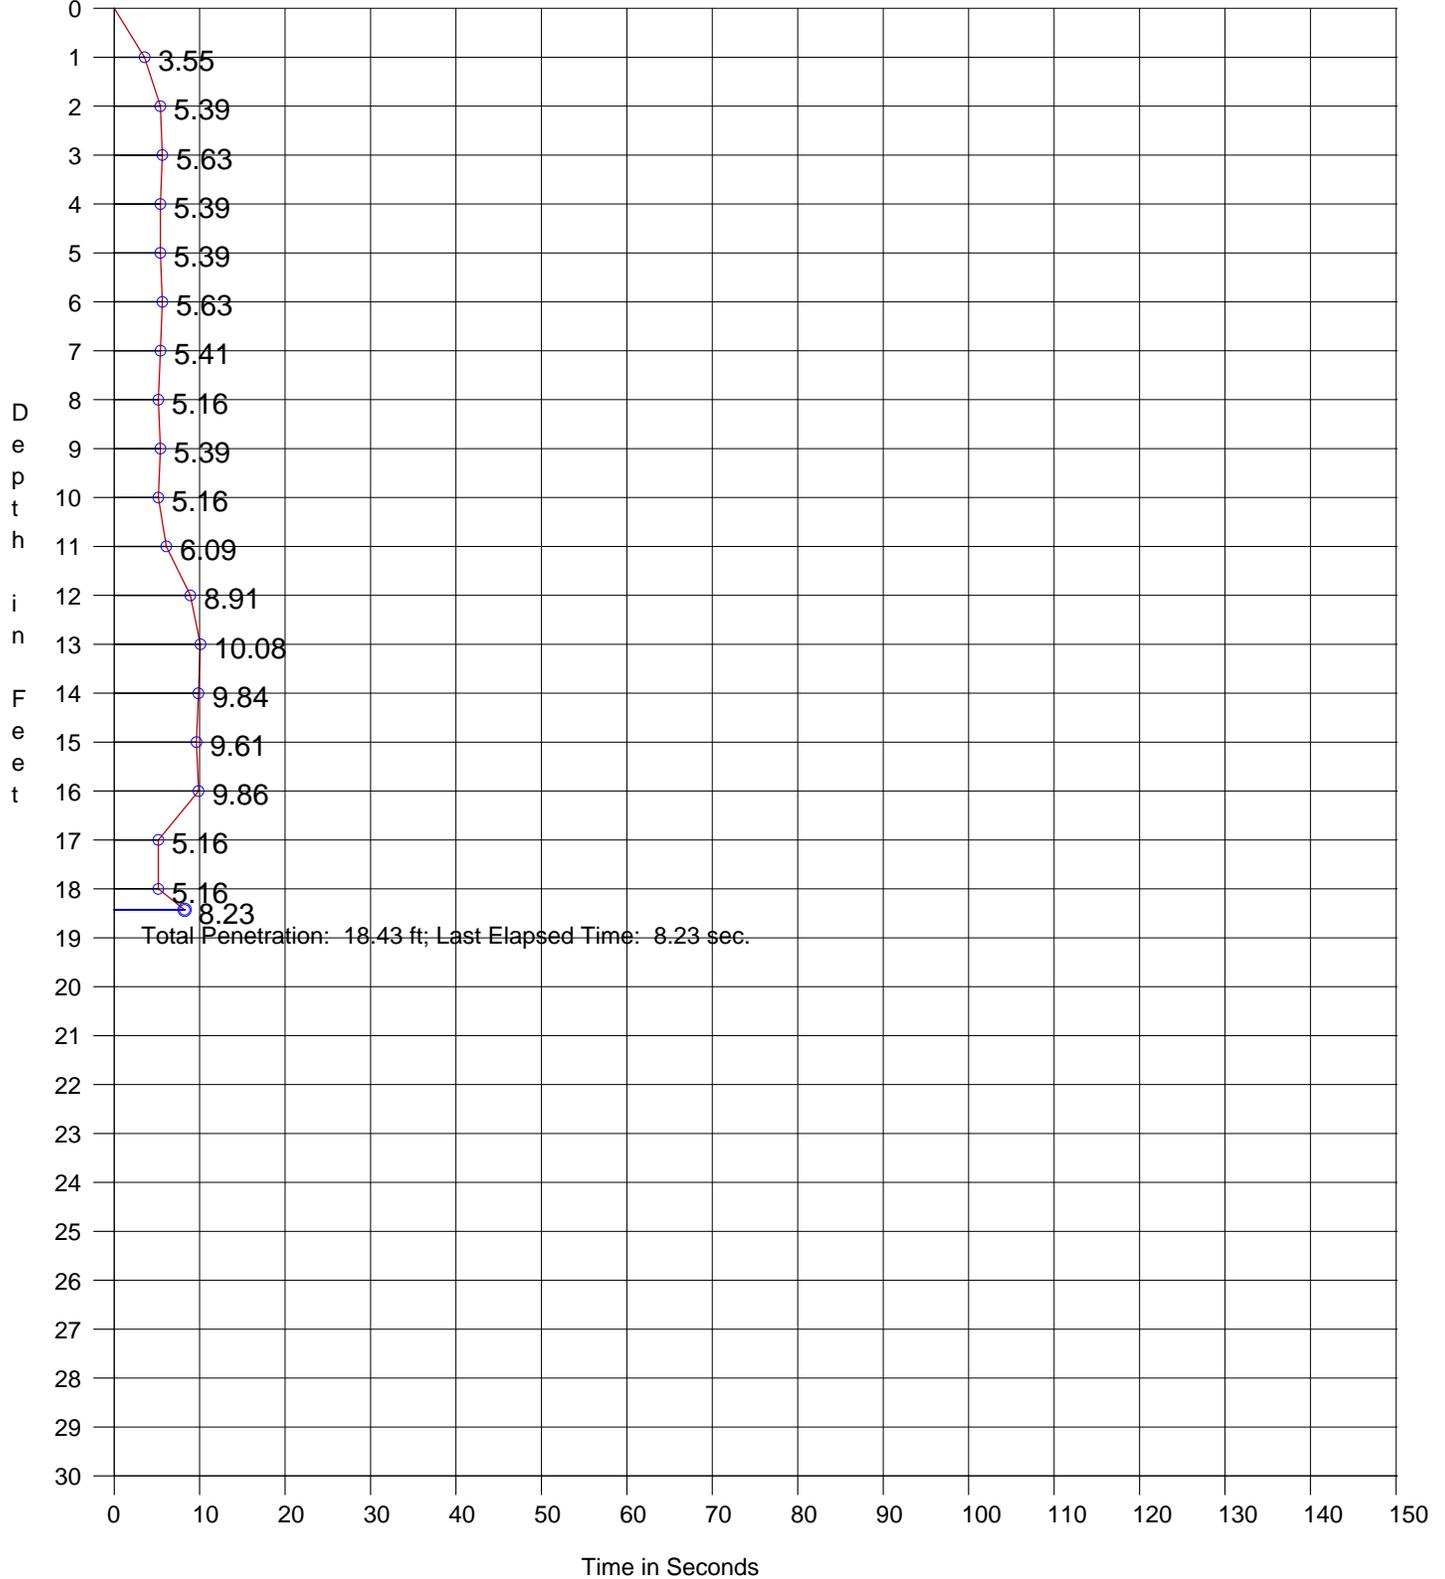
Penetration Graph for Core No. MREVC-08-11, Run 1

Date: 12/18/2008
Start Time: 10:43:17 AM
End Time: 10:45:32 AM
