2015 Operations, Maintenance, and Monitoring Report

Bayou Chevee Shoreline Protection (PO-22)

State Project Number PO-22 Priority Project List 5

August 10, 2015 Orleans Parish

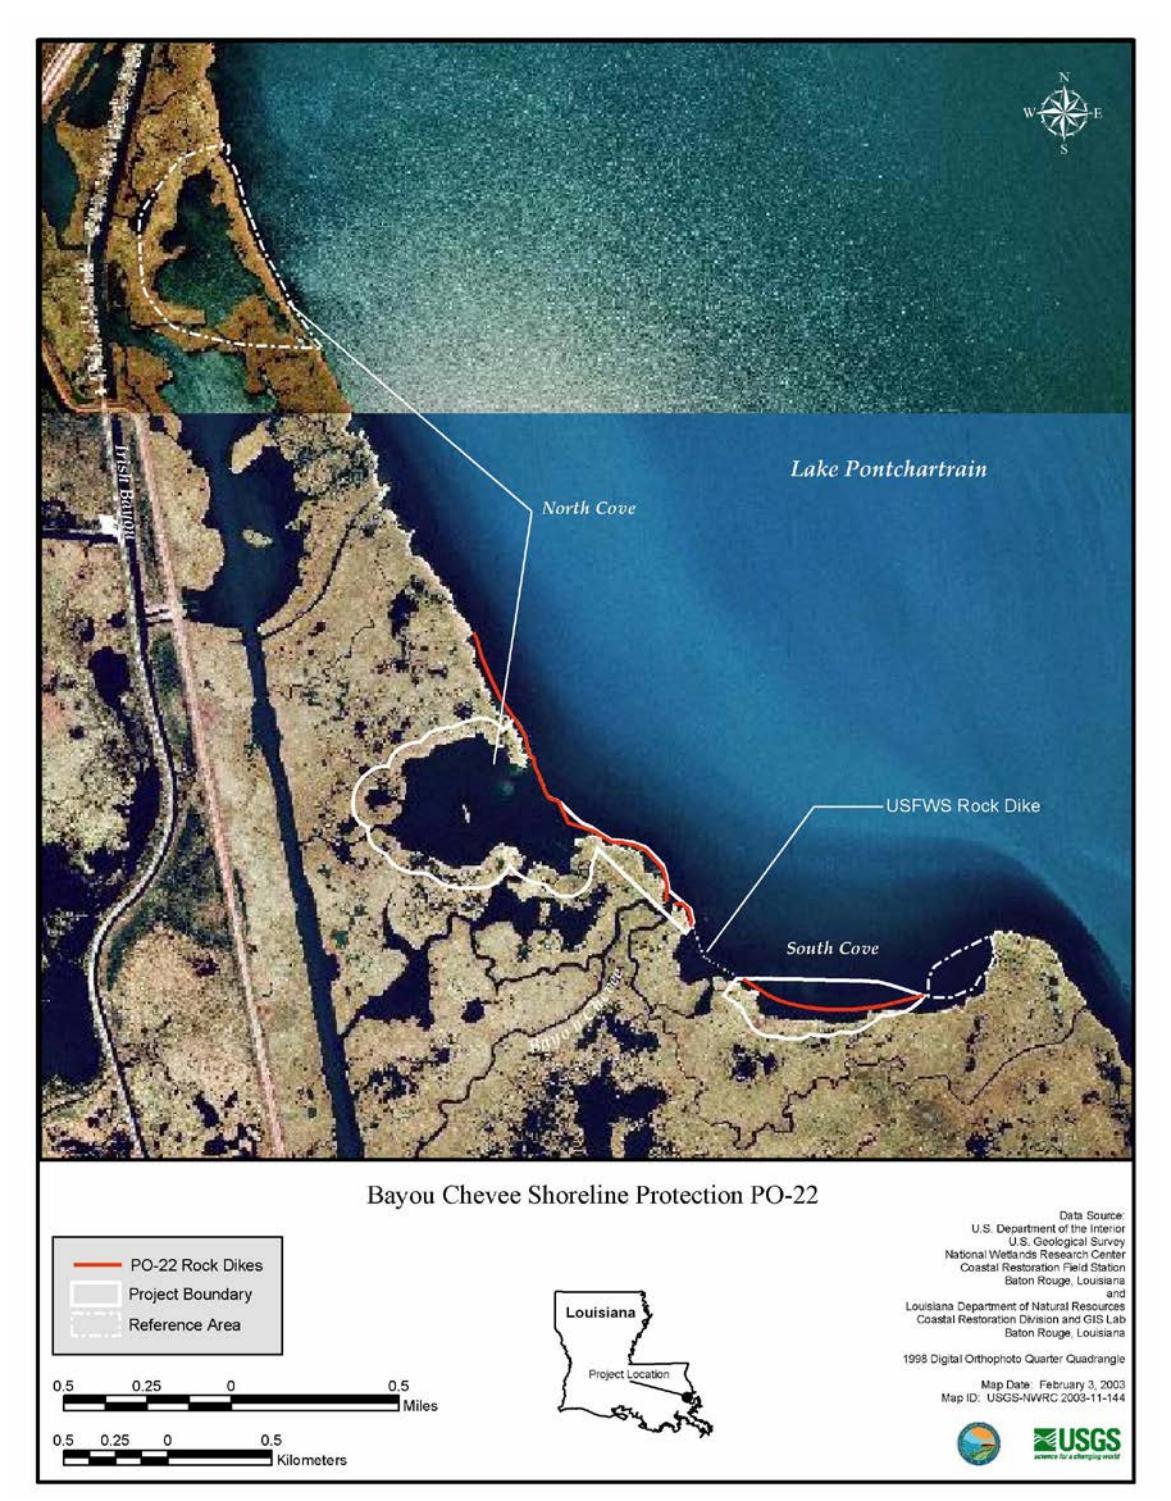
The PO-22 project consists of approximately 8,875 linear feet of rock bankline protection along the shoreline of Lake Pontchartrain, extending north and south from Bayou Chevee. Construction was completed on December 12, 2001. The shore protection should create conditions that allow for the enclosed shallow water areas to be colonized by a greater abundance of submerged aquatic vegetation (SAV).

Figure 1. Bayou Chevee Shoreline Protection (PO-22) project location and features.

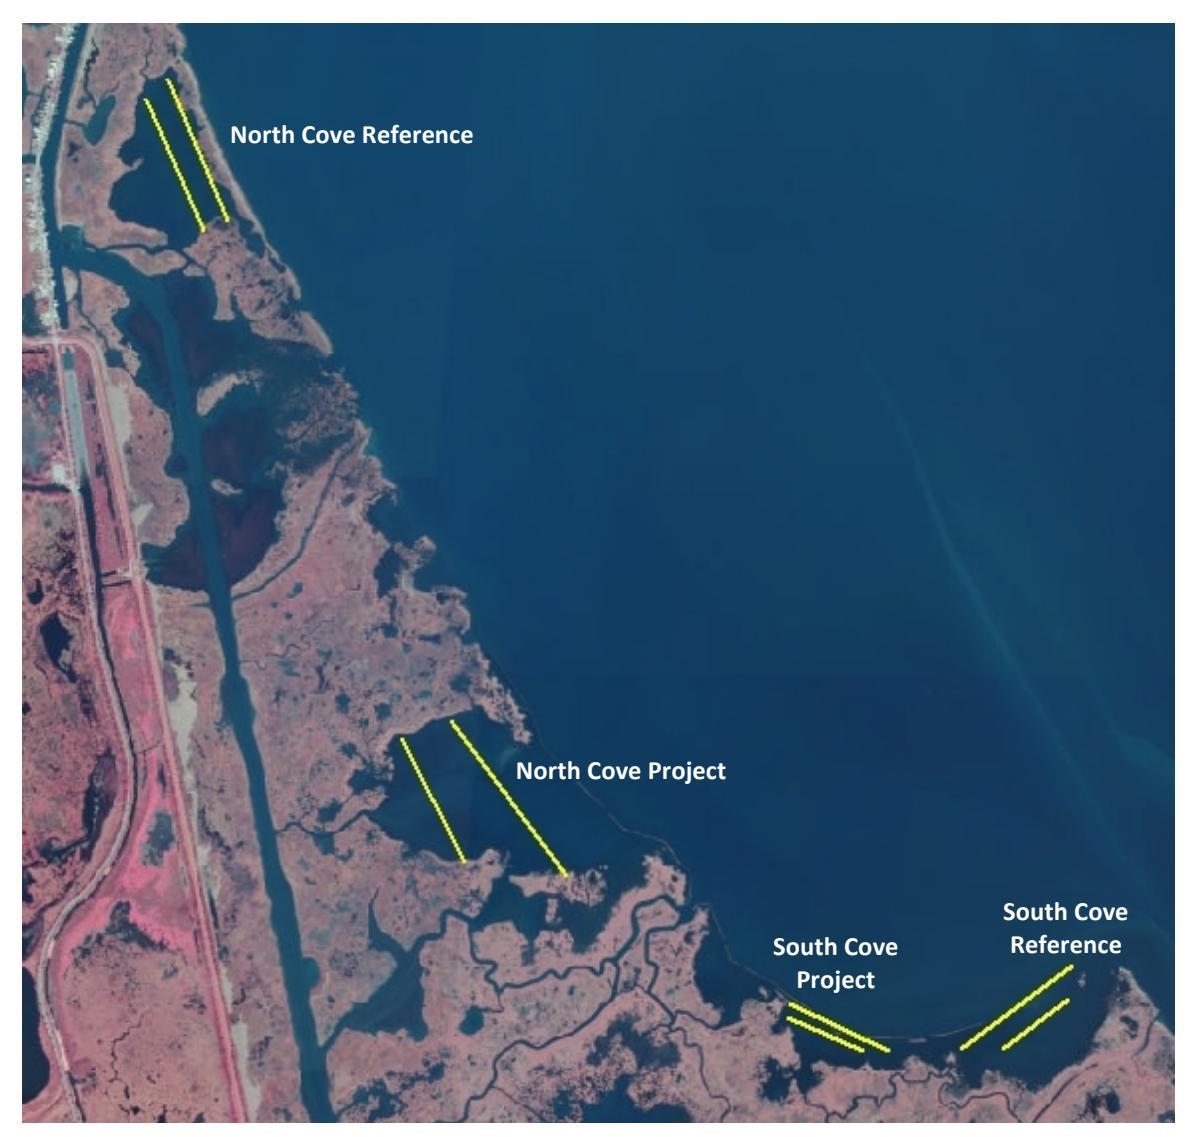
The line-intercept method described in Nyman and Chabreck (1996) was used to determine the frequency of occurrence of SAV along two transects established in each of the north and south cove project and reference areas (Fig. 2). Transects in the North Cove area had 50 equally spaced sampling stations and transects in the South Cove area had 25 equally spaced sampling stations. Transects were traversed by airboat and at each sampling station a garden rake was dragged along the bottom to collect any SAV present. The presence or absence of SAV was recorded at each station to determine frequency of occurrence. When SAV was present it was identified to species to determine frequency of individual species. SAV was sampled for pre-construction years 1998 and 2001, and in 2004, 2008, 2011, and 2014 post-construction. Additional surveys will be conducted in years 2017, and 2020.

Figure 2. Yellow lines indicate the location of submerged aquatic vegetation transecst for the Bayou Chevee Shoreline Protection (PO-22) project.

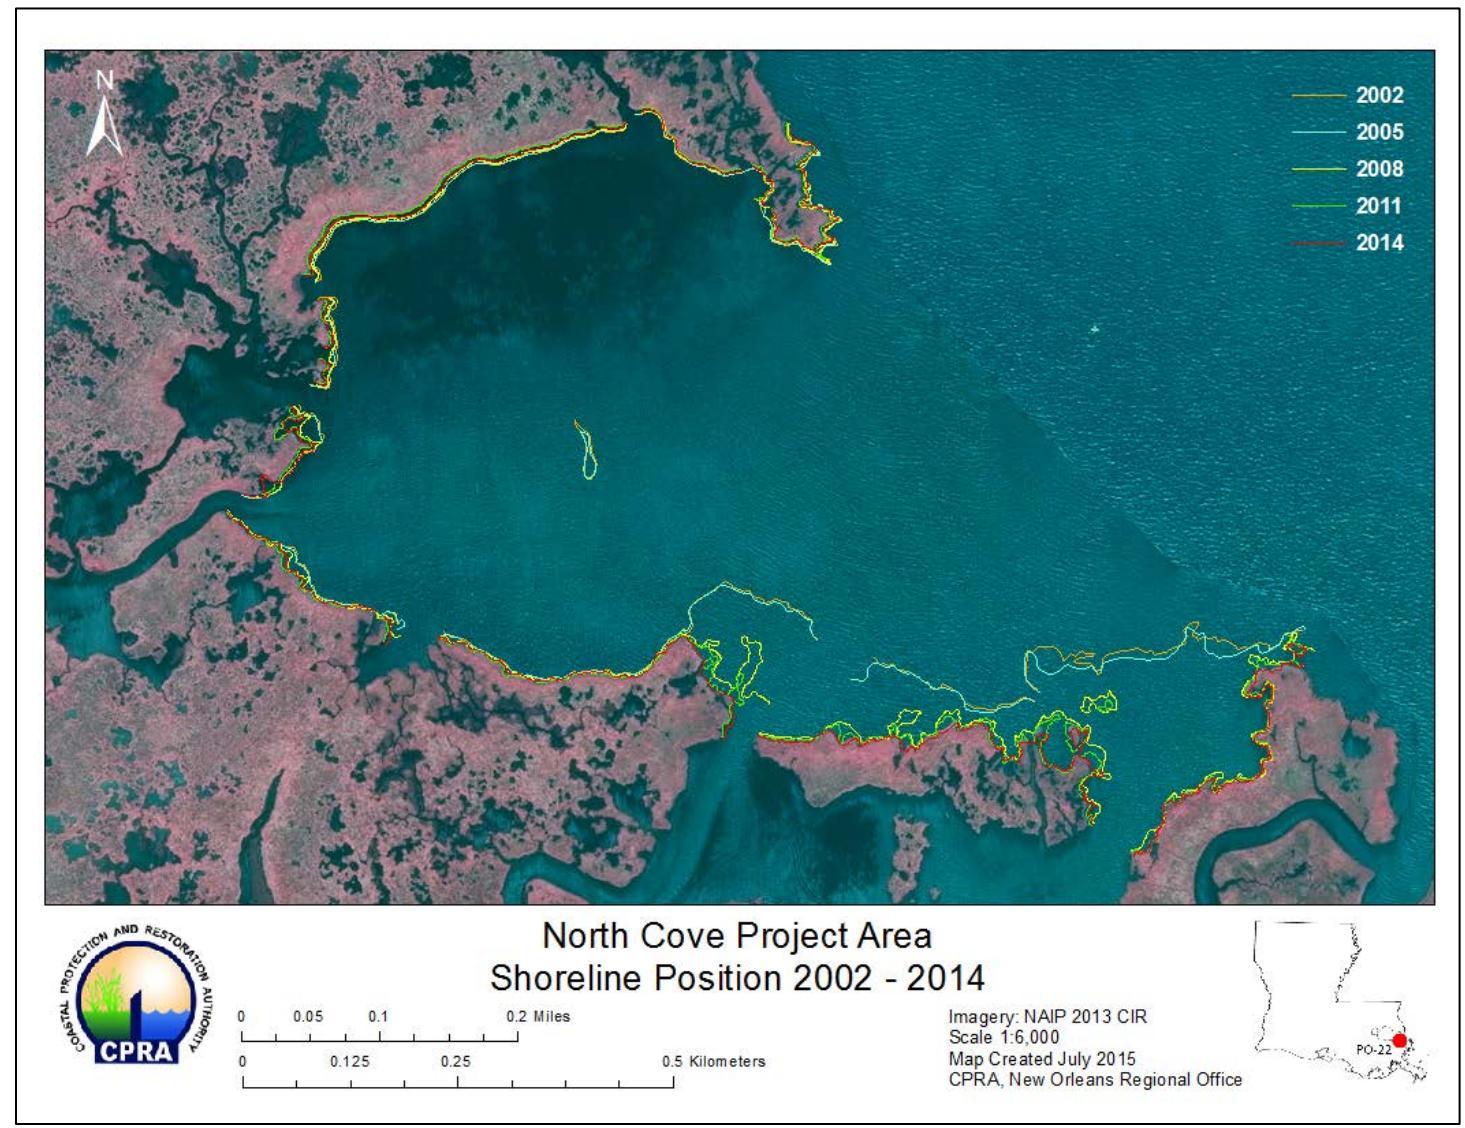
All areas have experienced some shoreline retreat since the previous survey in 2011. For the period of time from 2011 to 2014 the North Cove project area experienced an average rate of shoreline retreat of 1.4 ft/yr (Table 1) and an average net shoreline loss of 4.8 ft (Table 2). This represents the lowest rate of shoreline retreat of any of the 4 time periods since project construction. Similar to patterns observed in previous surveys, the majority of the shoreline retreat in the North Cove project area occurred on the north facing bank along the southeastern shoreline (Figure 3).

Figure 3. 2002, 2005, 2008, 2011, and 2014 shoreline position for the North Cove project area of the Bayou Chevee Shoreline Protection (PO-22) project.

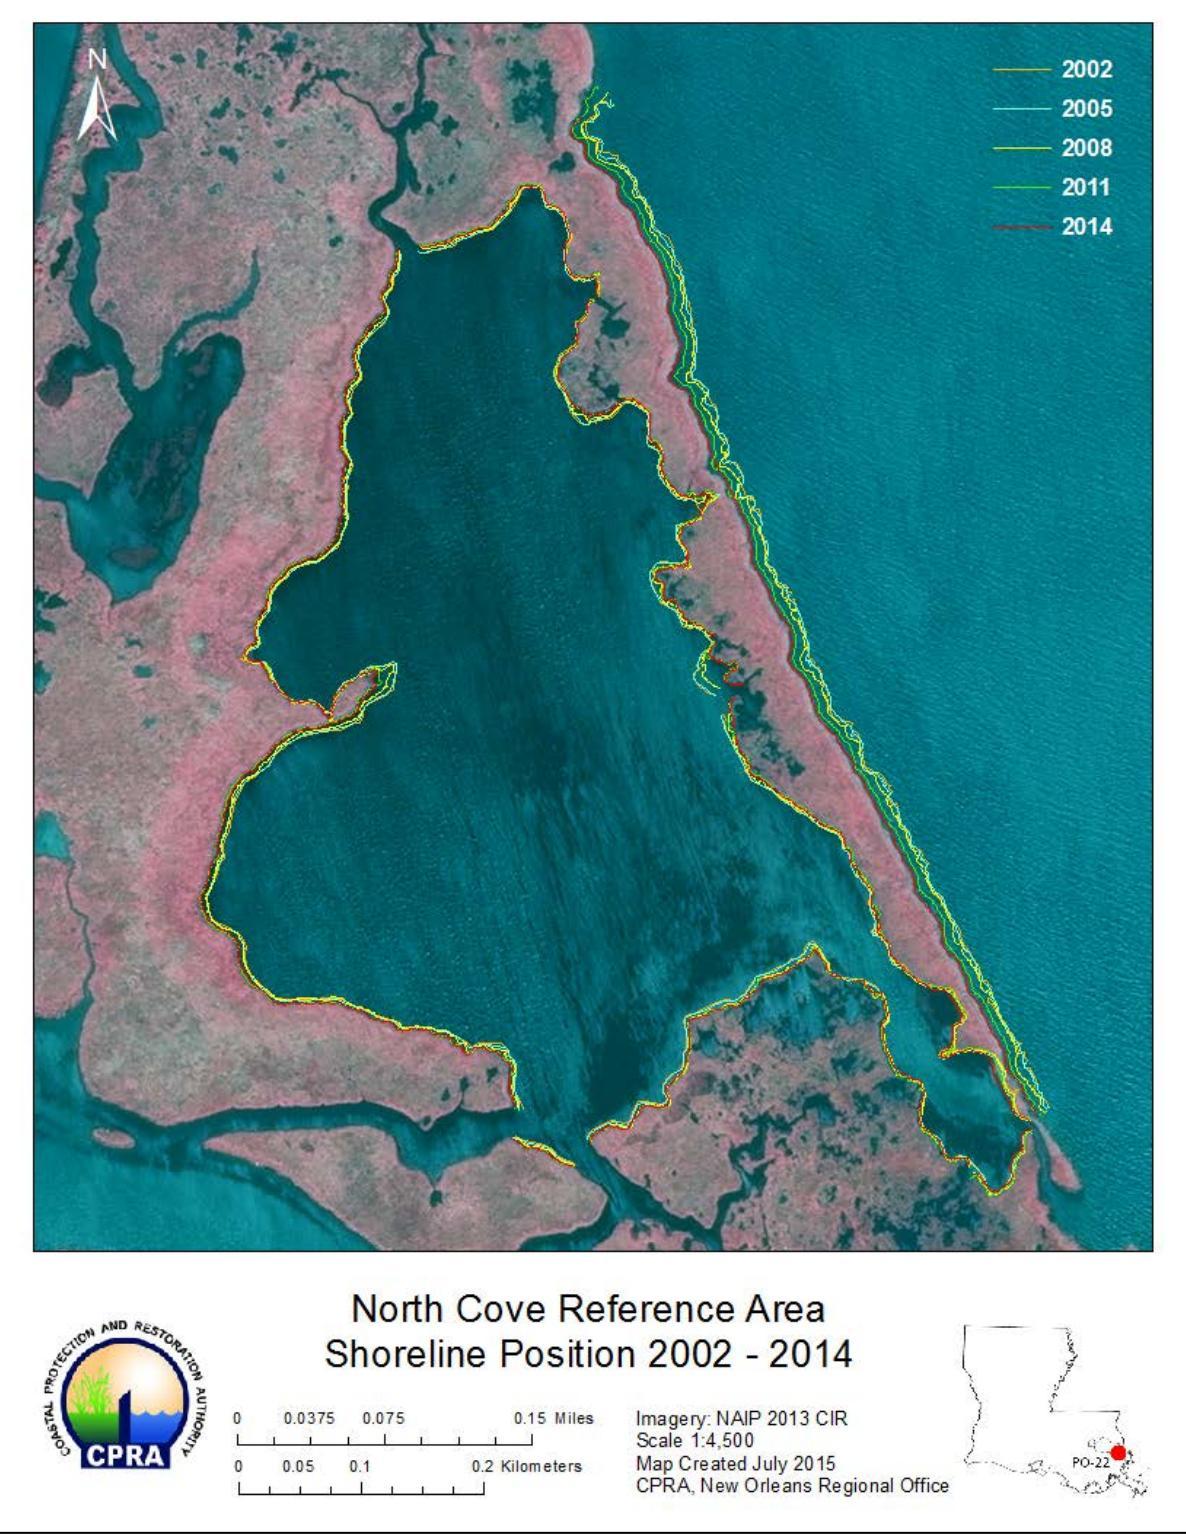
The North Cove reference area is divided into 2 sub-areas: 1.) an interior pond protected by a narrow strip of marsh from the wave action of Lake Pontchartrain, and 2.) a northeast-facing segment of Lake Pontchartrain shoreline (Figure 4). For the 2011 – 2014 time period the pond portion of the North Cove reference area had a positive average rate of shoreline change of 0.3 ft/yr (Table 1), however it is unlikely that any land gain actually occurred. The small, positive rate of change is more likely the result of error inherent in the data collection and analysis processes. The Lake Pontchartrain shoreline portion of the North Cove reference area experienced an average rate of shoreline retreat of 3.9 ft/yr (Table 1), and an average net shoreline loss of 13.0 ft (Table 2). The shoreline has retreated along the entire surveyed length of the Lake Pontchartrain shoreline at a fairly uniform rate. At some point between the 2008 and 2011 surveys, the narrow strip of marsh separating the interior pond from the lake breached at the southern end, just below southern extent of the surveyed area, creating a connection between the two. This breach does not appear to have expanded since then; however, there are several other locations north of the breach where the strip of marsh separating the interior pond from Lake Pontchartrain is approximately 40-ft wide and in danger of breaching in the near future (Figure 4).

Figure 4. 2002, 2005, 2008, 2011, and 2014 shoreline position for the North Cove reference area of the Bayou Chevee Shoreline Protection (PO-22) project.

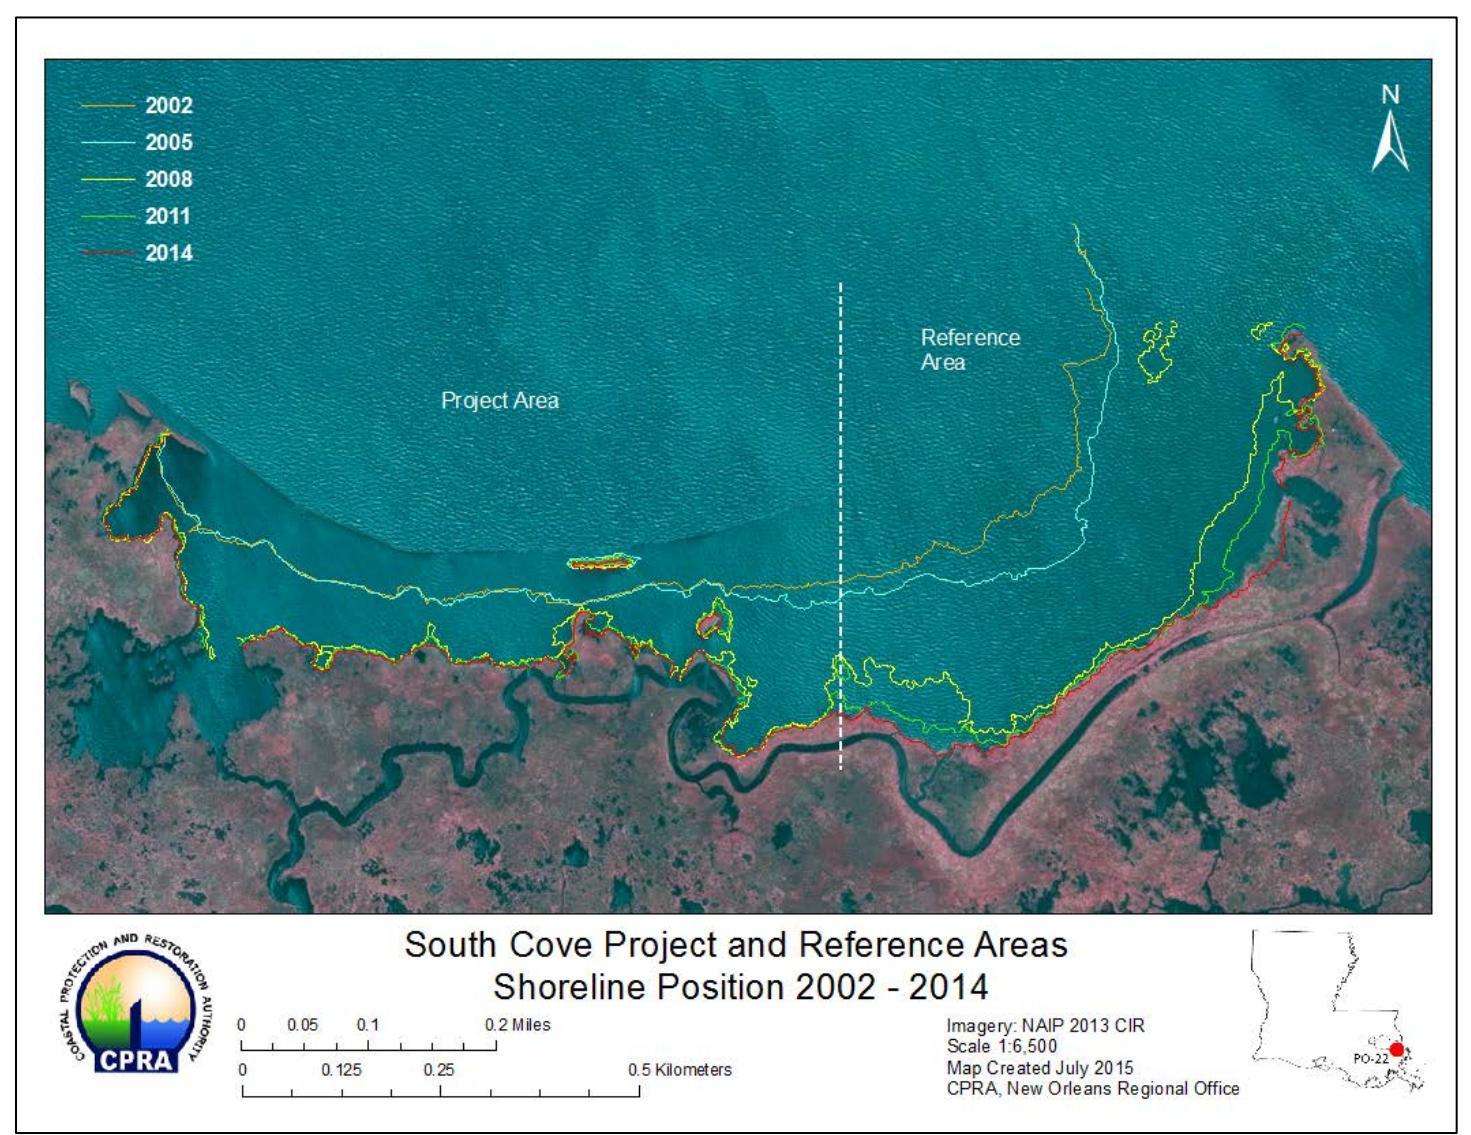
For the 2011 - 2014 time period, the South Cove project area experienced an average rate of shoreline retreat of 4.7 ft/yr (Table 1), and an average net shoreline loss of 15.5 ft (Table 2). The island created directly behind the rocks from the placement of spoil during construction remains intact, although it has decreased in size with each successive survey (Figure 5). Since construction, shoreline retreat along the eastern end of the South Cove project area has been greater than the western end. This phenomenon can be

explained by the termination of the rock structure offshore rather than on land. Waves approaching from the northeast are not broken by the rocks and therefore are able to impact the shoreline behind the structure.

Figure 5. 2002, 2005, 2008, 2011, and 2014 shoreline positions for the South Cove project and reference areas of the Bayou Chevee Shoreline Protection (PO-22) project. The dashed line indicates the boundary between project and reference areas.

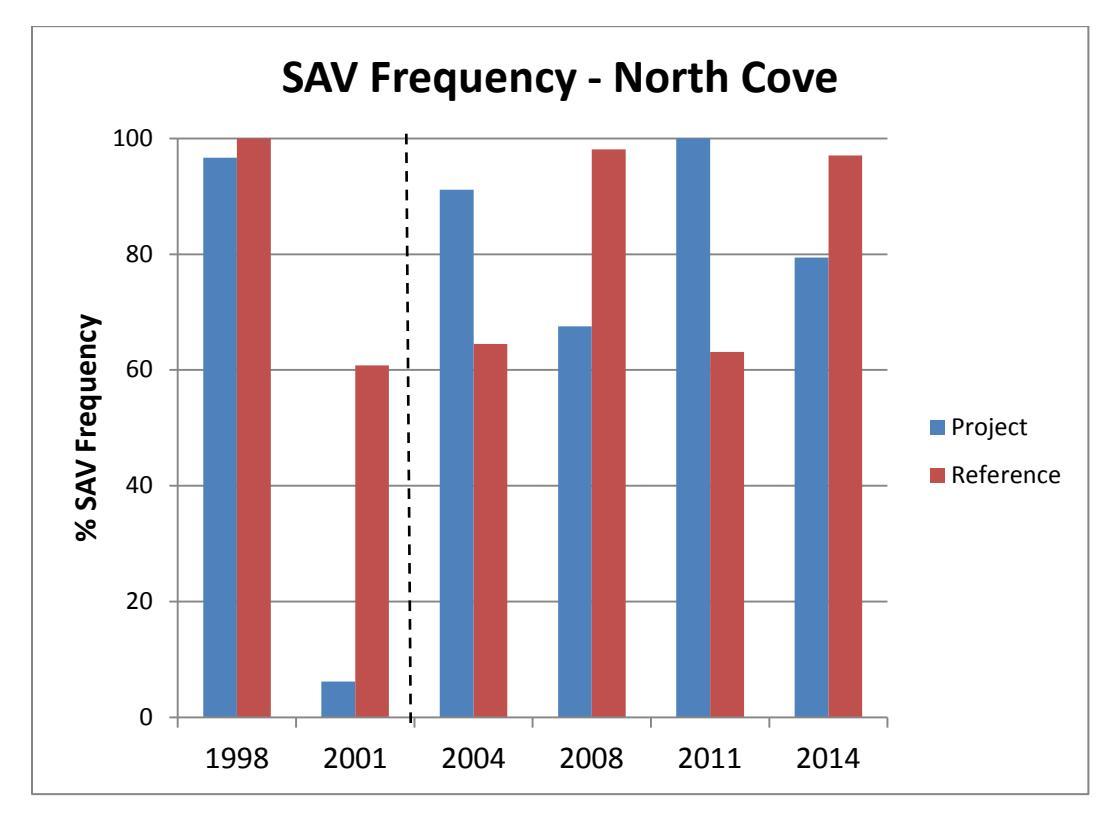
The pre-construction surveys for overall SAV frequency for the North Cove showed mixed results. The project and reference areas showed very similar frequencies (96.8% and 100%, respectively) in the 1998 survey; however in 2001 SAV frequency in the project area had fallen to 6.2% versus 60.8% in the reference area (Figure 6). The post-construction surveys show higher SAV frequency in the project area in 2004 and 2011, with the 2008 and 2014 surveys showing higher frequency in the reference areas. Post-construction surveys indicate greater similarity between project and reference areas. Mean SAV frequency was 84.5% in the project area for the four post-construction surveys.

Figure 6. Frequency of occurrence of submerged aquatic vegetation (all species) in samples for North Cove project and reference areas for survey years 1998, 2001, 2004, 2008, 2011, and 2014 for the Bayou Chevee Shoreline Protection (PO-22) project. Dashed line indicates project construction.

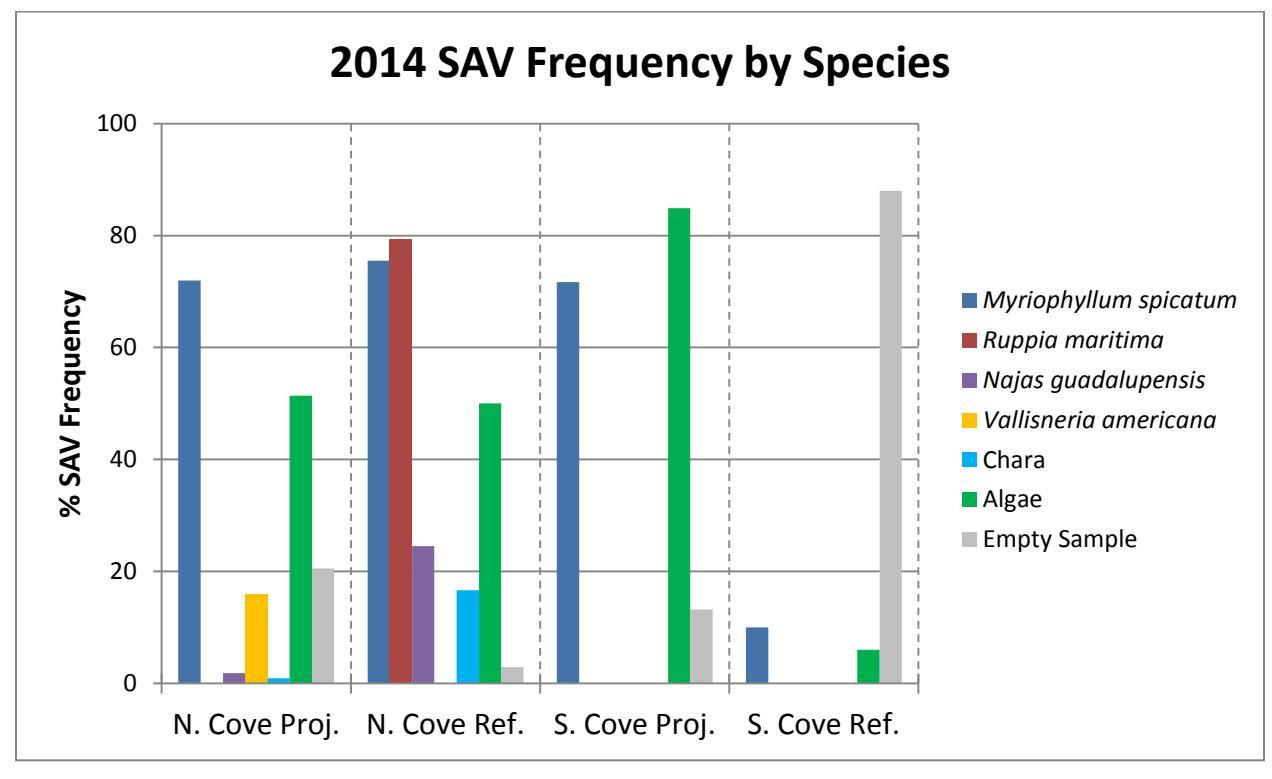
In the 2014 survey, Eurasian water milfoil, *Myriophyllum spicatum*, was the dominant species in the North Cove project area (Figure 7, Table 3), while wigeongrass, *Ruppia maritima* dominated the reference area. Southern naiad, *Najas guadalupensis*, was present in both areas but much more abundant in the reference area than the project area. Similar to previous surveys eelgrass, *Vallisneria americana*, was observed in the project area but not the reference area. The relative frequency of eelgrass increased in the 2014 survey, and a large eelgrass bed was observed in the northeastern portion of the project area.

Figure 7. Frequency of occurrence of submerged aquatic vegetation in samples for North and South cove project and reference areas during the 2014 survey for Bayou Chevee Shoreline Protection (PO-22).

Although SAV frequency was high in the South Cove project area (86.8%) in 2014, species diversity was low (Figure 7, Table 4). Excluding algae, the SAV observed in the project area was entirely *Myriophyllum spicatum*. The South Cove reference area was mostly devoid of SAV; 88.0% of samples contained no SAV. The species composition of samples that did contain SAV was similar to the project area, with *Myriophyllum spicatum* accounting for all SAV in the area.

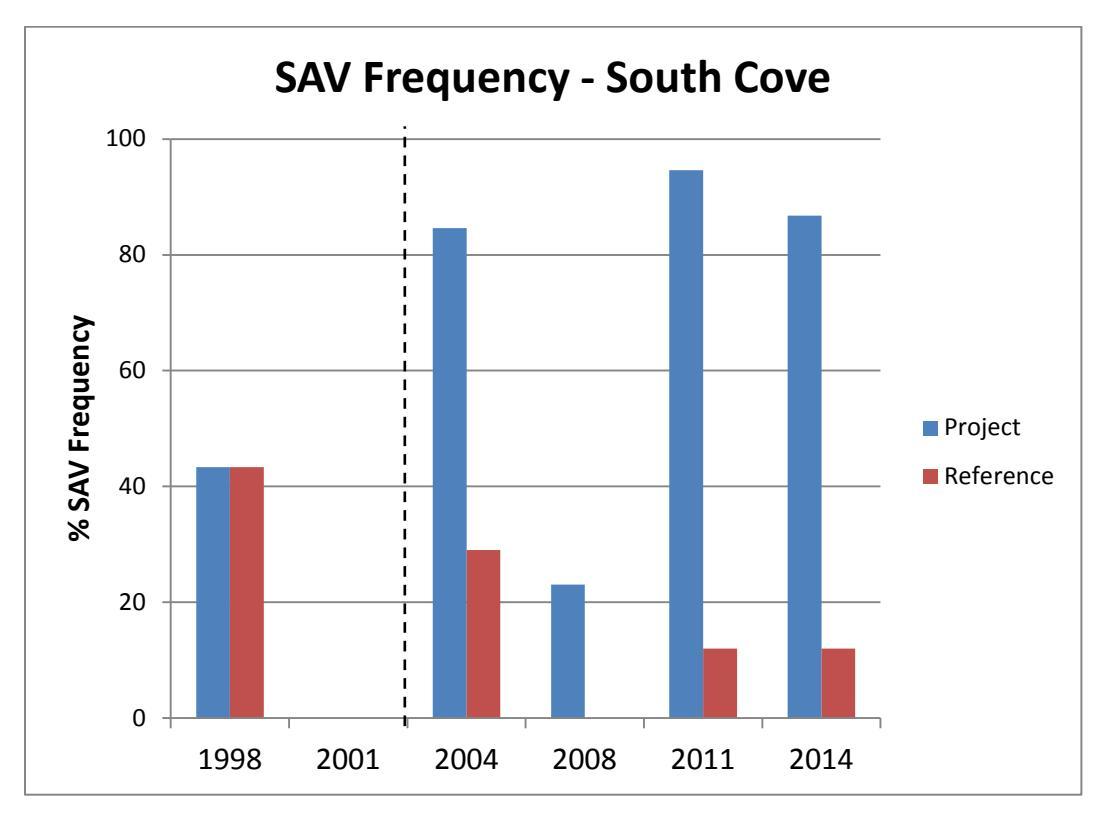
In the South Cove, both pre-construction surveys for overall SAV frequency of occurrence showed similar results for project and reference areas. In 1998, both areas had frequencies of 43.3%. In 2001, no SAV was measured in either area. However, post-construction surveys show consistently higher SAV frequency in the project area than in the reference area (Figure 8). Mean SAV frequency for the three post-construction surveys was 72.3% in the project area and 13.3% in the reference area.

Figure 8. Frequency of occurrence of submerged aquatic vegetation (all species) in samples for South Cove project and reference areas for survey years 1998, 2001, 2004, 2008, 2011, and 2014 for the Bayou Chevee Shoreline Protection (PO-22) project. Dashed line indicates project construction

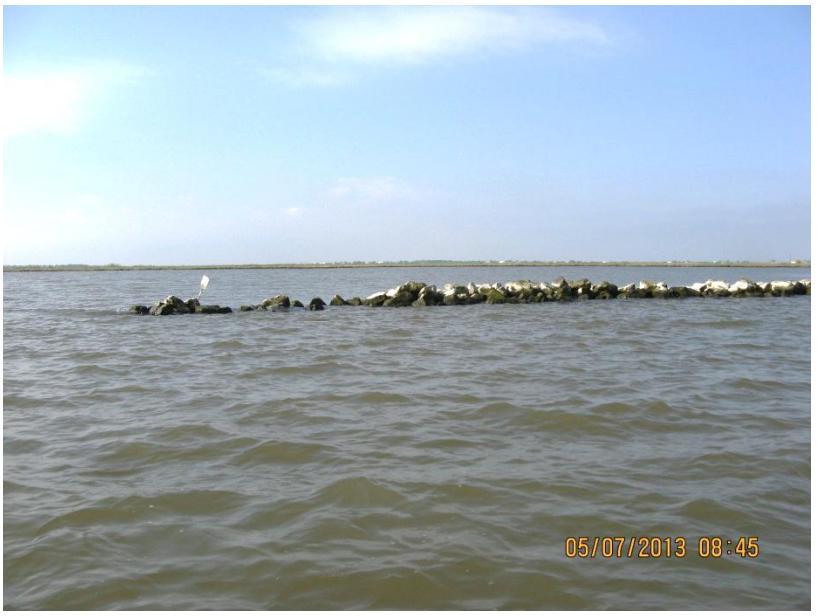
Photo #1 – Terminus of Southern Reach.

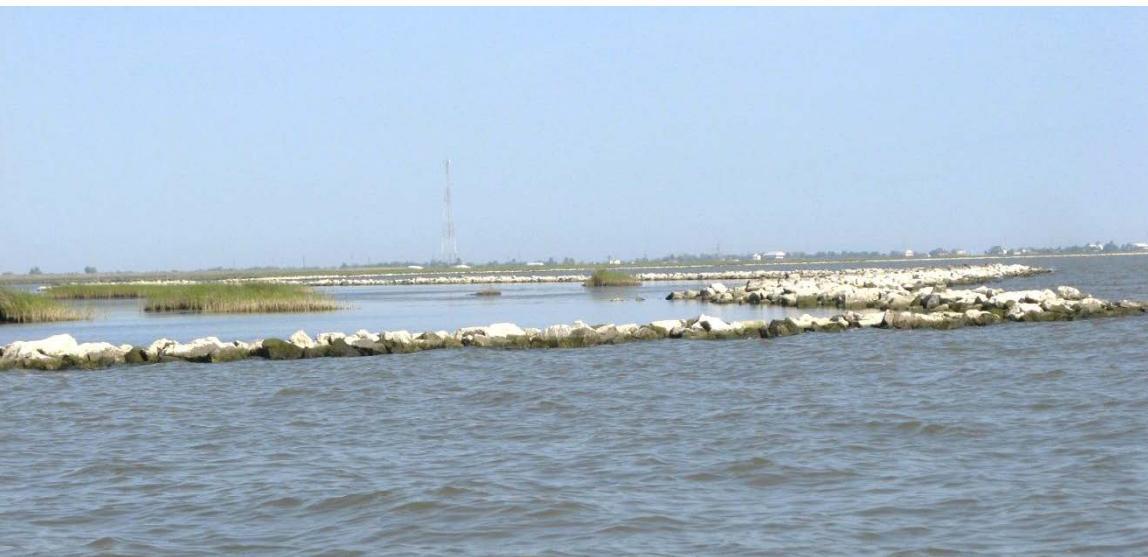
Photo #2 –Northern Reach.

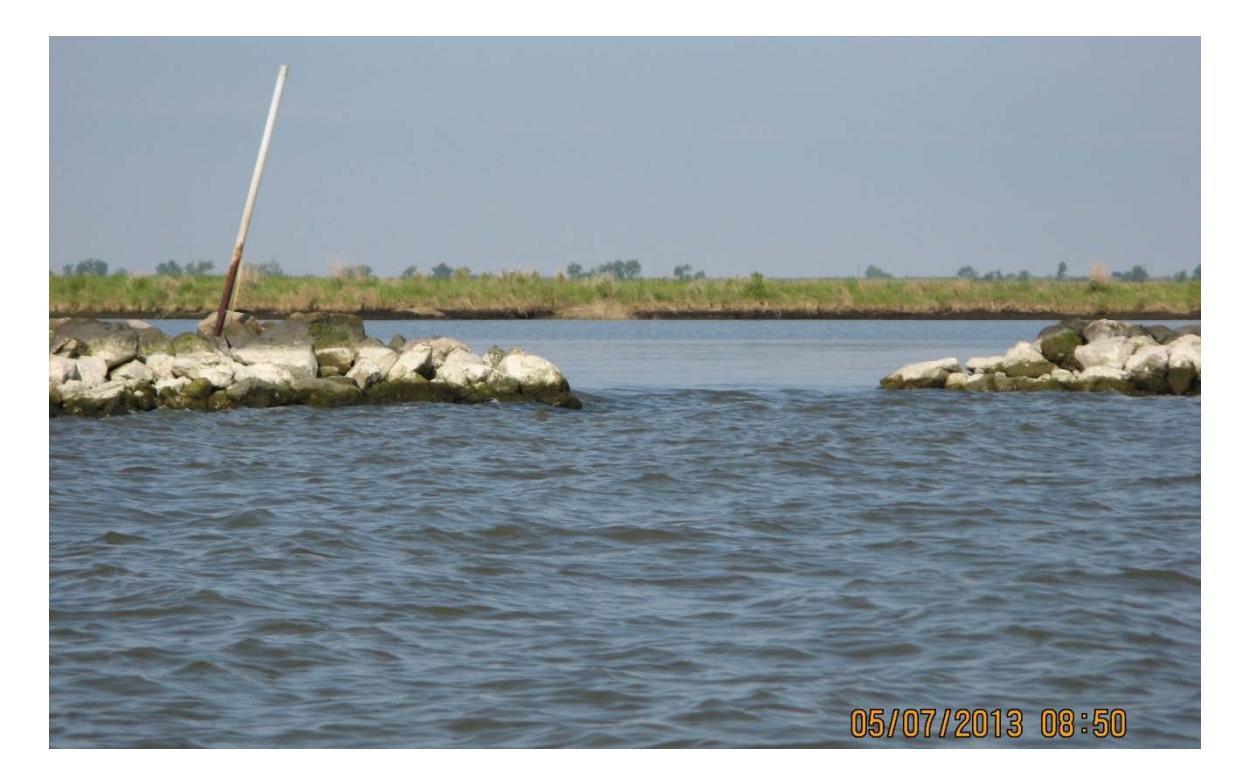
Photo #3 – Fish Dip, Northern Reach.

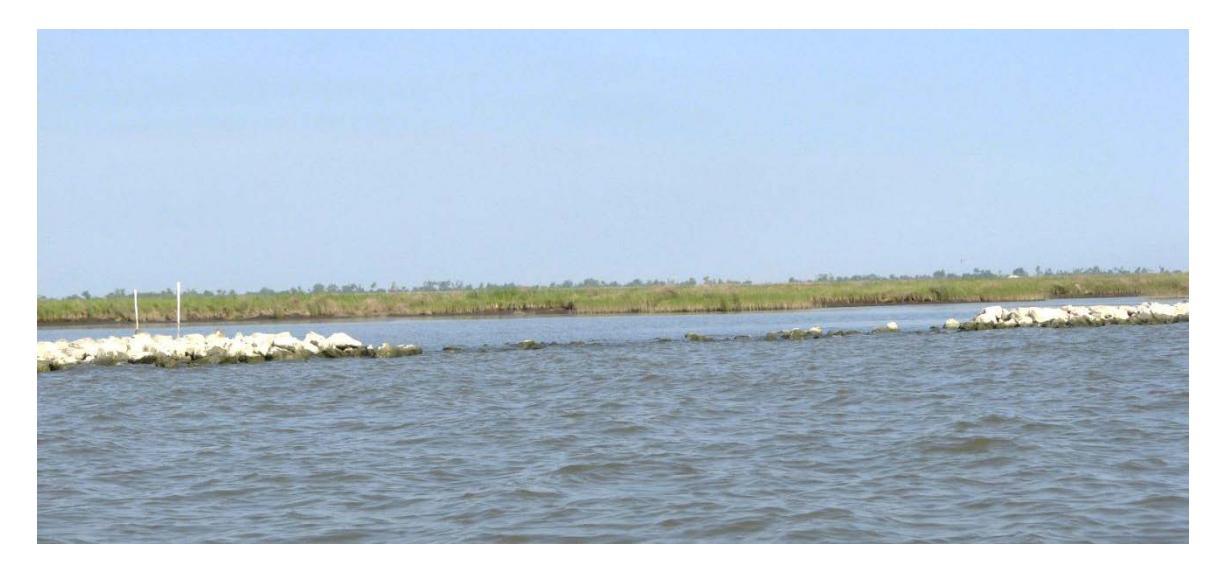
Settlement noted during the 2011 inspection is still evident. The rock structure has maintained its shape although some sections were beneath the water surface. No mud waves or loose geotextile were noticed. The settlement plates at each fish dip are no longer in operable condition. This was observed during the March 2012 survey.

Photo #4 – Failed Section, Southern Reach.

A maintenance lift is necessary to raise the elevation of the rock dike in the areas where it has settled. The inspection team discussed a maintenance rock lift, which would require a request for additional funding due to the minimal amount of remaining Operations and Maintenance funds. Additional improvements discussed were extending the rock dike to meet the headland of Chef Menteur Pass. The agreed upon course of action was to contact the landowner (USFWS)

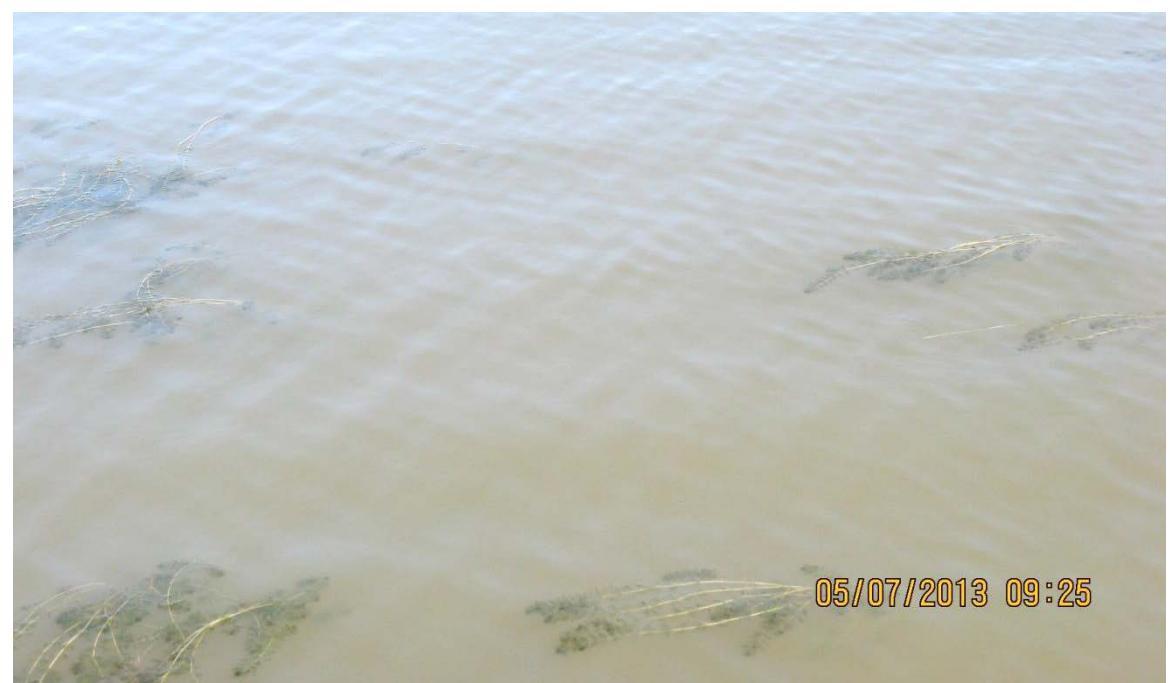
Photo #5 – Submerged Aquatic Vegetation behind rock dike

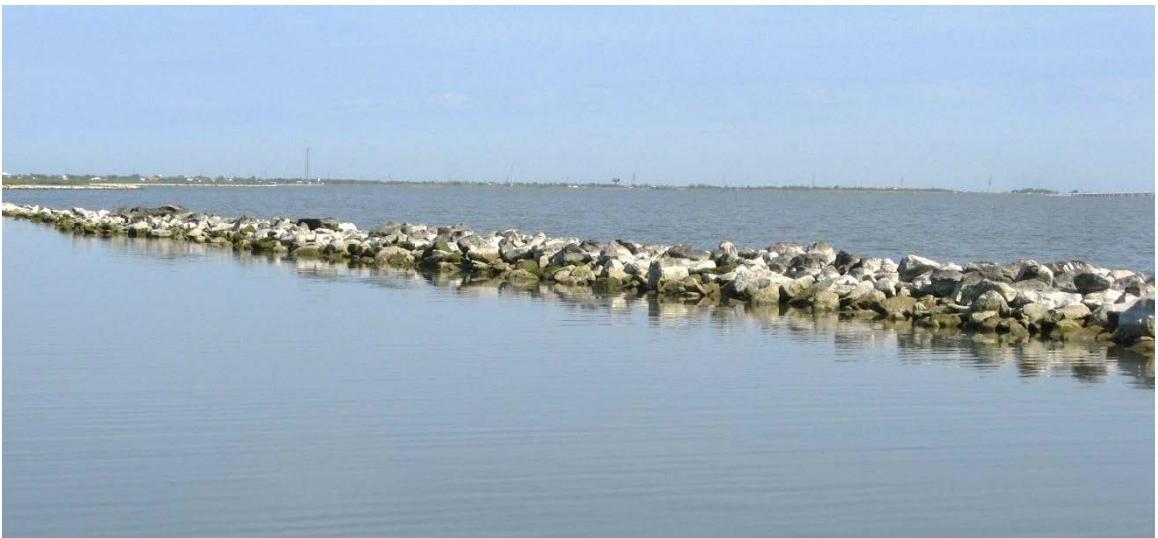
Photo #6 – Behind rock dike
