Holly Beach Sand Management (CS-31)

Coastal Wetlands Planning, Protection and Restoration Act

2005 Photomosaic and Land-Water Analysis

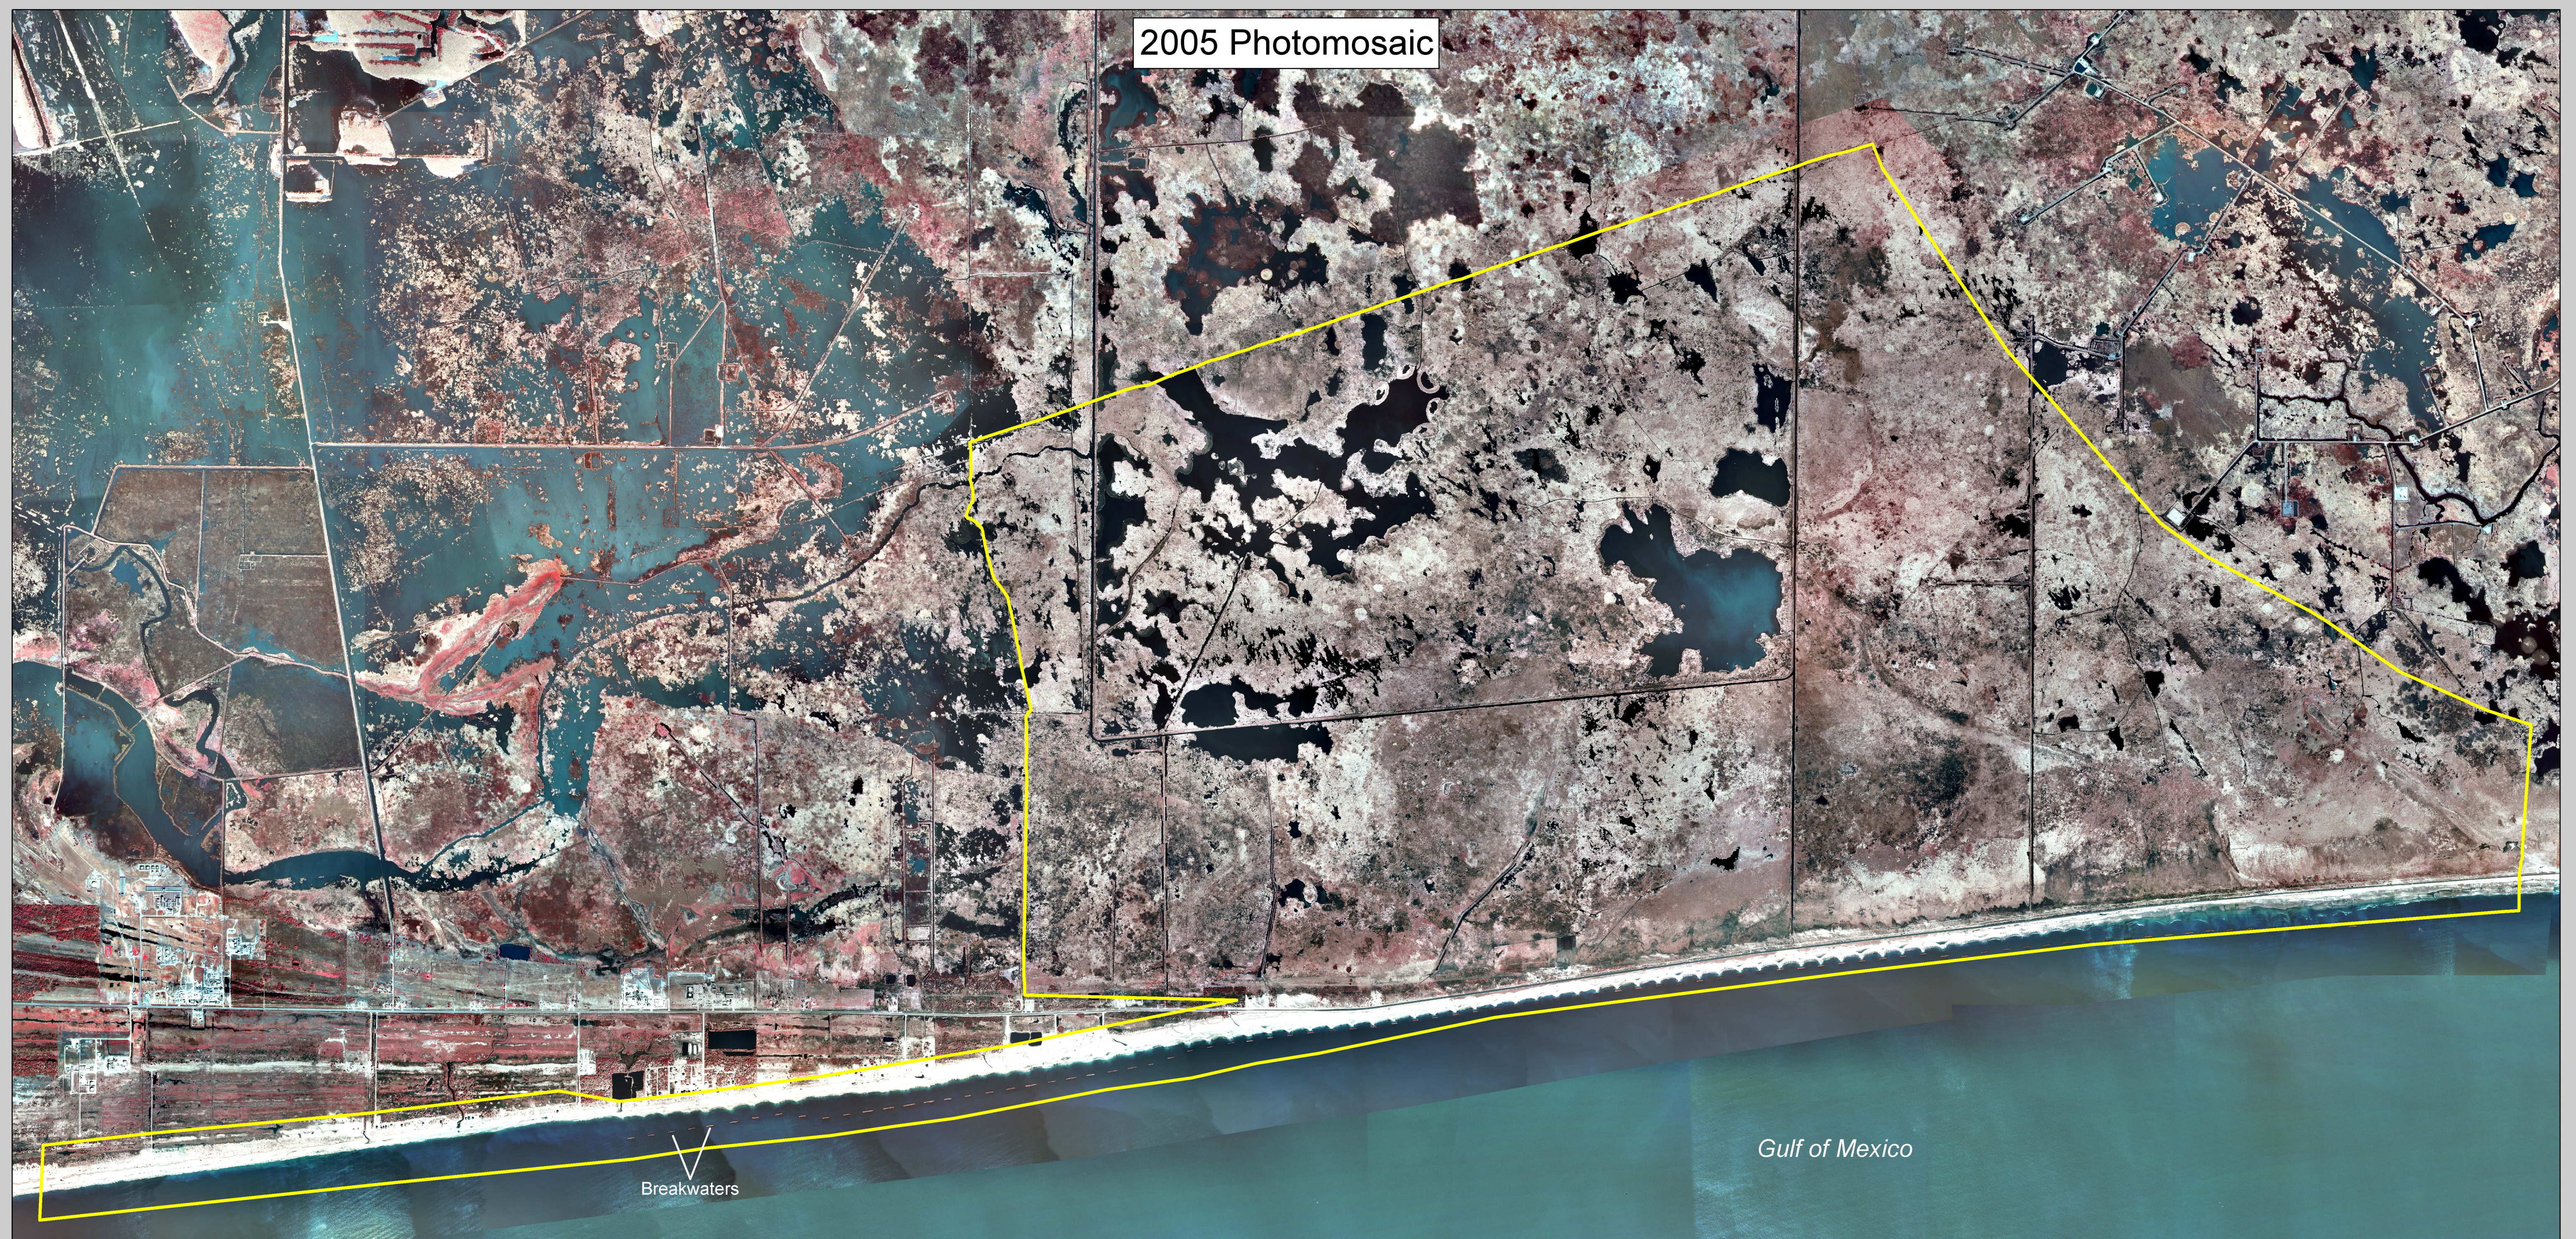
Project Background:
The Holly Beach Sand Management Project (CS-31) area is located on the Gulf of Mexico shoreline of southwestern Louisiana, west of Calcasieu Pass in Cameron Parish. This area of coastal Louisiana is known as the chenier plain. The chenier plain is characterized by alternating or coalescing shore-parallel ridges composed primarily of sand, shell, and shell fragments deposited on top of and separated from each other by swales of emergent marsh on alluvial deposits. Historically, the general mechanism of deposition along the chenier plain shoreline was closely related to variations in the influx of alluvial sediment transported westward by the littoral transport system when the Mississippi River oscillated between

subdeltas. Chronic erosion in this area is caused by a deficit of sand and sediment in the littoral transport system, caused by stabilization of the Mississippi River and regulation of the Atchafalaya River to the east. In addition, the Calcasieu and Mementau Rivers are not supplying coarse grained sediment (sand) to the area, and the Cameron jetties associated with the Calcasieu Ship Channel deflect what little material that exists away from the project area. Through the use of breakwaters, sand fencing, and vegetative plantings, the Holly Beach Sand Management project attempts to re-establish and maintain a vital shoreline critical to Louisiana's coast.

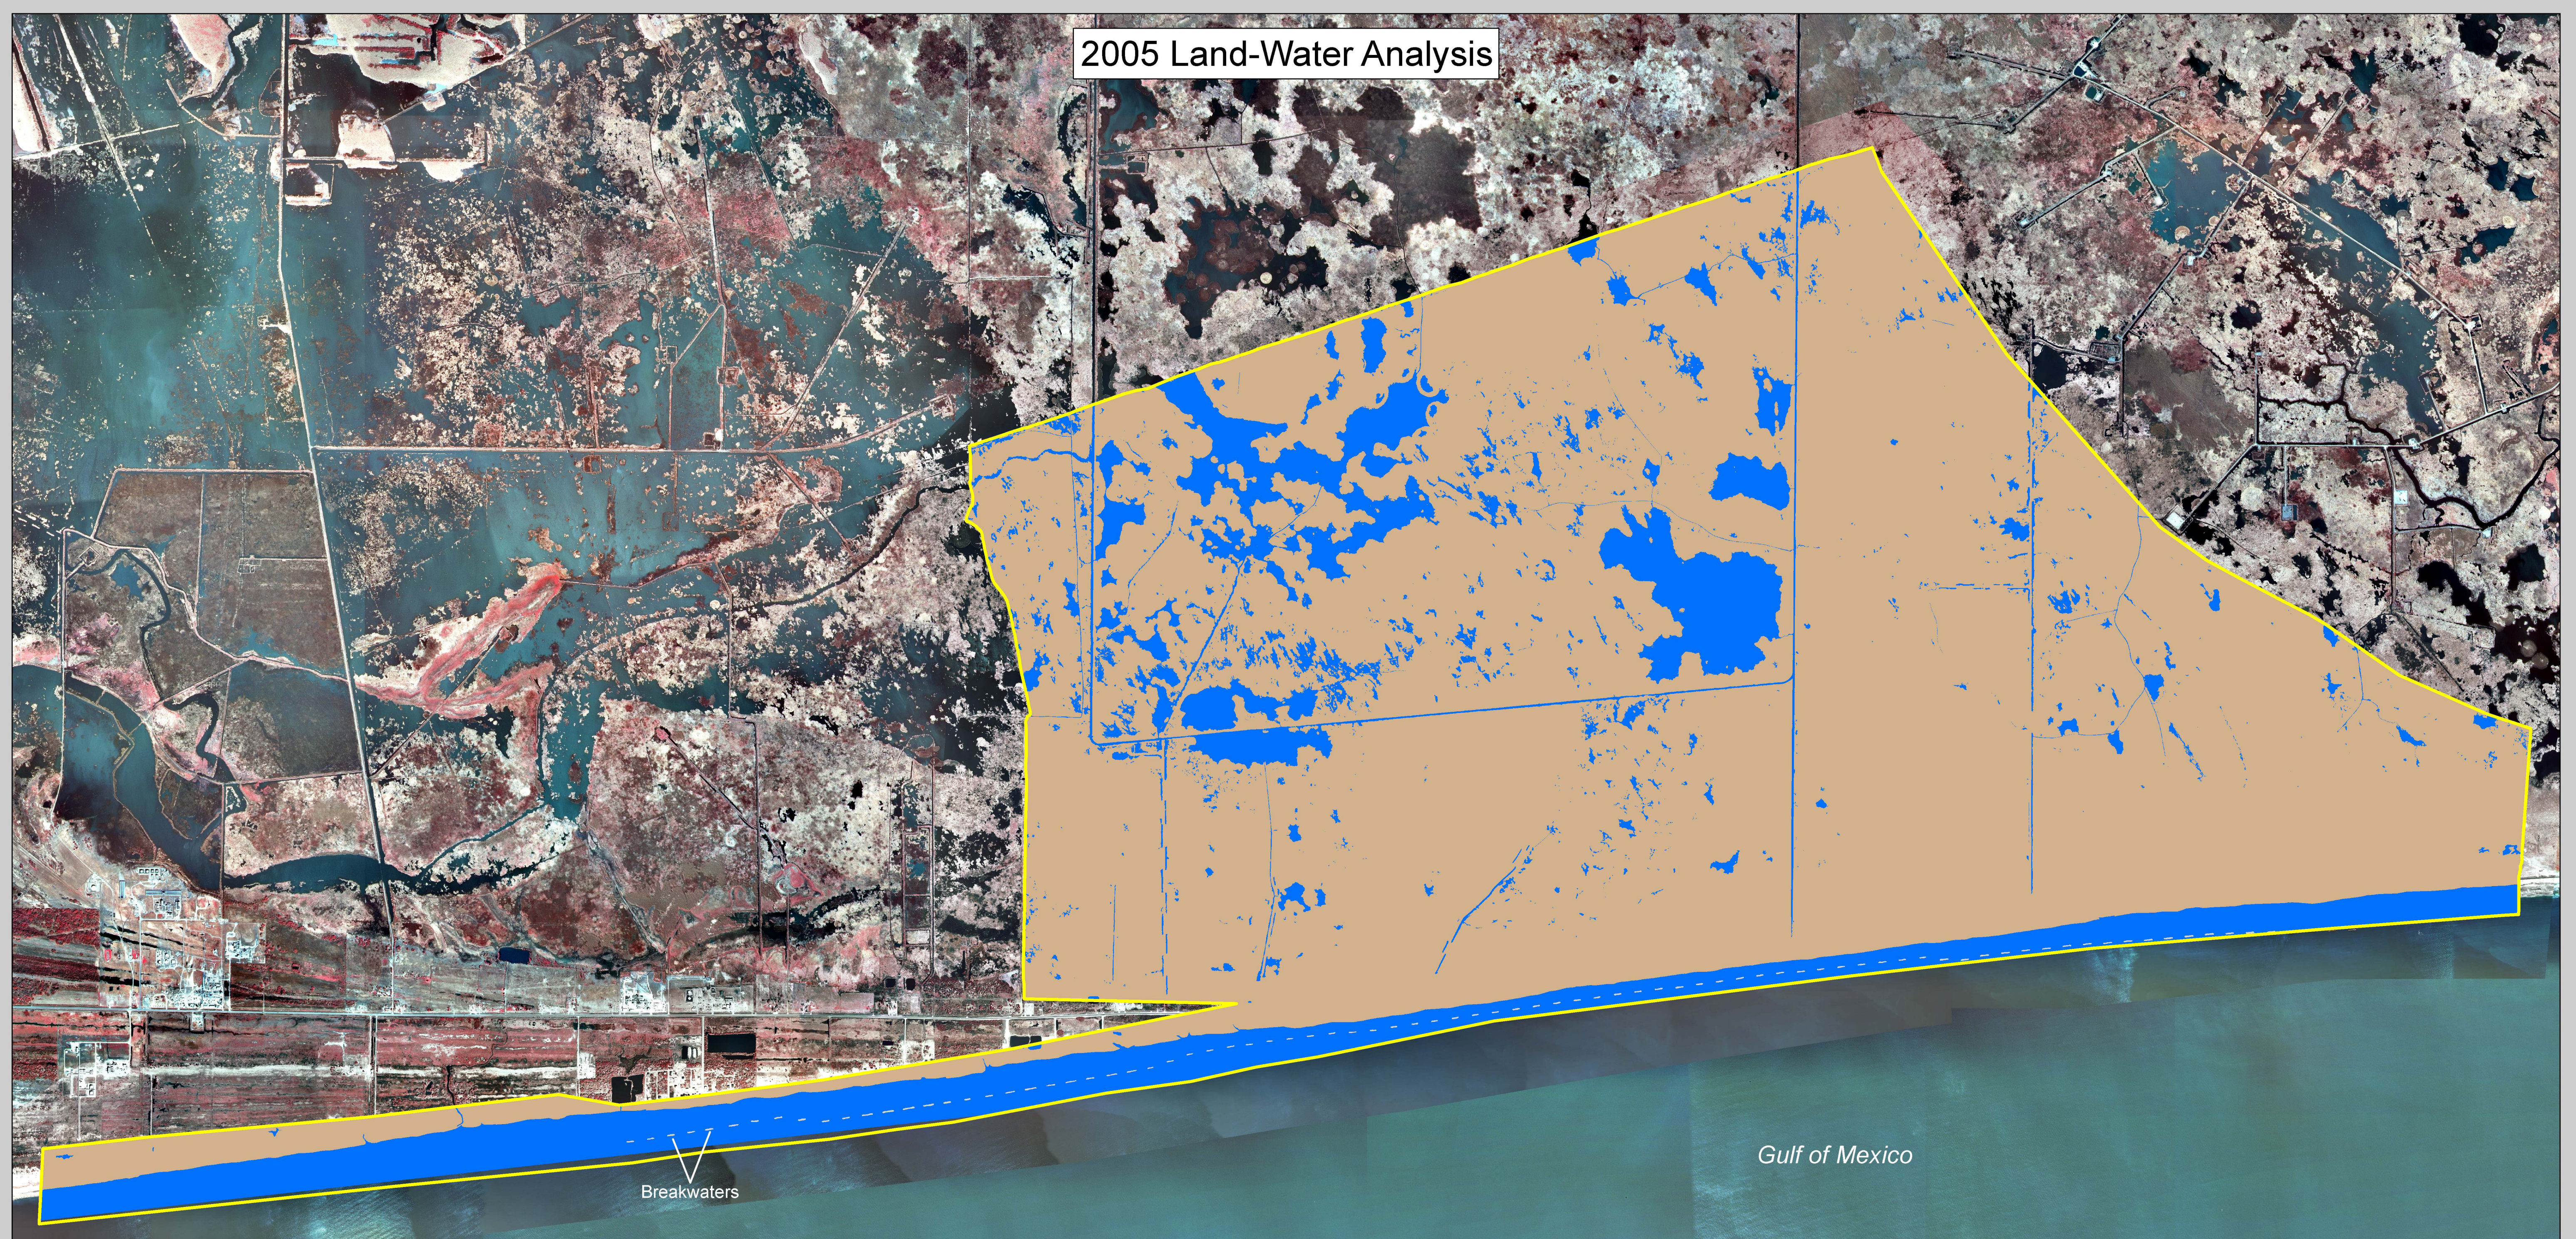
Class	Project Acres
Land	8,897
Water	1,894
Breakwaters	10
TOTAL	10,801

Land-Water Analysis:
To conduct the land-water analysis, aerial photographs were scanned, and classified into two categories. All areas characterized by emergent marsh, scrub-shrub, upland, and dunes that are not affected by tide were classified as land. Areas characterized by open water, aquatic beds, and mud flats were classified as water. Shoreline was established based on the line between regularly and irregularly flooded water regimes. Regularly flooded regimes are tidewaters that alternately flood and expose land surfaces at least once daily, while irregularly flooded regimes are tidewaters that flood land surfaces less often than daily.
