Riverine Sand Mining/ Scofield Island Restoration (BA-40)

Project Status

Approved Date: 2005 **Project Area:** 746 acres
Approved Funds: \$3 M **Total Est. Cost:** \$3 M
Net Benefit After 20 Years: 234 acres
Status: Deauthorized
Project Type: Barrier Island Restoration
PPL #: 14

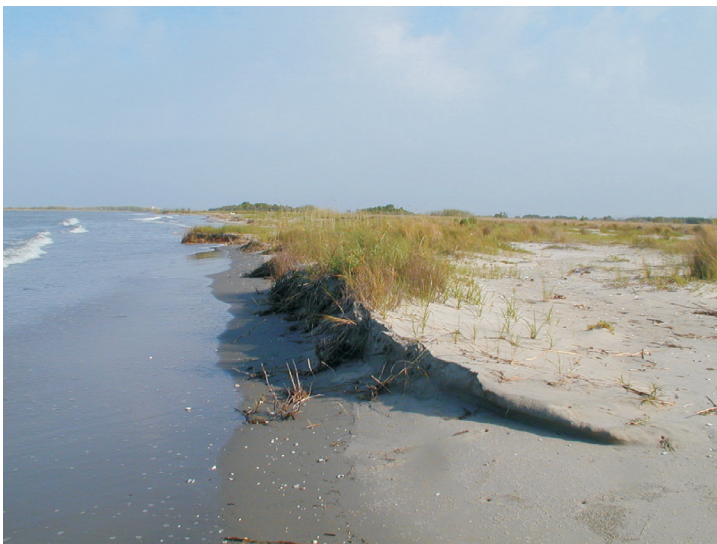
This project will help to stabilize the eroding barrier shoreline, which is shown above.

A large shoreline breach developed early in 2003 after the passage of Hurricane Lili in October 2002. The gulfside erosion rate is approximately 13 feet per year. It is expected that the shoreline erosion rates and percent loss per year have increased since the passage of Hurricane Lili in 2002 and the relatively high frequency of tropical storms in 2003. Wetlands, dune, and swale habitats within the project area have undergone substantial loss due to oil and gas activities (e.g., pipeline construction), subsidence, sea level rise, and marine- and wind-induced erosion causing landward transgression and, more recently, breaching and breakup.
