# Cameron-Creole Plugs (CS-17)

## Project Status

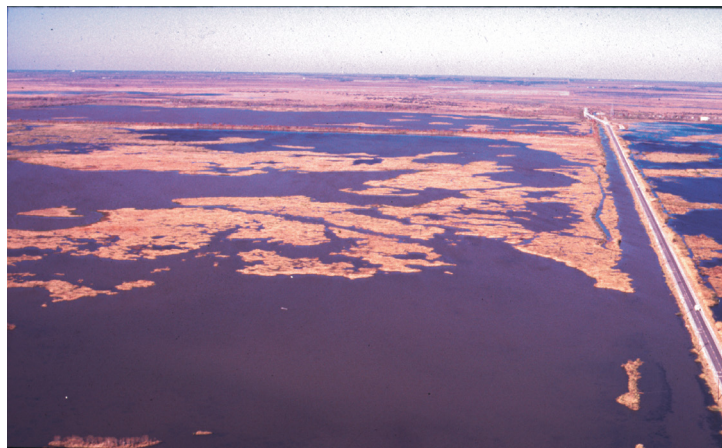
The northeastern portion of the Cameron Creole watershed is bordered by Louisiana Highway 27.

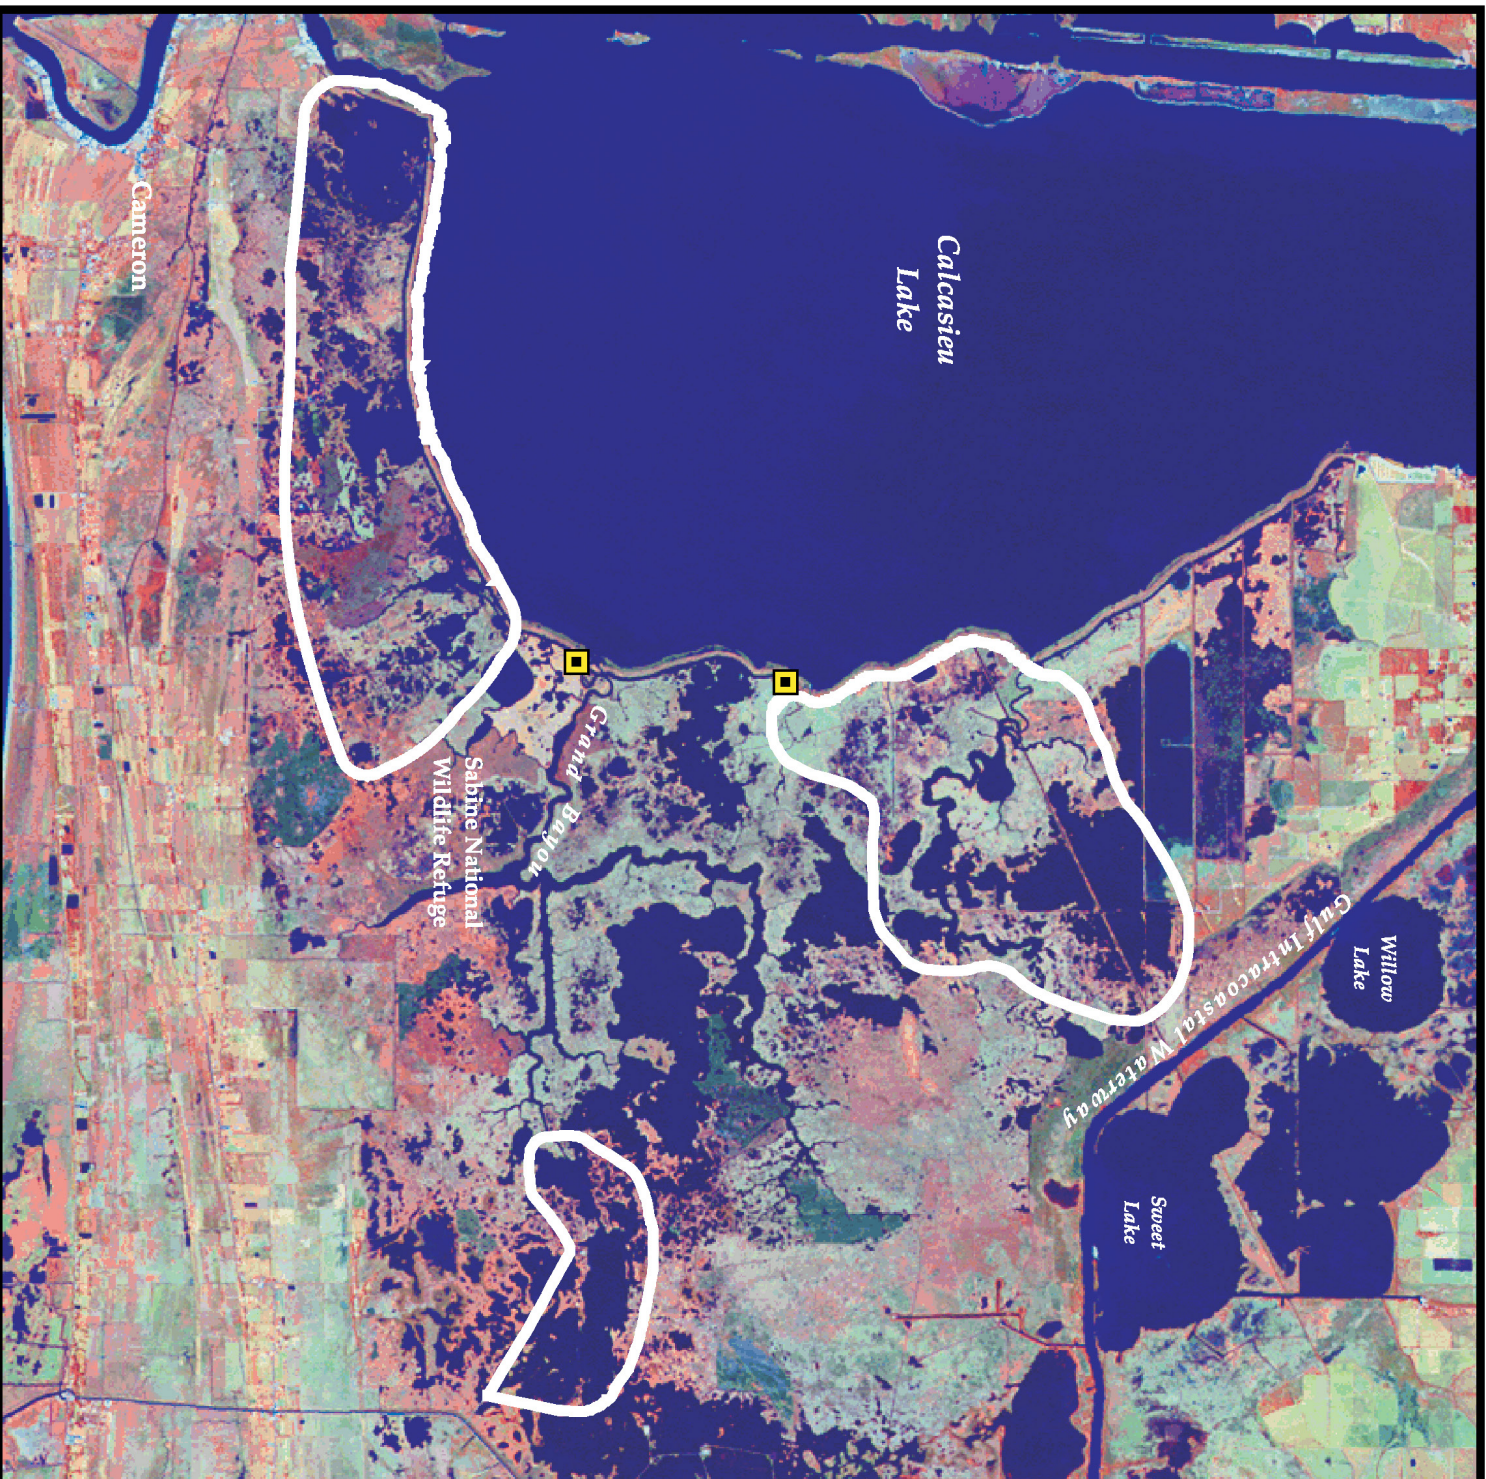
# Cameron Creole Plugs (CS-17)

Plug
-

Project Boundary

In 1989, a levee and five water control structures were constructed along the east shore of Calcasieu Lake as part of the Cameron-Creole Watershed Management Project. In the current project (CS-17), two plugs were installed in the Lakeshore Borrow Canal to moderate water circulation and flow, as well as reduce the duration of inundation in the southern project area.
