West Hackberry Vegetative Planting Demonstration (CS-19)

Project Status

Approved Date: 1991 **Project Area:** 0 acres
Approved Funds: \$0.25 M **Total Est. Cost:** \$0.25 M
Net Benefit After 20 Years: 0 acres
Status: Completed March 1994
Project Type: Demonstration: Vegetative Planting and Sediment Trapping

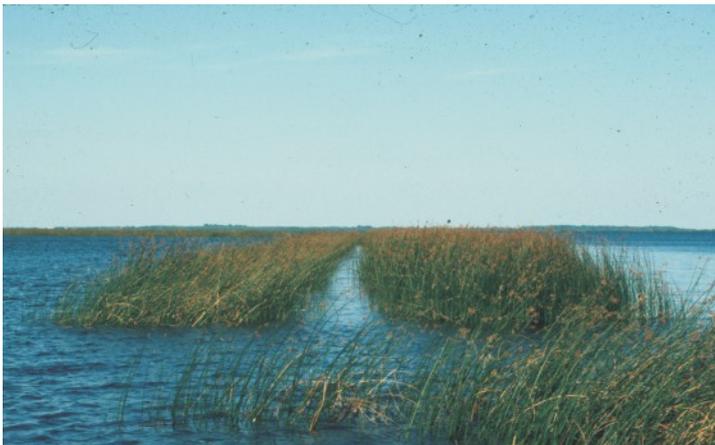
California bulrush plantings after prolonged exposure to elevated salinity levels.

California bulrush plantings were initially successful, creating 4.3 acres of emergent vegetation that formed an effective wave buffer. However, following droughts in 1996 and 1999-2000, less than 1.2 acres survived. During the drought of 1996, salinity levels rarely fell below 20 parts per thousand (ppt) for six weeks, and salinity levels averaged 15 to 20 ppt for the period of drought in 1999 to 2000. Prolonged exposure to these extreme conditions exceeds the typical salinity tolerance of California bulrush. Nevertheless, some plants did manage to survive the droughts and eventually showed gain in lateral spread, although thinning within the plots was noted.

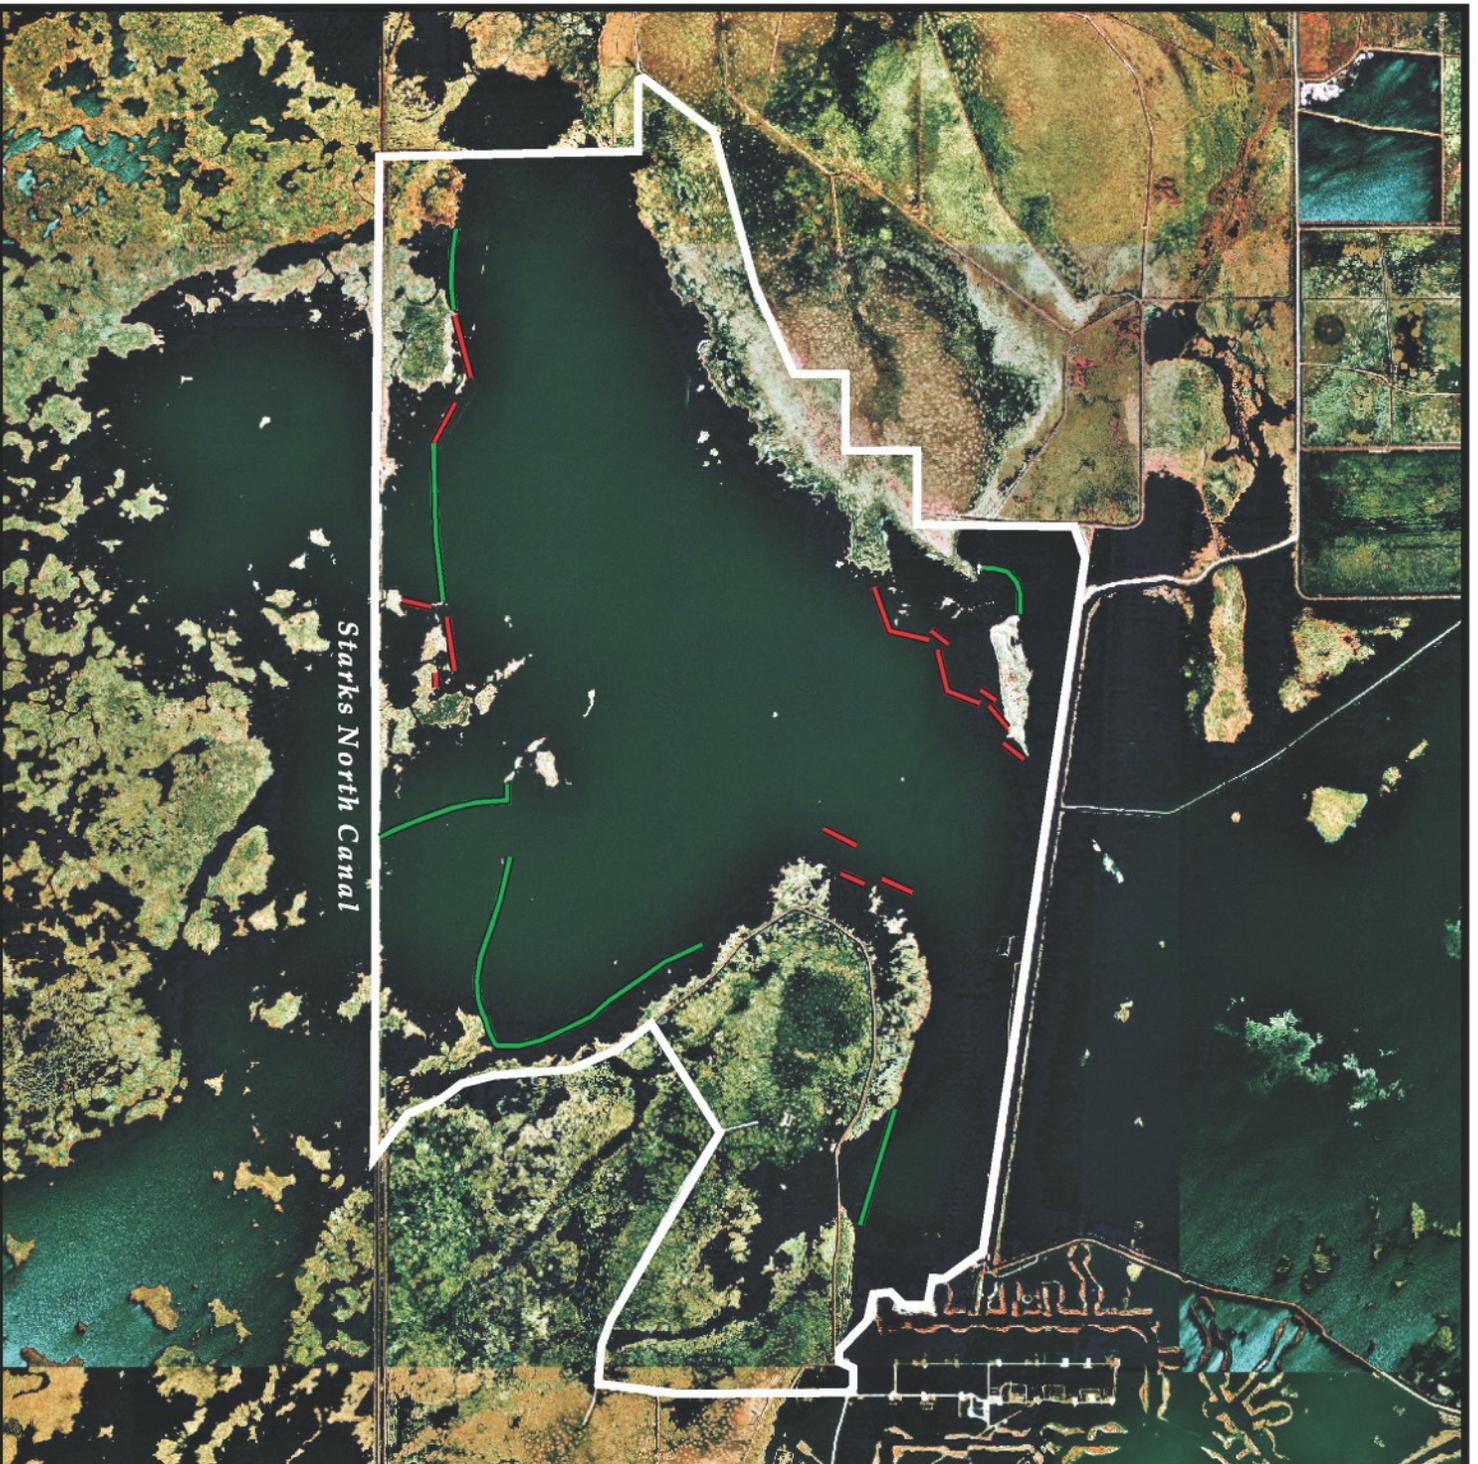
West Hackberry Vegetative Planting Demonstration (CS-19)

Vegetative Planting

Sediment Fence

Project Boundary

In April 1994, 6,000 linear feet of hay-bale fencing segments were constructed parallel to the project area shorelines in an effort to reduce erosion from wind-induced wave energy, and increase the amount of sediment deposition.

In June 1994, 4,750 California bulrush (*Schoenoplectus californicus*) plants were installed along 11,875 linear feet of marsh shoreline to protect against wave erosion.
