East Sabine Lake Hydrologic Restoration (CS-32)

Project Status

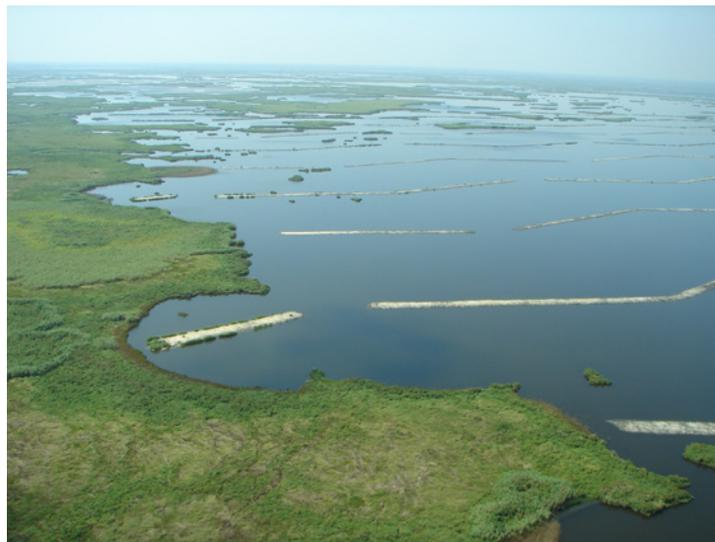
Portion of the 232,000 linear feet of vegetated earthen terraces constructed near Greens Lake on Sabine National Wildlife Refuge.

The project features include: a rock weir in Pines Ridge Bayou; three culverts with flap gates at Bridge Bayou; a 3,000 foot-long rock rip-rap breakwater along the Sabine Lake shoreline at Willow Bayou; a weir/plug at the opening at Starks South Canal Section 16 levee; and 232,000 linear feet of vegetated earthen terraces in the vicinity of Greens Lake.

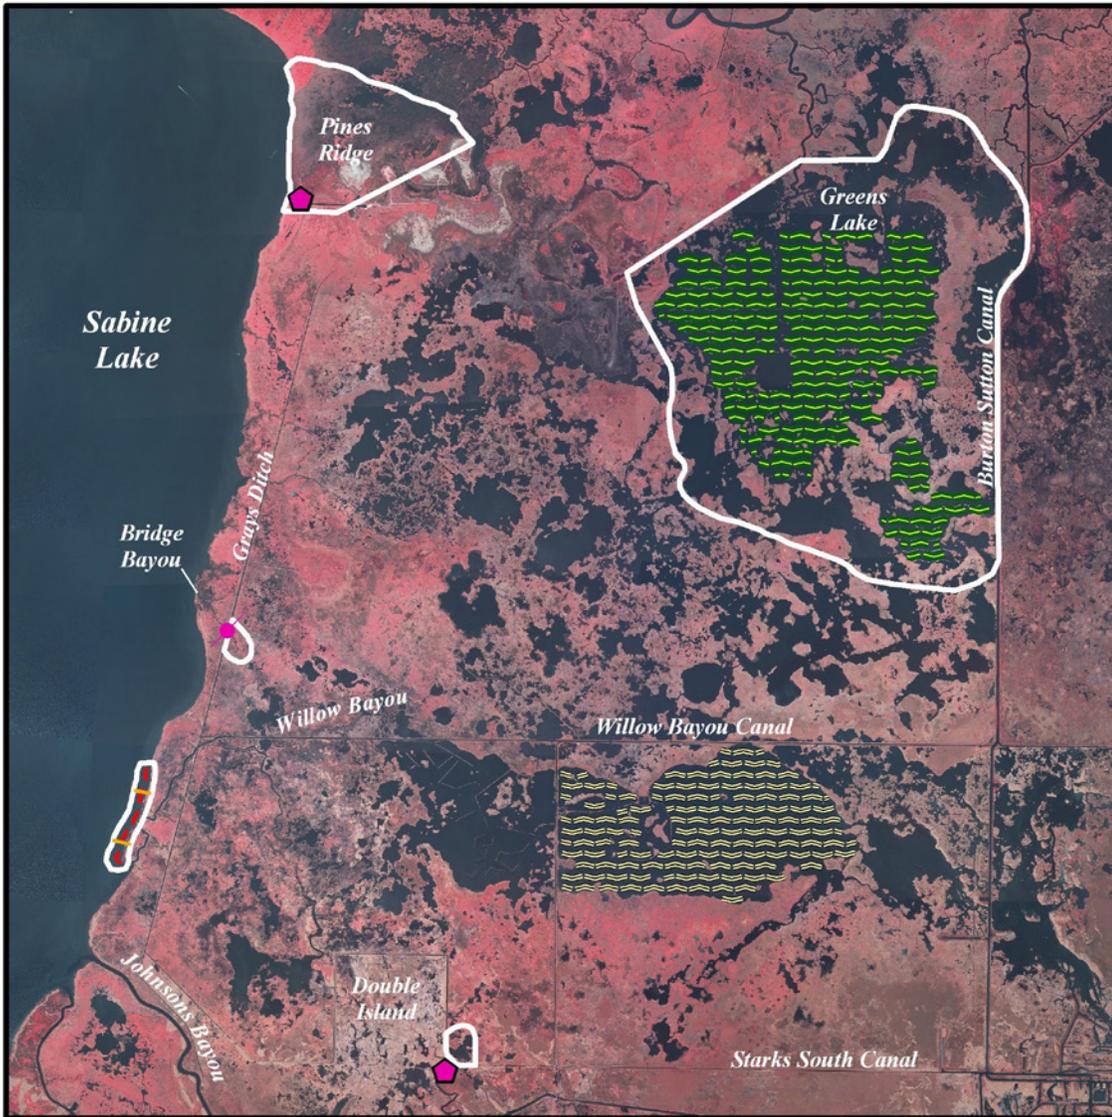
Water Control Structure *
 -

Weir *
 -

Rock Dike
 -

Gap in Rock Dike
 -

Terraces
 -

Existing and Proposed Terraces for SNWR
 -

Project Boundary
- *denotes proposed features
