East Sabine Lake Hydrologic Restoration (CS-32)

Project Status

Approved Date: 2001 **Project Area:** 6,589 acres
Approved Funds: \$6 M **Total Est. Cost:** \$6 M
Net Benefit After 20 Years: 225 acres
Status: Completed October 2010
Project Type: Hydrologic Restoration, Terraces
PPL #: 10

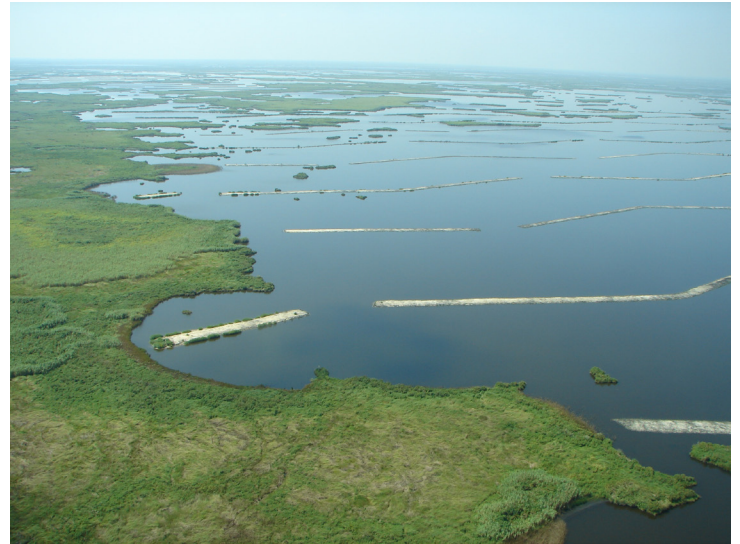
Portion of the 232,000 linear feet of vegetated earthen terraces constructed near Greens Lake on Sabine National Wildlife Refuge.

The project features include: a rock weir in Pines Ridge Bayou; three culverts with flap gates at Bridge Bayou; a 3,000 foot-long rock rip-rap breakwater along the Sabine Lake shoreline at Willow Bayou; a weir/plug at the opening at Starks South Canal Section 16 levee; and 232,000 linear feet of vegetated earthen terraces in the vicinity of Greens Lake.
