Freshwater Bayou Wetland Protection (ME-04)

Project Status

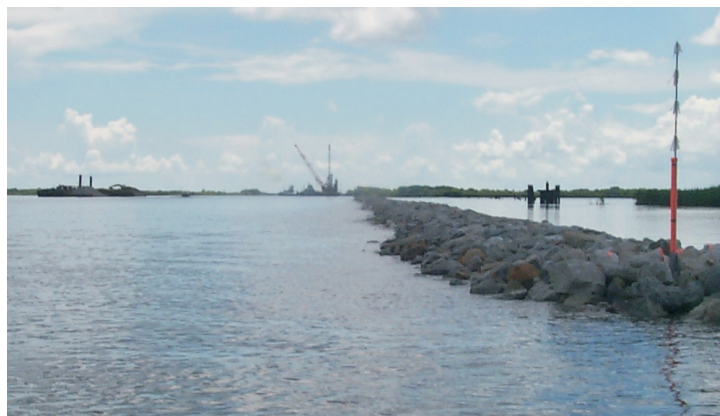
This continuous rock dike will drastically reduce boat wake-induced shoreline erosion.

Approximately 28,000 linear feet of freestanding, continuous rock dike were built along the west bank of Freshwater Bayou Canal. The USDA Natural Resources Conservation Service and Louisiana Department of Natural Resources worked with the landowner to develop other preservation features in the area. The landowner installed several other structures that were not funded by CWPPRA but will complement CWPPRA project features.

Shoreline surveys taken 1 year after construction show that while reference area sites eroded at a rate of 9.00 feet per year, the project area built land at an average rate of 1.53 feet per year. These data indicate that the rock dike has successfully prevented or significantly reduced erosion of the protected segment of canal bank for the year following construction.
