Freshwater Introduction South of Highway 82 (ME-16)

Project Status

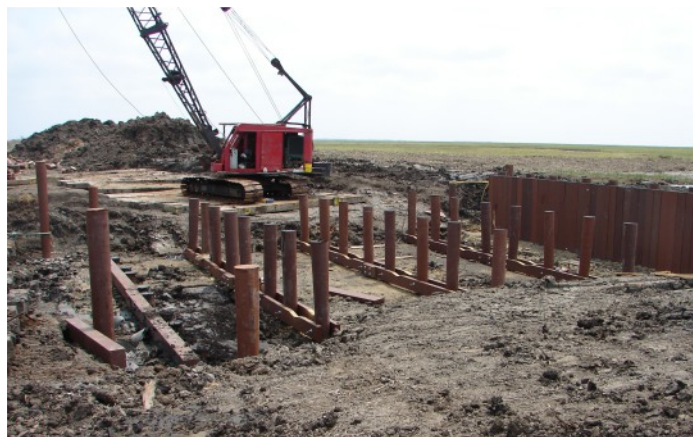
Early stages of the construction of a water control structure to move freshwater to brackish marshes to the south.

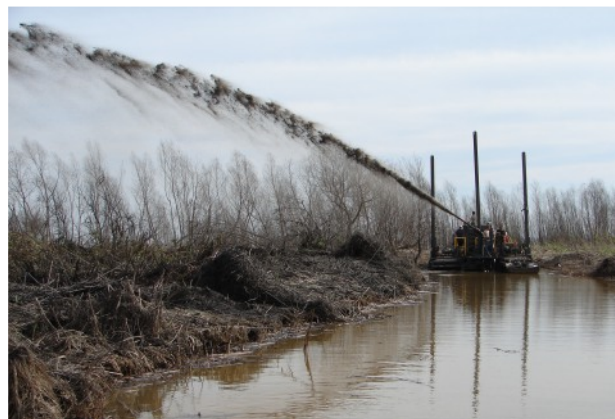
Small spray dredge enlarging the Grand Volle Ditch and spraying the spoil over existing marsh.

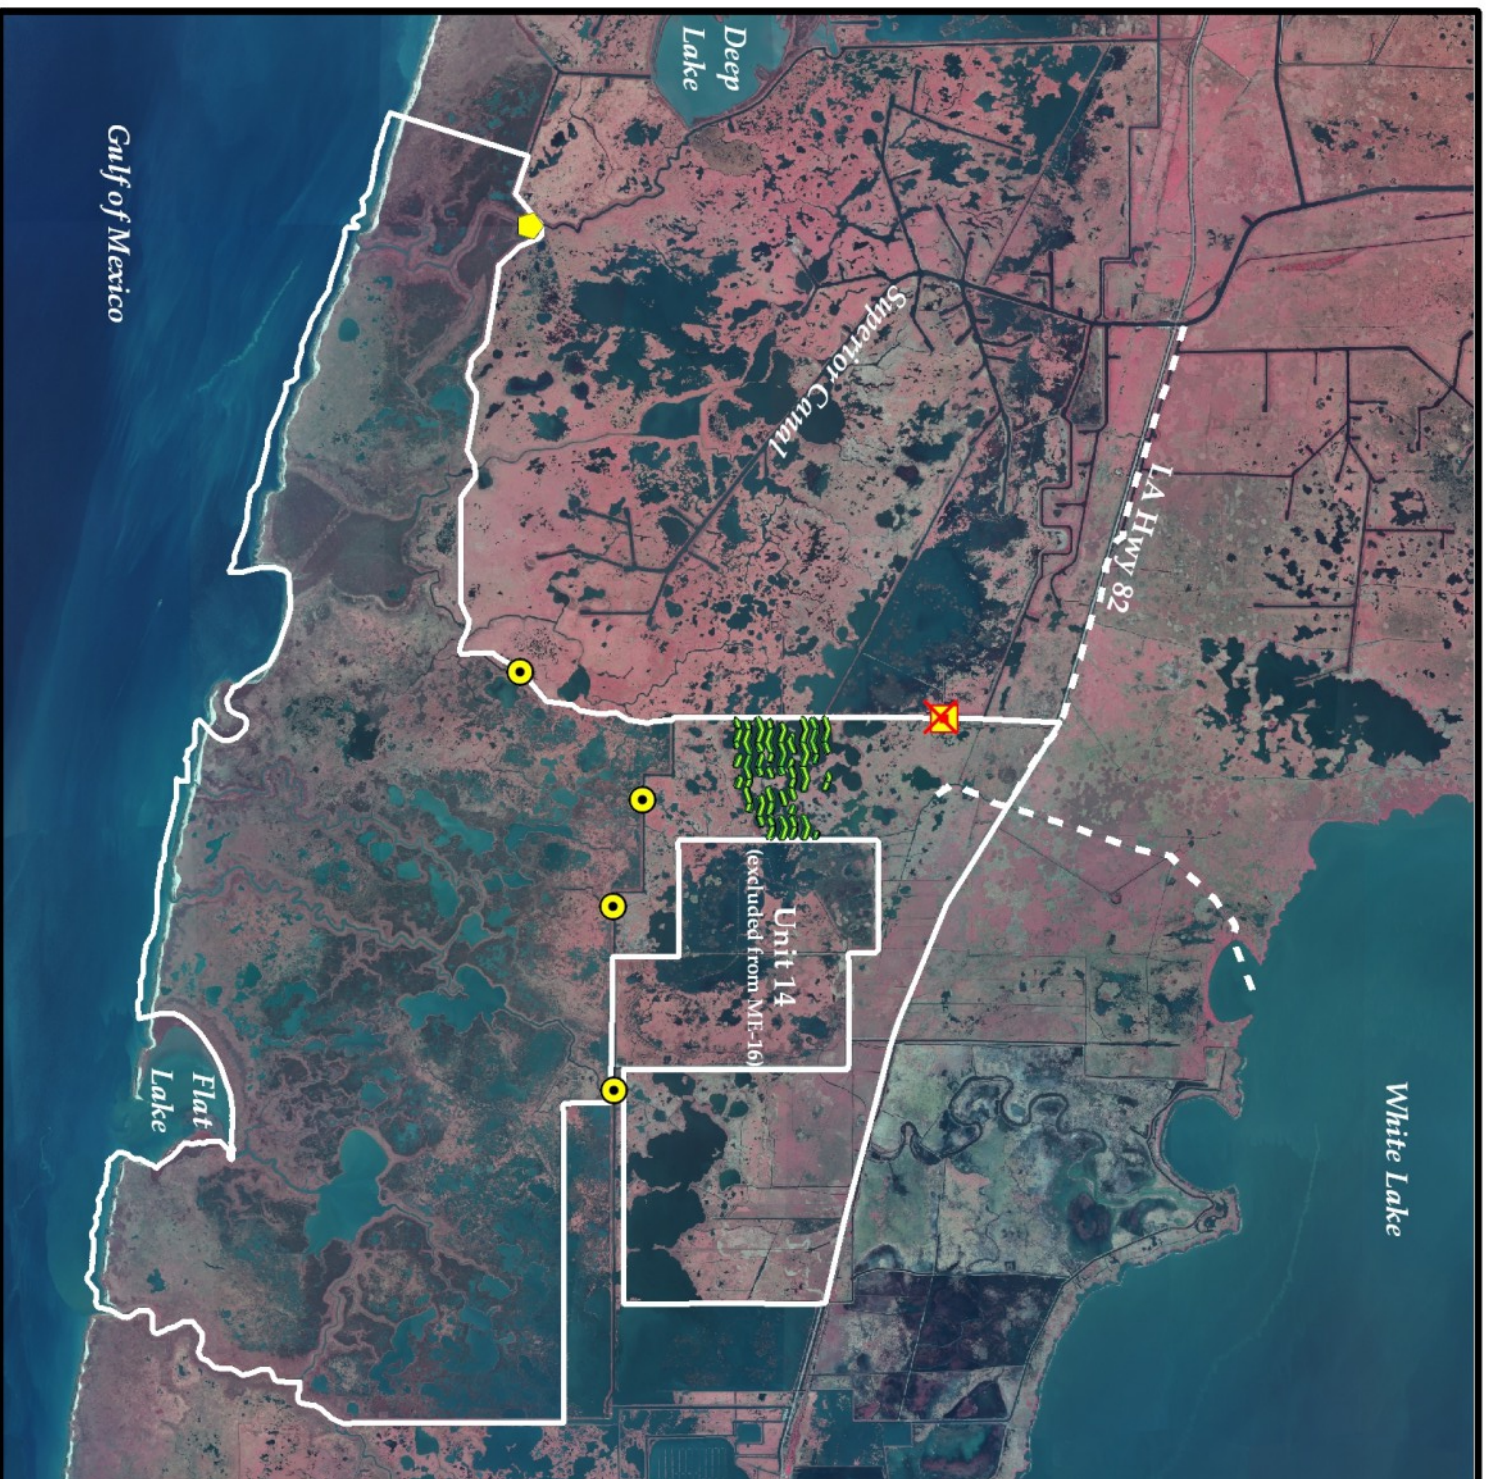
Freshwater Introduction South of Highway 82 (ME-16)

Culvert
-

Remove Existing Plug
-

Weir
-

Dredge Channels
-

Terrace
-
