## Delta Wide Crevasses (MR-09)

**Approved Date:** 1997      **Project Area:** 5,210 acres  
**Approved Funds:** \$9 M      **Total Est. Cost:** \$18 M  
**Net Benefit After 20 Years:** 2,386 acres  
**Status:** Completed 1999  
**Project Type:** Water Diversion  
**PPL #:** 6

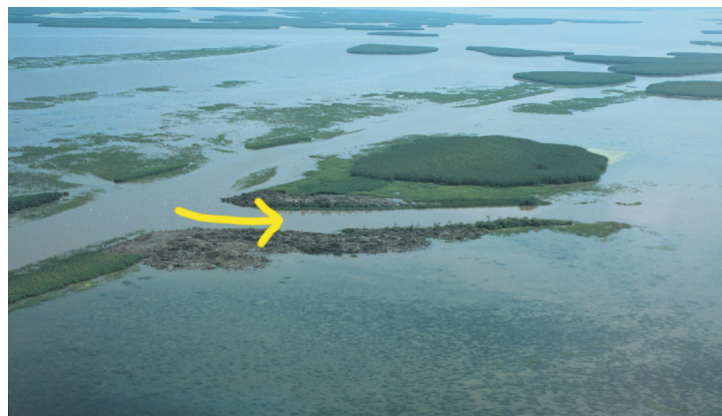
The arrow shows how water and sediments flow through a crevasse in the Mississippi River.

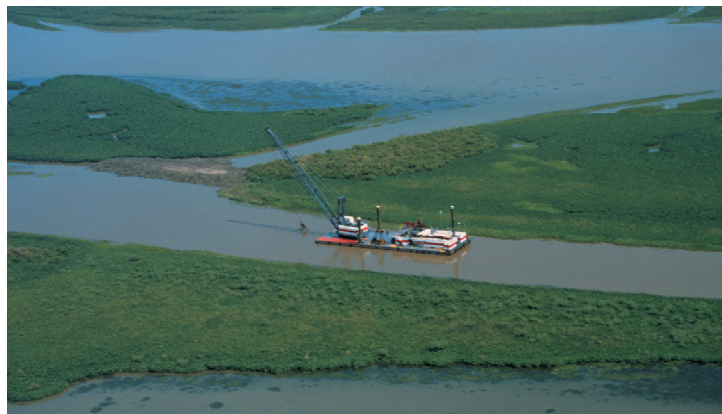
This image shows a crevasse being plugged in 1999 in order to maximize the effectiveness of crevasses downstream. As this project contains several building cycles, project components are adjusted over time to achieve optimal performance as new features are constructed.
