Boston Canal/Vermillion Bay Bank Protection (TV-09)

Project Status

Boston Canal/ Vermilion Bay Bank Protection (TV-09)

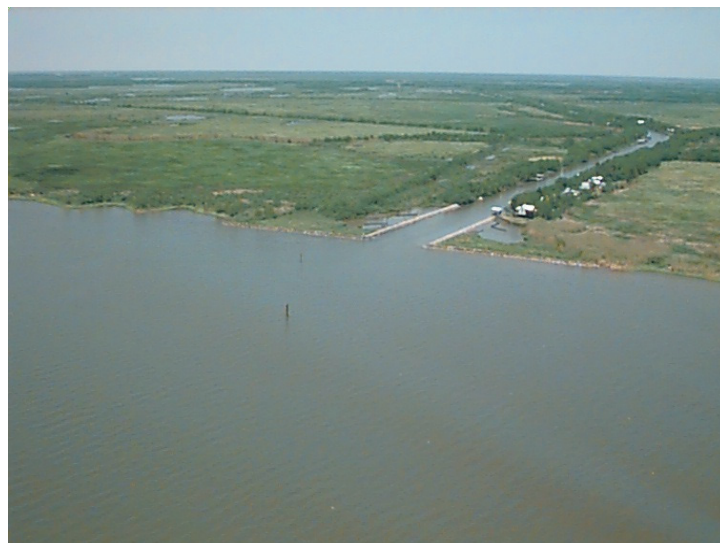
Planted smooth cordgrass (*Spartina alterniflora*) protecting the Vermilion Bay shoreline.

Vegetation was planted along 14 miles of the Vermilion Bay shoreline to act as a wave buffer and decrease shoreline erosion rates.

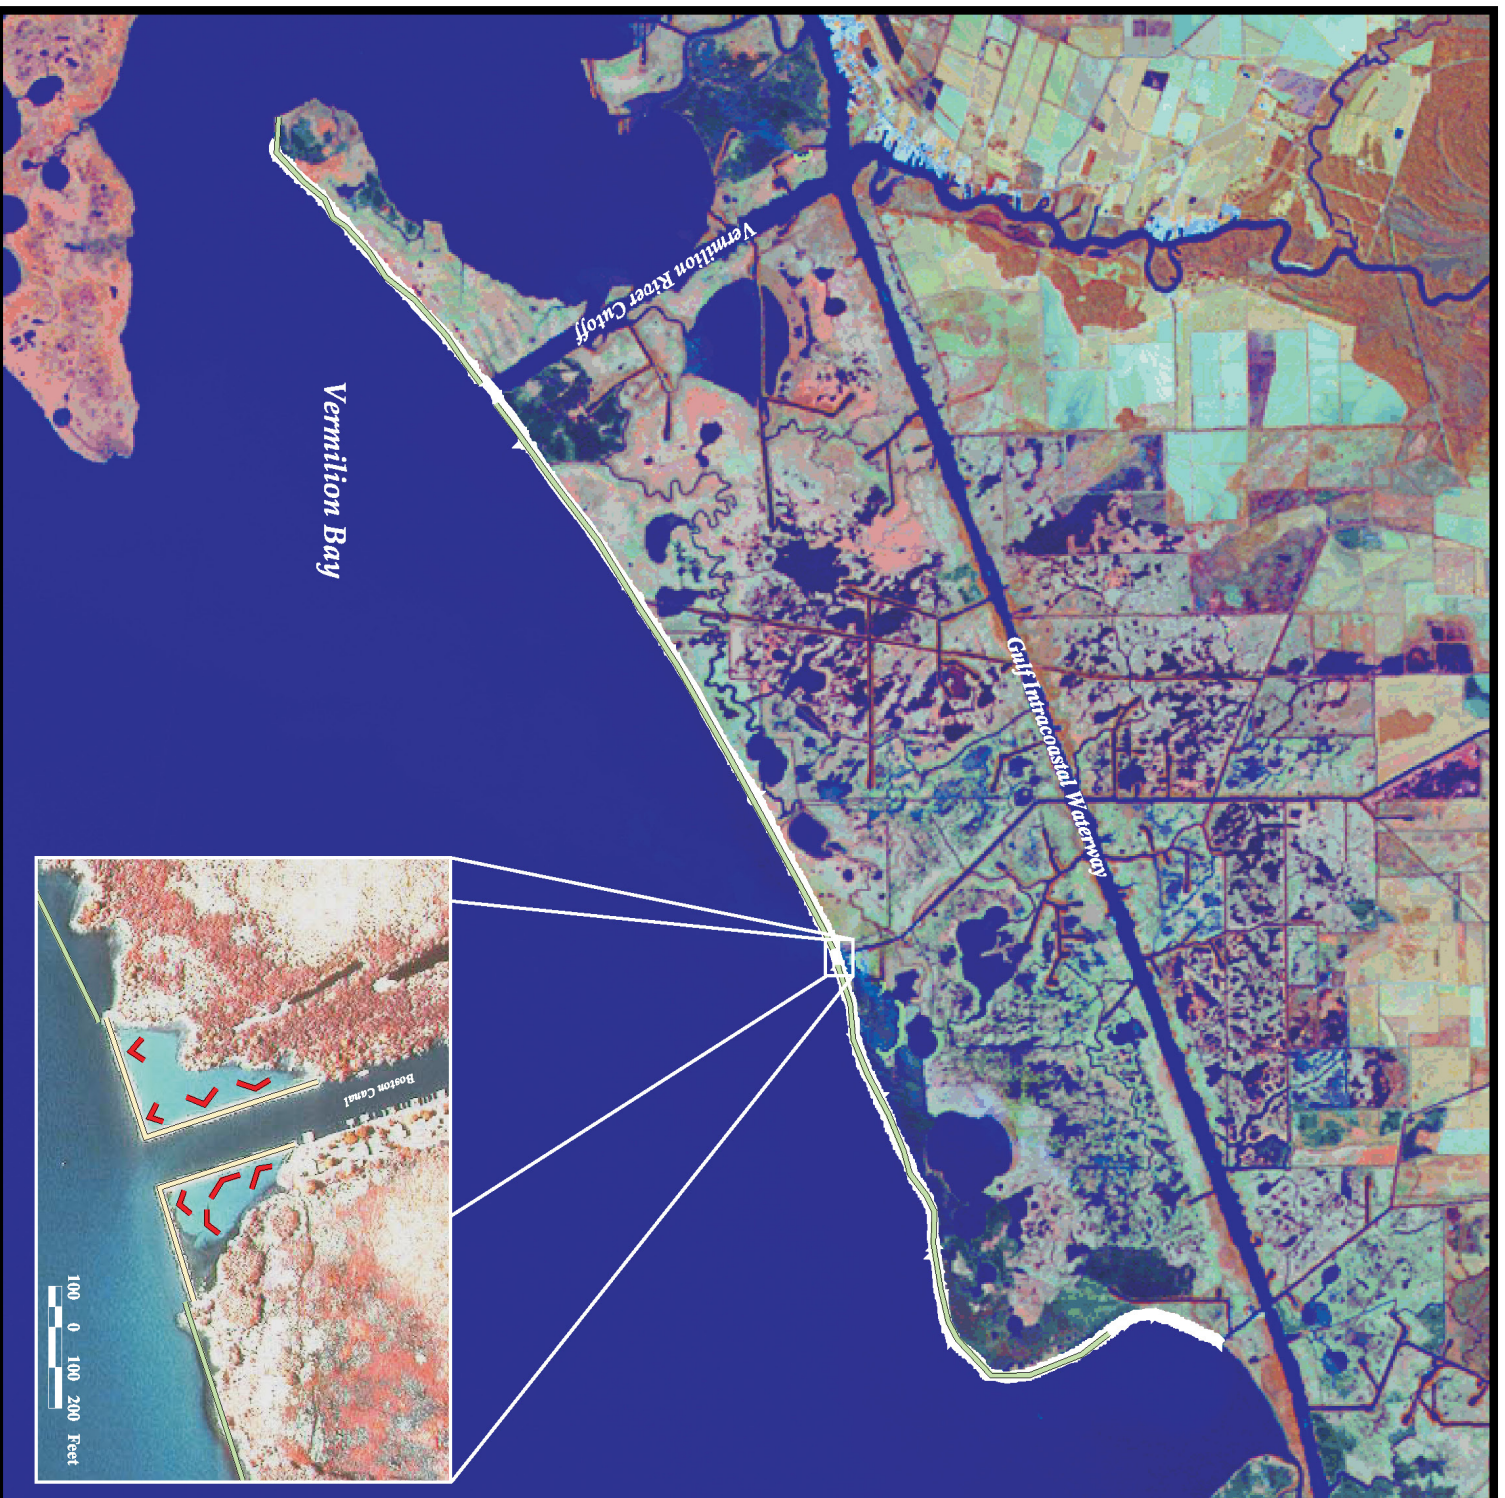
- Containment Dike
- Vegetative Plantings
- Sediment Fence
- Project Boundary

Background Imagery:
Map Image: Thematic Mapper Satellite Imagery 2000
Inset Image: 1994 Color Infrared Aerial Photography

Rock dikes configured as sediment traps were constructed along the shoreline at the mouth of Boston Canal to promote sediment deposition and protect the shoreline and adjacent wetlands from continued wave-induced erosion.
