**2004 Operations, Maintenance,
and Monitoring Report**

**ISLES DERNIERES
RESTORATION EAST ISLAND**

State Project Number TE-20
Priority Project List 1

May 2004
Terrebonne Parish

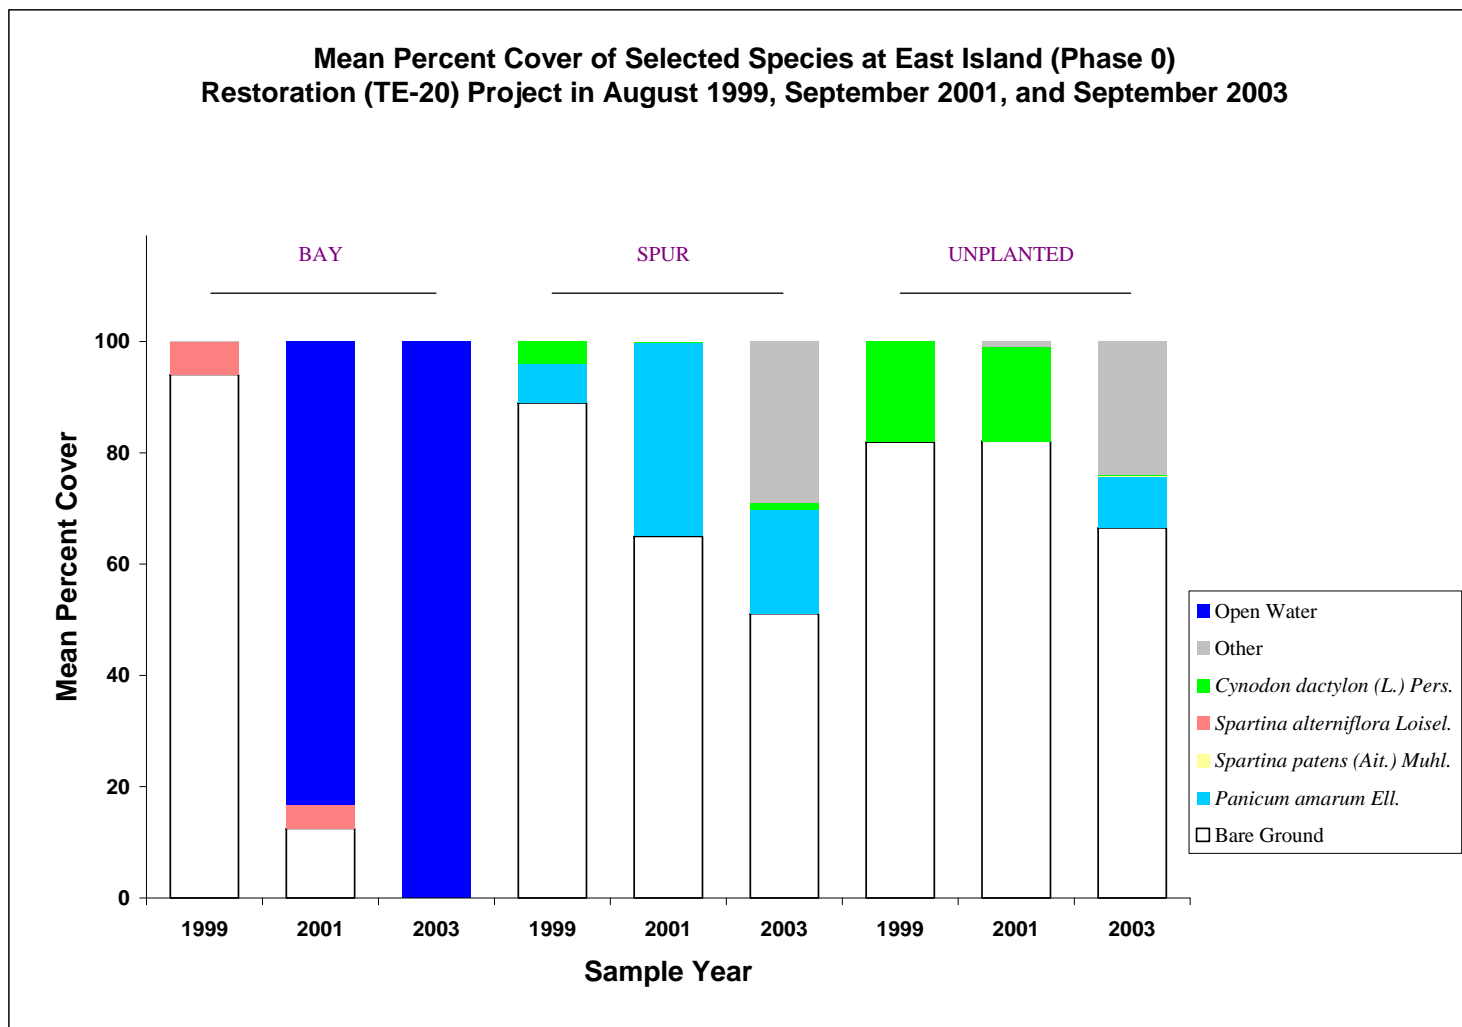
Figure 5: Mean percent cover for selected vegetation species at East Island Restoration (TE-20).

Nine of the 12 bay plots in 2001 and all the plots in 2003 were under water at the time of the vegetative sampling trips (figure 5). These results suggest that East Island continues to narrow and to experience considerable erosion. In 2003, vegetation percent cover was 33.5% in unplanted plots and 48.9% in spur plots. Percent cover of bare ground tended to decrease with each subsequent year in unplanted and spur plots.
