**2007/2008 Annual Inspection
Report**

**VERMILION RIVER CUT-OFF
BANK EROSION PROTECTION
PROJECT (TV-03)**

State Project Number TV-03
Priority Project List 1

April 24, 2008
Vermilion Parish

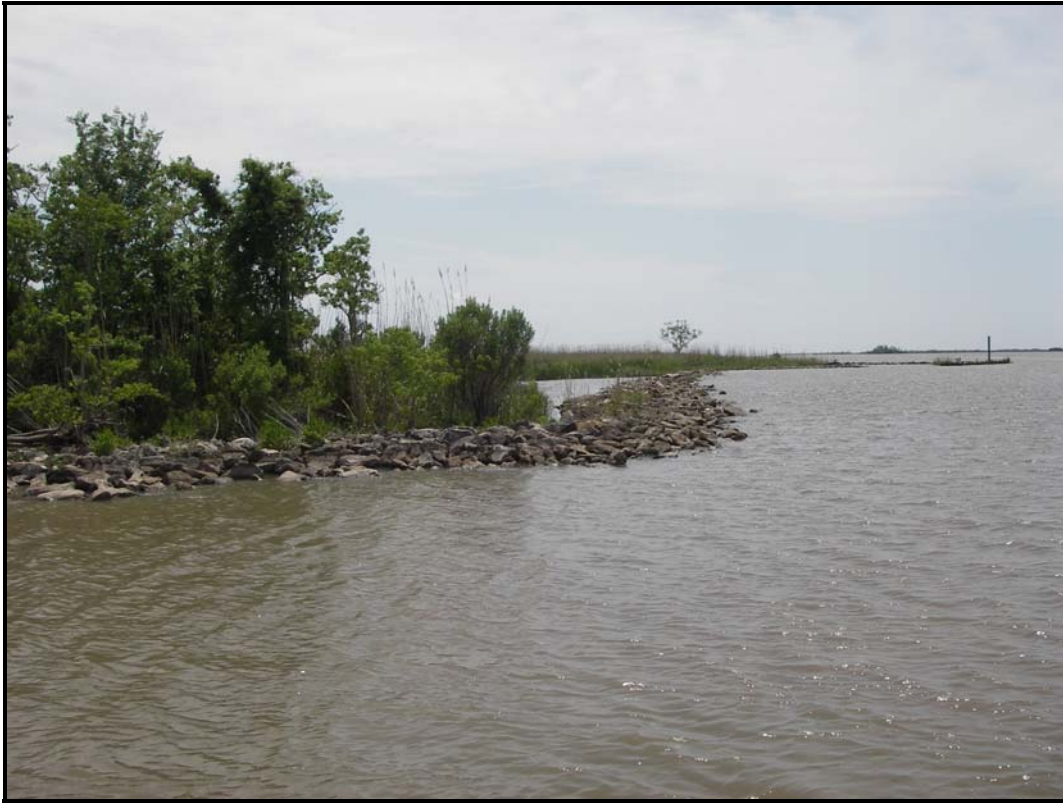
Photo 1—north tie-in

The foreshore dike is in excellent condition with no maintenance required or foreseen. A staff gauge needs to be installed in the area. (Photos, Appendix B, Photos, 1, 2 & 3).

- Install staff gauge

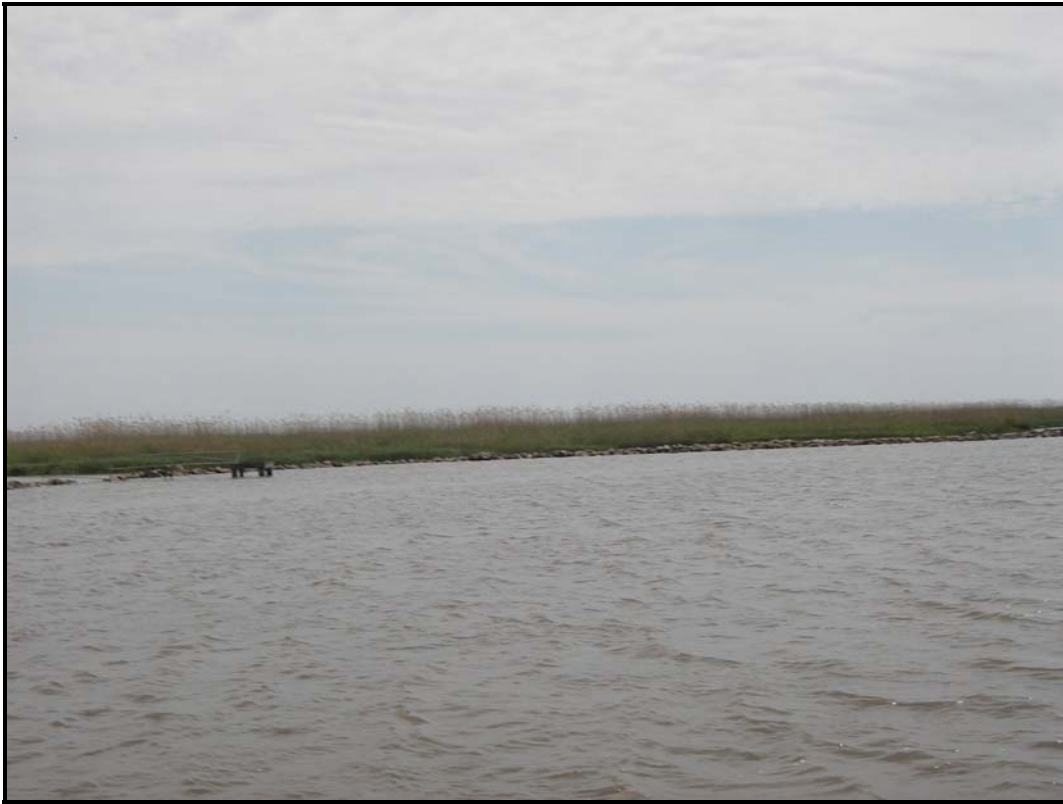
Photo 3-typical rock dike section

Item	Condition	Physical Damage	Corrosion	Photo #	Observations and Remarks
Steel Bulkhead / Caps	N/A				
Steel Grating	N/A				
Stop Logs	N/A				
Hardware	N/A				
Timber Piles	N/A				
Timber Wales	N/A				
Galv. Pile Caps	N/A				
Cables	N/A				
Signage /Supports	N/A				
Rip Rap (fill) (foreshore dike)	Good			1, 2 & 3	The foreshore dike was just recently elevated to original permitted height.
Earthen Embankment	N/A
