Monitoring Series No. PO-17-MSPR-0499-5

PROGRESS REPORT 5

**BAYOULA BRANCHE  
WETLAND RESTORATION PROJECT  
PO-17 (PPO-10)**

**First Priority List Beneficial Use of Dredged Material Project  
of the Coastal Wetlands Planning, Protection, and Restoration Act  
(Public Law 101-646)**

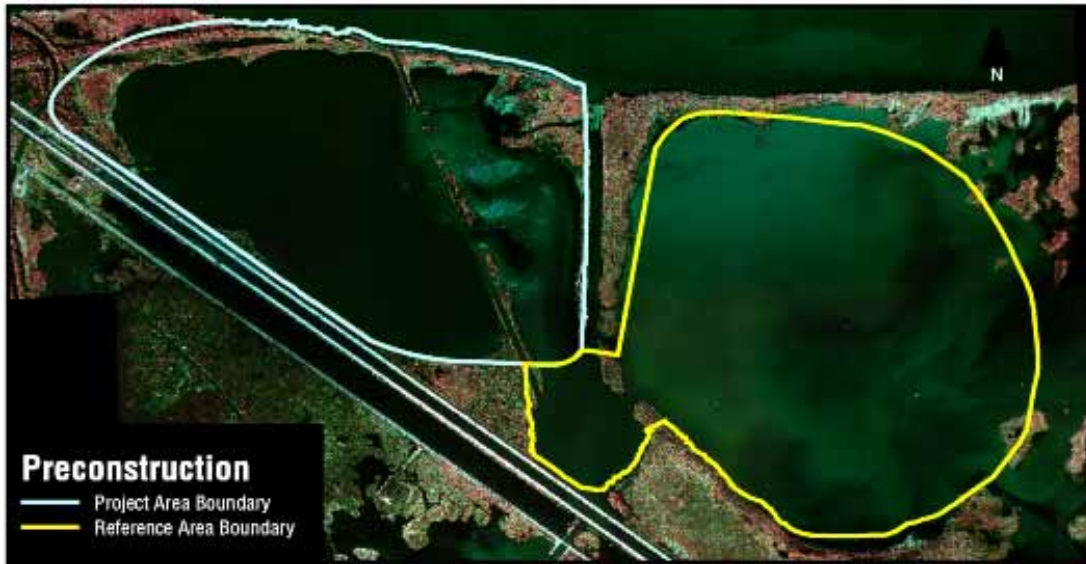
**Figure 4.** Preconstruction and postconstruction aerial photography for the Bayou La Branche project and reference areas.

1:12,000 scale aerial photography taken November 7, 1993,  
shown here at 1:23,000 scale.

1:12,000 scale aerial photography taken November 17, 1997,  
shown here at 1:23,000 scale.

The mean wetland status or prevalence index for the project area in 1996 was  $1.75 \pm 0.08$  SE. In 1997 the index decreased to  $1.42 \pm 0.13$  SE, but increased to  $1.61 \pm 0.10$  SE in 1998. Analysis of variance indicated that no significant differences ( $df = 2$ ,  $F = 2.21$ ,  $p = 0.1137$ ) were found in these index values among years. Although no differences were found among years, the index indicates that the project area was classified as wetland (a prevalence index less than three) for all three years. GIS land-water analysis of aerial photography revealed that the land to open water ratio in the project area increased between 1993 and 1997 but remained unchanged in the reference area during the same time period (figure 11). In the project area, proportions of land to water increased from 18.5% land and 81.5% water in 1993 to 81.7% land and 18.3% water in 1997. In the reference area, the land to open water ratio remained constant at 2.2% land and 97.8% water in both 1993 and 1997 (figure 11).

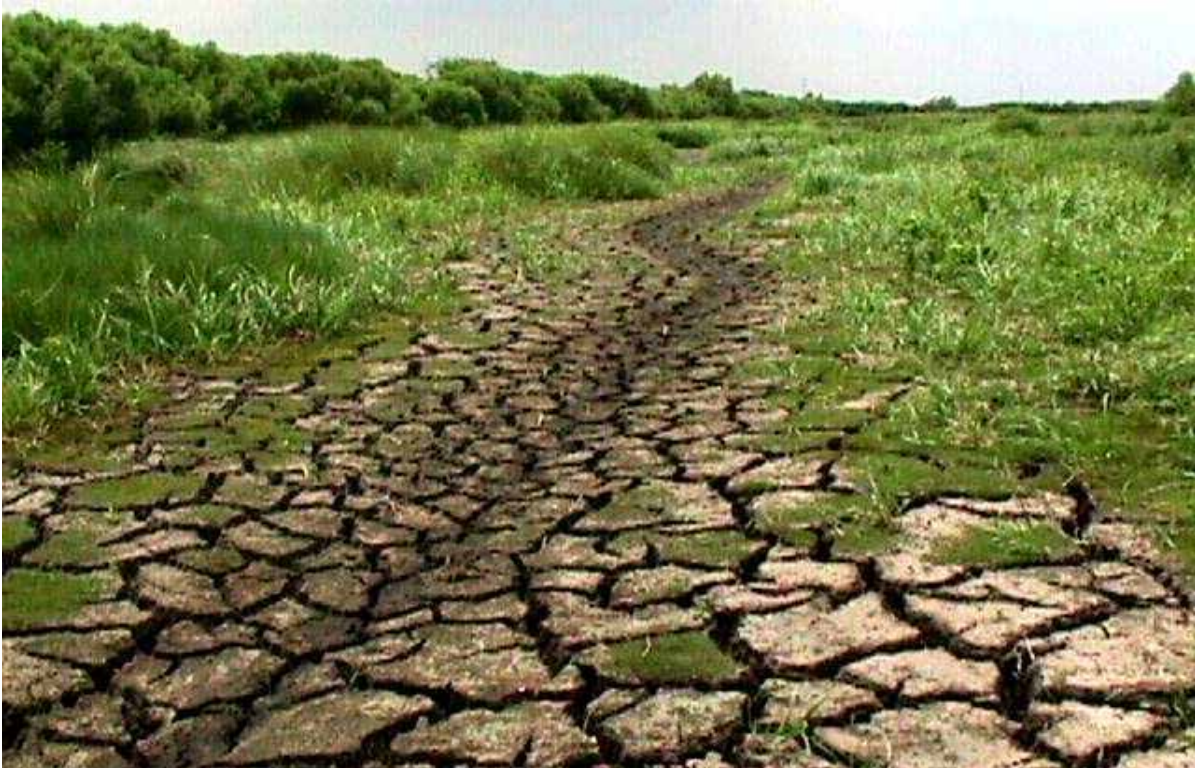
**Figure 14.** Dry conditions in the Bayou La Branche project area during an extended dry period (May-August) during 1998.
