**COMPREHENSIVE MONITORING REPORT NO. 1**

For the period May 8, 1997 to May 8, 2001

**POINT AU FER ISLAND HYDROLOGIC  
RESTORATION  
TE-22 (PTE22-24)**

**Second Priority List Hydrologic Restoration Project  
of the Coastal Wetlands Planning, Protection, and Restoration Act  
(Public Law 101-646)**

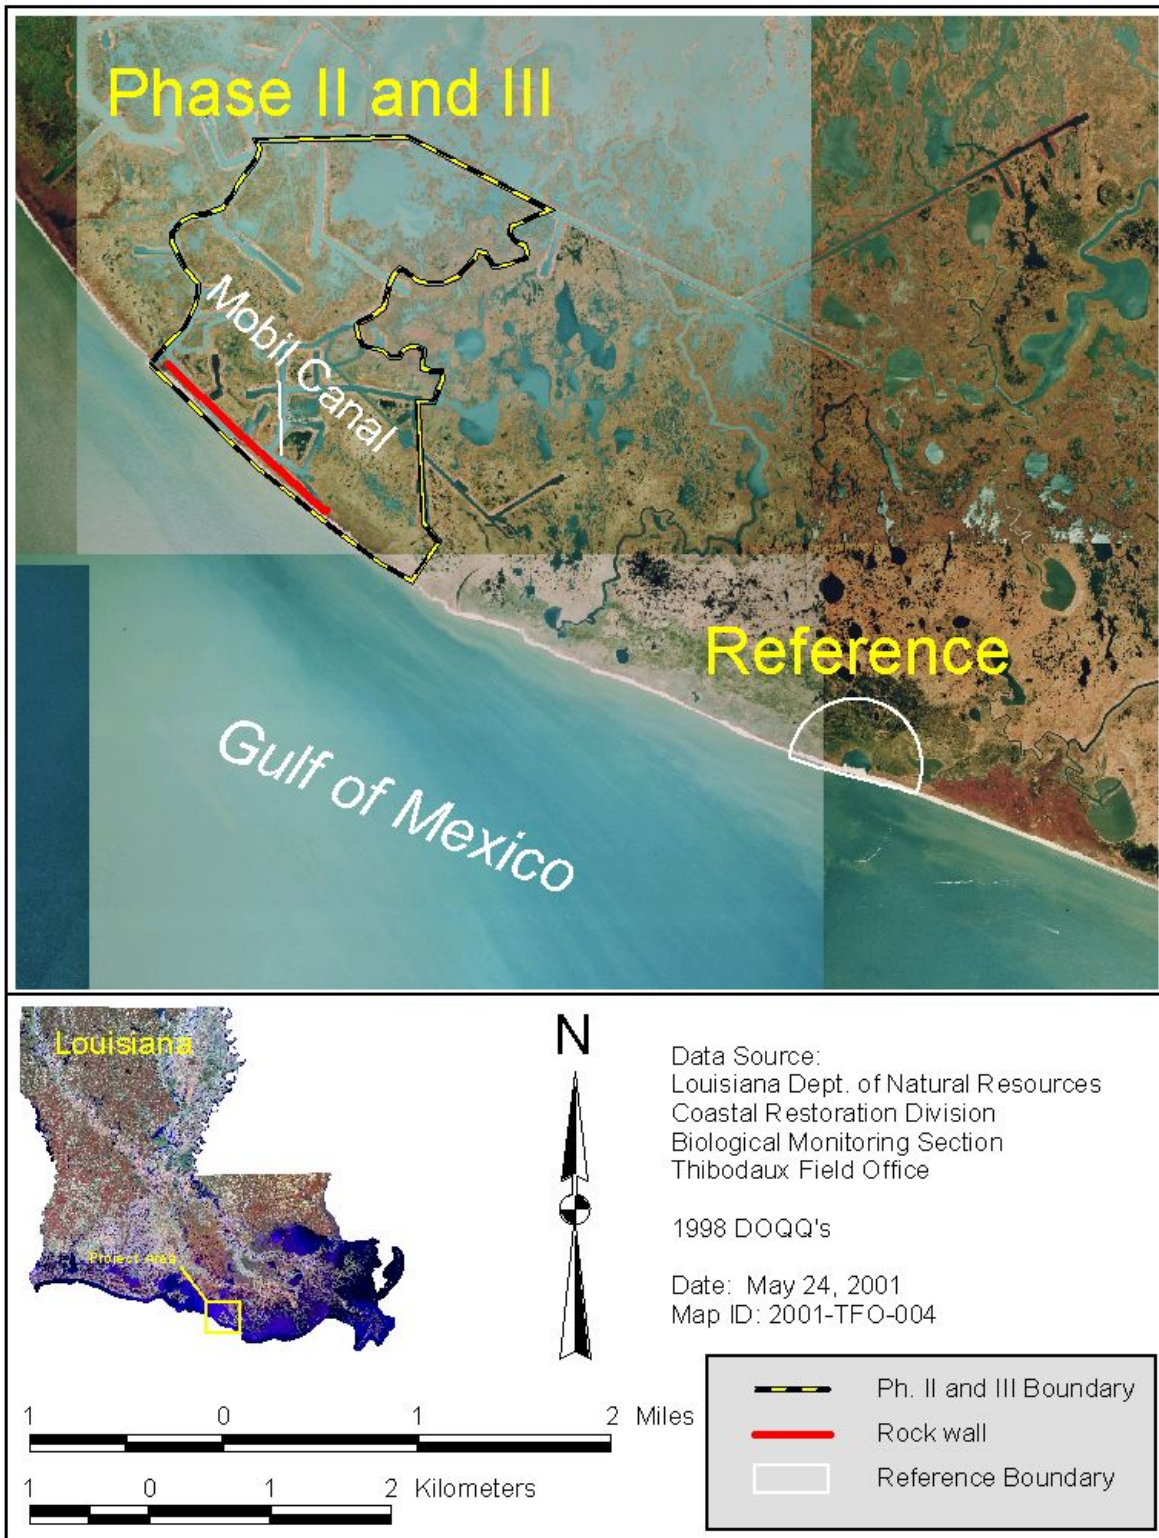
**Figure 3.** Point Au Fer Island Hydrologic Restoration (TE-22) project - Phase II and III boundary and features, and reference area boundary.

Phase II - The original intent of this phase was to backfill the oil well access canal known as Mobil Canal (figure 3). It was determined to be not economically feasible, therefore, the project was changed to a shoreline protection system (figure 6). In a joint financial effort between the LDNR/CRD, the NMFS, and the Mobil Oil and Exploration Company, approximately 3,600 ft (1,097 m) of 200 pound (90.72 kilogram) class stone underlain with a combination of geo-textile grid, filter cloth, and geo-textile woven fabric were constructed in the Spring of 1997. Construction was completed on May 7, 1997. The structure ranges from 25 ft to 33 ft (7.62 to 10.05 m) wide with an average height of 2.67 ft (0.81 m). There is a section of the shoreline referred to as the “breach area” - located near the eastern edge of the Phase II rock armor (figure 7). Within this area, the stone width was increased to a range of 35 ft to 45 ft (10.67 to 13.72 m), and varied in height from 3 ft to 4 ft (0.914 to 1.22 m), to compensate for the possibility of future breaches.

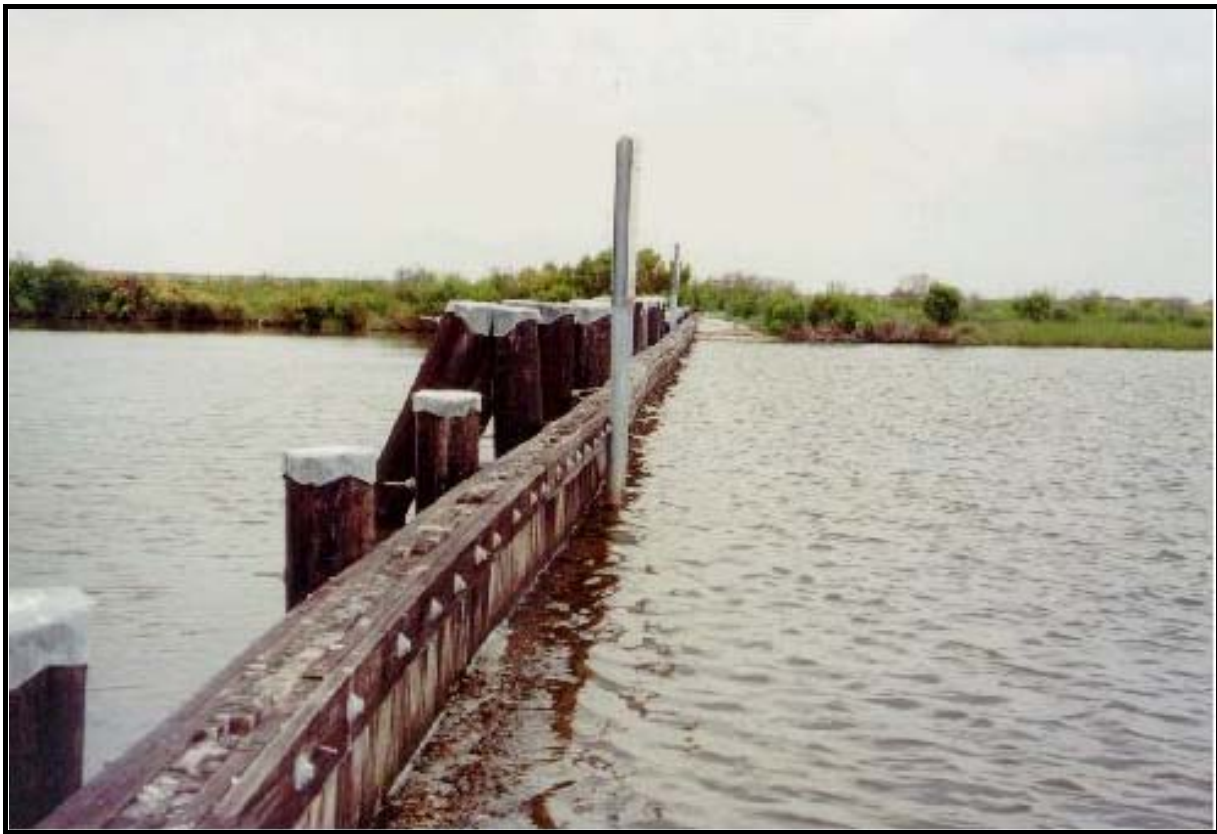
**Figure 4.** Creosote timber plug. One of seven plugs built by LDNR/CRD within the Phase I project area.

Phase I - Two canals were designated to be plugged: 1) the Hester Canal which extends east to west, and 2) the Transco Canal which was dredged in a north-south alignment to facilitate the transmission of oil and gas resources from the Gulf of Mexico to on-shore facilities (figure 2). A total of seven plugs were constructed across the two pipelines in late April 1997 - four in Hester Canal and three in the Transco Canal. Of the eight constructed, six were timber canal plugs (figure 4) and two were oyster shell plugs. Each timber canal plug was constructed using creosote treated pilings and lumber that extended across the canal, and the ends were reinforced with oyster shell. These plugs are designated as #1, 2, 3, 6, 7, and 8 (figure 2). Plugs #3A and 4 were constructed using oyster shell underlain with geotextile fabric (figure 5).

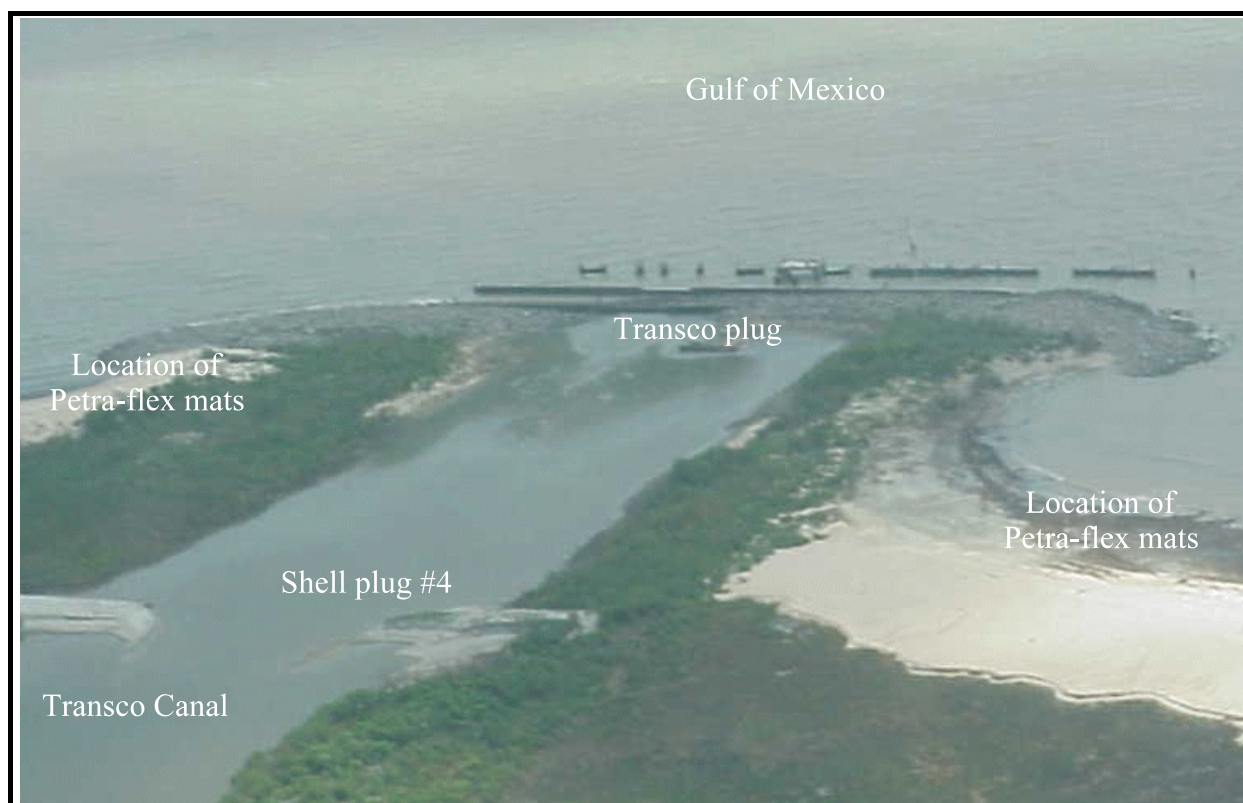
**Figure 5.** Shell plug #4 after breaching (lower left) with the Transco plug and the Gulf of Mexico in the background. Photo was taken prior to Phase III construction.

Additionally, due to suspected shoreline erosion on either side of the Transco plug (figure 5), a total of 125 Petraflex<sup>®</sup> articulated concrete mats were added to the southern portion of Phase I during the Phase III construction period. Mats measured 8 ft (2.44 m) wide by 20 ft (6.1 m) long, and were laid perpendicular to the shoreline. Sixty-seven mats were placed west of the plug (536 feet; 163.4 meters) and fifty-eight to the east (464 feet; 141.4 meters).

Additionally, as mentioned above, the height of the rock in the “breach area” (Phase II) was increased, Petraflex® articulated concrete mats were added near plug #4 (Phase I), and plug #4 was re-built using oyster shell.

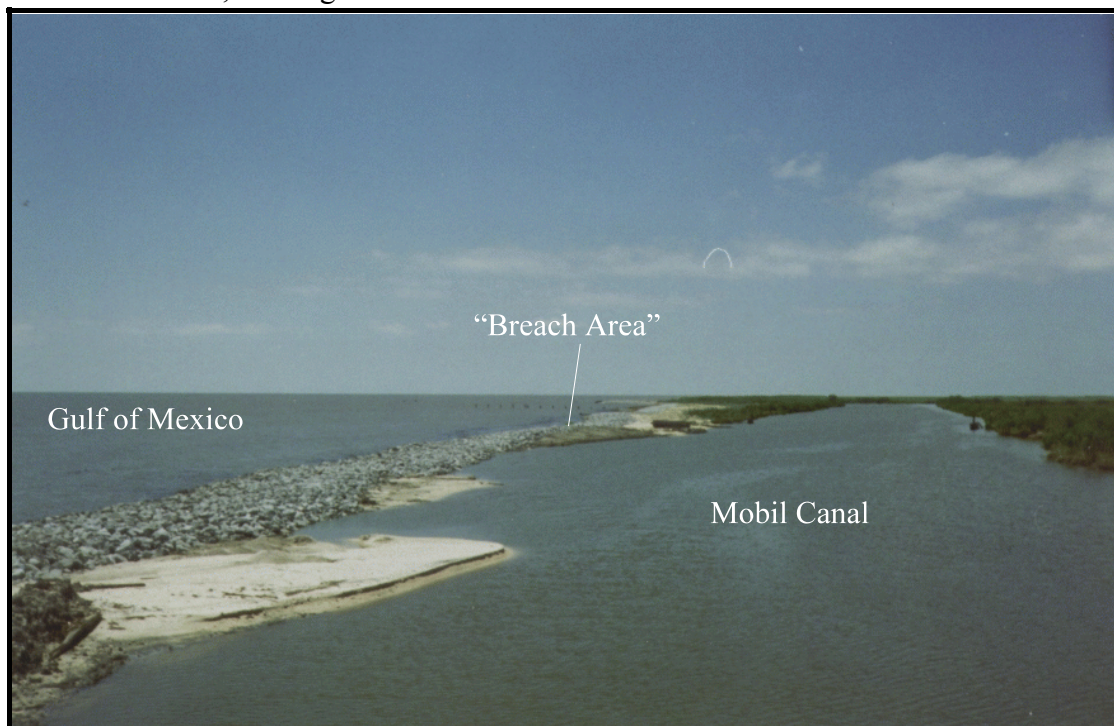
**Figure 7.** The "breach area" following the placement of rock armor (Phase II construction), looking west.

An additional 388 linear ft (118.26 m) of 250 lb. (113.4 kg) class stone was added to Phase II during the Phase III construction period, specifically from May 11 - 12, 2000. The stone was added to the “breach area” to increase the rock armor elevation another 1 ft to 2 ft (0.31 to 0.61 m).
