# E C O L O G I C A L   R E V I E W

## **Rockefeller Refuge Gulf Shoreline Stabilization**

CWPPRA Priority Project List 10

(State No. ME-18)

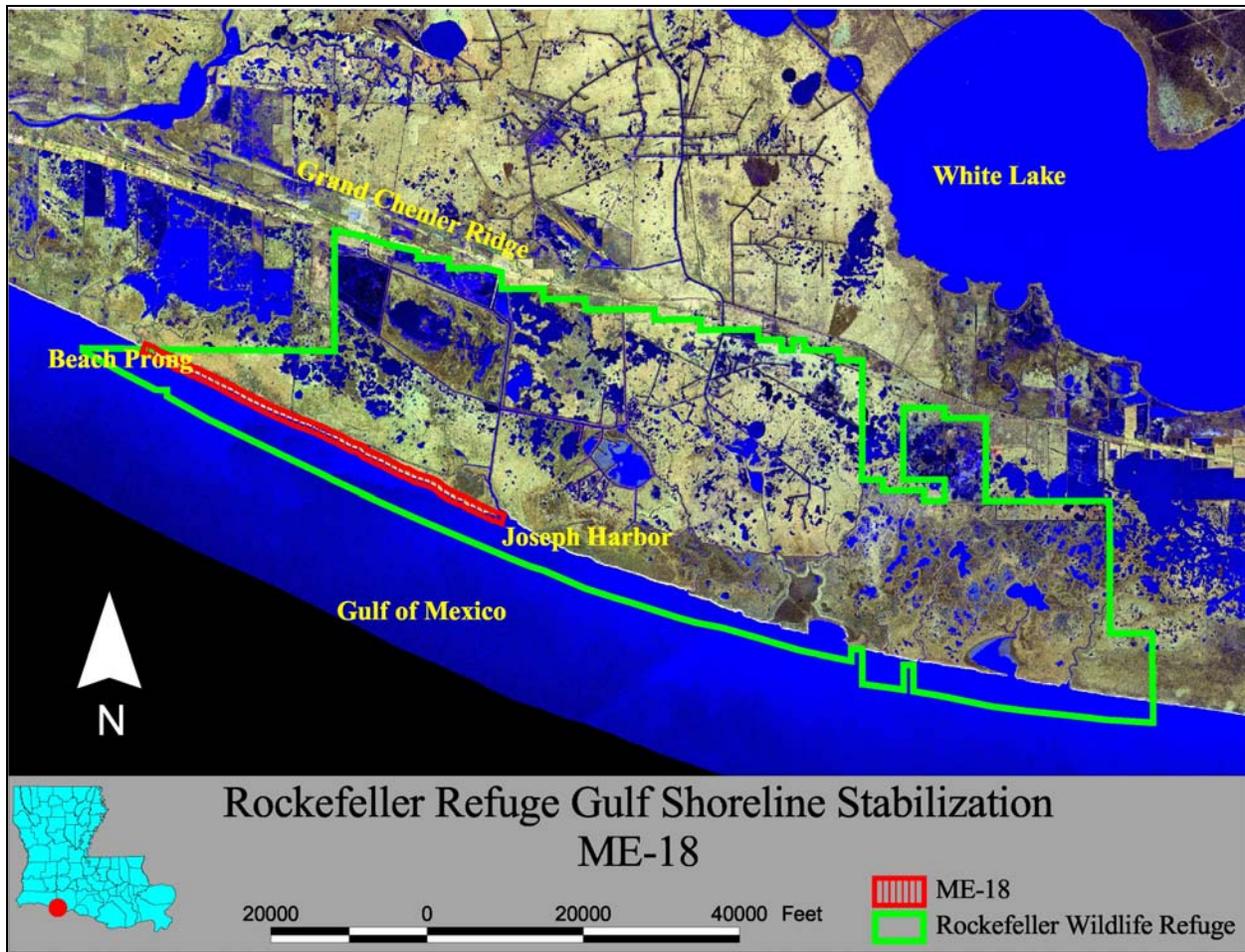
Figure 1. Rockefeller Refuge Gulf Shoreline Stabilization project area.

The proposed Rockefeller Refuge Gulf Shoreline Stabilization (ME-18) project is intended to protect a stretch of shoreline along the Rockefeller Wildlife Refuge extending for 9.2 miles from Joseph Harbor to Beach Prong (Figure 1). The Rockefeller Wildlife Refuge, owned by the State of Louisiana and managed by the Louisiana Department of Wildlife and Fisheries, is located in eastern Cameron Parish and western Vermilion Parish and encompasses approximately 76,042 acres. The refuge is bordered on the south by the Gulf of Mexico for 26.5 miles and extends inland toward the Grand Chenier Ridge, a stranded beach ridge, six miles from the Gulf. The Rockefeller Refuge Gulf Shoreline Stabilization project is co-sponsored by the National Marine Fisheries Service (NMFS) and the Louisiana Department of Natural Resources (LDNR). The project would reduce or halt Gulf shoreline retreat and direct marsh loss from Joseph Harbor to Beach Prong, protect saline marsh habitat, and enhance fish and wildlife habitat. Stabilizing the Gulf of Mexico shoreline in the vicinity of Rockefeller Wildlife Refuge was identified by *Coast 2050* as a Region 4 ecosystem strategy which would address the direct loss of coastal wetlands (Louisiana Coastal Wetlands Conservation and Restoration Task Force and the Wetlands Conservation and Restoration Authority 2001).

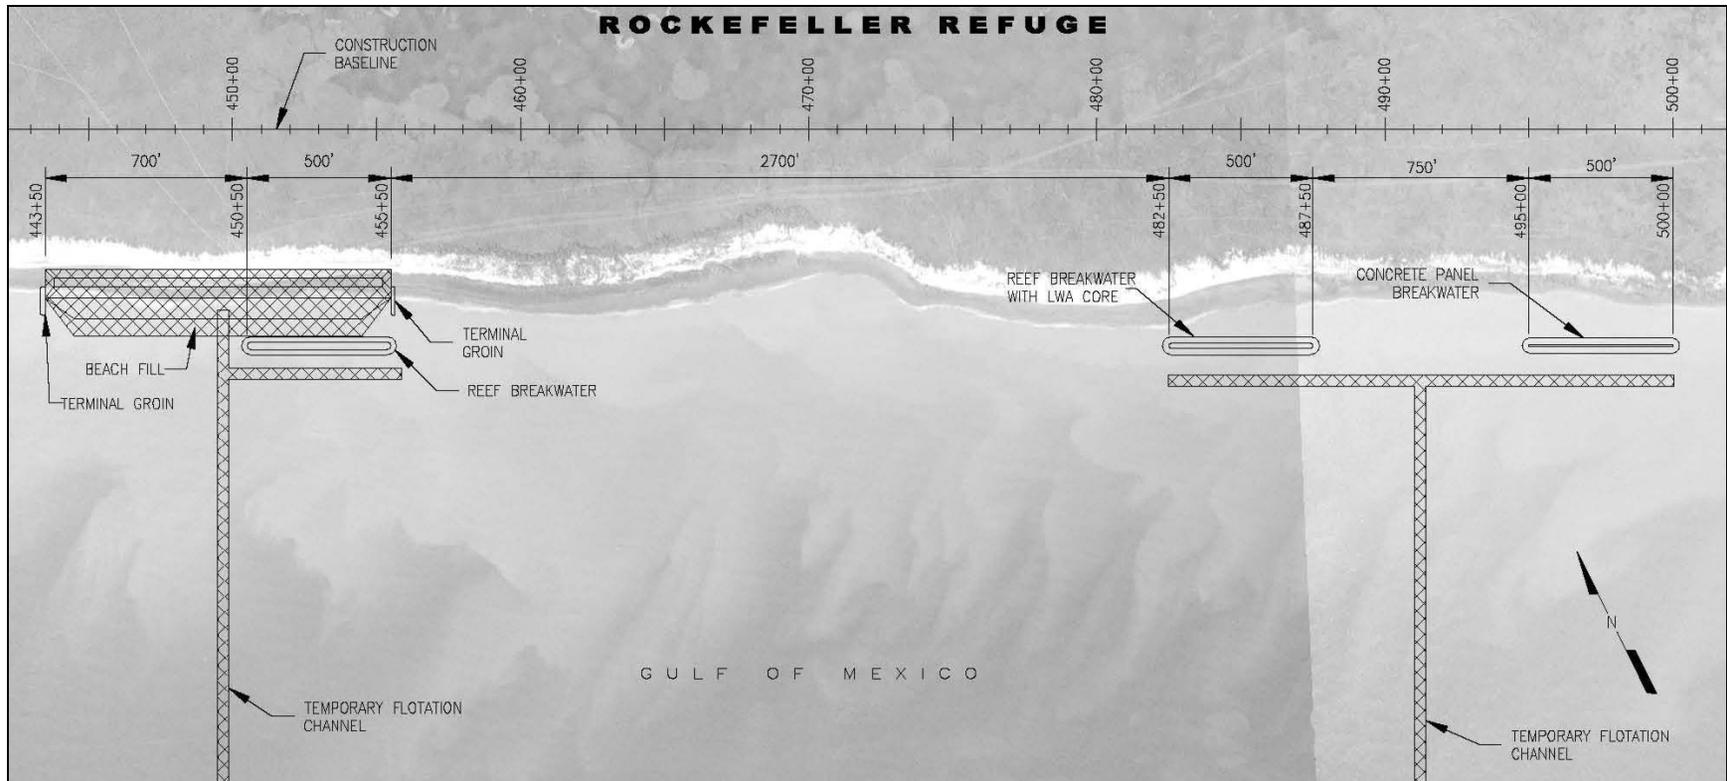
Figure 2. Design layout for test sections (Shiner Moseley and Associates, Inc. 2005).

The location of the test program was selected to be at the eastern end of the 9.2 mile project area, a minimum of 2,000 feet from Joseph Harbor. This location was selected to offer Joseph Harbor as a possible offloading point and shelter from waves for construction contractors. A minimum offset of 2,000 feet was selected to minimize the potential influence of the inlet on the test installations. Each of the four chosen shoreline protection treatments will be placed along the shoreline (Figure 2). A 2,000-foot control area will be located 1,350 feet west of the test area. Comparisons of each alternative in terms of constructability, ability to withstand the soft soils, wave attenuation, shoreline response, maintenance requirements, cost, and aesthetics will be made.

Shiner Moseley and Associates, Inc. (2005) calculated the length needed for the breakwater treatments by evaluating the influence of wave diffraction at the breakwater tips. The results suggested that the diffracted waves could influence shoreline response within approximately 150 feet of each end of the breakwaters. Therefore, each breakwater test section was designed with a length of 500 feet, providing approximately 200 feet of protected shoreline that is expected to be beyond significant influence of diffracted waves. Similarly, wave diffraction was also considered for spacing of the breakwater alternatives. Shiner Moseley and Associates, Inc. (2005) estimated that a breakwater spacing that exceeds five times the wavelength will allow the breakwaters to function independently of each other. Following this guidance, for a typical wavelength of 150 feet, the breakwater separation required for discrete evaluation of the alternatives was selected as 750 feet.

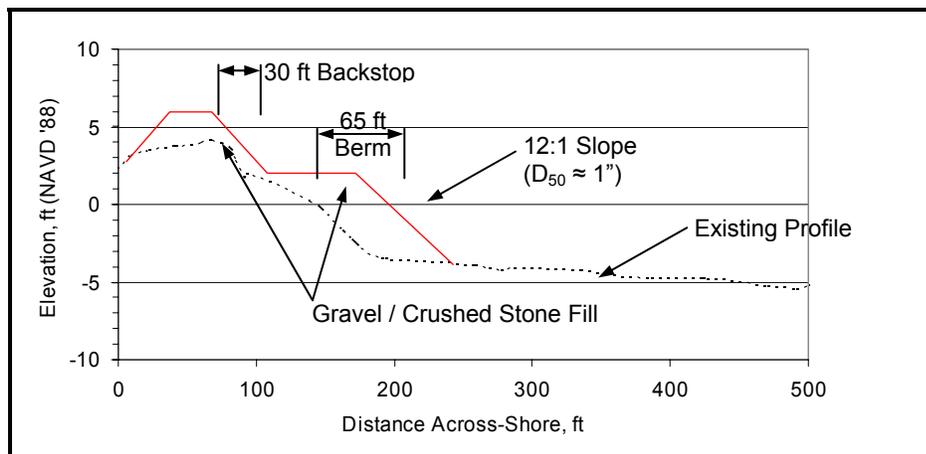
This test section will be 700 feet in length and will be contiguous to the next test section to the east. For this stand-alone beach fill Shiner Moseley and Associates, Inc. (2005) recommended gravel or crushed stone (G/CS) rather than sand because of the gravel or crushed stone's higher stability under wave action. For the given project budget, sand is not expected to provide adequate storm protection unless applied in combination with retention structures. This alternative will be constructed with material having a median particle size of approximately one inch. Terminal groins will be constructed at each end of the beach fill to reduce spreading alongshore and to reduce the influence of end effects (Shiner Moseley and Associates, Inc. 2005). This will mimic the effects of a longer reach of fill, and allow for a shorter test section.

Figure 3. Alternative 1: Beach fill with gravel/crushed stone (Shiner Moseley and Associates, Inc. 2005).

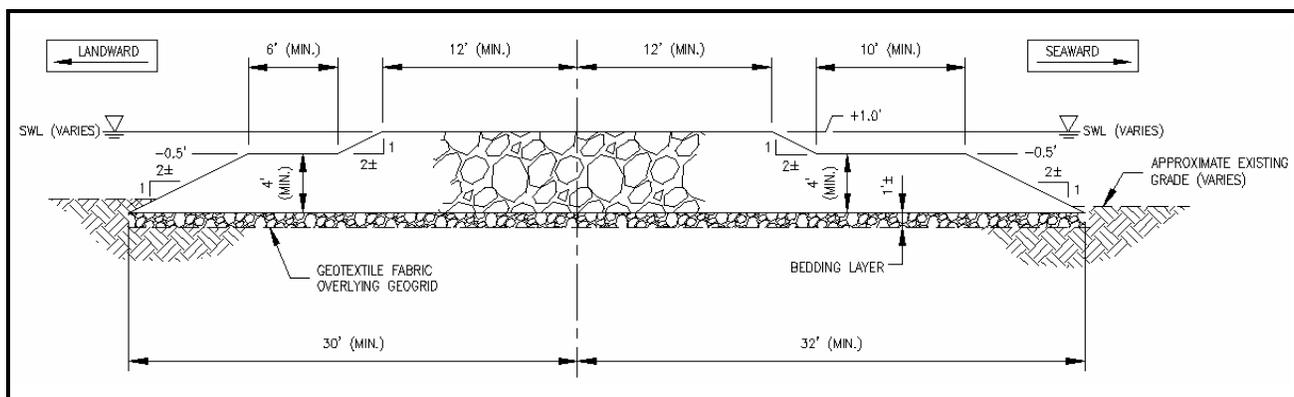
This test section will be 500 feet in length, contiguous to the test section to the west and 2,700 feet from the test section to the east. Shiner Moseley and Associates, Inc. (2005) recommended that to maximize protection during storms, the breakwaters should be aligned parallel to the shore. Furthermore, to prevent any potential wave regeneration between the breakwater and the shoreline, a fetch of 200 feet or less would effectively limit the erosive waves that could harm an un-vegetated shoreline. It is generally understood that a 4 to 5 foot water depth is the minimum required for barged-based operations. Therefore, a water depth of approximately 5 feet, corresponding to a bottom depth of -4.0 feet NAVD-88, was determined to be the appropriate distance offshore to set the breakwaters. The -4 foot contour is located approximately 150 feet from the shoreline (Shiner Moseley and Associates, Inc. 2005). For this alternative, gravel/crushed stone was recommended over sand due to its greater stability; in addition, the relatively flat profile that would have been required for sand could potentially bury the breakwater (Shiner Moseley and Associates, Inc. 2005). Terminal groins will be constructed at each end of the beach fill to reduce spreading alongshore and to reduce the influence of end effects (Shiner Moseley and Associates, Inc. 2005). This will mimic the effects of a longer reach of fill, and allow for a shorter test section.

Figure 4. Reef breakwater concept for Alternative 2 (Shiner Moseley and Associates, Inc. 2005).

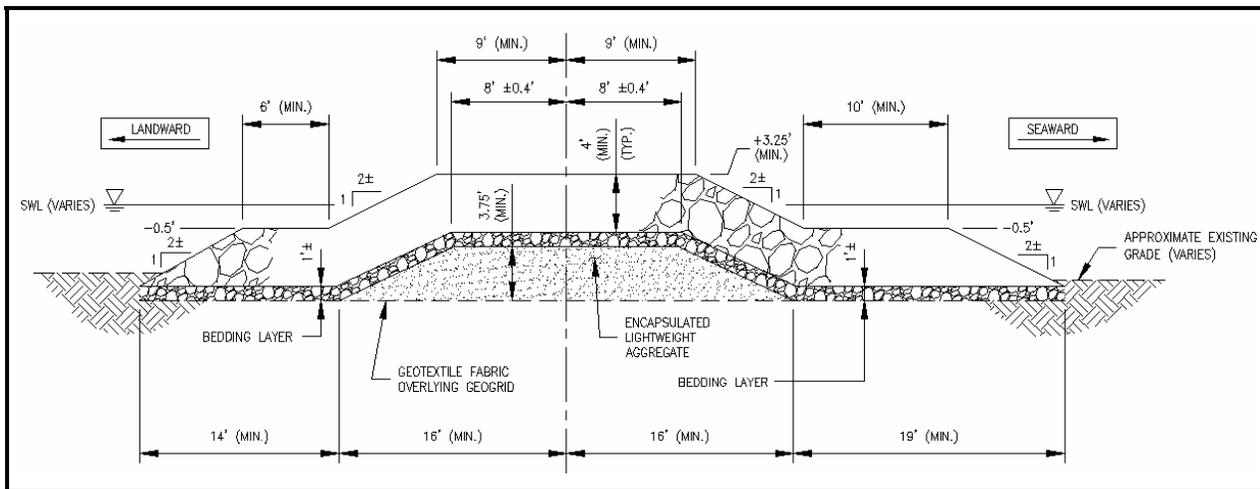
This test section will be 500 feet in length and will be 750 feet from the next test section to the east. The breakwater will be constructed parallel to the shore, at the -4.0 feet NAVD-88 contour (approximately 150 feet from shore). The current design calls for approximately 3.75 feet of lightweight aggregate covered by 4 feet of armor stone, resulting in an initial crest elevation of +3.25 feet NAVD-88. Fugro South has estimated that structure settlement will lower the crest elevation to approximately +1.9 feet NAVD-88 over a time period of several decades (Shiner Moseley and Associates, Inc. 2005). The structure would have a crest width of 18 feet. It should be noted that the less-permeable core and approximate 2.25 feet greater crest elevation of the reef breakwater with LWA core will result in less stability than the Alternative 2 reef breakwater (Shiner Moseley and Associates, Inc. 2005).

The typically constructed solid rock reef breakwater may be deemed to be too heavy for the very soft soils in this project area; therefore, the design was modified by using lightweight aggregate for the core of the breakwater. The submerged weight of the aggregate is approximately 9 pounds per cubic foot versus the 91 pounds per cubic foot for conventional stone thereby greatly reducing the bearing pressure (Shiner Moseley and Associates, Inc. 2004a).

**Figure 5. Alternative 3: Reef breakwater with lightweight aggregate core (Shiner Moseley and Associates, Inc. 2005).**

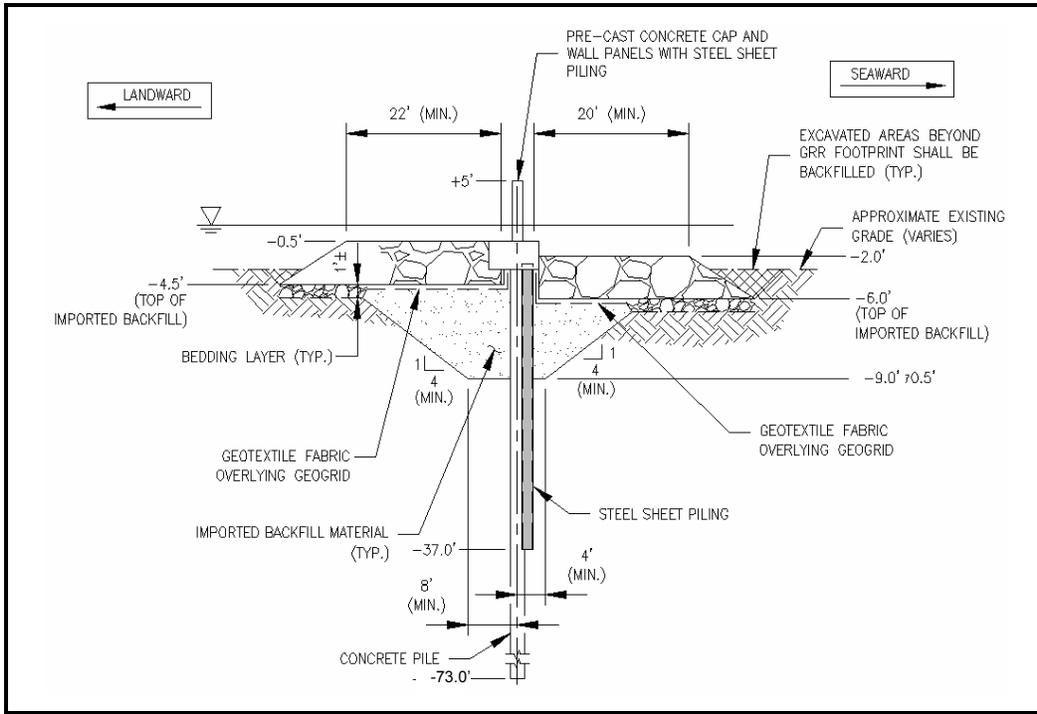
This test section will be 500 feet in length and will be 750 feet from the test section to the west. The concrete panel breakwater resulted from the Shiner Moseley and Associates, Inc. review of non-standard structures, and involves contiguous 40-foot long pre-cast concrete cap with wall panels and steel sheet piles. Each forty-foot cap consists of three 10-foot long panels and two 5-foot gaps. With this methodology, as compared to a solid wall, there is a resultant lower wave force on the wall and consequently a lower construction cost, as compared to a solid wall. With less wave force, the structure can be lighter and require less material. The 10-foot sections would reduce wave energy to an acceptable level (Shiner Moseley and Associates, Inc. 2005). The concrete panel breakwater will be constructed parallel to the shore, at the -4 feet NAVD-88 contour (approximately 150 feet from shore). The upper soft clays at the site will be removed to -9 feet NAVD-88 and replaced with sand to improve soil strength and allow the cantilevered wall to resist wave force. The

sand, which will be protected by armor rock, will provide lateral resistance that the soft clays cannot. These panels and cap will be pre-cast and set on two concrete piles that are driven into deeper firm clays to prevent settlement of the panels (Shiner Moseley and Associates, Inc. 2005).

Figure 6. Alternative 4: Concrete panel breakwater (Shiner Moseley and Associates, Inc. 2005).

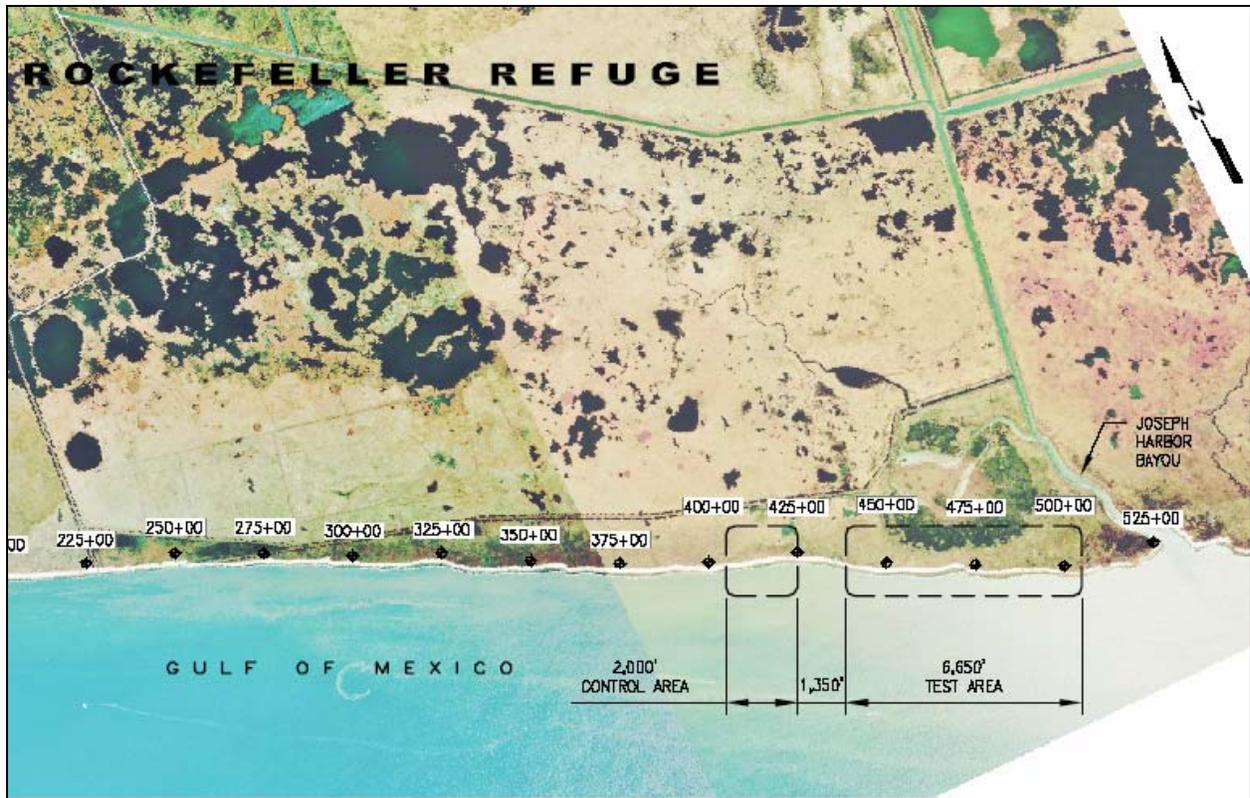
The objectives of the monitoring plan are (1) to collect data that will allow for design optimization of each section and (2) to determine performance characteristics of each alternative tested. The monitoring plan will consist of land-based and aerial photography, wave and tide gauging, bathymetric and topographical surveying, and measurement of structure settlement with settlement plates (Shiner Moseley and Associates, Inc. 2005). Monitoring will begin during construction of the test sections and last for one year. In accordance with scientific experimental protocol, a control section has been identified that is outside of the influence of the test sections (see Figure 7).

Figure 7. Location of test and control areas (Shiner Moseley and Associates, Inc. 2005).

- Surveying:** Locations for survey transects are shown in Figure 8. Transects shown are spaced 100 feet along the test section for Alternative 1 and 50 feet along test sections for Alternatives 2, 3, and 4 and should be surveyed pre-construction, post-construction, and quarterly for one year for a total of five surveys. Additional transects should be surveyed at 100 feet, 300 feet, and 500 feet beyond each test alternative to evaluate updrift and downdrift impacts. A 2,000 foot control area will be located 1,350 feet west of the test area, as shown in Figure 7. Transect spacing within the control area will be 200 feet.

- **Settlement Plates:** Settlement plates will be installed to measure the magnitude and rate of settlement of each structure. Up to 16 settlement plates will be installed during construction and surveyed by the contractor. Settlement of the plates will be measured during each monitoring survey. Locations of the settlement plates are shown in Figure 8.
