### **2025/2026 Annual Inspection Report**

### **BLACK BAYOU CULVERTS HYDROLOGIC RESTORATION PROJECT (CS-29)**

State Project Number CS-29  
Priority Project List 9

January 27<sup>th</sup>, 2026  
Calcasieu and Cameron Parishes

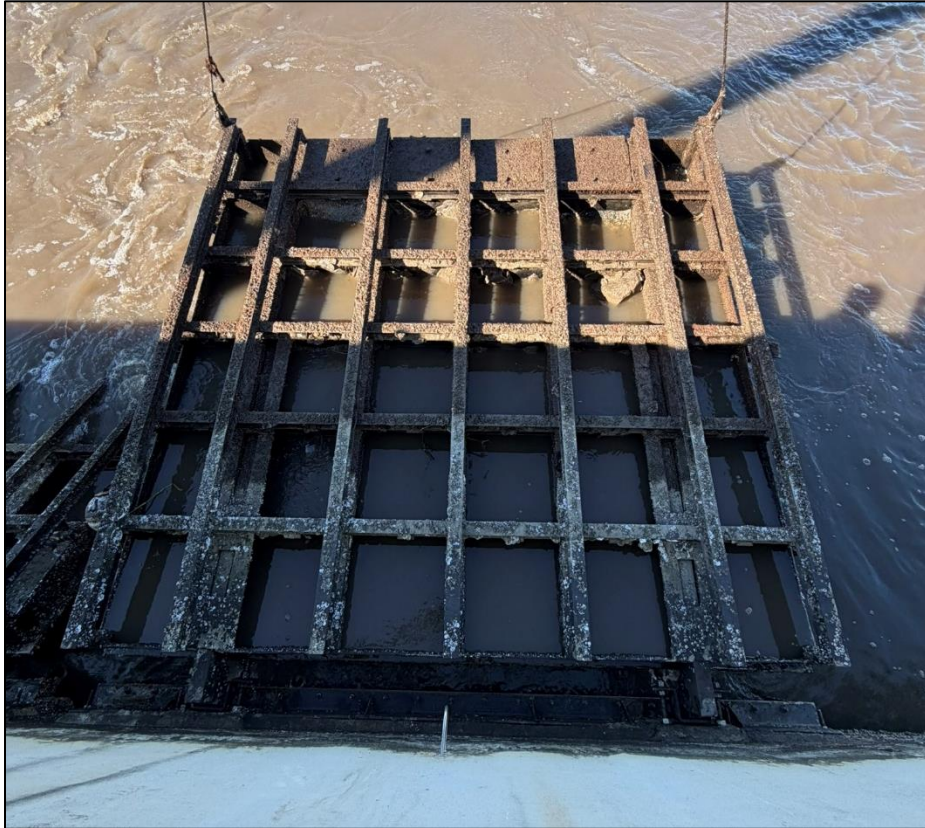
A	Water levels in the channel did not allow for visual inspection of the locking rings attached to the gate frames.			
B	With all but one locking ring on the gate intact, barring issues with the rings on the receiver gate frame, there should be no problems locking the gate in the closed position.			
C	A new padlock was installed through the shackle of the lifting cables once the gate was lowered.			
D	Observed an increase in the growth of marine vegetation on the gate surface from that observed during last year's inspection.			
E				
F

**1a. Gate No. 1 – Top View of Gate**

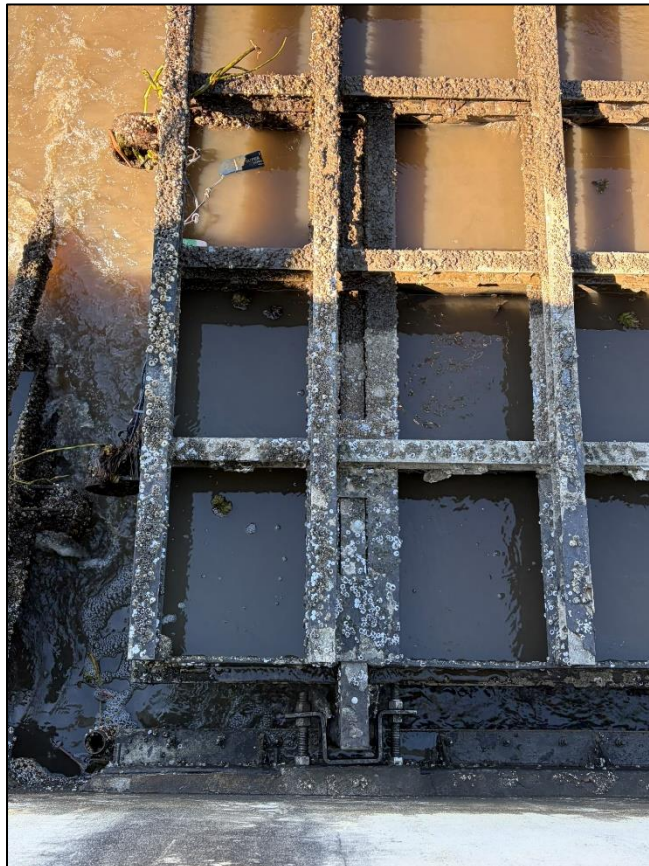
**5f. Gate No. 5 – Hinge Assembly and Stop Plate – South Side**

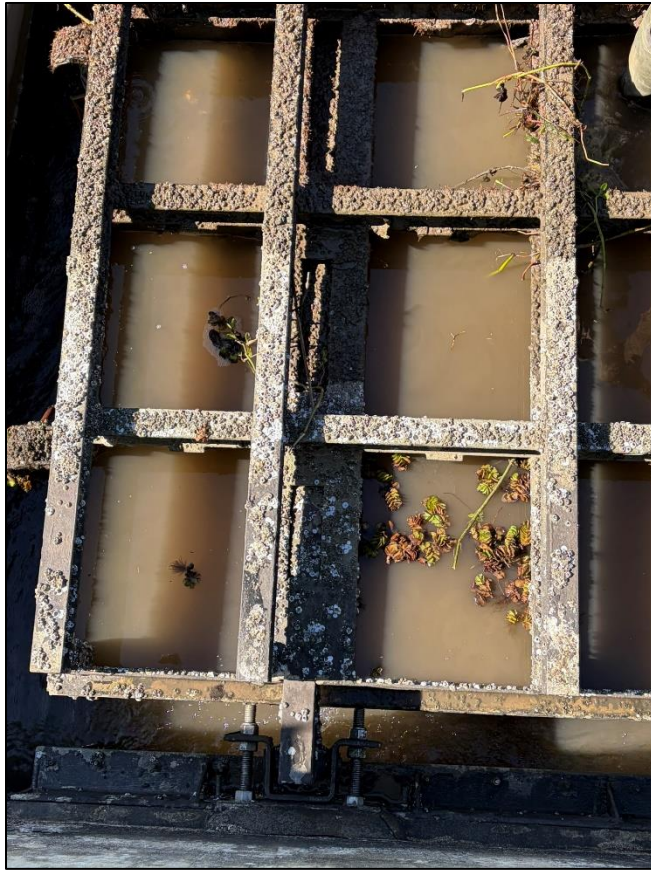
**10g. Gate No. 10 – Hinge Assembly and Stop Plate – South Side**
