2011 Operations, Maintenance, and Monitoring Report

Point Au Fer Island Hydrologic Restoration (TE-22)

State Project Number TE-22
Priority Project List 2

July 2011
Terrebonne Parish

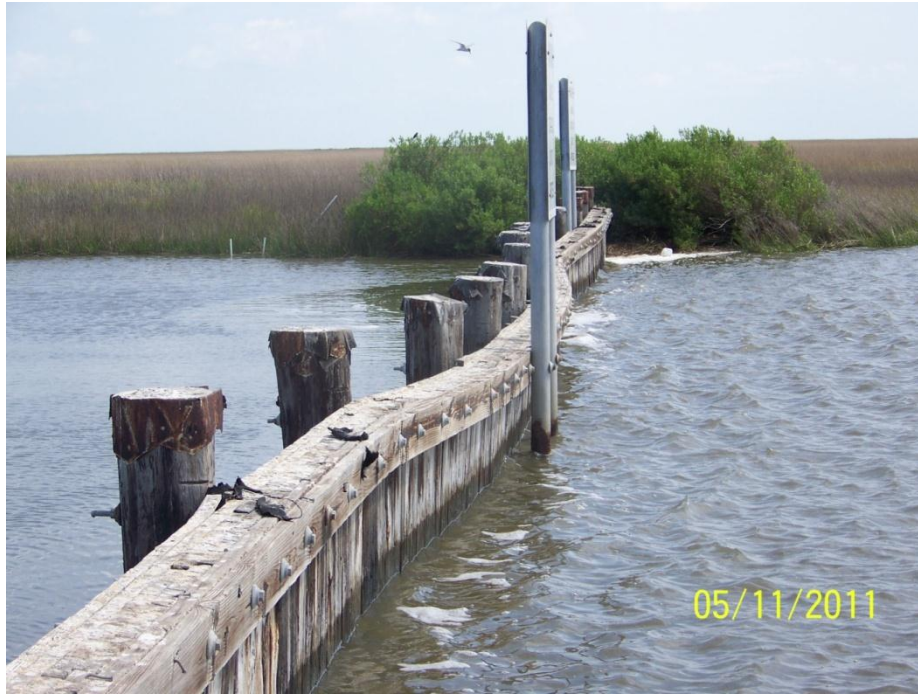
The timber bulkhead and vinyl sheet pile extension are in good condition. There is an existing breach around the southern end of the structure that occurs adjacent to the sheetpile. In addition the Submar scour mats placed on the southern end of the structure are no longer visible. It is assumed that these sections were undermined from the water rushing through the breach and may lie somewhere on the bottom of the breach. The embankment tie-in on the north side of the structure has no signs of erosion or breaching. The warning signs and supports were in good overall condition. There are no recommendations for corrective action at this time, but the structure and breach should be monitored during future inspections for further deterioration.

Photo #1: view of timber bulkhead Plug No. 8 from on top of the structure, looking northeast

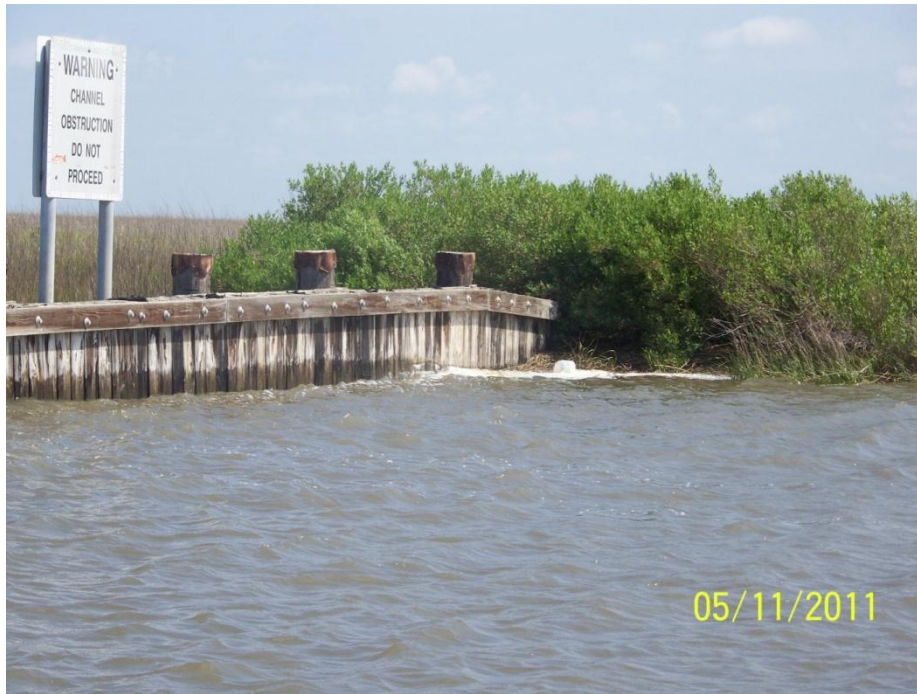
Photo #5: view of timber bulkhead Plug No. 8 northeast end embankment tie-in, looking north

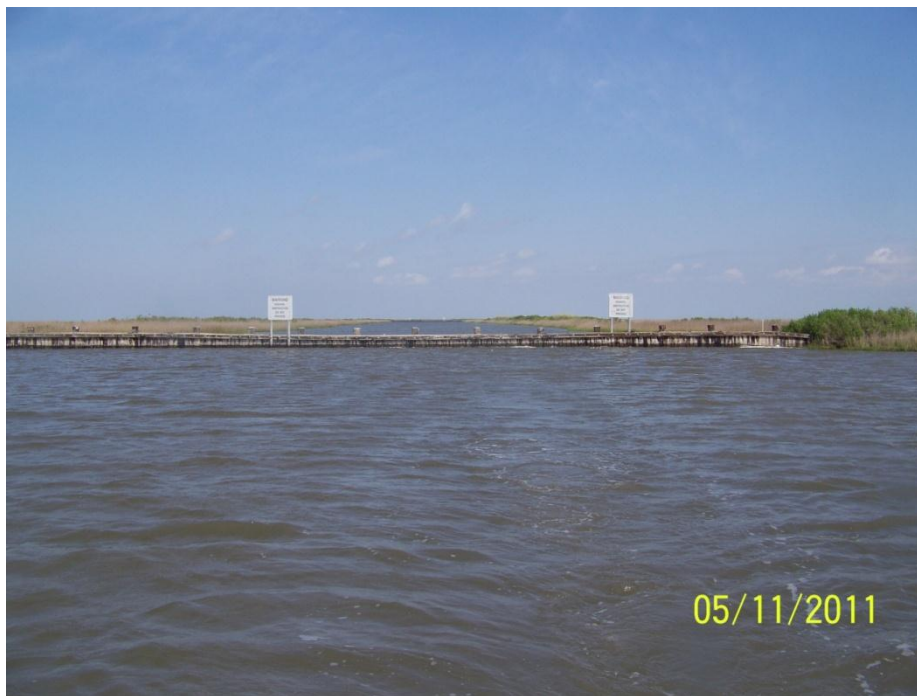
Photo #6: view of timber bulkhead Plug No. 8 from Hester Canal, looking northwest

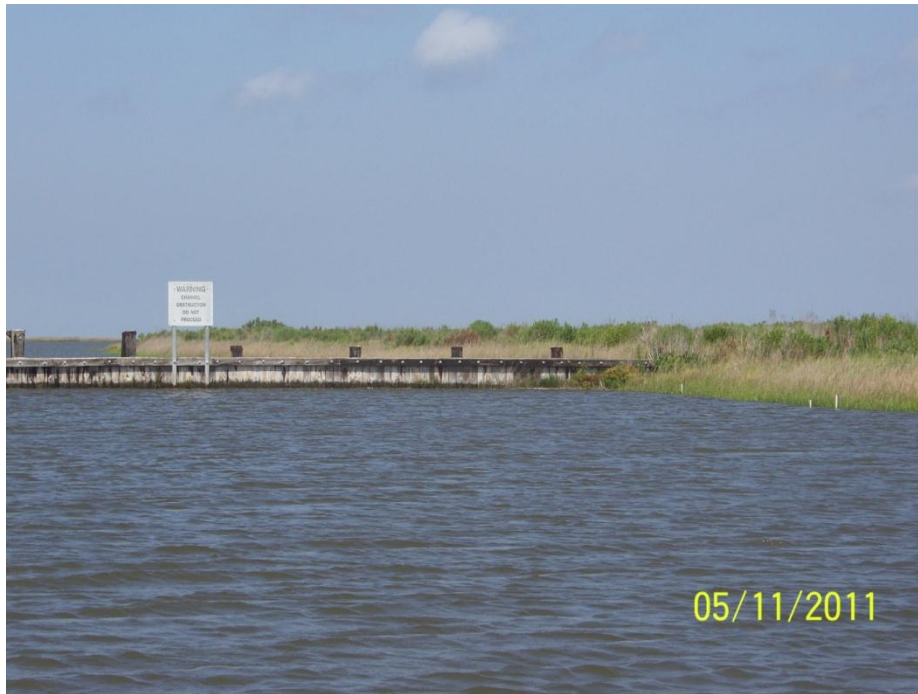
The timber bulkhead Plug No. 1 located on the west end of Hester Canal near Mosquito Bay appeared to be in good overall condition. All structural components are intact with no visible signs of damage. The embankment tie-ins have no signs of erosion or breaching. The warning signs and supports are also in good condition. There are no recommendations for corrective action at this time.

Photo #9: view of north side of timber bulkhead Plug No. 1, looking west

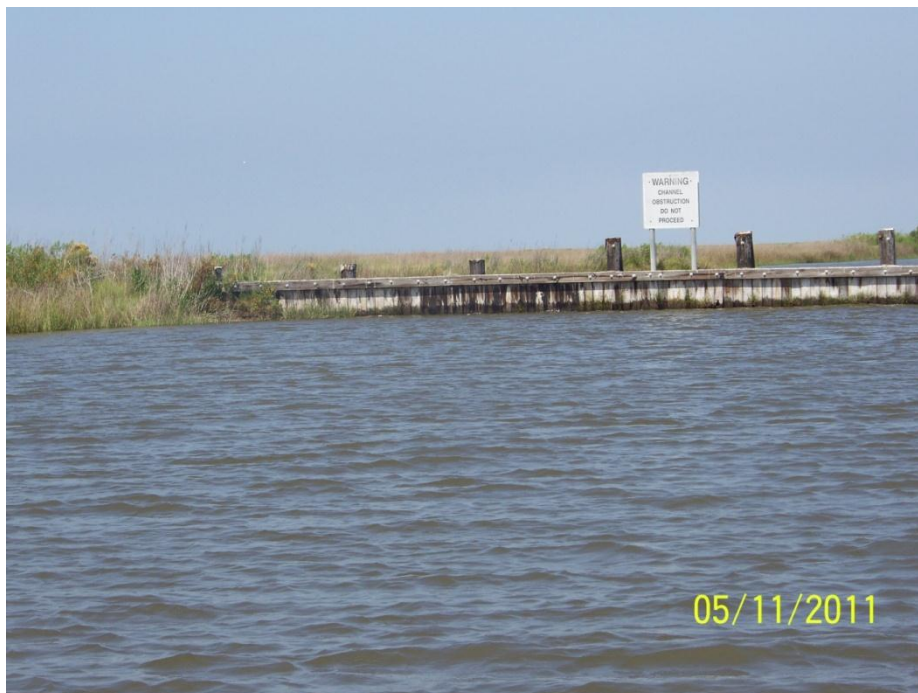
Photo #10: view of south side of timber bulkhead Plug No. 1, looking west

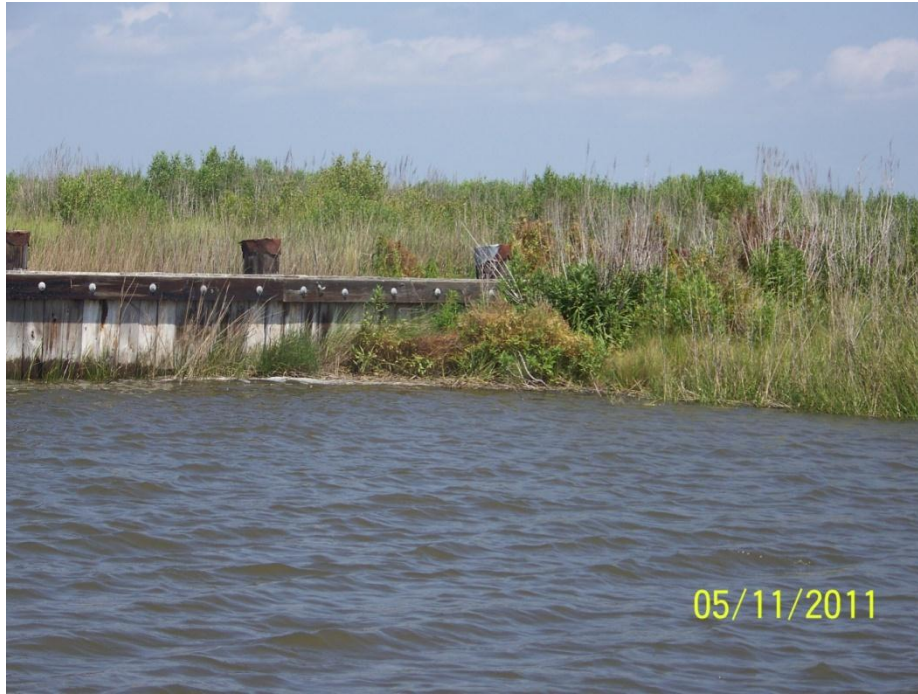
Photo #11: view of embankment tie-in on north side of timber bulkhead Plug No. 1, looking west

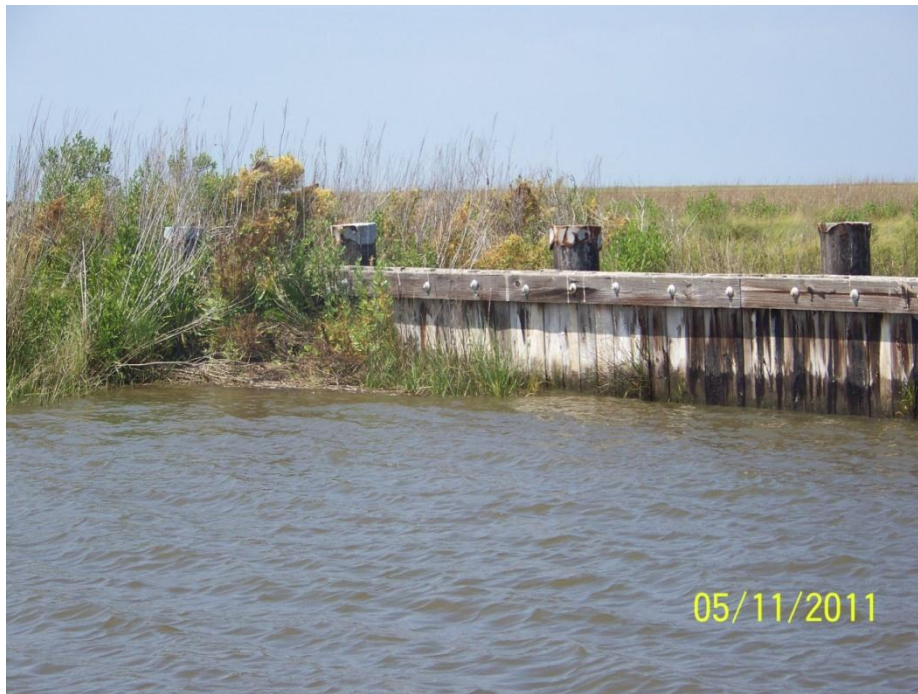
Photo #12: view of embankment tie-in on south side of timber bulkhead Plug No. 1, looking west

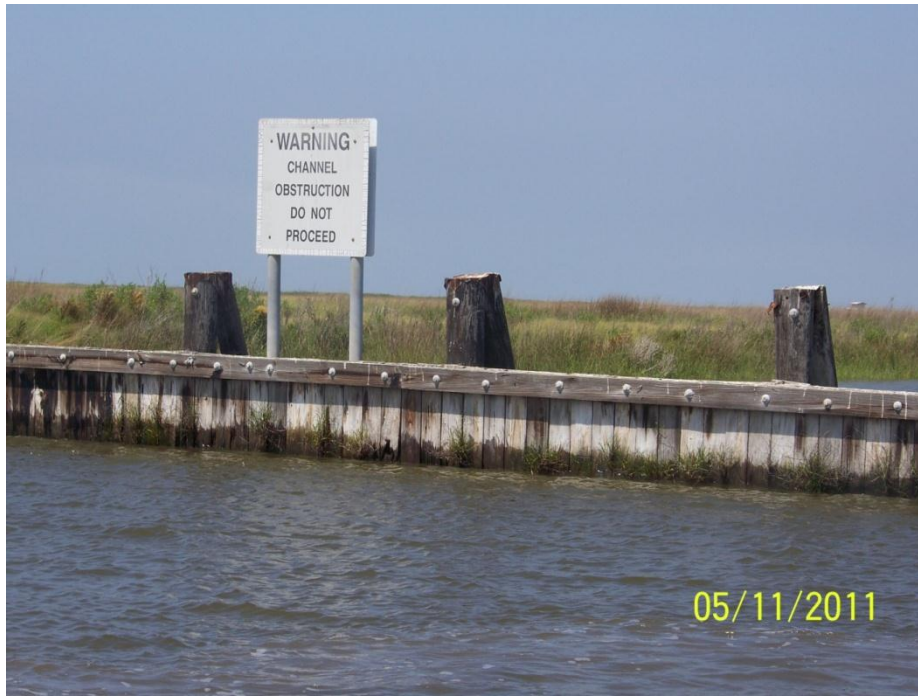
Photo #13: view of warning sign and support of timber bulkhead Plug No. 1, looking west

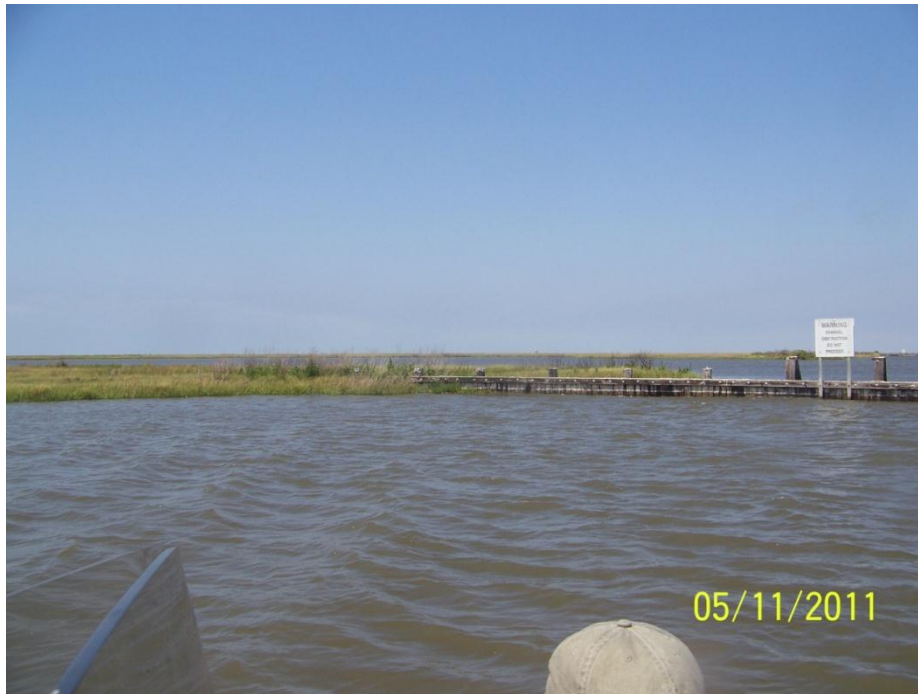
The timber bulkhead Plug No. 2 located just east of Plug No. 1 in Hester Canal appeared to be in good overall condition. All structural components are intact with no visible signs of damage. The embankment tie-ins have no signs of erosion or

breaching. The warning signs and supports are also in good condition. Although the timber bulkhead and its tie-ins have no defects, the structure is considered ineffective due to a large breach (approximately 50 feet) on the south side of the structure which allows tidal flow around Plug No. 2. There are no recommendations for corrective action at this time due to construction access constraints.

Photo #15: view of timber bulkhead Plug No. 2 from Hester Canal, looking west

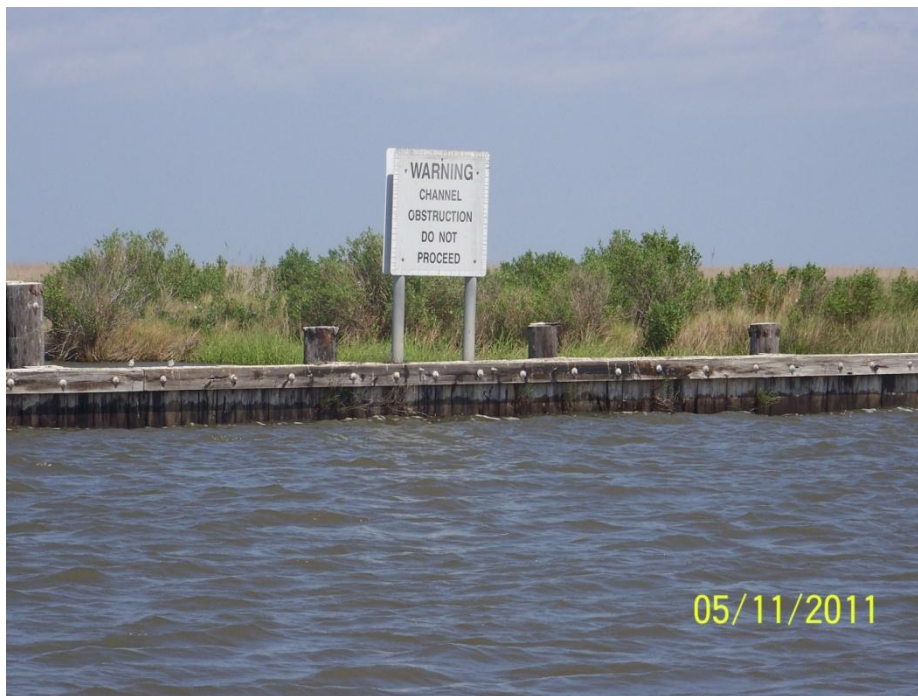
Photo #16: view of timber bulkhead Plug No. 2 from Hester Canal, looking west

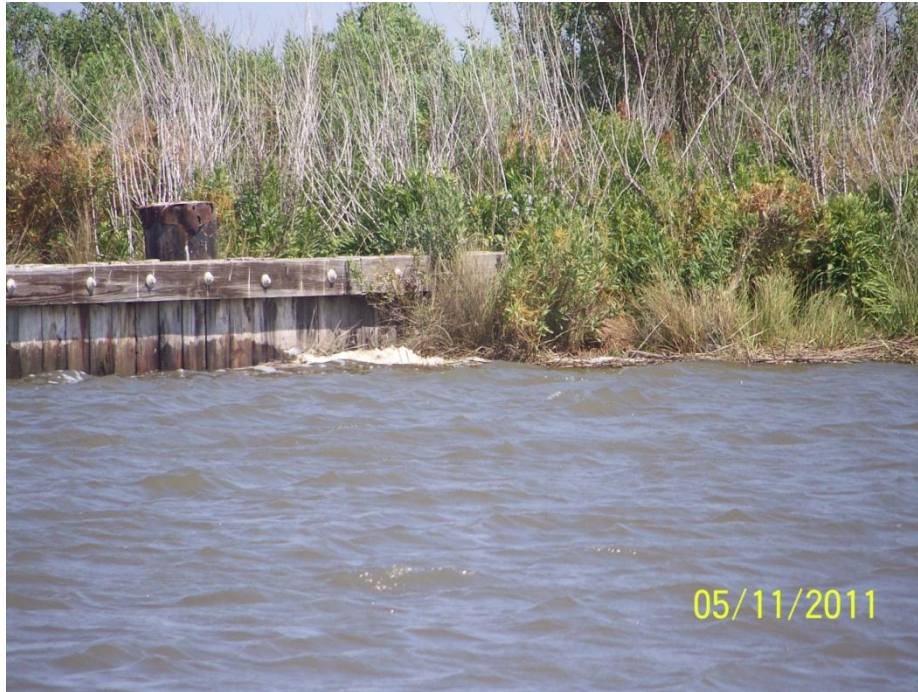
Photo #17: view of embankment tie-in on the north side of Plug No. 2, looking west

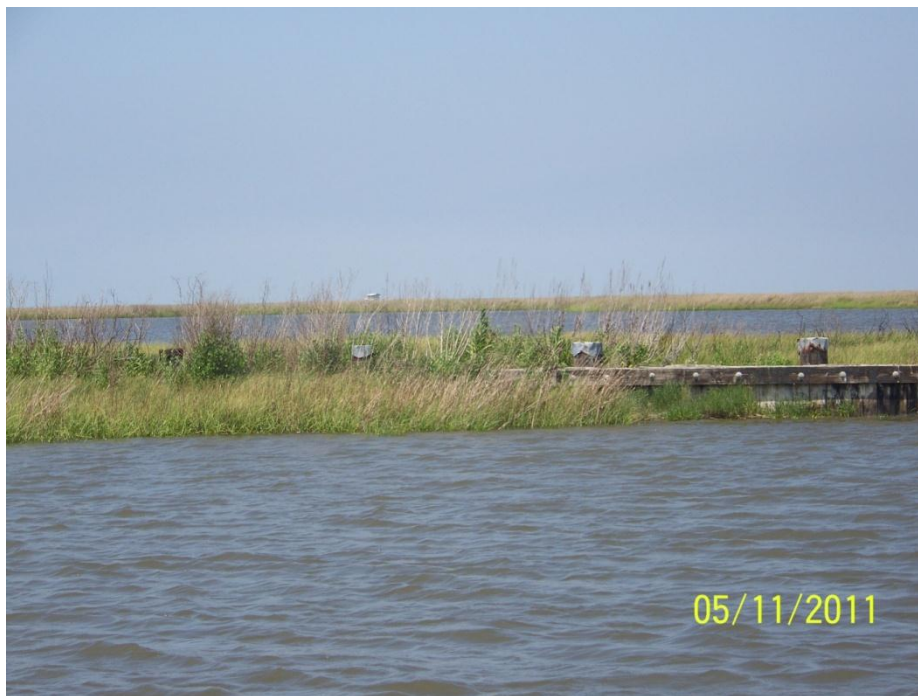
Photo #18: view of embankment tie-in on the south side of Plug No. 2, looking west

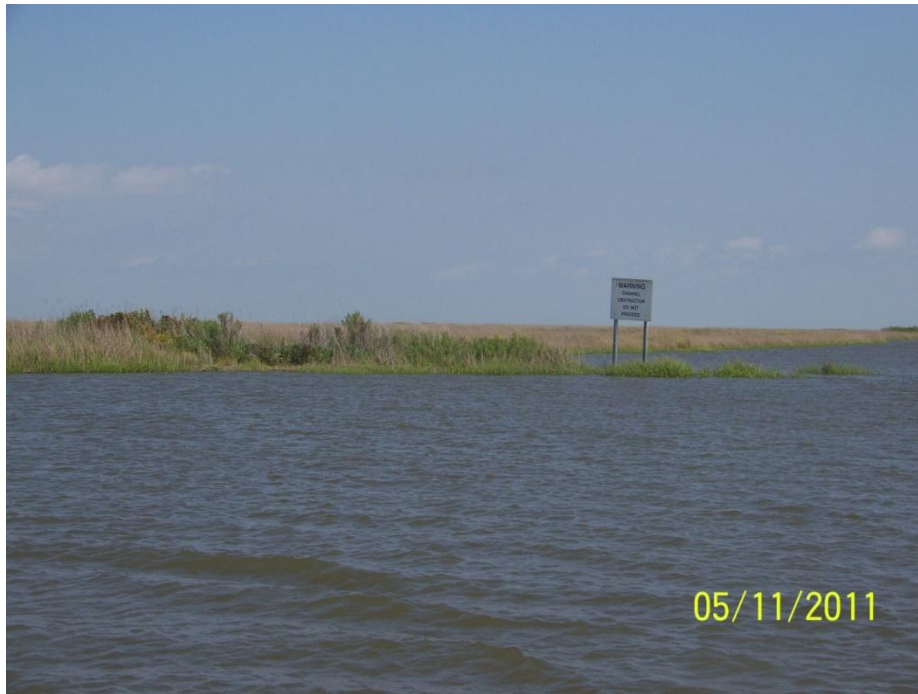
The shell Plug No. 3A located in Transco Canal just north of Hester Canal is in poor condition. As previously reported, the shell plug has eroded in the center of the structure leaving the plug crest below water elevation at the time of the inspection. According to the as-built and construction plans, the shell plug was constructed to elevation +4.0 NGVD. The embankment tie-ins are in good condition and have no signs of erosion or breaching. The west warning sign and supports are also in good condition, but the east sign and support is missing. At this time repairing the shell plug is not recommended due to construction access constraints; however, this plug should continue to be monitored on future site visits.

Photo #19: view of embankment tie-in on west side of Plug No. 3A, looking north

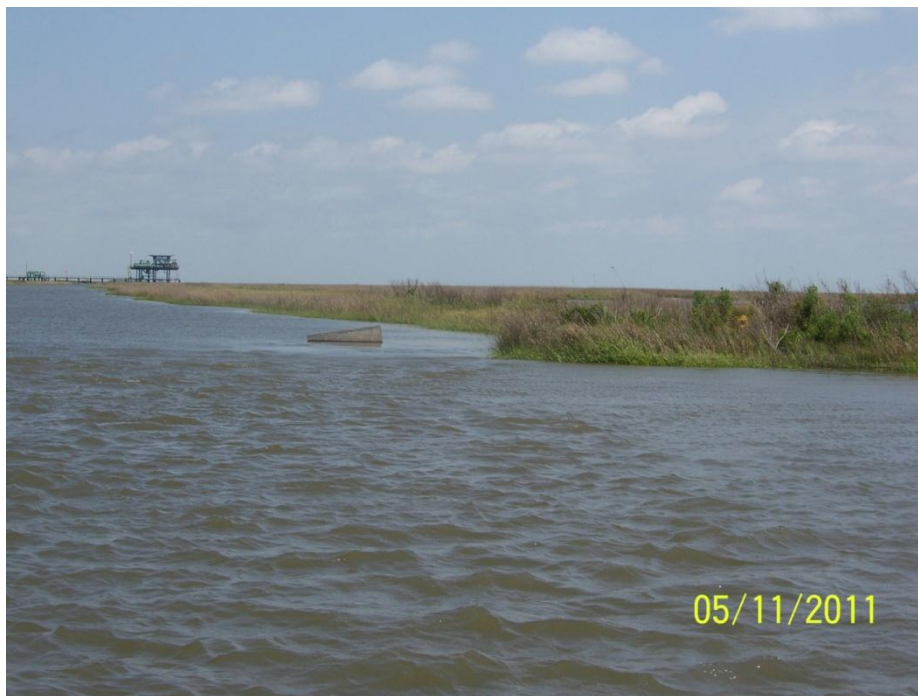
Photo #20: view of embankment tie-in on east side of Plug No. 3A, looking north

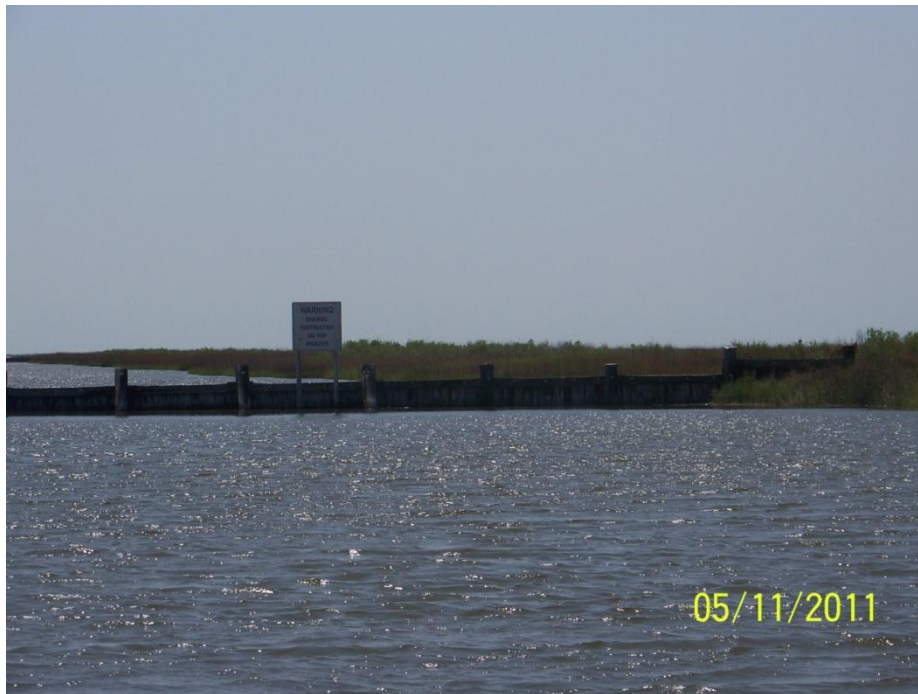
The timber bulkhead Plug No. 7 located on the east end of Hester Canal just west of Plug No. 8 appeared to be in good overall condition. All structural components are intact with no visible signs of damage. The embankment tie-ins have no signs of erosion or breaching. The warning signs and supports are also in good condition. There are no recommendations for corrective action at this time.

Photo #22: view of southwest end of Plug No. 7 from Hester Canal, looking southeast

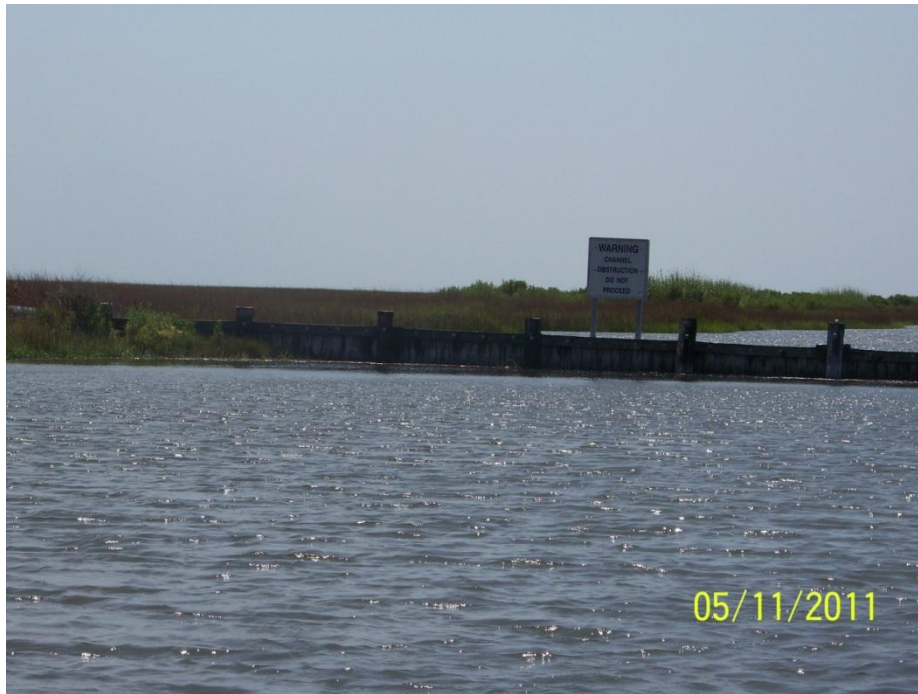
Photo #23: view of northeast end of Plug No. 7 from Hester Canal, looking southeast

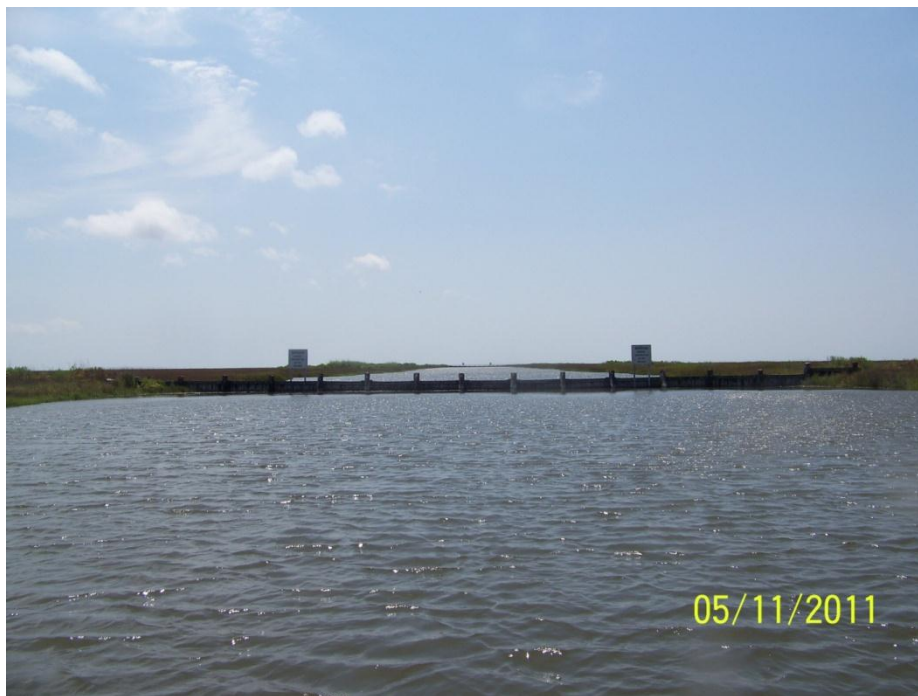
Photo #24: complete view of Plug No. 7 from Hester Canal, looking southeast

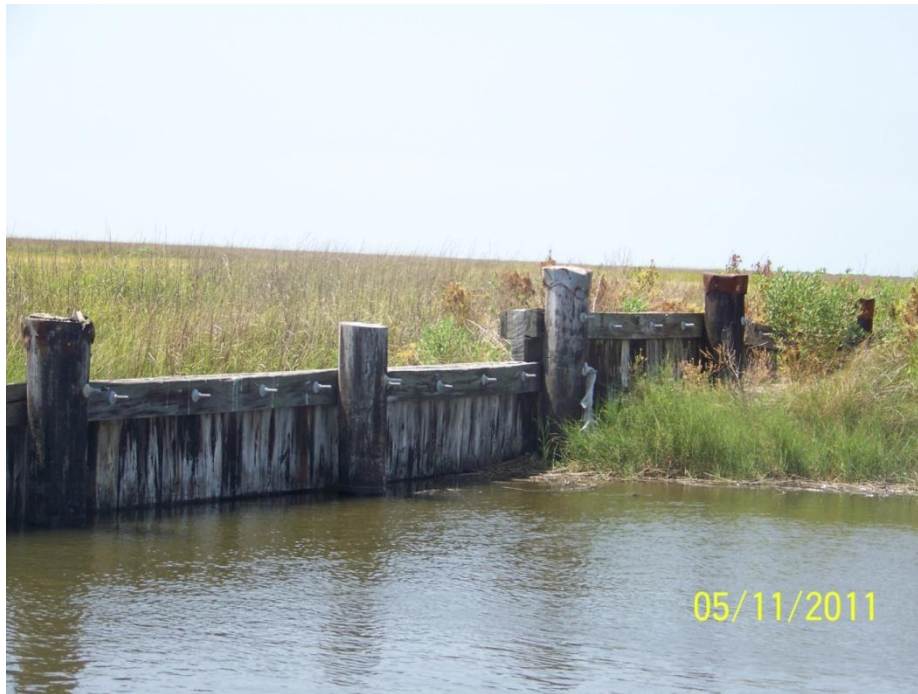
Photo #25: view of embankment tie-in on southwest end of Plug No. 7, looking south

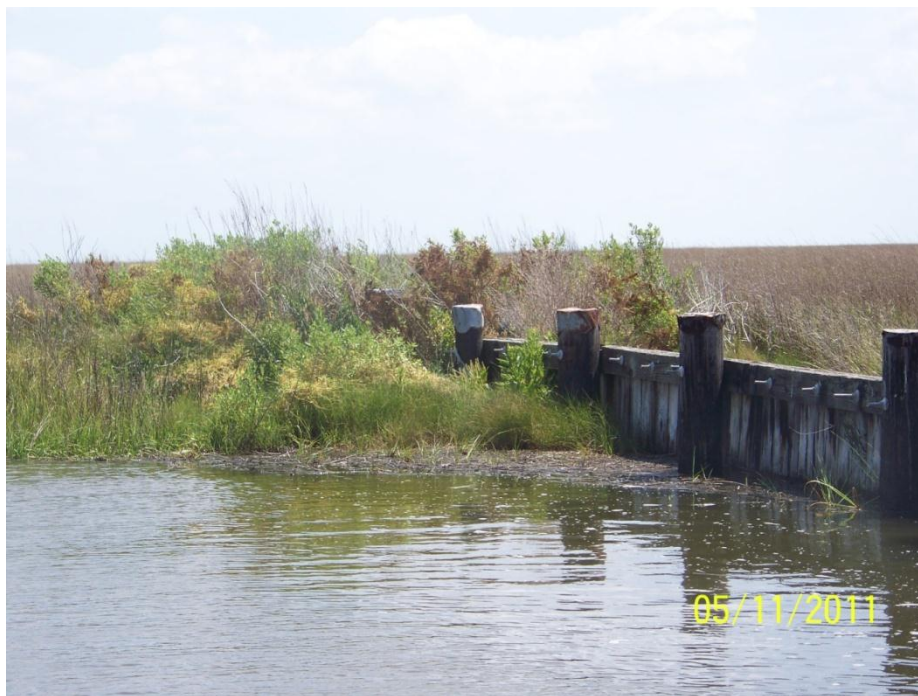
Photo #26: view of embankment tie-in on northeast end of Plug No. 7, looking east

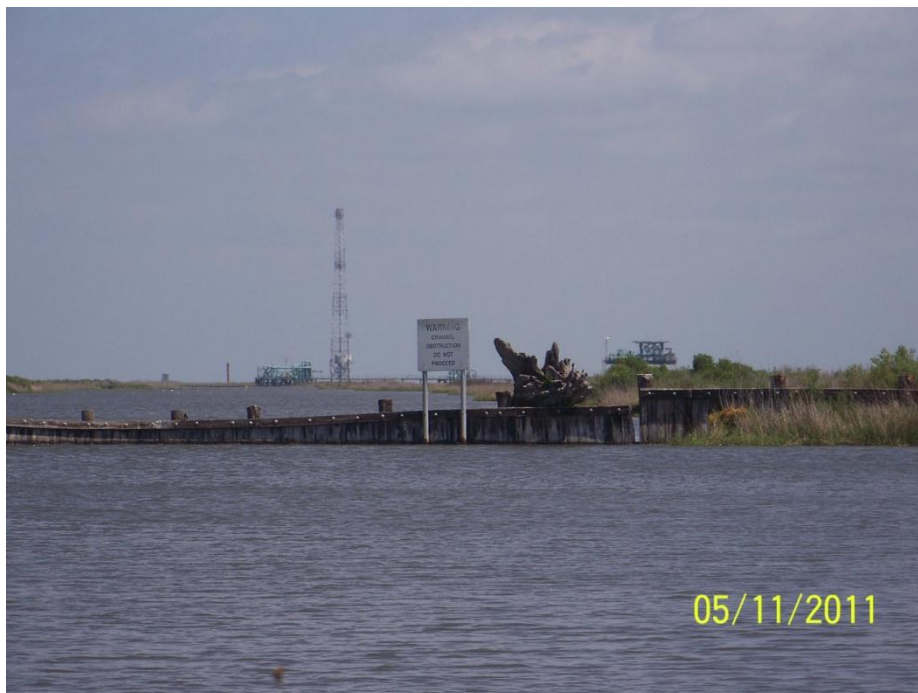
The timber bulkhead Plug No. 6 showed signs of deflection (wavy pattern across canal) shortly after construction. During this annual inspection, the deflection is more apparent than what was observed during the construction. The embankment tie-ins appear intact with no signs of erosion or breaching. There is a separation of the bulkhead (or missing board) near the embankment tie-in on the east side of the structure. This separation has been observed to allow small amounts of water to pass through the bulkhead. The warning signs and supports appear to be in overall good condition. There are no recommendations for corrective actions at this time, but the condition of the structure should continue to be monitored on future site visits.

Photo #28: view of Plug No. 6 from Transco Canal, looking north

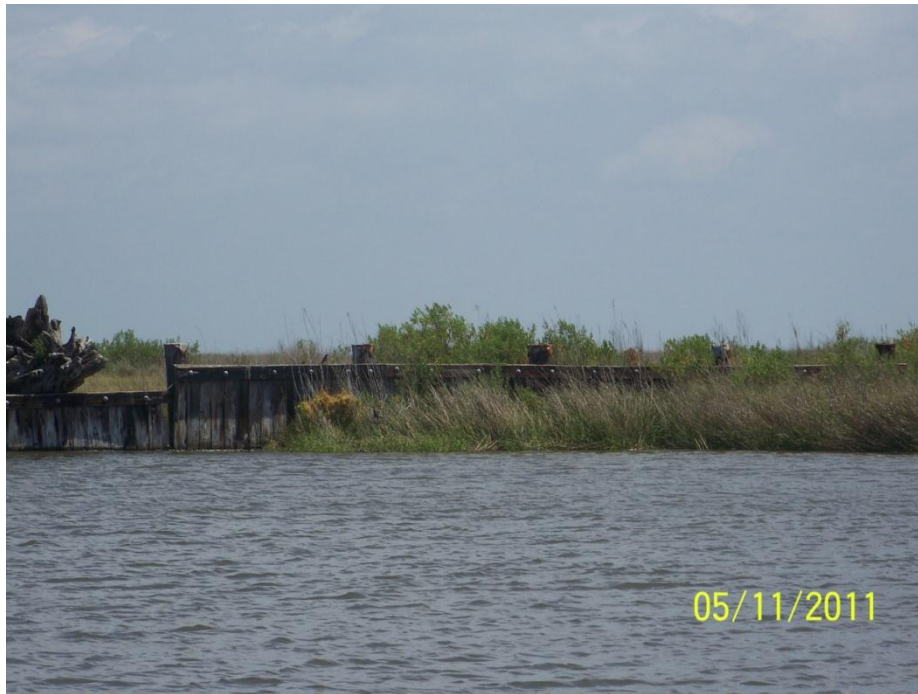
Photo #29: view of embankment tie-in on east end of Plug No. 6, looking north

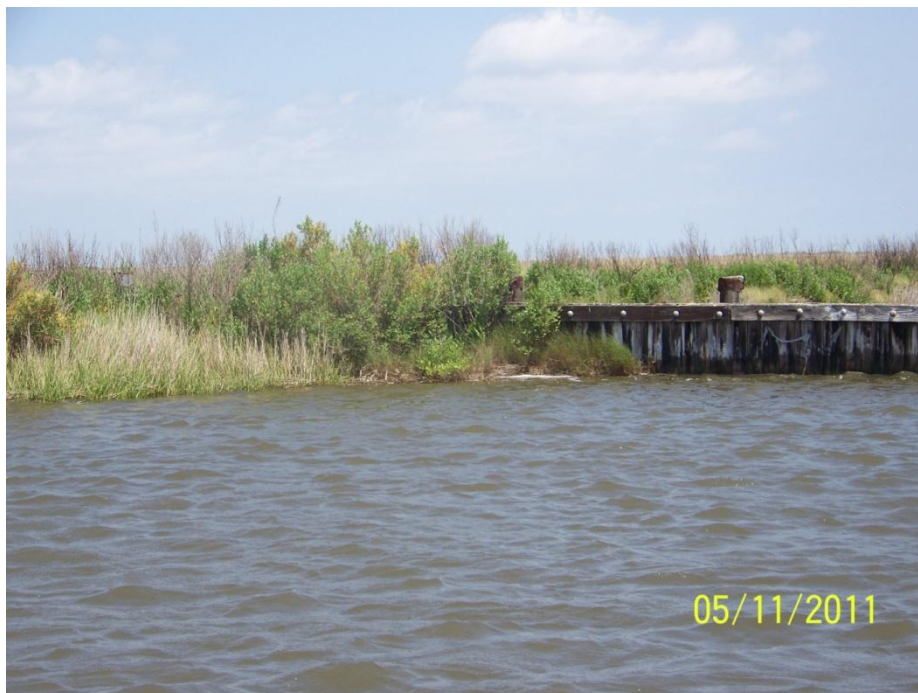
Photo #30: view of embankment tie-in on west end of Plug No. 6, looking north

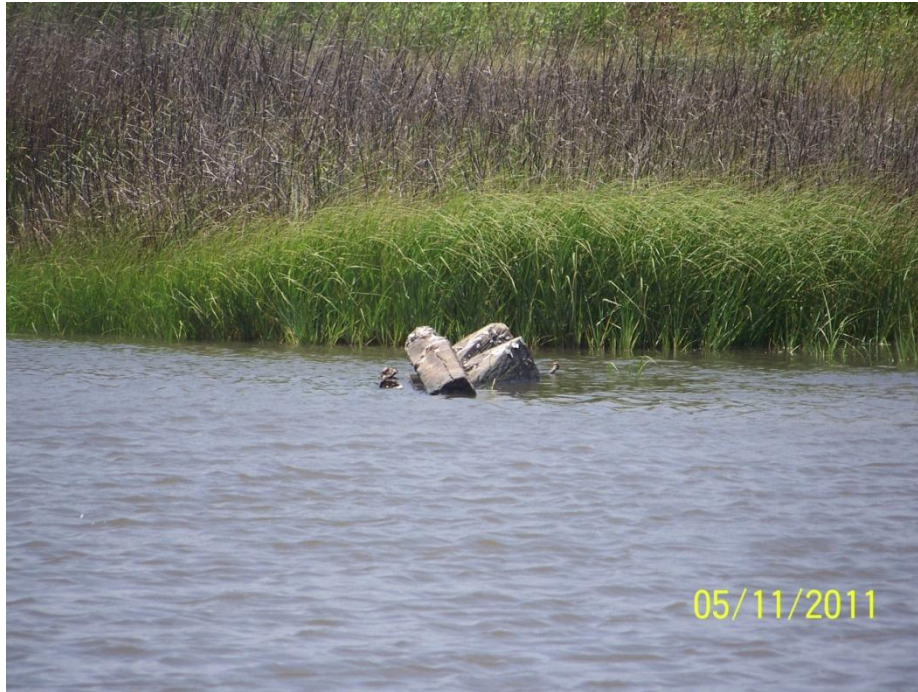
The shell Plug No. 4 is also in poor condition. As previously reported, the structure has been eroded below the waterline for several years. No corrective action is recommended at this time, instead maintenance efforts have been focused on Plug 4A (Transco Canal bulkhead) located at the Gulf of Mexico approximately 200 feet south of Plug No. 4.

Photo #33: view of shell Plug No. 4 from Transco Canal, looking south

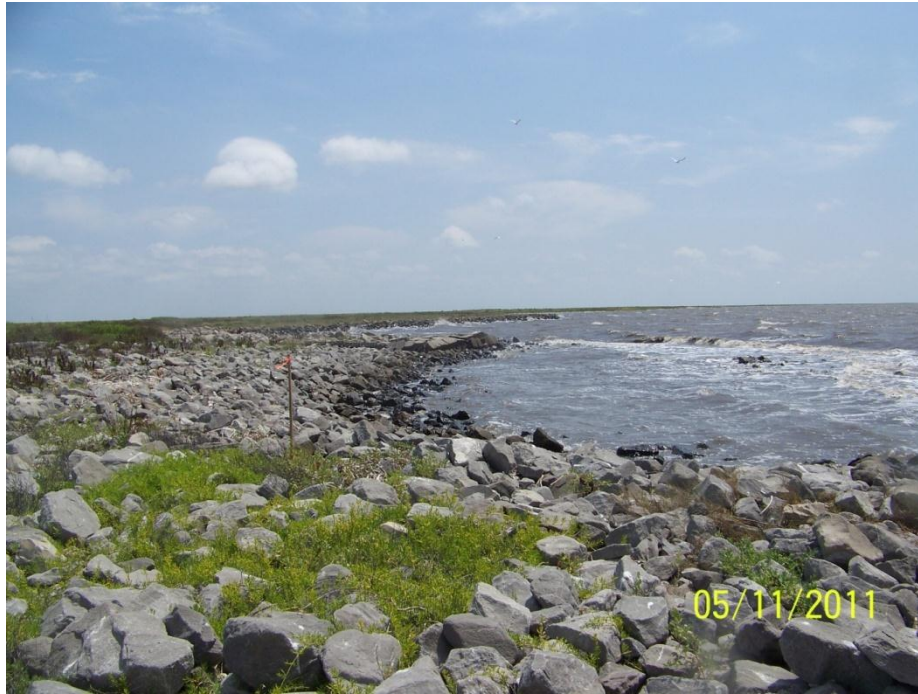
The erosion directly behind the mats on the east side of the structure has been slowed or halted since the maintenance rock lift in 2005. Material has been accumulated behind the rock lift and that deposited material is now vegetated. But, shoreline erosion continues to be observed at the east embankment tie-in. On the other end of the structure, the west mats have settled and are over washed during normal tidal events. In addition, due to erosion around the embankment tie-in the mats no longer connect to the shoreline. This allows tidal exchange behind the mats similar to the east end before the 2005 maintenance. At the existing Transco bulkhead, tidal exchange occurs between the Gulf and Transco Canal where water passes behind the bulkhead and over the rocks into the canal. This has been observed in previous inspections but seems to be increasing. The steel sheetpile and tie-rods are heavily corroded and should continue to be monitored.

Photo #37: view of Plug No. 4A just north of existing Transco Pipeline bulkhead, looking east

At Plug No. 4A (Transco at Gulf) in order to address the continued erosion at the west shoreline tie-in, behind the west mats, and at the east shoreline tie-in, a survey was recommended in the 2010 Annual Inspection Report. At the time of the 2011 inspection and report, this survey is in progress and is expected to be completed later this summer 2011. Based on the results of the survey, maintenance recommendations may include constructing a rock lift on the west mats, closing off the connection

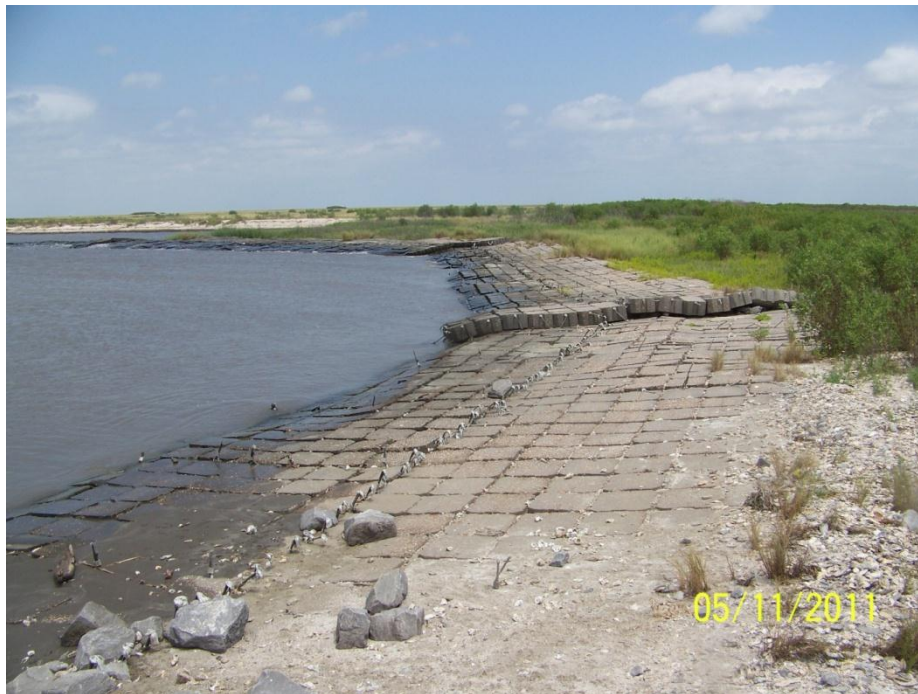
Photo #38: view of Petriflex mats on the west side of Plug No. 4A, looking west

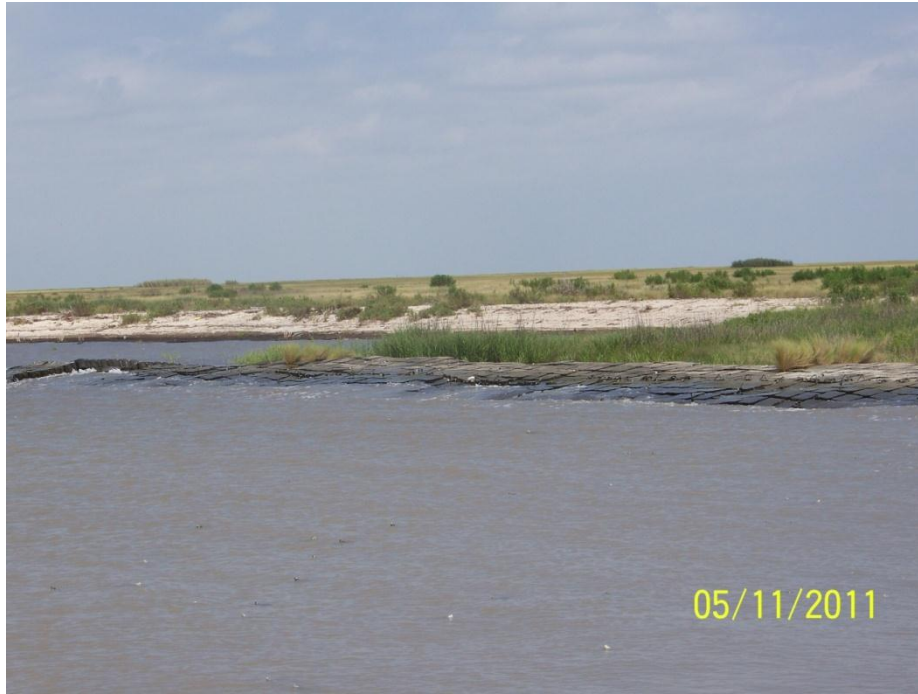
Photo #39: view of Petraflex mats on the west side of Plug No. 4A, looking northwest

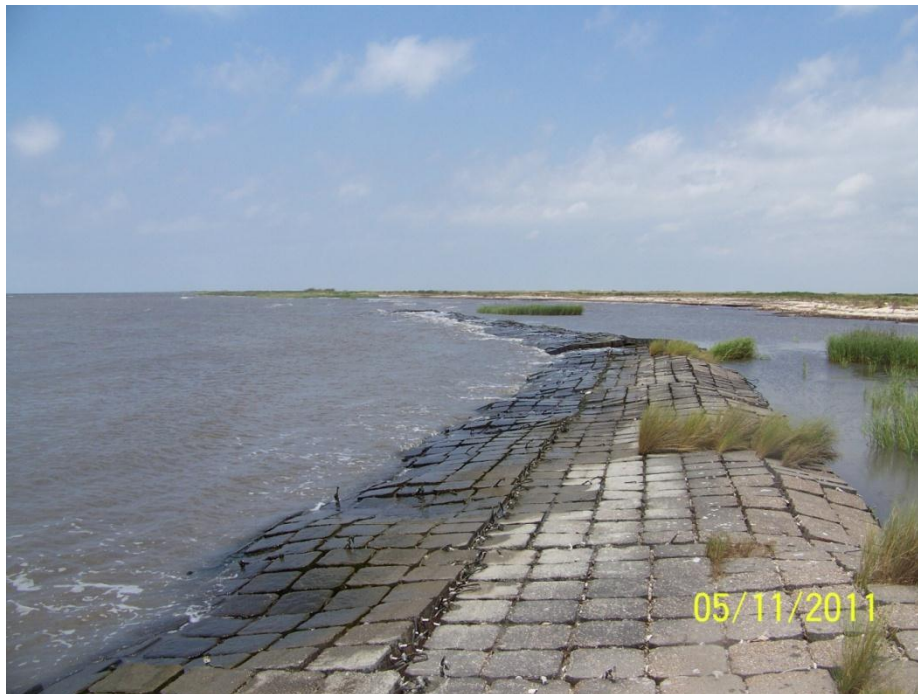
Photo #40: view of Petraflex mats on the west side of Plug No. 4A, looking west

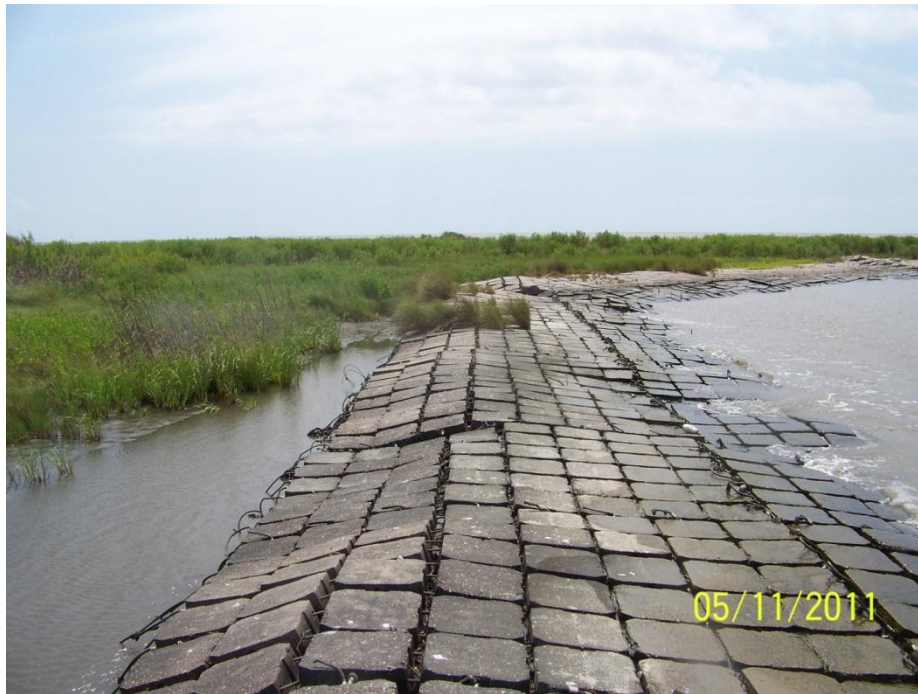
Photo #41: view of Petraflex mats on the west side of Plug No. 4A, looking east

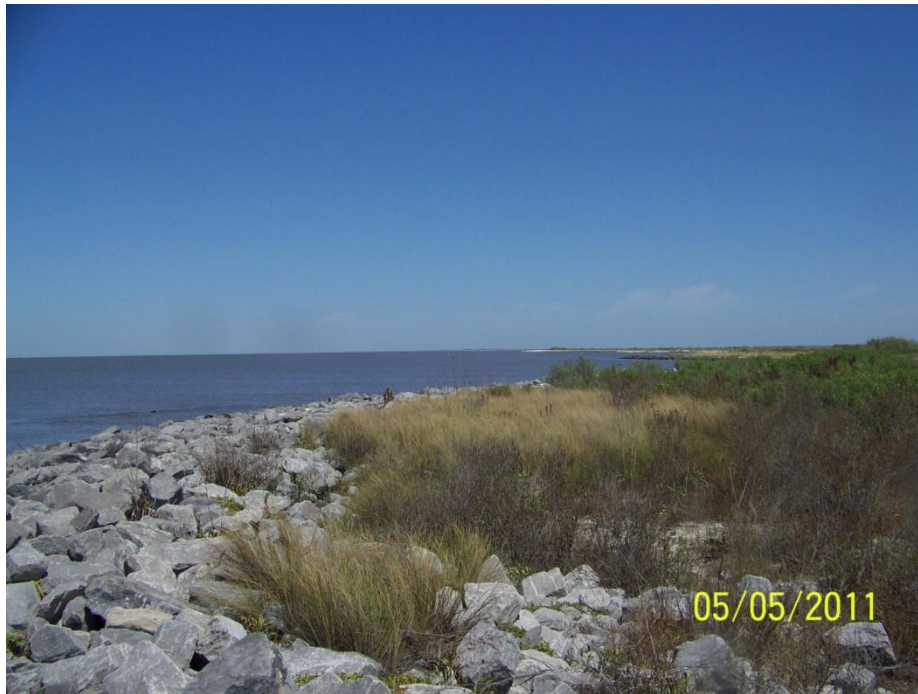
Photo #51: view of Shoreline Protection Phase III rock wall, looking west

For the Phase II and III rock dikes, several areas appear to be low. Also, the Gulf shoreline continues to erode where the project rock terminates. This is true of the Phase III Area 4 and Area 5 rock dike. A survey was recommended in the 2010 Annual Inspection Report. At the time of the 2011 inspection and report, this survey is in progress and is expected to be completed later this summer 2011. Based on the results of the survey, maintenance recommendations may include a rock lift along low areas of the dike and extension of the ends back to the shoreline (See Appendix C).

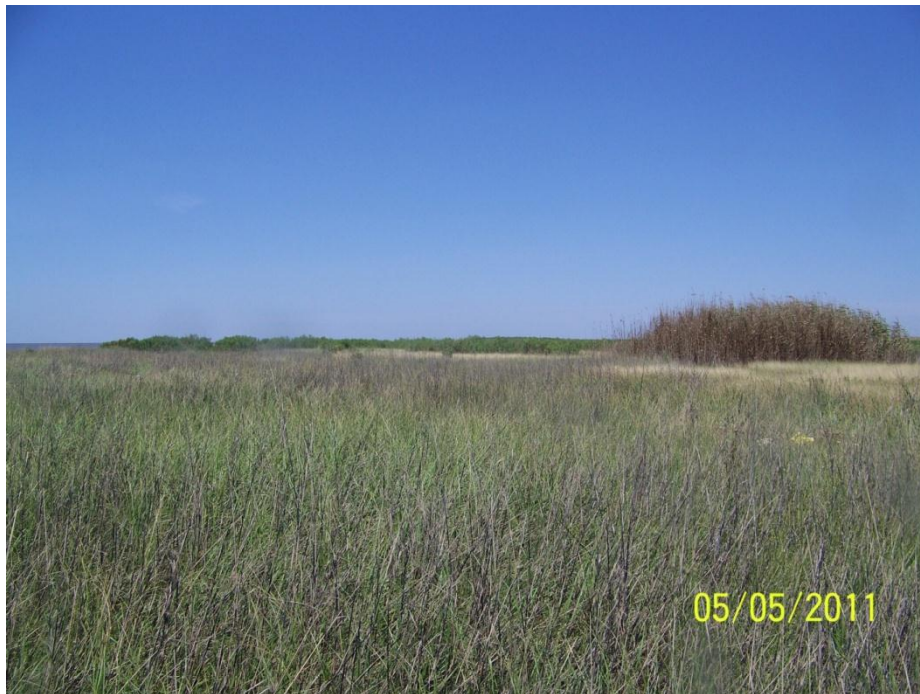
Photo #56: view of marsh created behind east end of Shoreline Protection Phase III, looking north

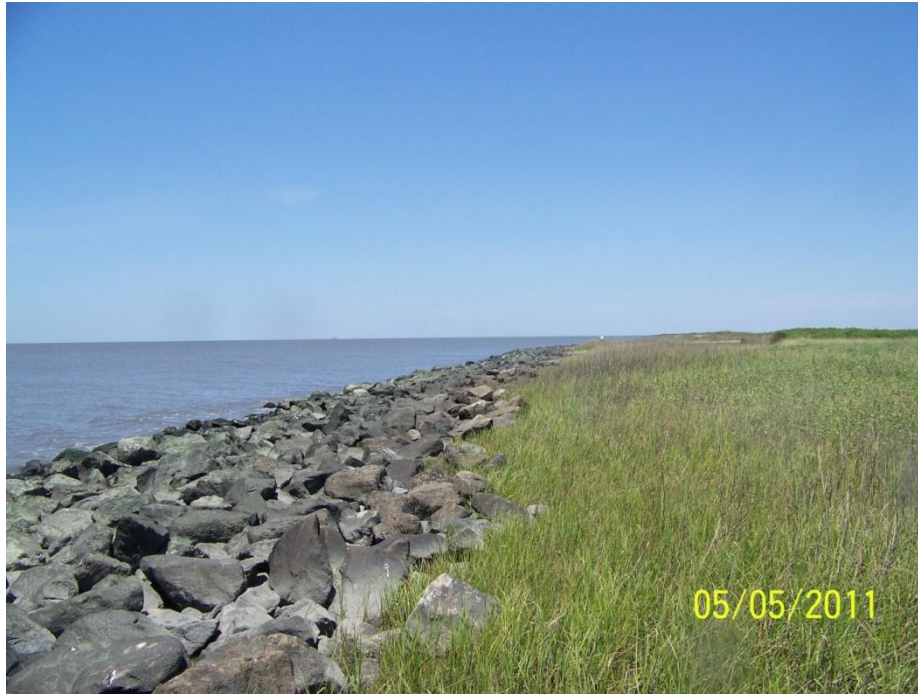
Photo #57: view of marsh created behind east end of Shoreline Protection Phase III, looking west

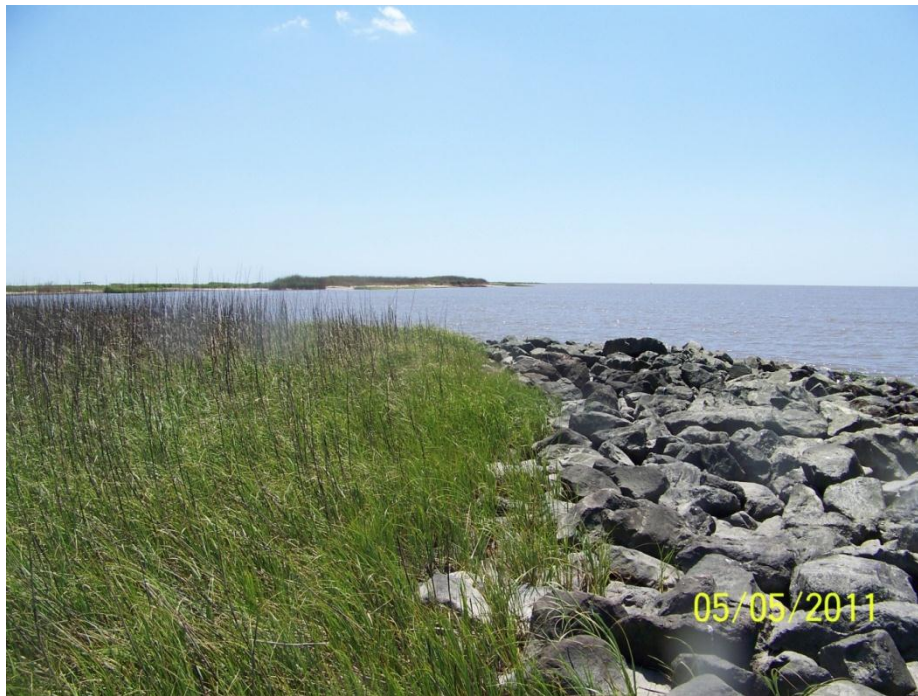
Photo #58: view of marsh created behind east end of Shoreline Protection Phase III, looking east
