2011 Operations, Maintenance, and Monitoring Report

Point Au Fer Island Hydrologic Restoration (TE-22)

State Project Number TE-22
Priority Project List 2

July 2011
Terrebonne Parish

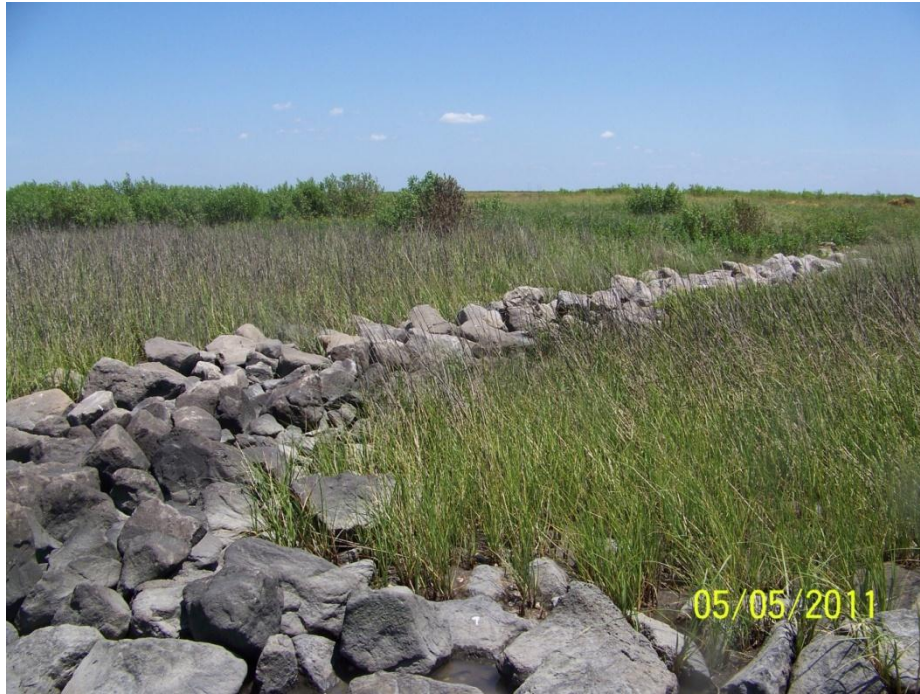
Photo #59: view of rock dike extension on east side of Shoreline Protection Phase III, looking north

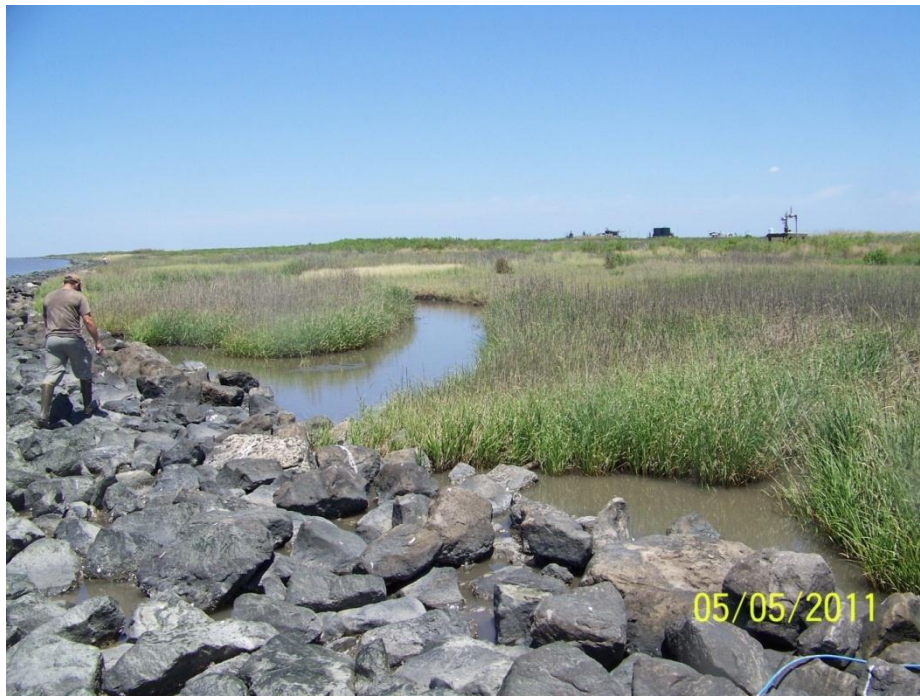
Photo #60: view of tidal channel behind Shoreline Protection Phase III, looking northwest

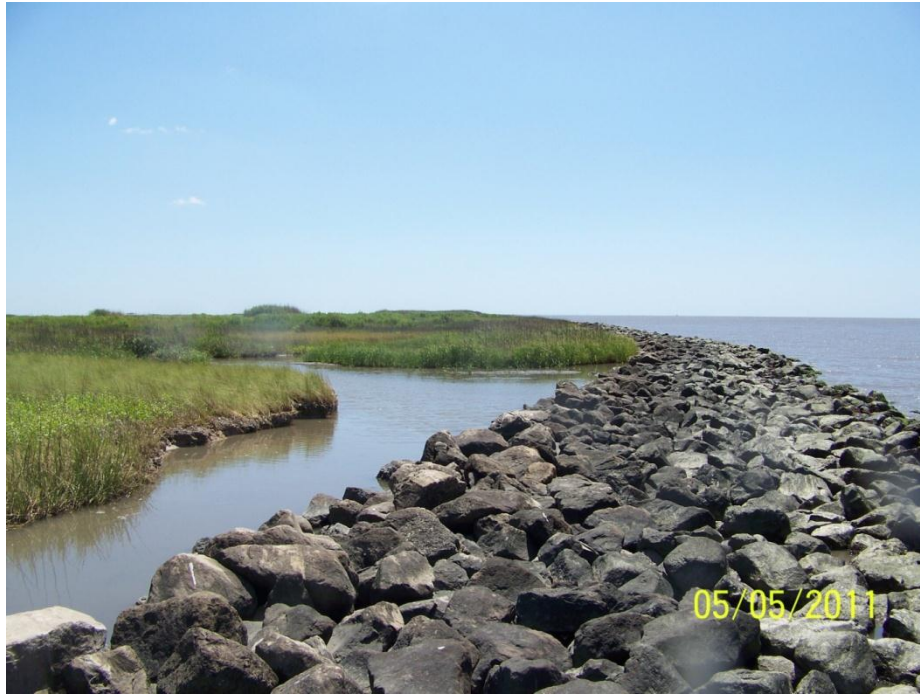
Photo #61: view of tidal channel behind Shoreline Protection Phase III, looking east
