2011 Closeout Report

Mandalay Bank Protection Demonstration (TE-41) Project

State Project Number TE-41
Priority Project List 9

August 2011
Terrebonne Parish

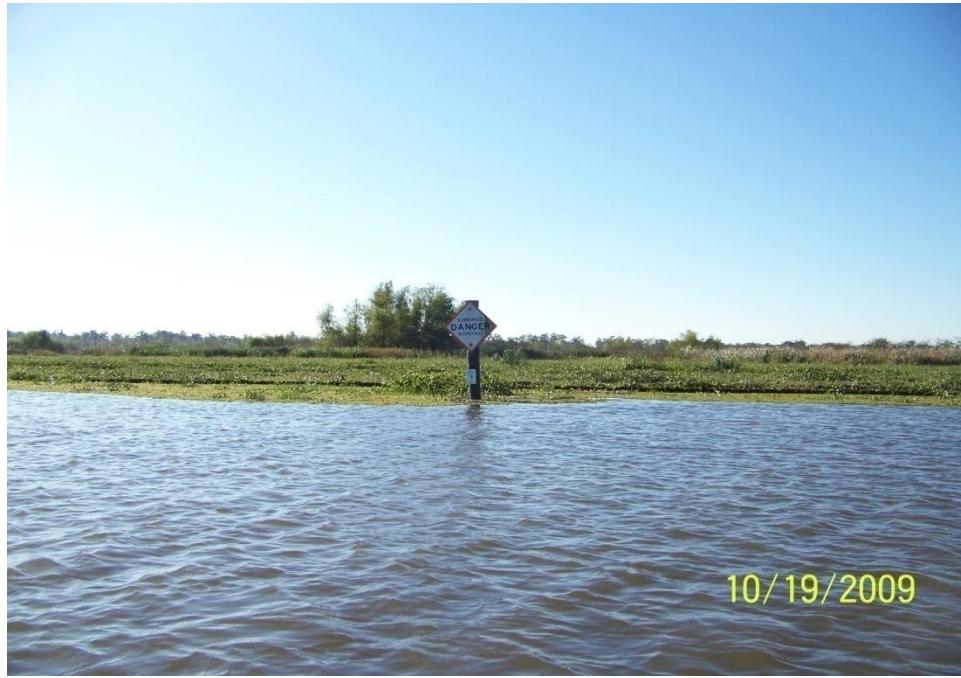
Photo No.2 - Site V3 – warning sign in front of fiberglass sheet pile (double) wall structure.

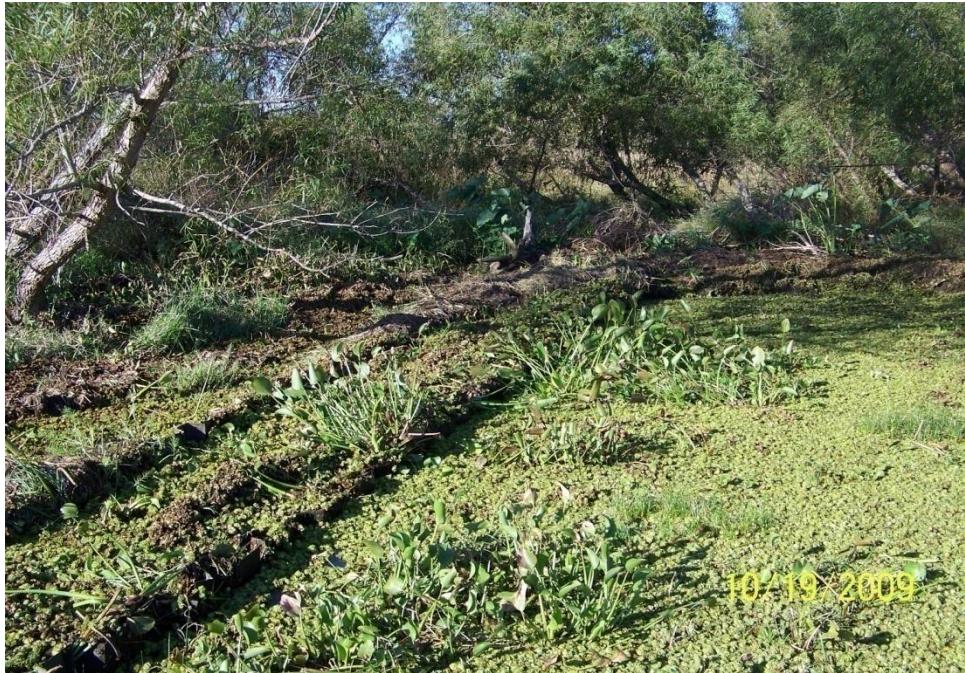
Photo No.3 – Site V3 – bank tie-in at the west end of the fiberglass sheet pile (double) wall.

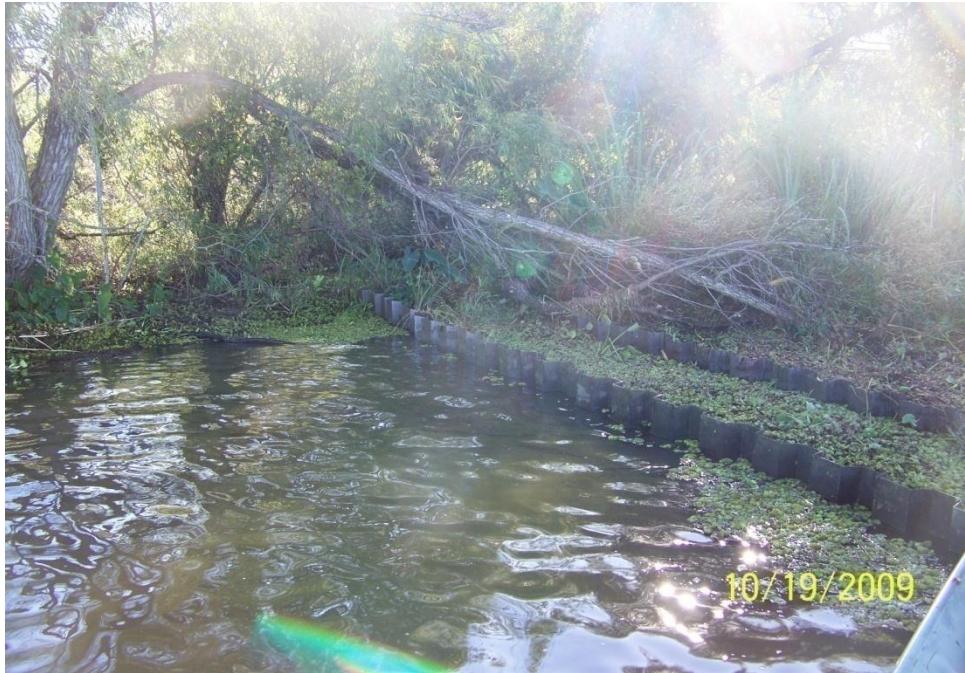
Photo No.5 - Site V3 – bank tie-in at the east end of the fiberglass sheet pile (double) wall.

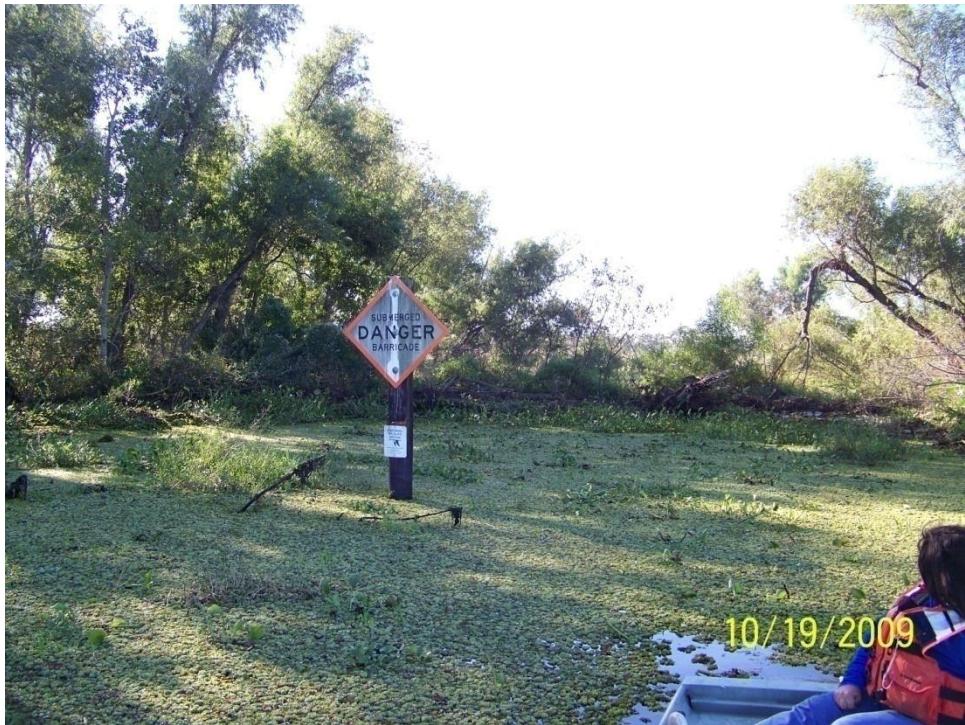
Photo No. 7 – Site A3- view of warning sign on the GIWW side of the armored earthen plug.

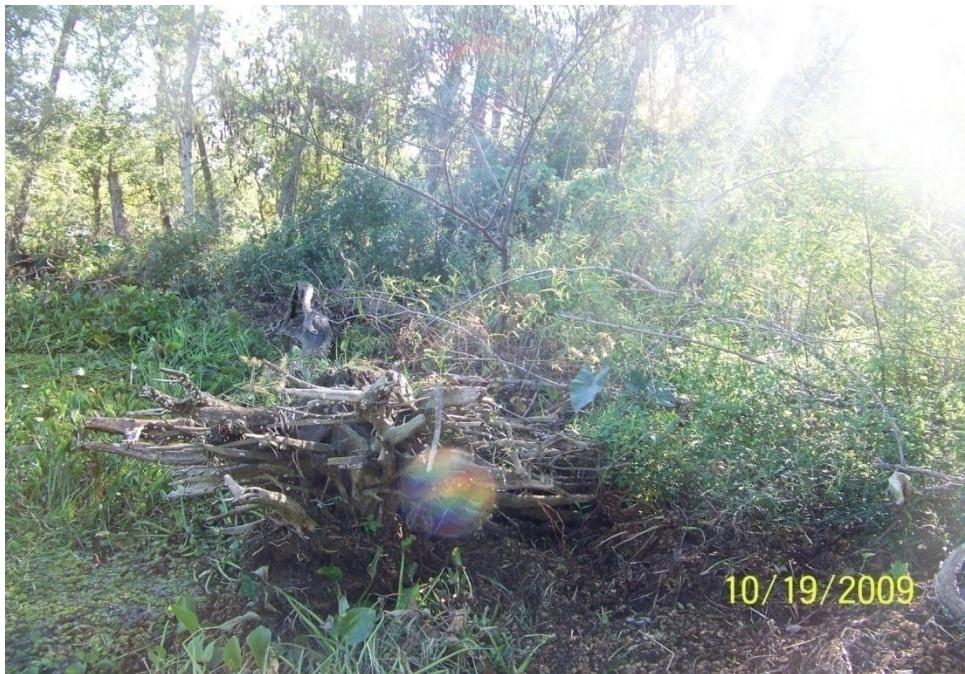
The concrete revetment mats appeared to be in good condition. Material has accreted in front of the Sites A1 and A2. The most accretion has occurred at Site A2 where the extent of vegetated accretion reaches well beyond the warning sign. The bank tie-ins were also in good condition. The warning signs and support piles were in excellent condition. Overall, the armored plugs appear to be intact and do not require any maintenance (Photos 7-11, 23-26 and 41; Appendix B).

Photo No.9 – Site A3 – view of debris covering the armored earthen bank structure.

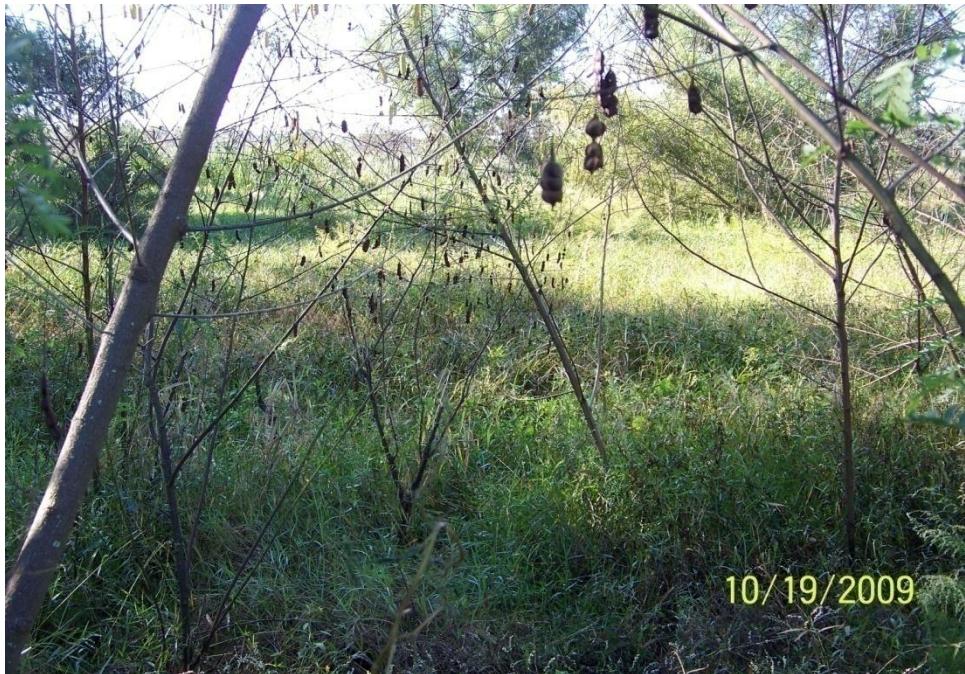
Photo No.11 – Site A3 - view of marsh behind (south side) of armored earthen plug.

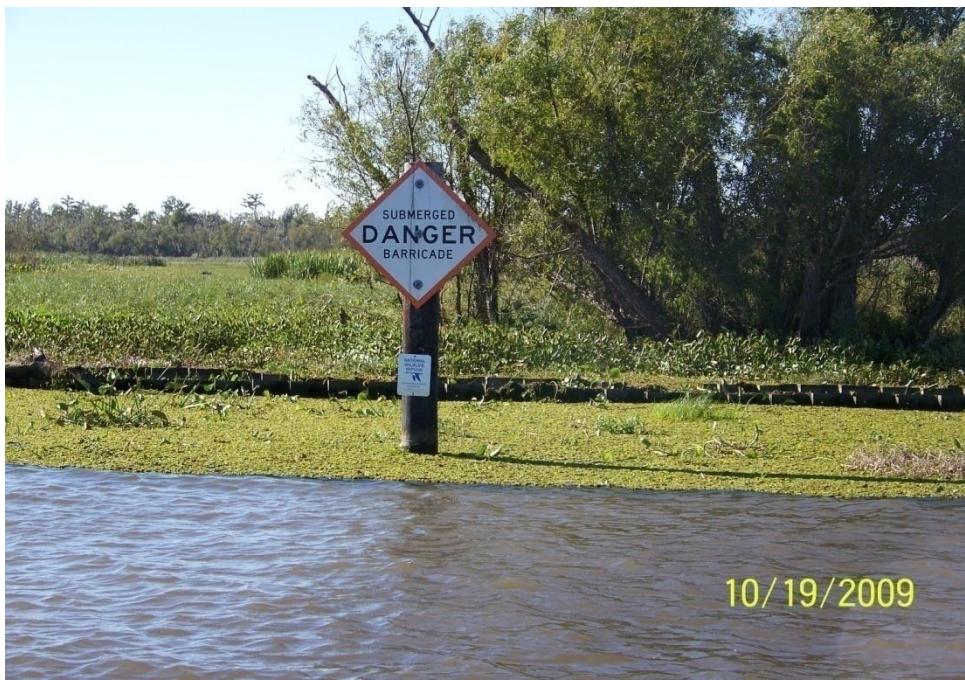
Photo No.12 – Site V2 –warning sign on north side of the fiberglass sheet pile (double) wall.

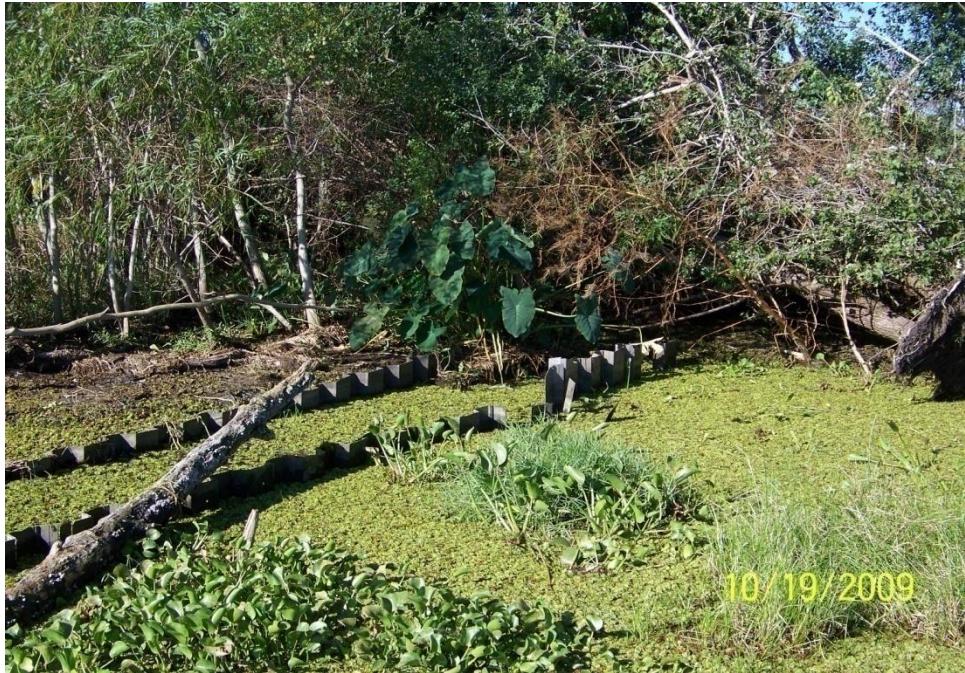
Photo No.13 – Site V2 – fiberglass sheet pile tie-in to bank on the west side of the structure.

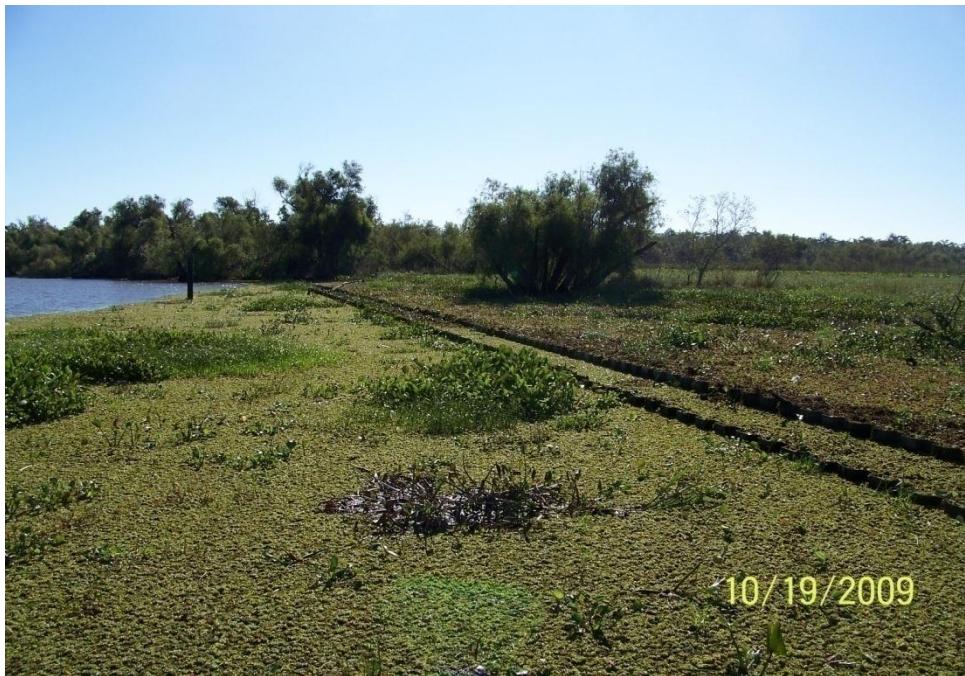
Photo No.14 – Site V2 - fiberglass sheet pile wall along south bank of GIWW looking east.

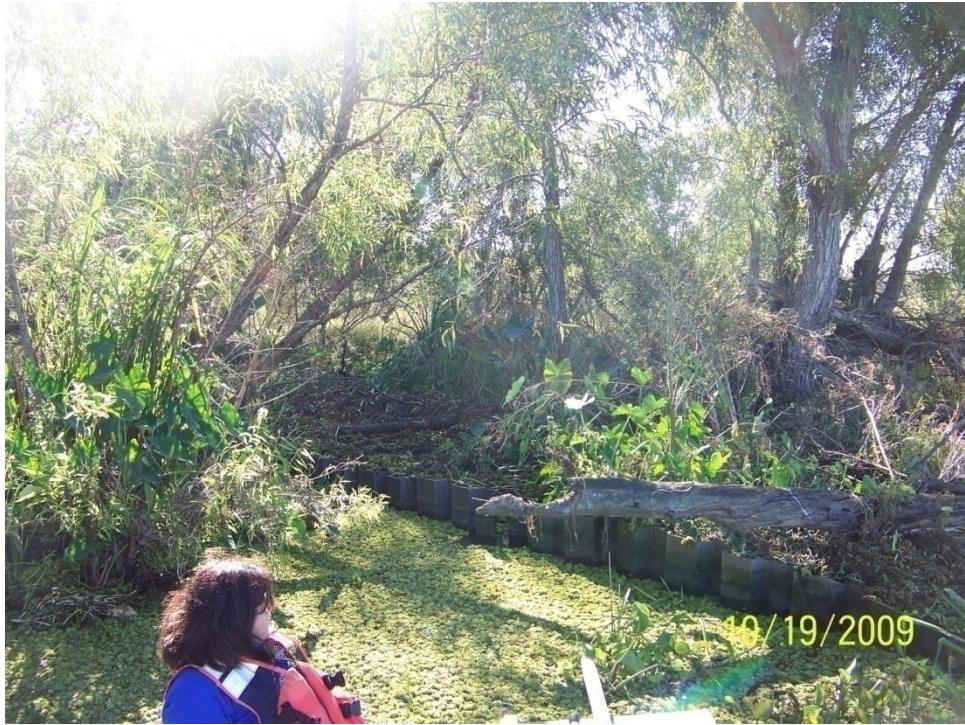
Photo No.16 - V2 - fiberglass sheet pile wall tie-in to bank on the east end of the structure.

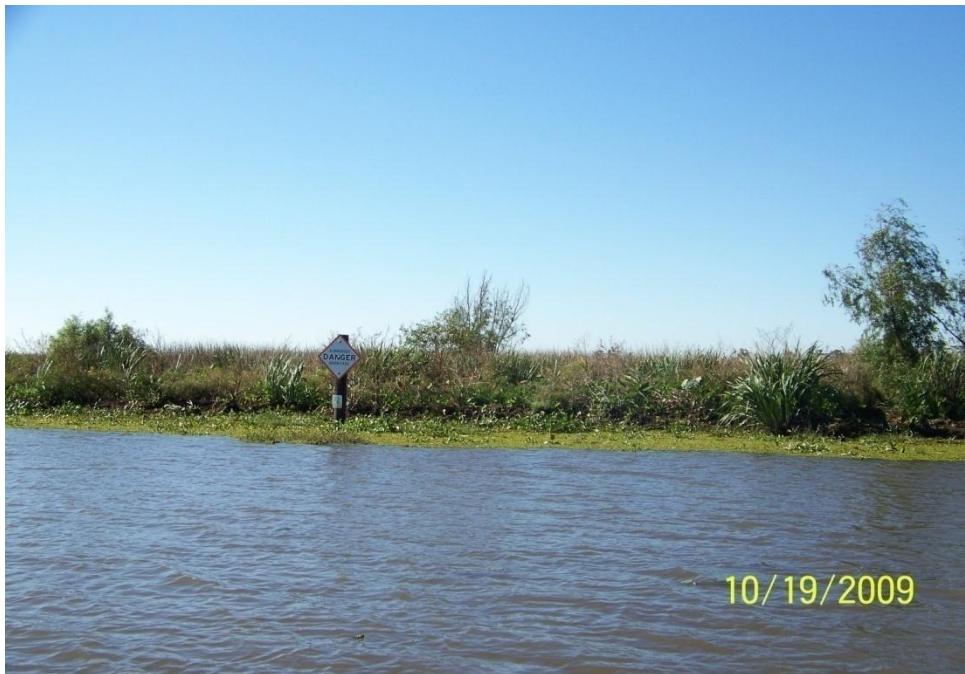
Photo No.17 – Site F3 – warning sign on north side (GIWW) of timber fence structure.

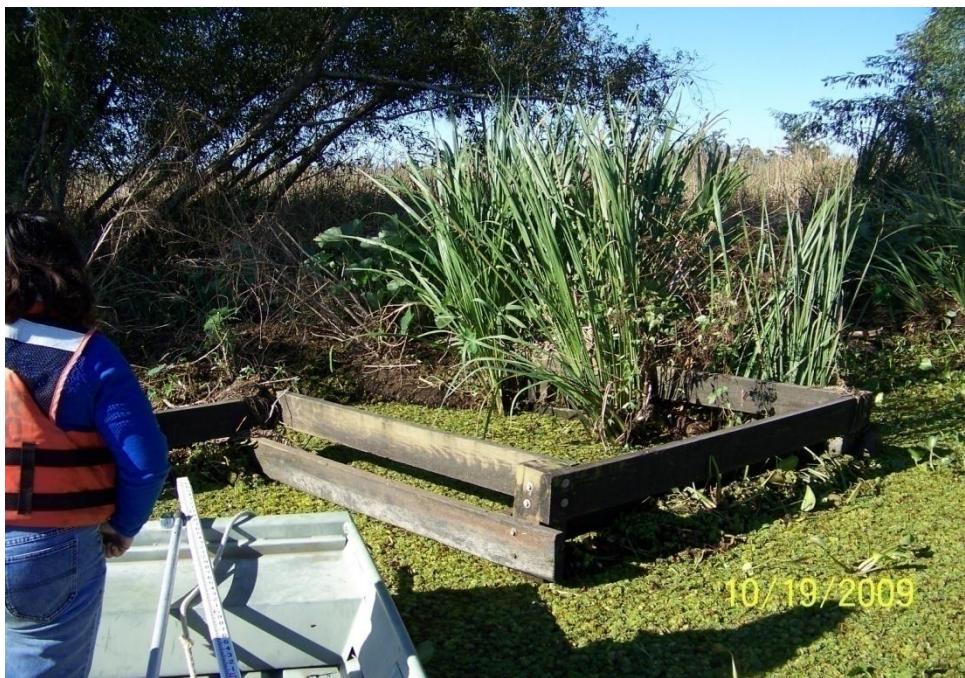
Photo No.18 – Site F3 – timber fence tie-in the bank line on the west side of the structure.

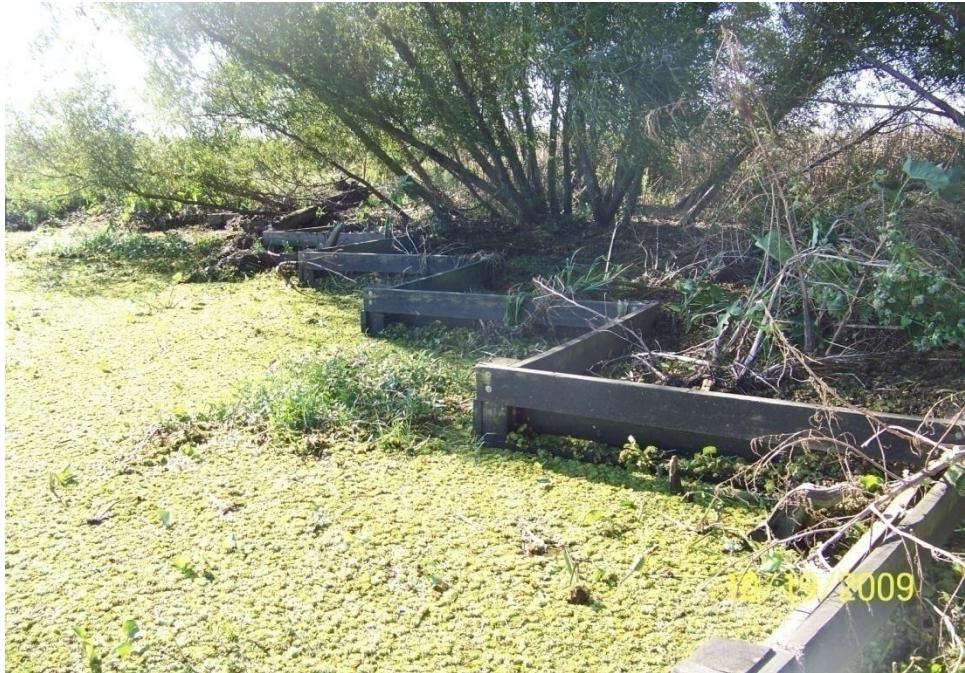
In general, the timber fencing and galvanized hardware at the three sites appeared to be in good condition with no signs of damage. One location of damage was noted however. At Site F2, approximately 7 or 8 fence spans were missing near the middle of the structure. It appears as if a barge struck the fence here. From communication with field personnel, it is believed this occurred in early May 2006. Most of the bank tie-ins were in good condition. The bank has eroded approximately 2' away from the west end of the fence at Site F2. The warning signs and support piles were in excellent condition at Sites F1 and F3. The warning sign support pile at Site F2 was struck by the barge as well and is now leaning with the sign partially submerged. At Site F3, significant accretion has occurred (an average of 10' in front of the structure and up to the bottom of the top cross timber on the structure). This fence site is adjacent to plug Site A2 where extensive accretion of material has occurred. In some locations material has accreted greater than 50' from the old shoreline behind the fence out to the warning sign. In the vertical direction the material has reached the second timber on the fence or higher. As noted in previous inspections, the survival rates of the planted giant cutgrass associated with Fencing Sites appears to still be very low. The only immediate maintenance need is the warning sign at Site F2. Also, consideration should be given to replacement of the damaged fence sections at Site F2. The damage to these sections as well as the length of time since the occurrence should be noted in the demonstration project results (Photos 17-22, 29-30, and 33-40; Appendix B).

Photo No.19 – Site F3 – view of the timber fence structure along south bank line of GIWW.

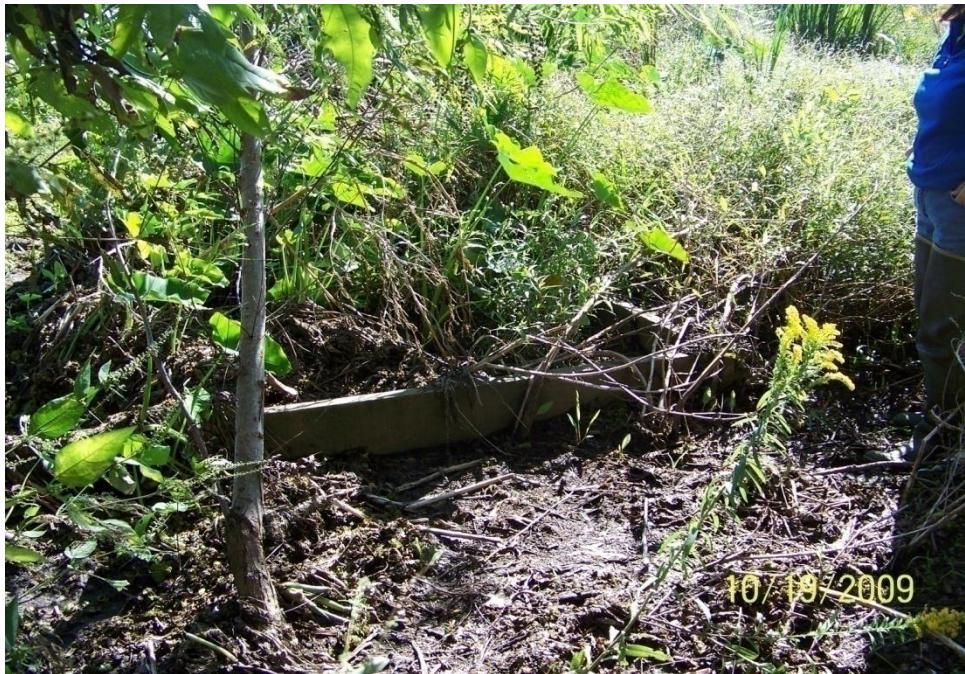
Photo No.21 – Site F3 – accretion in front and up to the top of the timber fence structure.

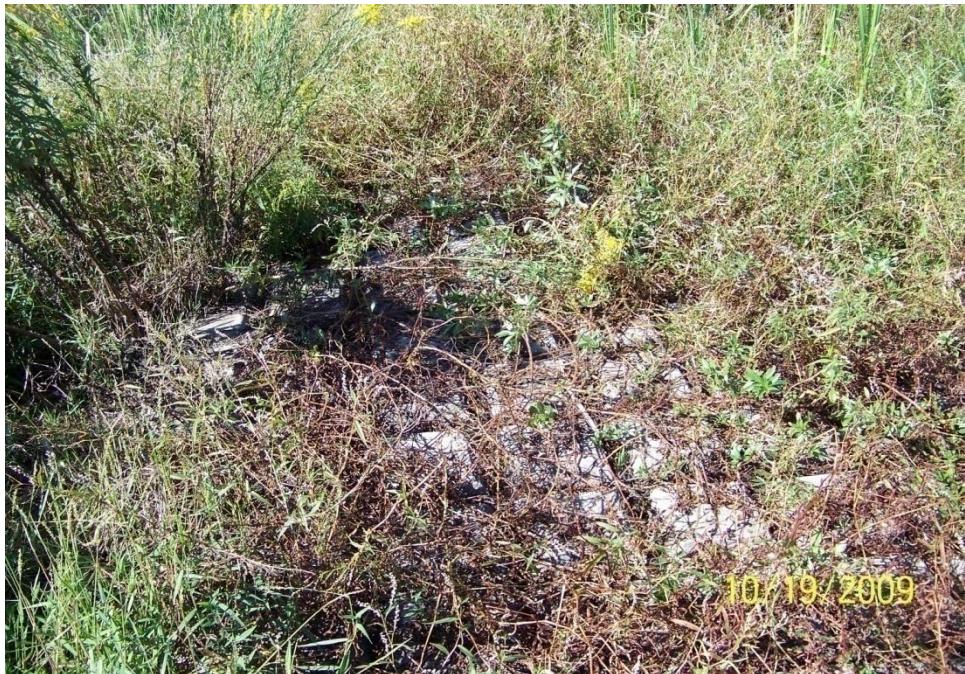
Photo No.23 - Site A2 - armored earthen plug tie-in the bank line on the west end of structure.

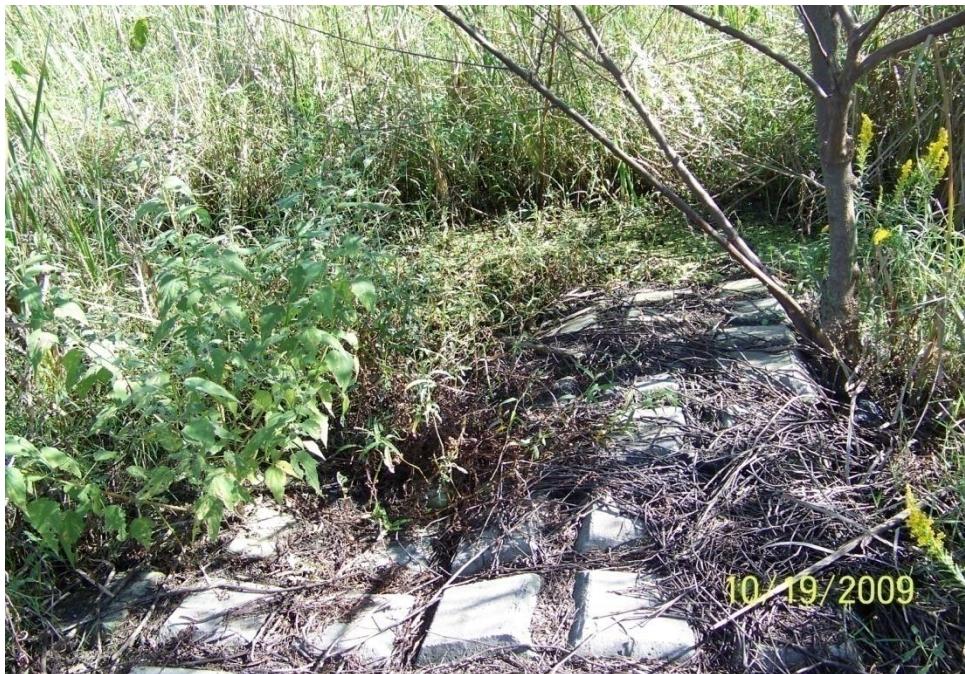
Photo No. 25 – Site A2 – armored earthen plug tie-in to bank on the east side of the structure.

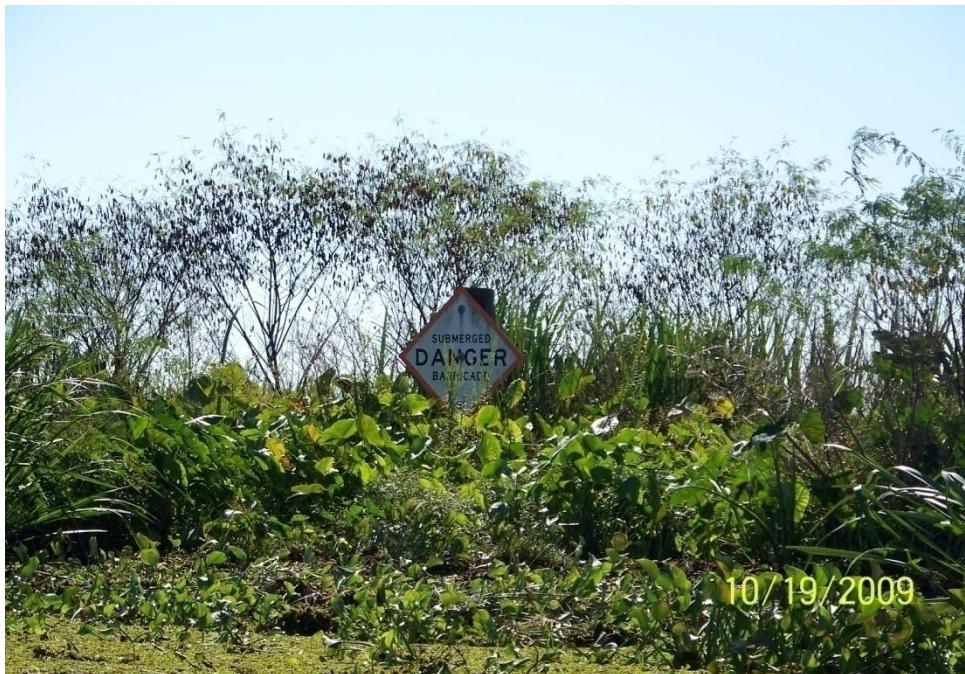
Photo No. 26 – Site A2 – warning sign on the GIWW waterway side of the armored plug.

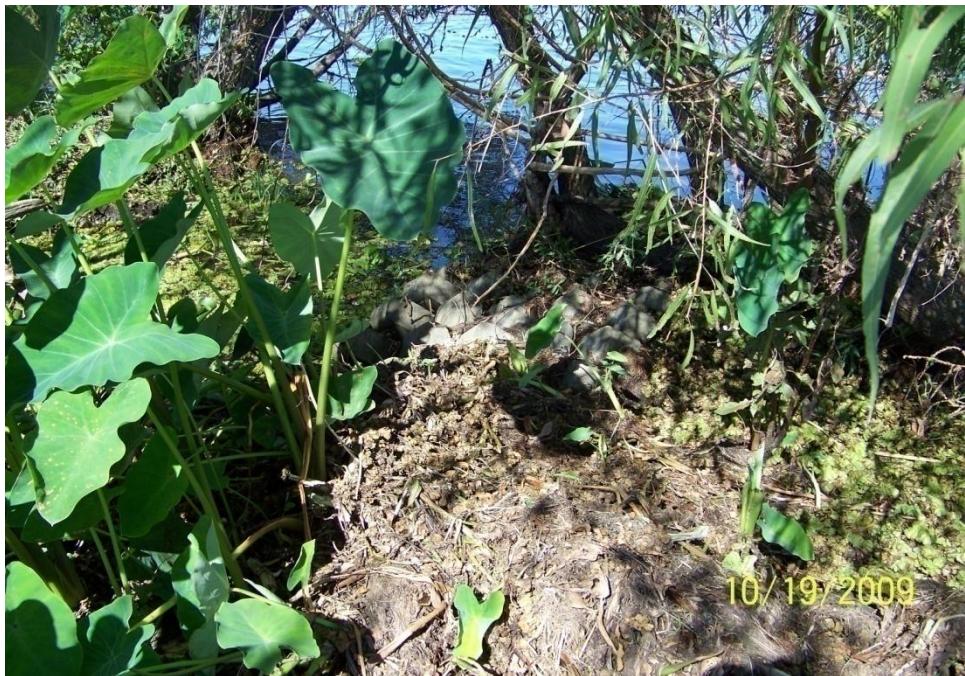
At the adjacent Sites J1 and J2, accretion has occurred, and the A-Jacks (double row) are now covered by well-vegetated, accumulated material. The depth of cover over the A-Jacks was found to be 1' to 2' in some locations (2007 inspection). The extent of vegetated accretion appears to be greater than 200' in some locations as it extends from the old shoreline behind the A-Jacks northward toward the GIWW beyond the warning signs at the two sites. The accreted material is densely vegetated. At Site J3, the water level was just below the tops of the A-Jacks. No accretion has occurred except at the west tie-in where the structure ties into the Site A2 plug. In fact, it appears as if the shoreline may have continued to experience some measure of erosion at this site. The survival rate of the plantings at Site J3 still appears to be the lowest (out of the three sites) as noted in the previous inspection reports. The tie-ins appeared to be in good condition at the three sites. The warning signs and support piles at the three sites were in excellent condition. No maintenance is recommended for the concrete armor unit sites at this time (Photos 27-28, 31-32 and 42-47; Appendix B).

Photo No. 28 – Site J3 – Double row A-Jacks near bank tie-in.

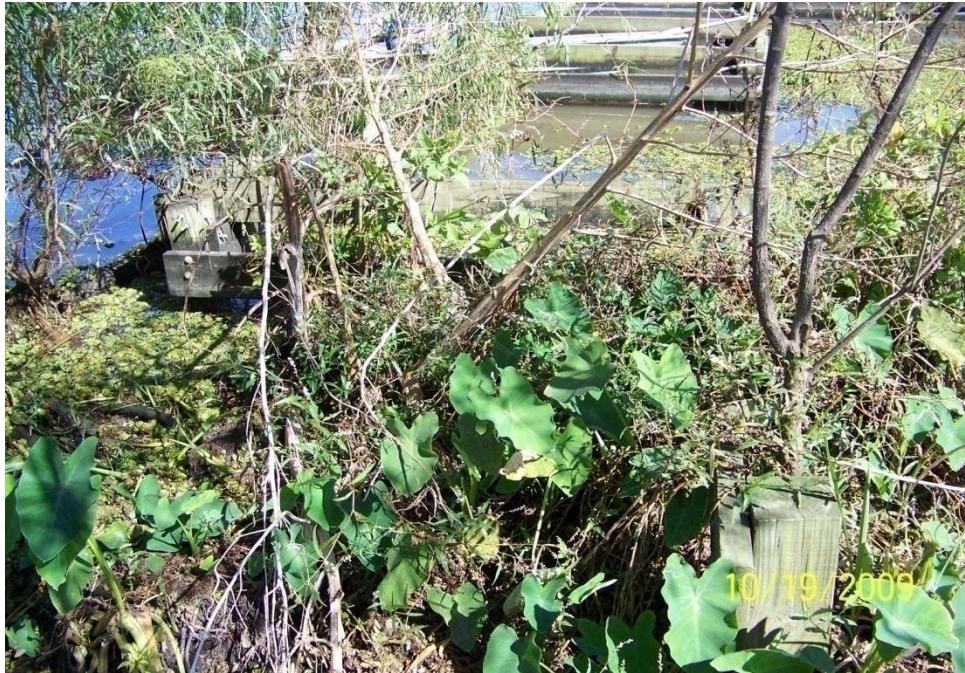
Photo No.29 – Site F2 – timber fence and vegetation growth on the west end of the structure.

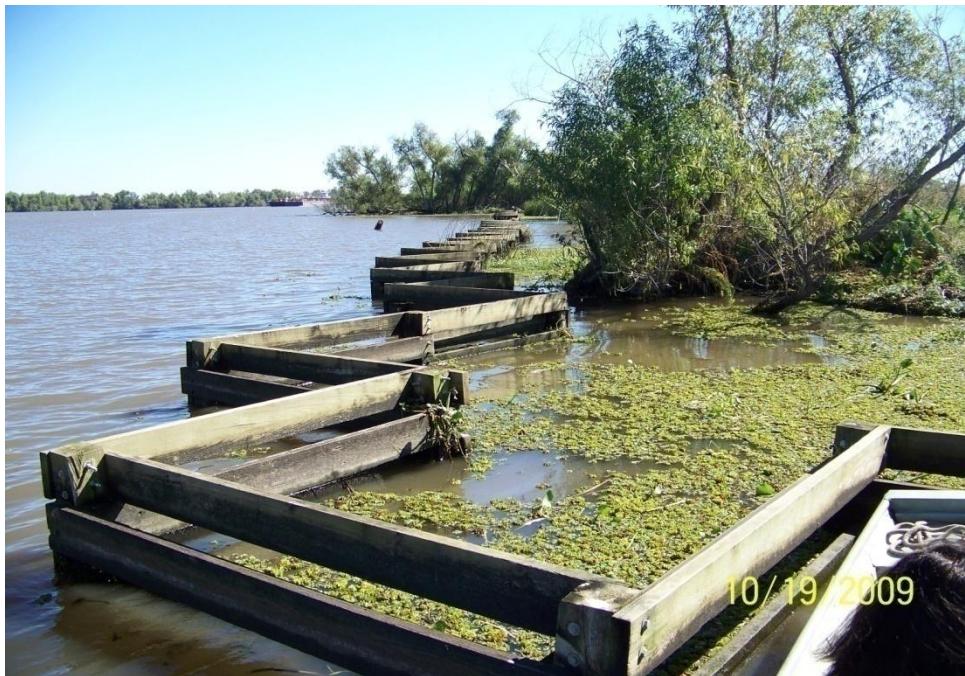
Photo No.30 – Site F2 – Timber fence treatment looking east.

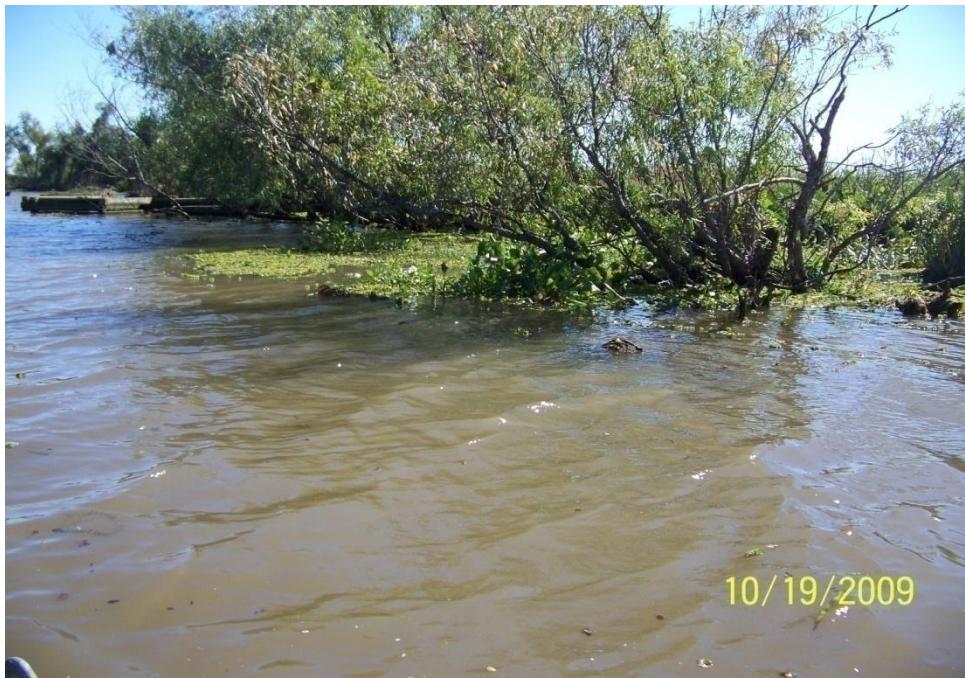
Photo No.32 – Site J3 – view of submerged double row concrete armoring units.

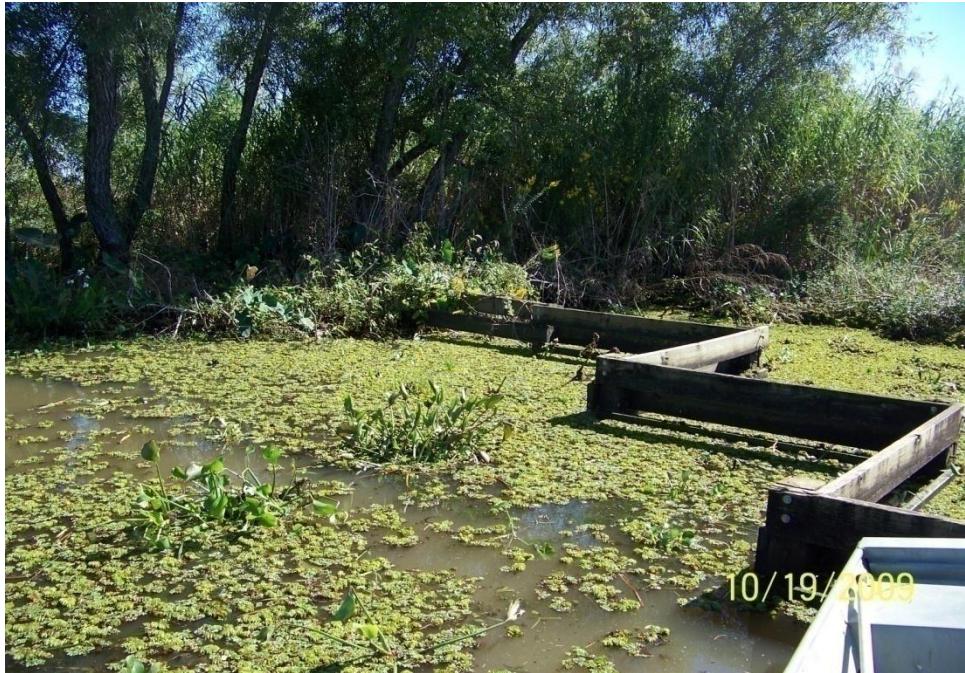
Photo No.35 – Site F2 – timber fence unit tie-in to bank on the west end of structure.

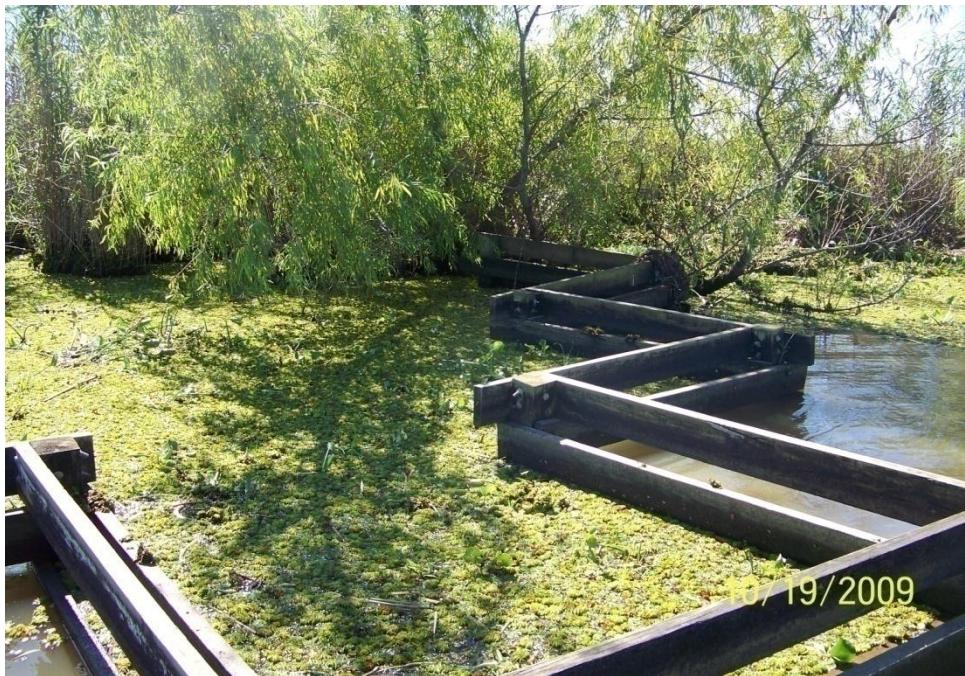
Photo No.36 – Site F1 – timber fence tie-in to bank on the west end of the structure.

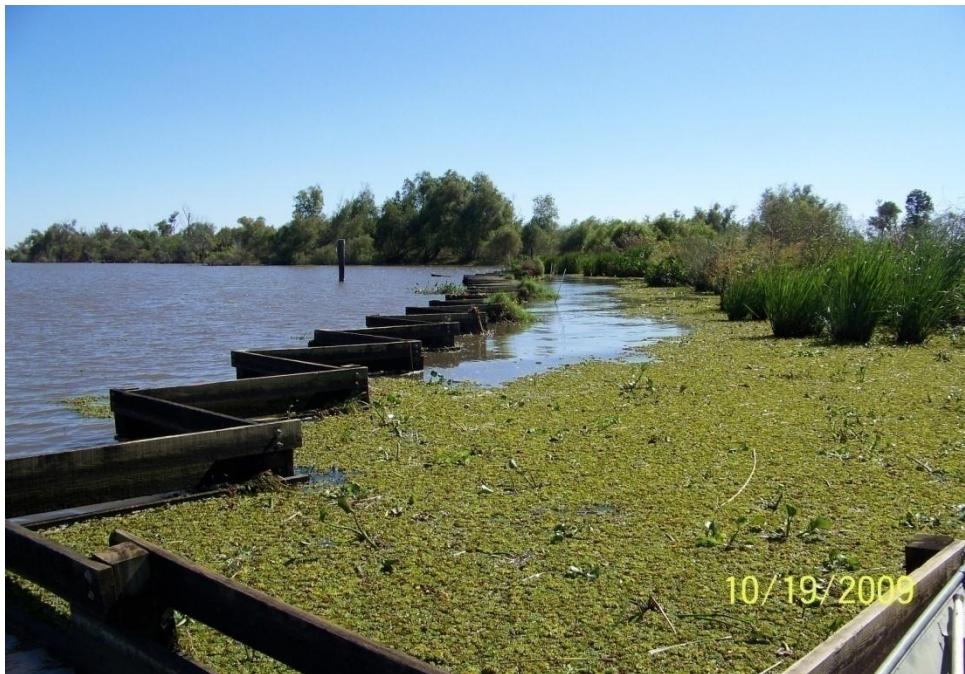
Photo No.37 – Site F1 – timber fence unit and vegetation behind structure looking east.

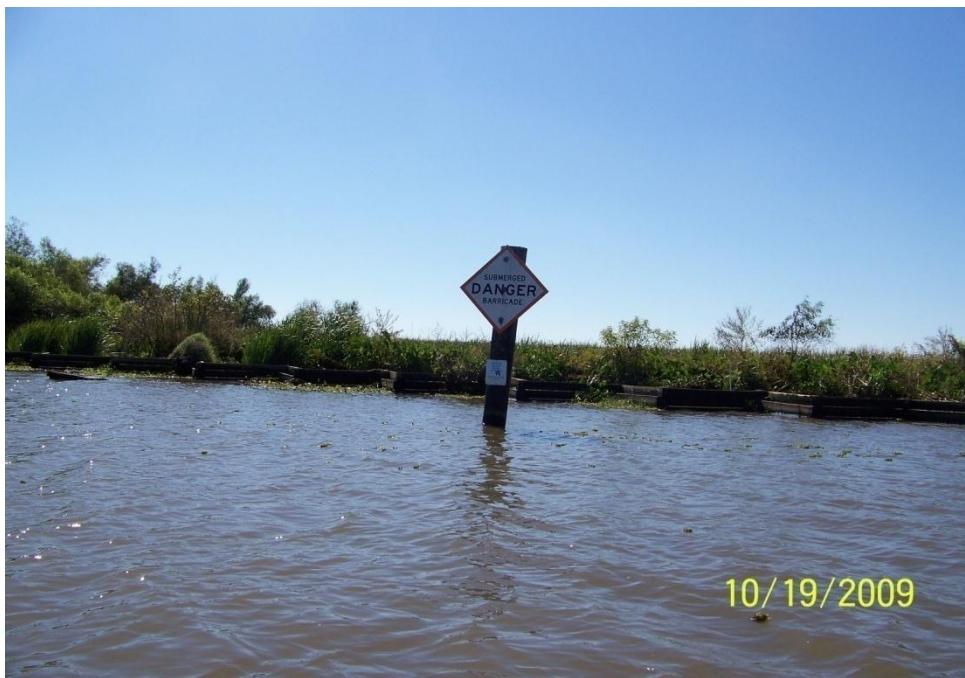
Photo No.38 – Site F1 – warning sign and timber fencing unit along south bank of GIWW.

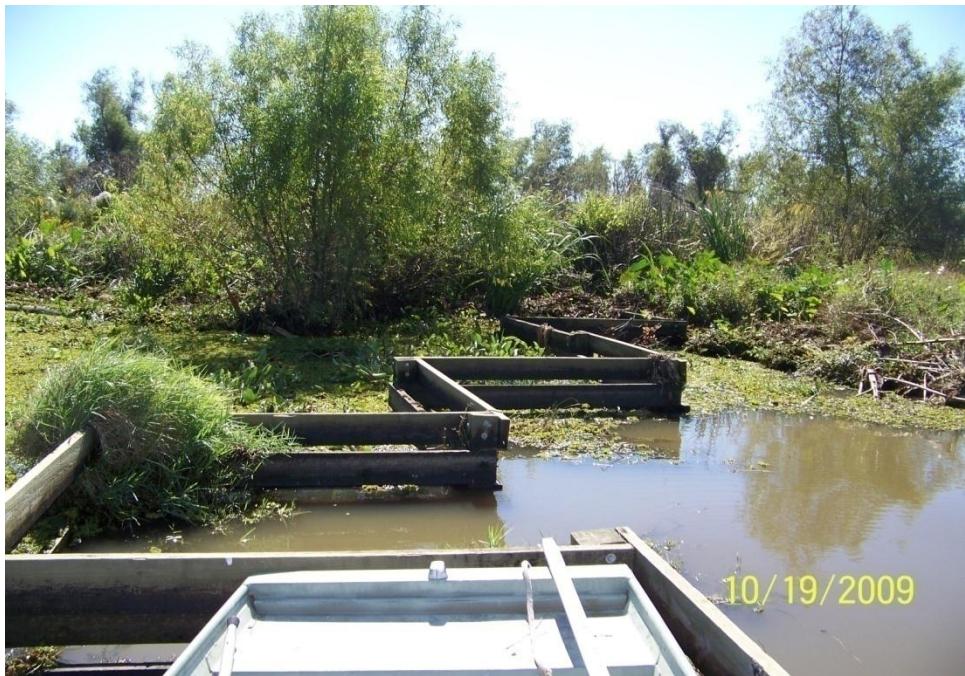
Photo No.39 – Site F1 – close-up of timber fence unit tie-in to bank on west side of structure.

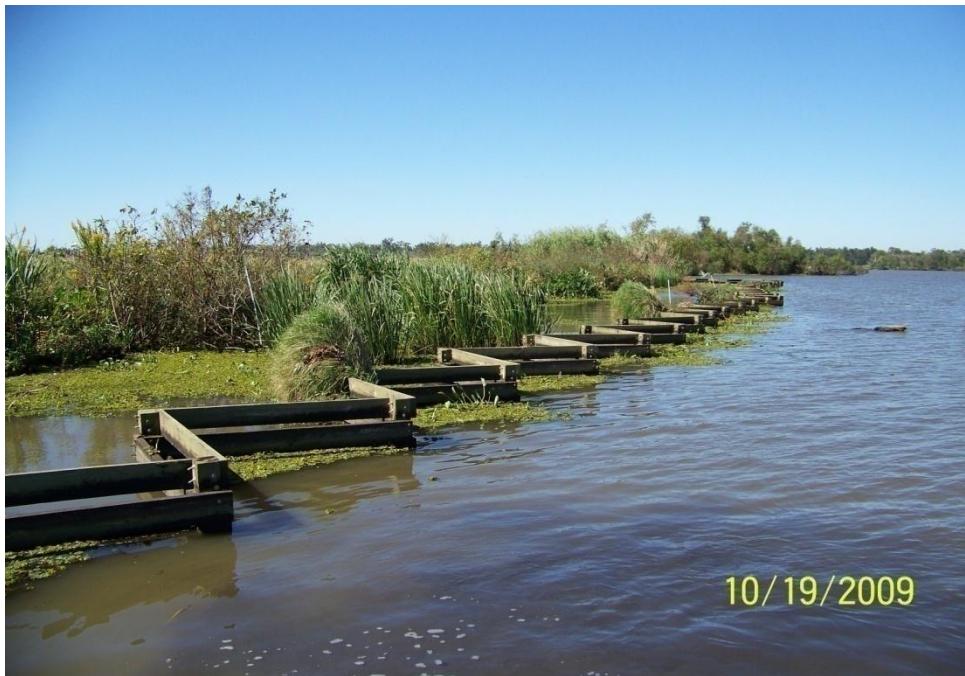
Photo No.40 – Site F1 – timber fencing units and vegetation along shoreline looking west.

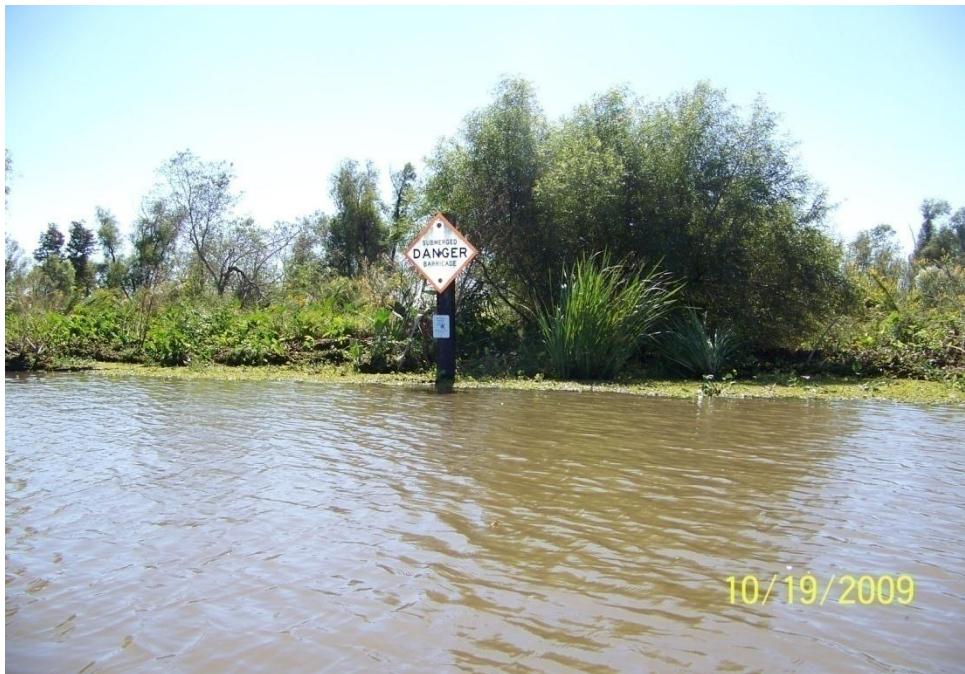
Photo No.41 – Site A1 – site view of armored earthen plug covered with vegetation.

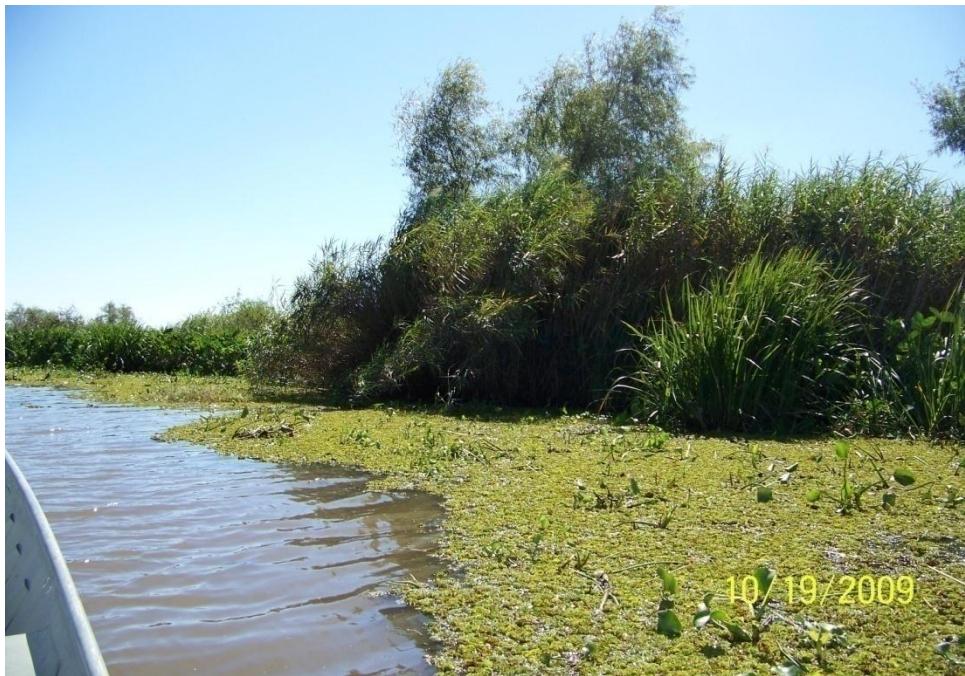
Photo No.43 – Site J2 – view of vegetation covering concrete armoring units.

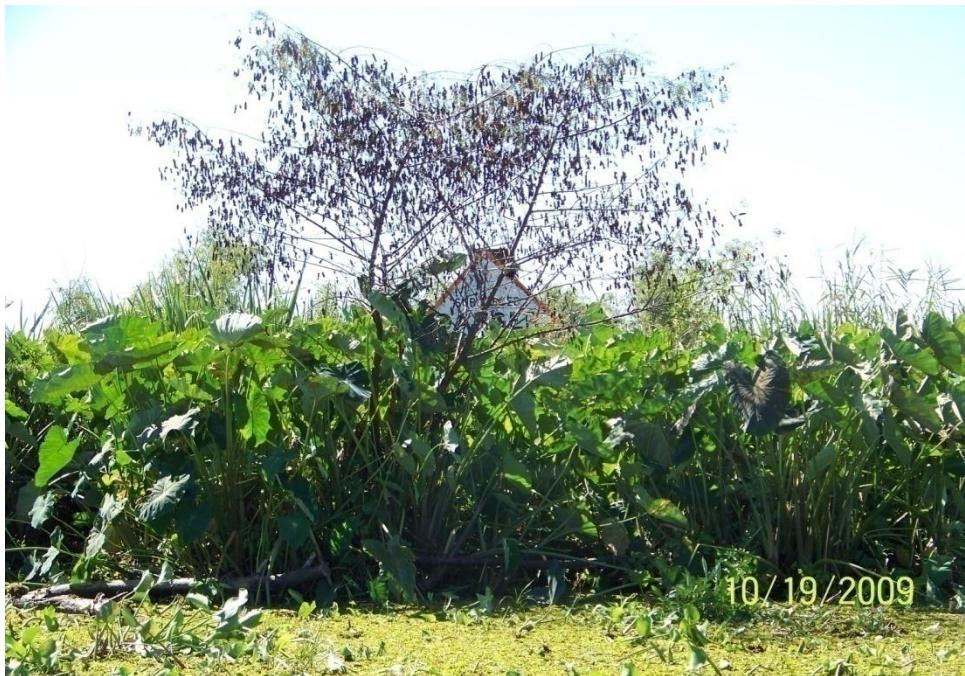
Photo No. 44 - Site J2 – view of warning sign and vegetative accretion in front of armoring units.

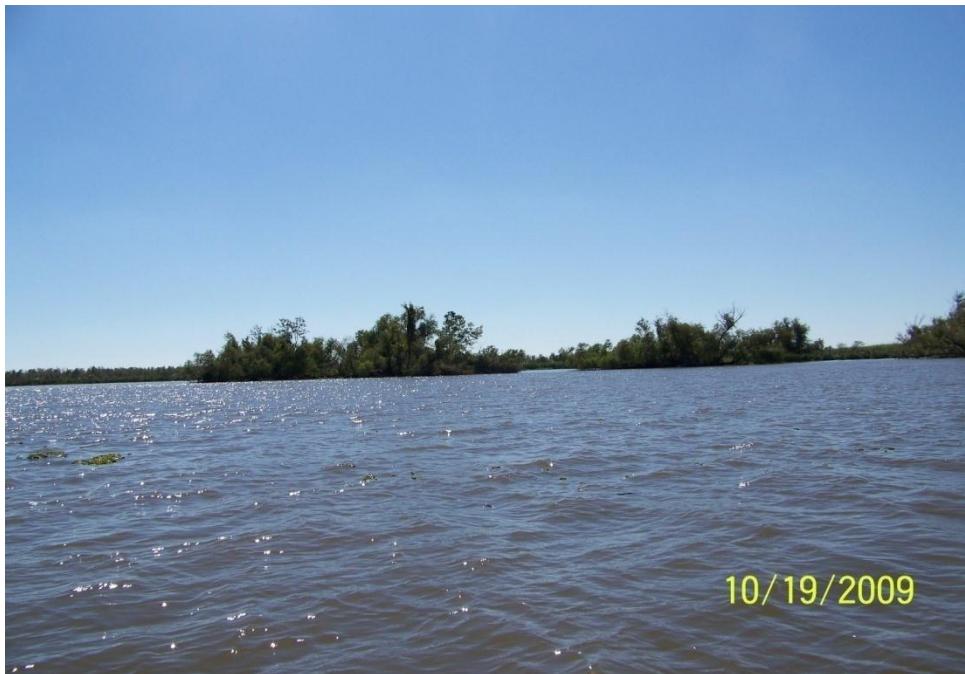
Photo No. 46 – Site J1 – view of accretion in front of double row concrete armoring units.

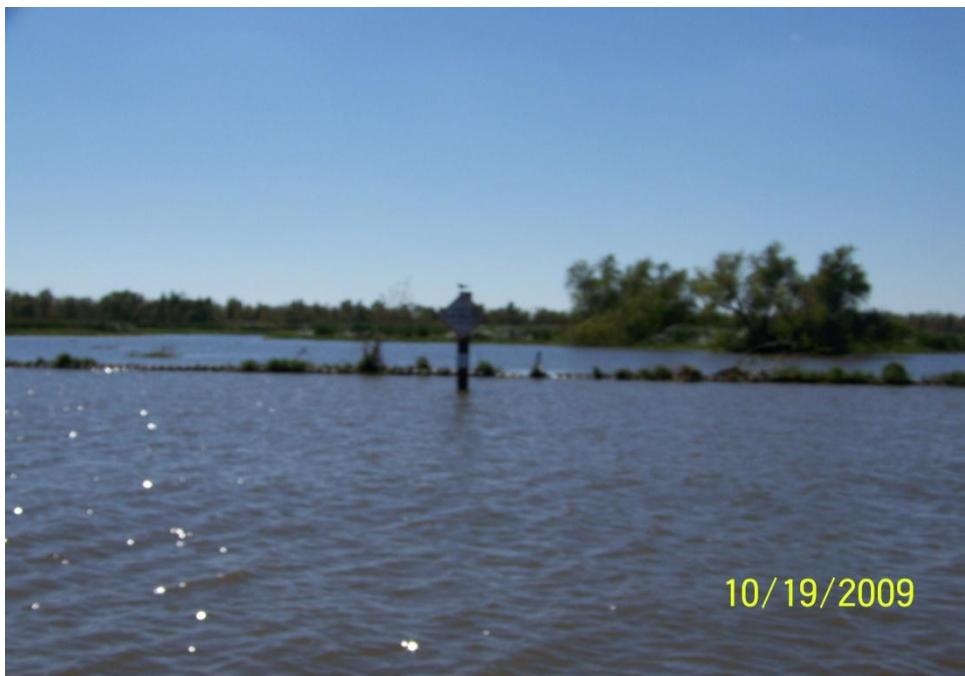
Photo No. 47 – Site J1 & J2 – site location of double row concrete armoring units.
