2011 Closeout Report

Mandalay Bank Protection Demonstration (TE-41) Project

State Project Number TE-41
Priority Project List 9

August 2011
Terrebonne Parish

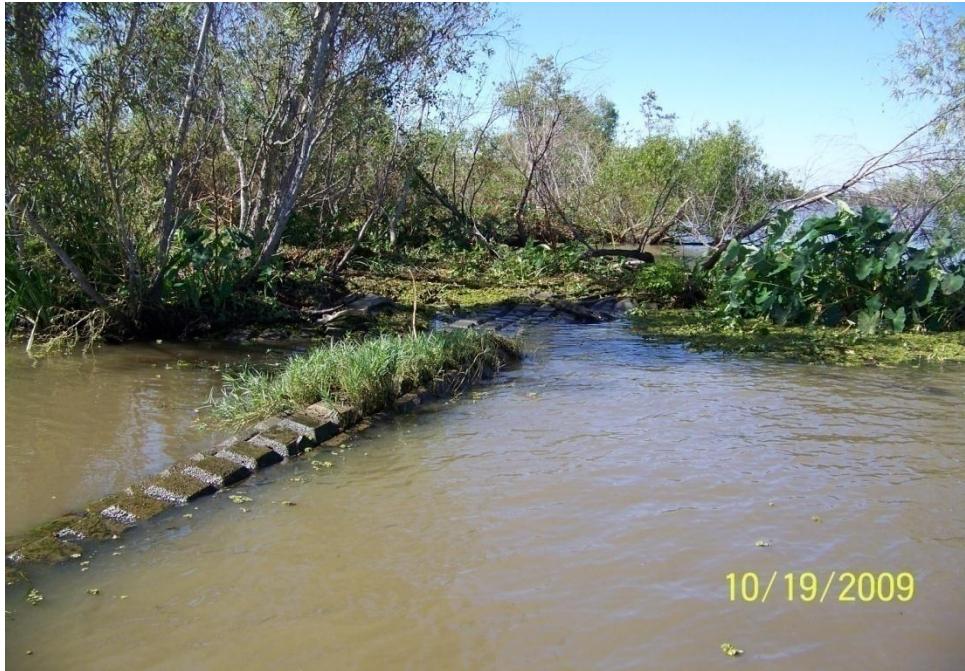
Photo No.48 – Site R1 – view of elevated shoreline system and warning sign looking south.

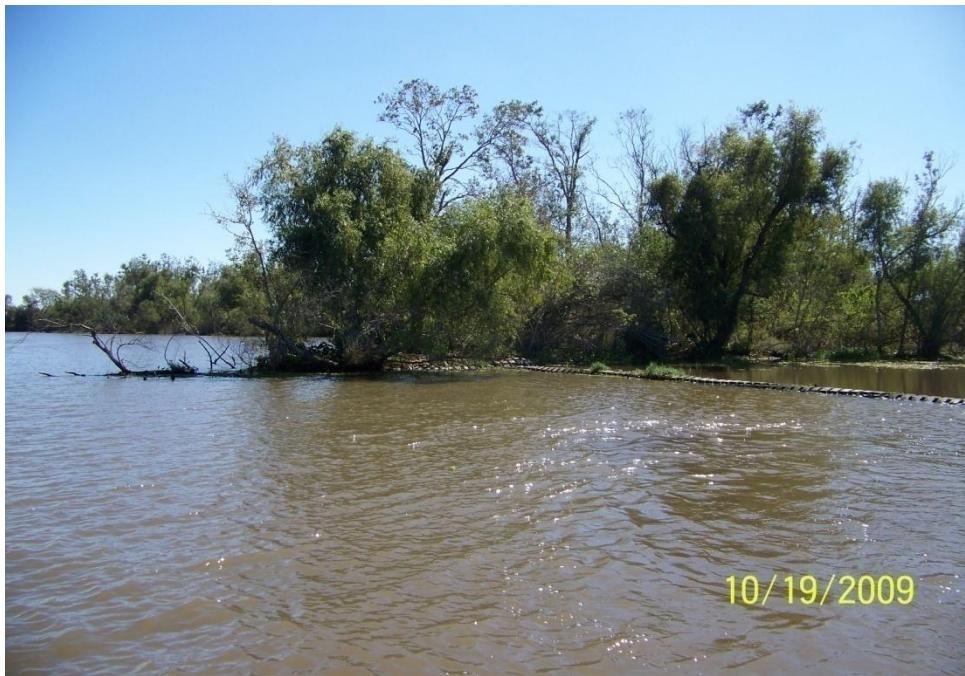
Photo No.50 – Site R1 – view of submerged revetment mats and CPE pipe looking east.

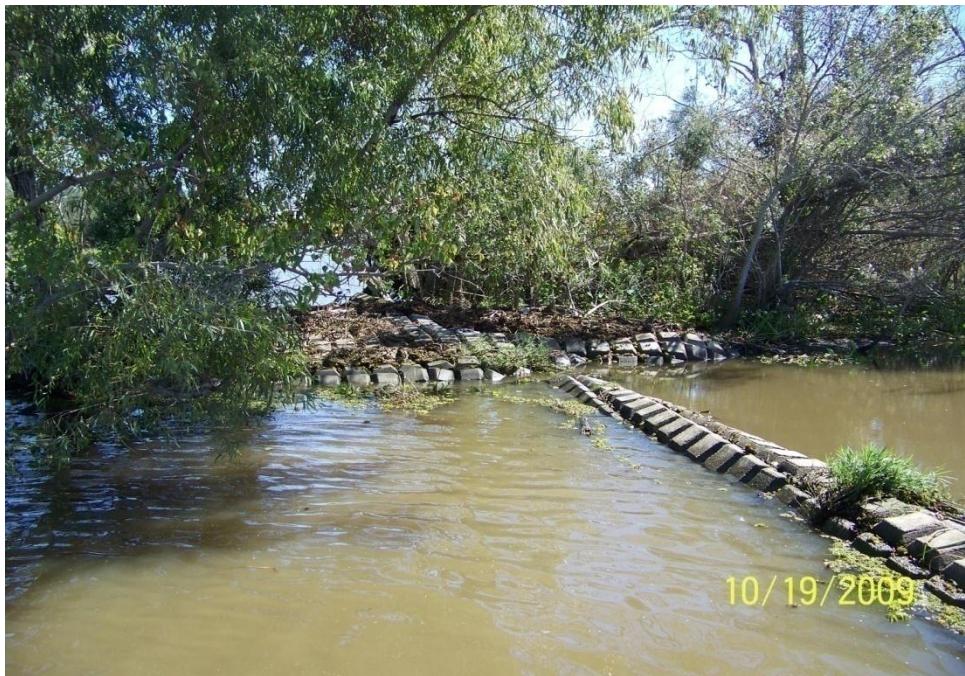
Photo No. 51 – Site R1 – elevated shoreline system tie-in to bank on east side of structure.

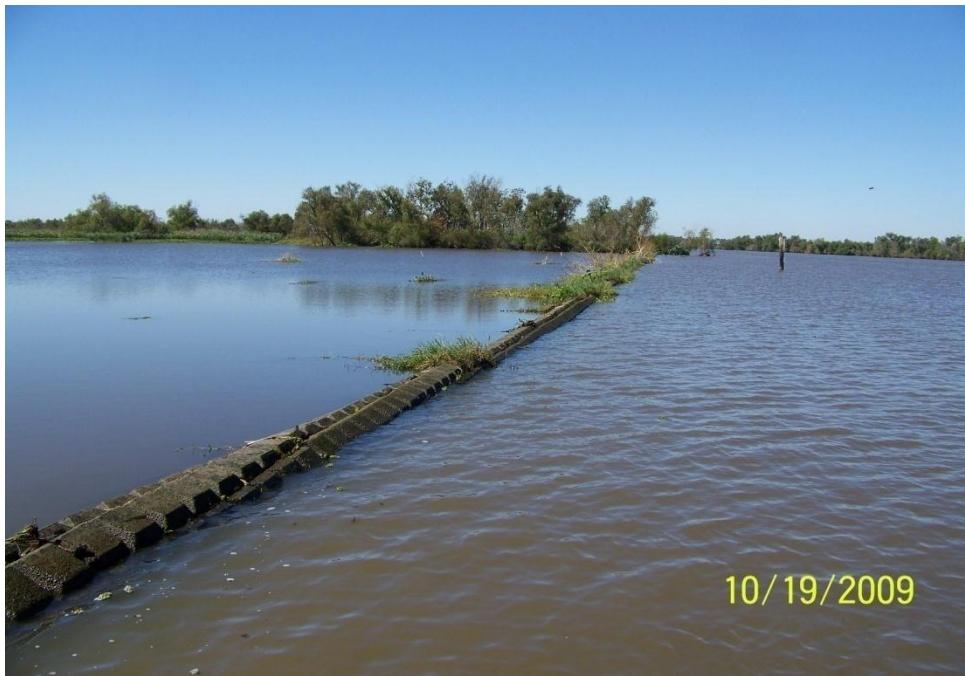
Photo No.52 – Site R1 – elevated shoreline system tie-in to bank on the east side of structure.

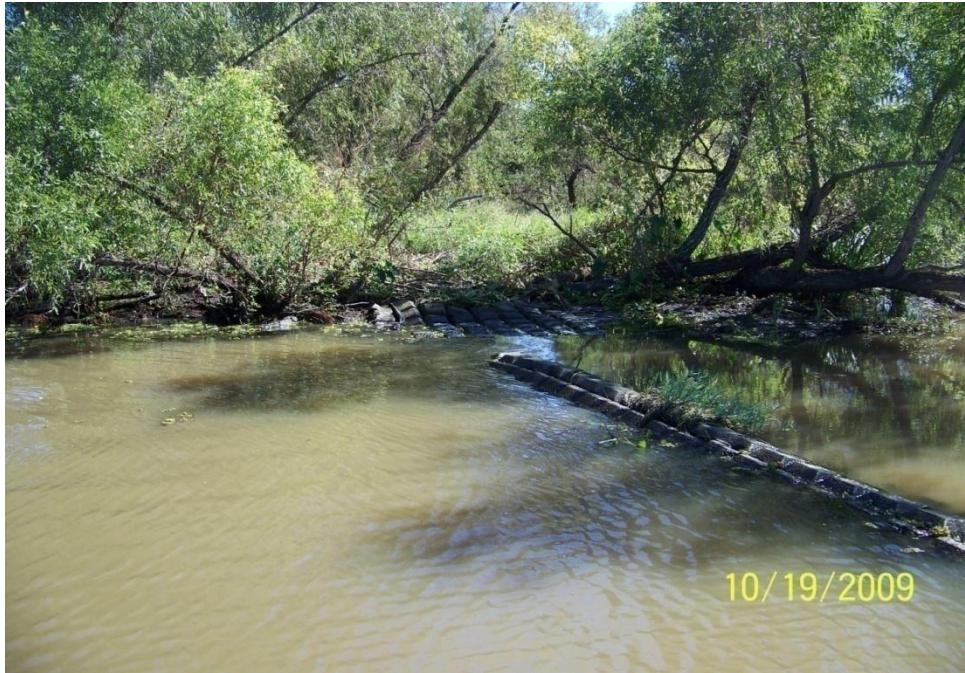
Photo No. 56 – Site R2 – view of settled areas along the elevated shoreline system.

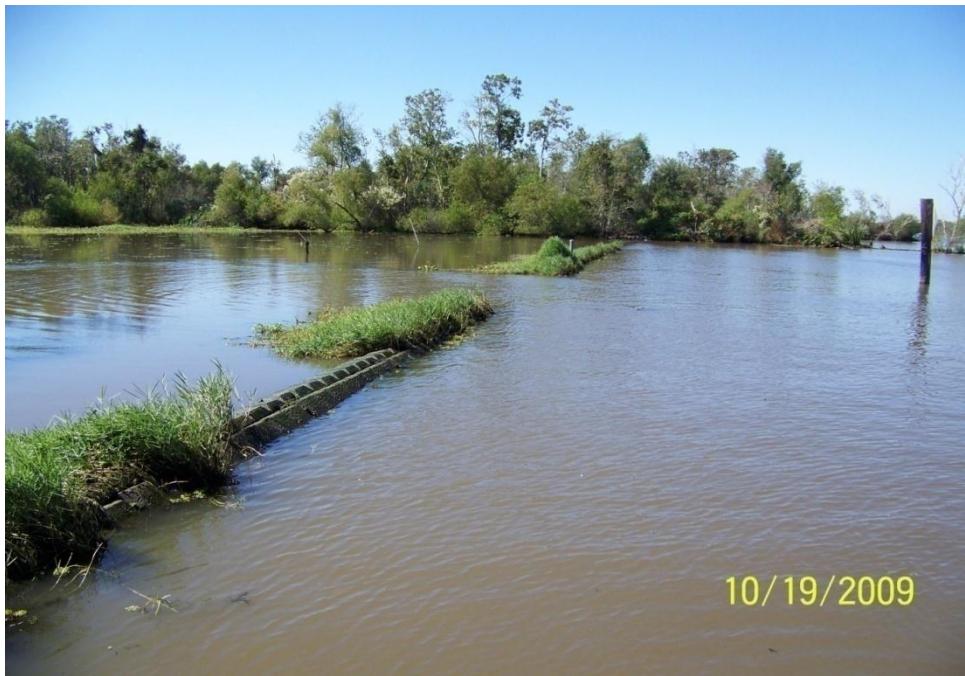
Photo No.57 – Site R2 – Elevation shoreline system (revetment & CPE) tie –in on the east side.

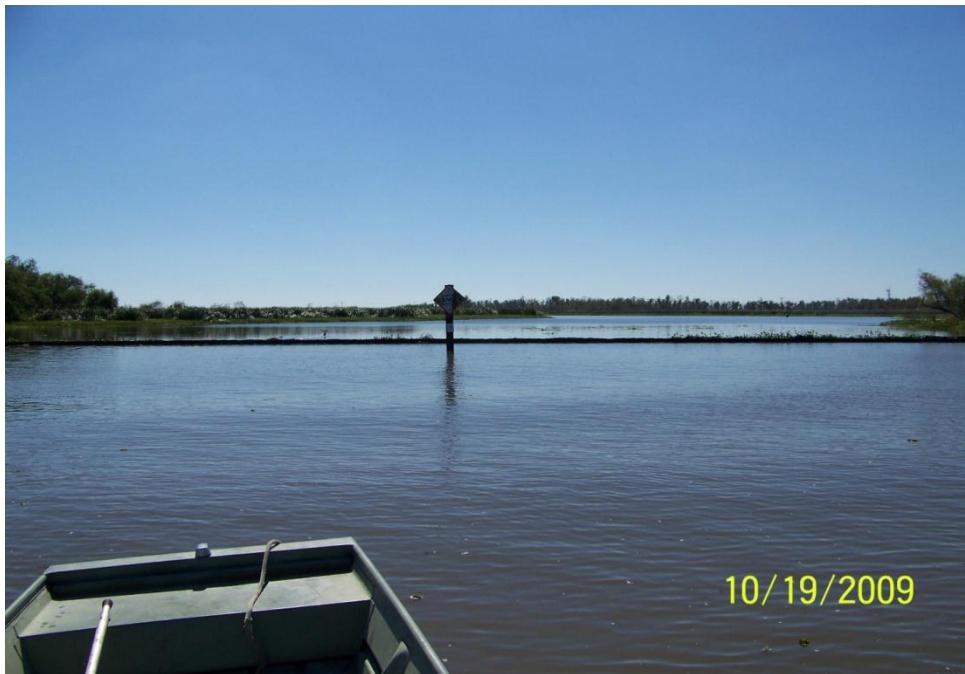
Photo No.58 – Site R2 – view of settled areas long the elevated shoreline system looking west.

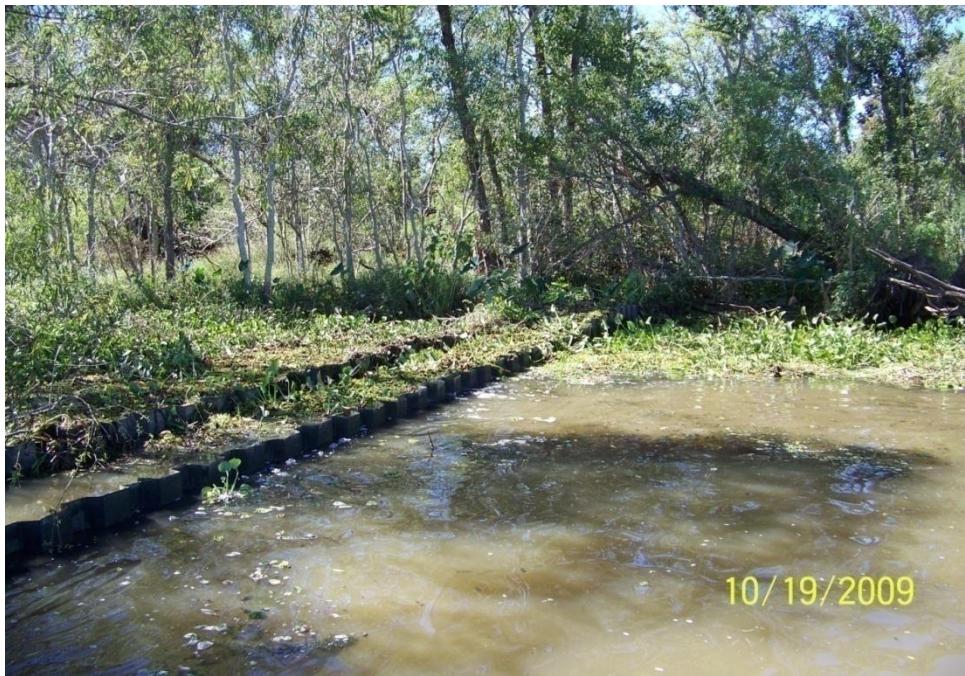
During the inspection, water levels were such that approximately 6 to 9 inches of the sheet pile structures were exposed. No noticeable breaching or major damage to the structures was apparent, and the earthen fill material placed between the double walls did not show signs of erosion. Some minor cracks, splits, and missing tops of sheet pile above the timber waler were observed. Timber walers appeared to be in good condition at all three sites. The galvanized tie rods and timber waler hardware were in good condition with only a minimal amount of corrosion present. The warning signs and support piles were in excellent condition. The bank tie-ins appeared to be in good condition. Overall, the sheet pile structures appear to be intact and do not require any maintenance (Photos 2-6, 12-16 and 59-64; Appendix B).

Photo No. 59 – Site V1 – view of warning sign in front of fiberglass sheet pile double wall.

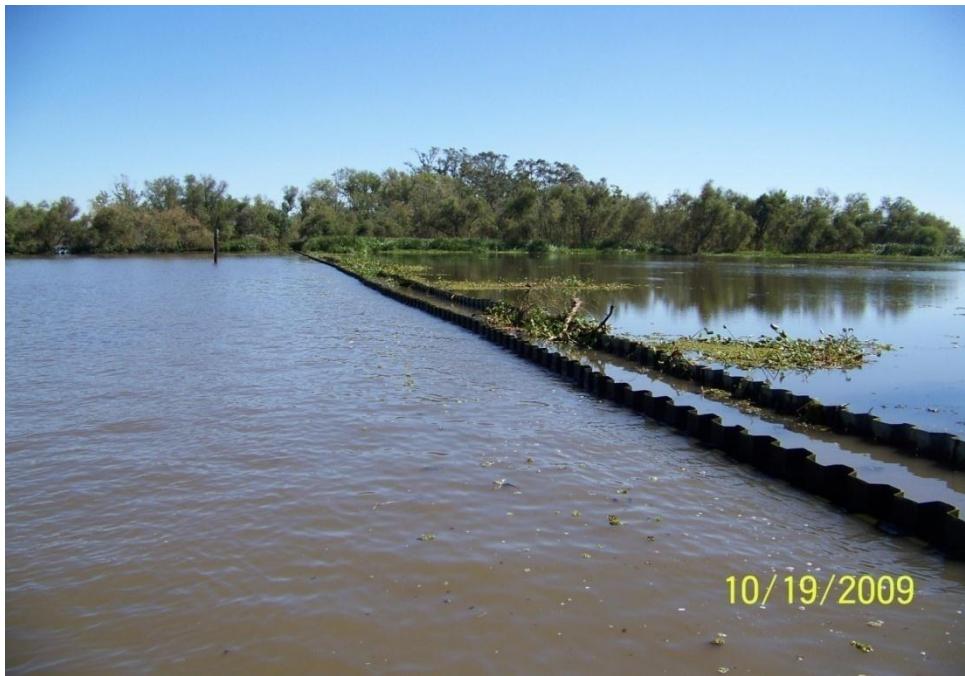
Photo No.60 – Site V1 – fiberglass sheet pile double wall tie-in on the west side of the structure.

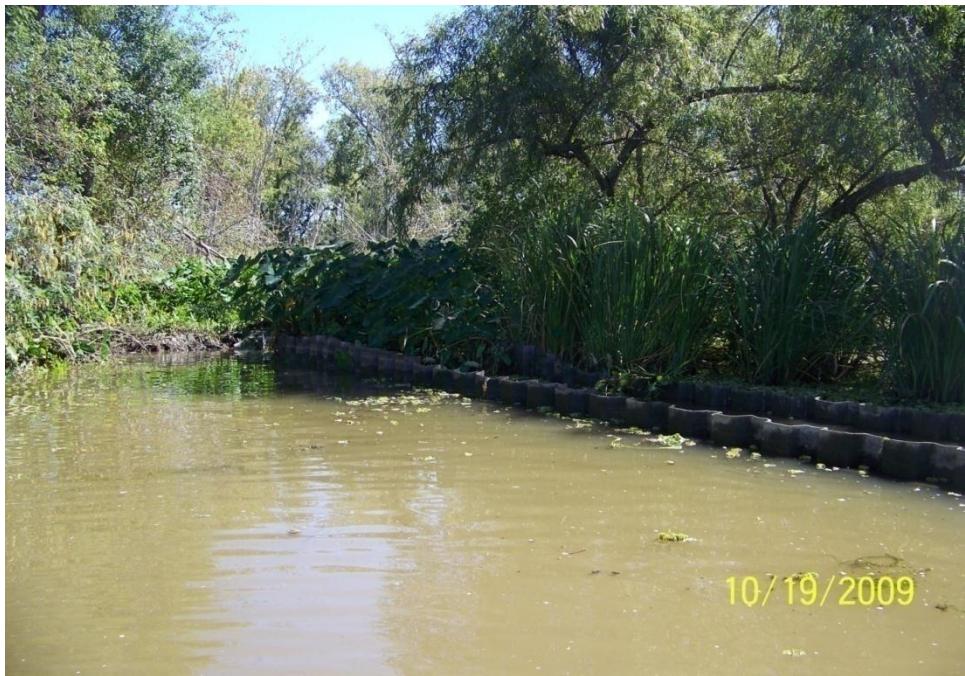
Photo No. 61 – Site V1 – view along fiberglass sheet pile double wall looking eastward.

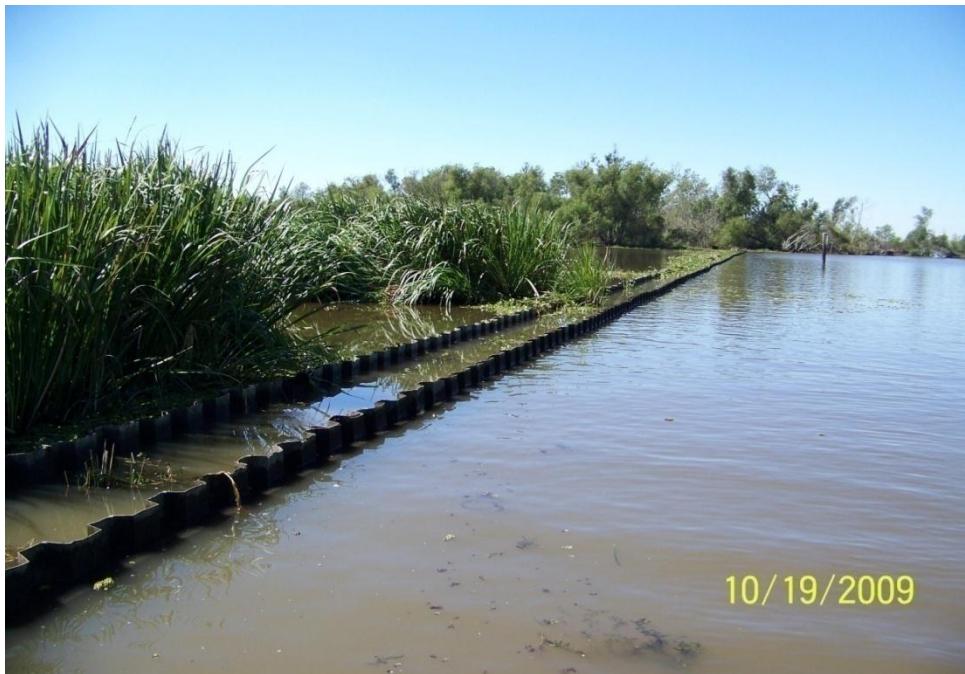
Photo No. 62 – Site V1 – fiberglass sheet pile double wall tie-in on east side of structure.

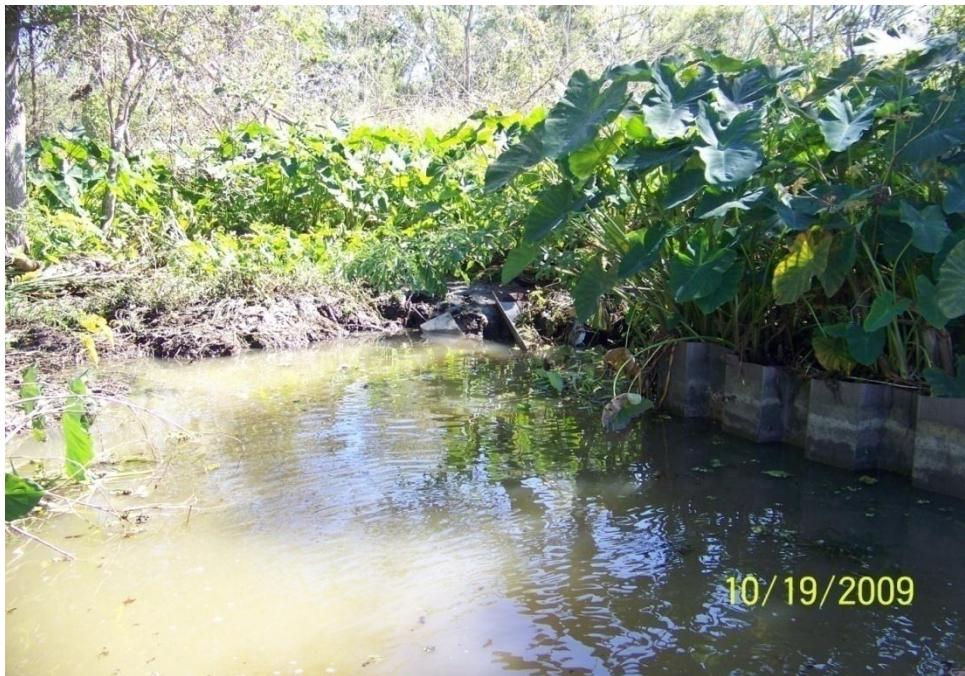
Photo No.63 – Site V1 – fiberglass sheet pile double wall looking westward.

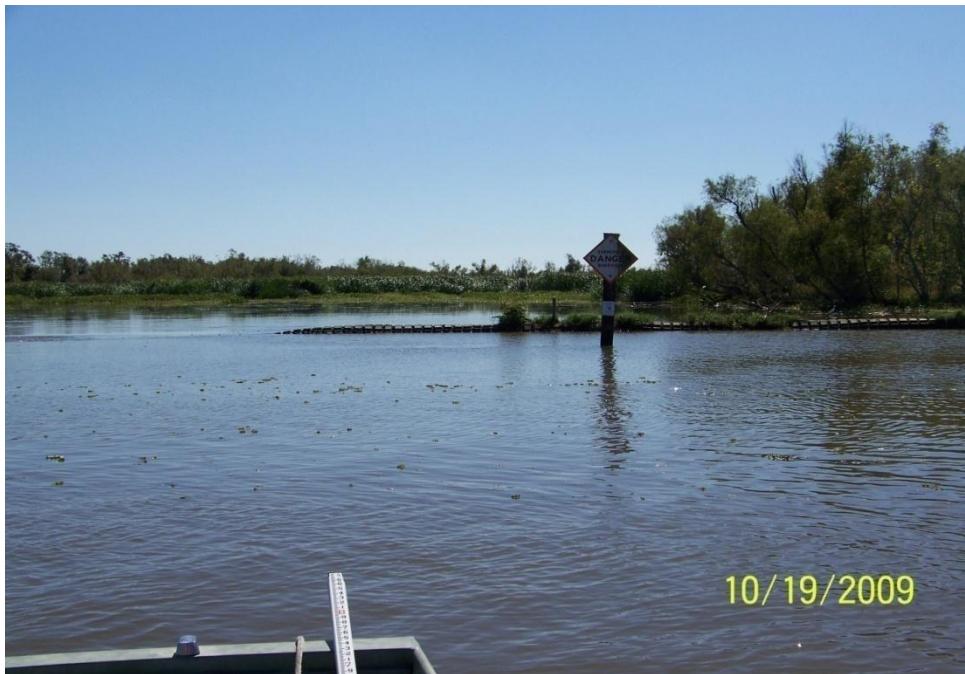
Photo No. 64 – Site V1 – fiberglass sheet pile double wall tie-in to bank on east side of structure.

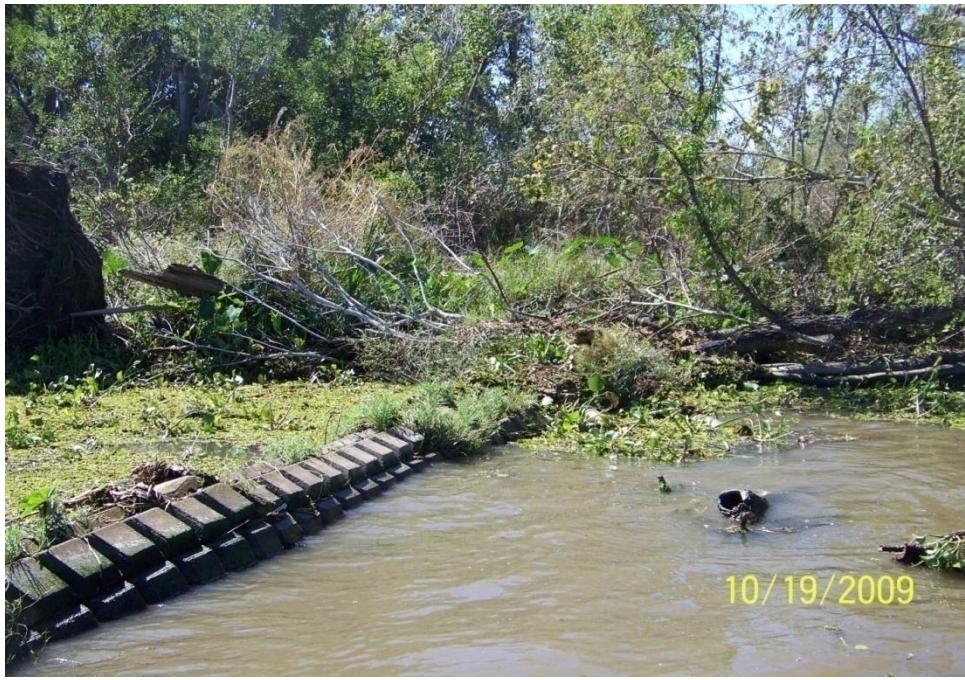
Photo No. 65 – Site R1 – settled area along elevated shoreline system (revetment mats and CPE).

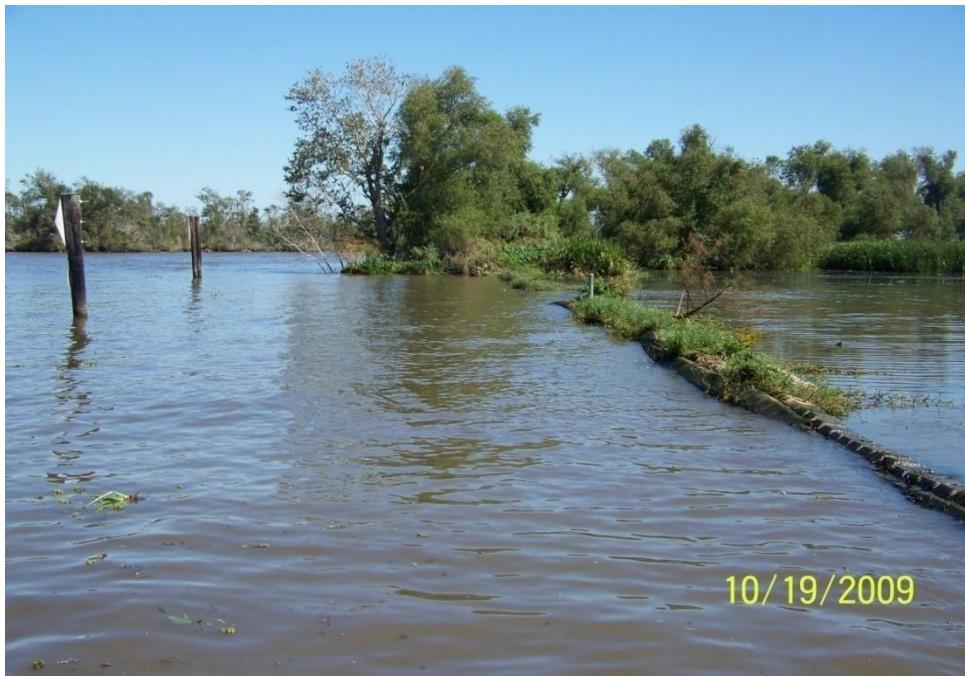
Photo No.66 – Site R1 – elevated shoreline system tie-in to bank on west side of structure.

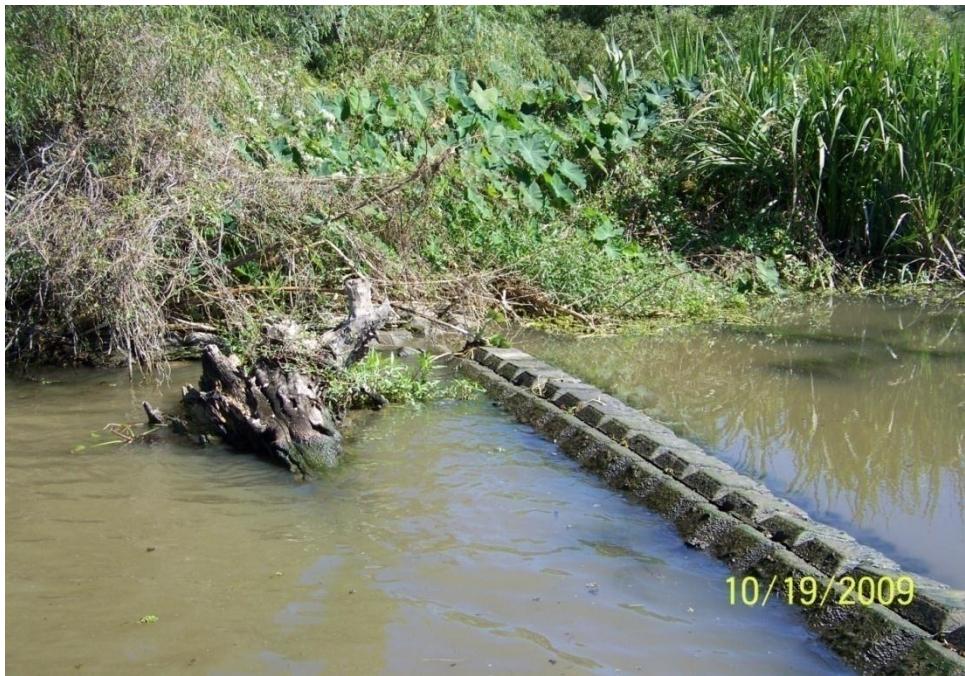
Photo No.67 – Site R1 – elevated shoreline system (revetment & CPE) looking eastward.

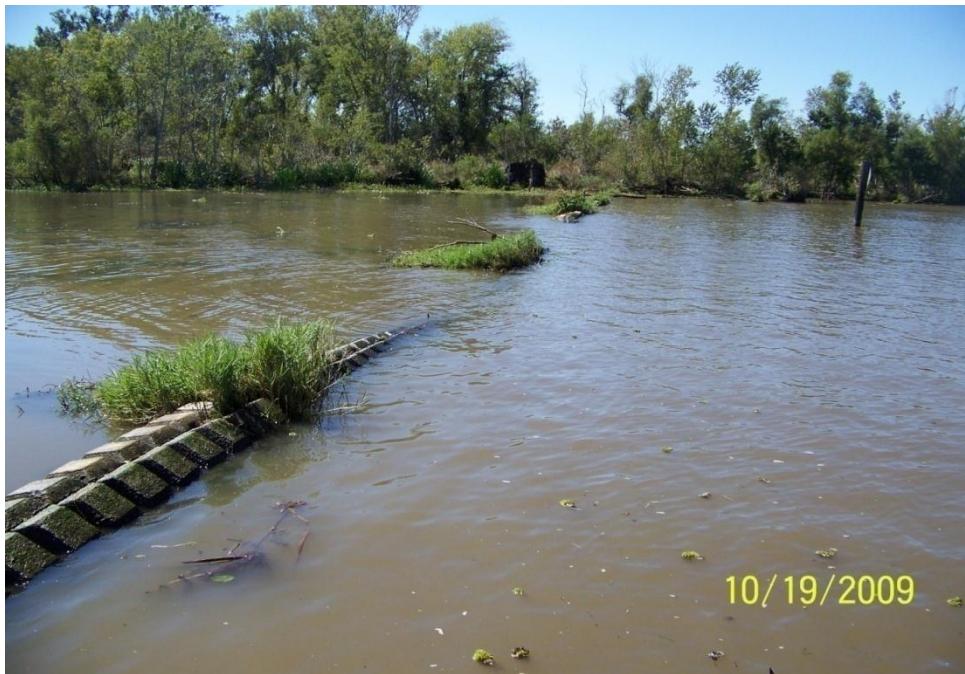
Photo No. 68 – Site R1 – elevated shoreline system tie-in to bank on east side of structure.
