2013 Operations, Maintenance, and Monitoring Report

GIWW (Gulf Intracoastal Waterway) to Clovelly Hydrologic Restoration (BA-02)

State Project Number BA-02 Priority Project List 1

December 2013 Lafourche Parish

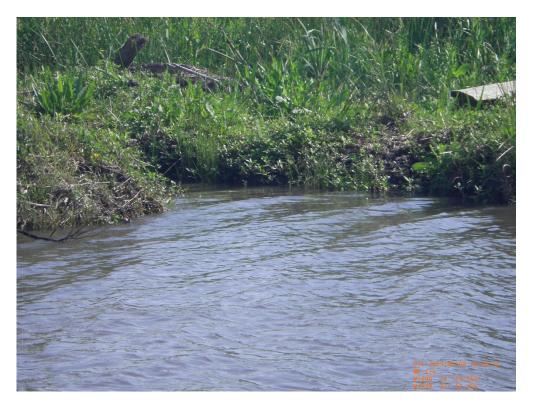
Photo 1: View of small breach around the east side of Structure 43

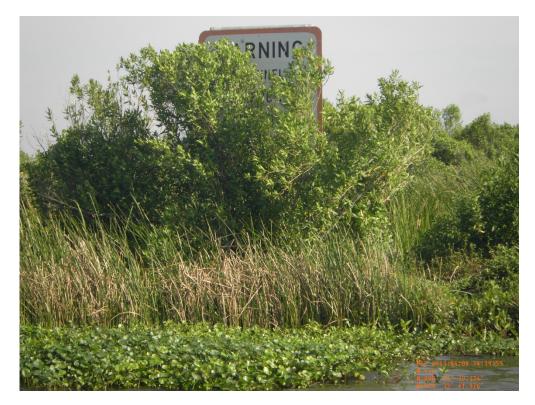
Photo 2: View of Structure 43 looking north. The rock plug is not visible through the vegetation.

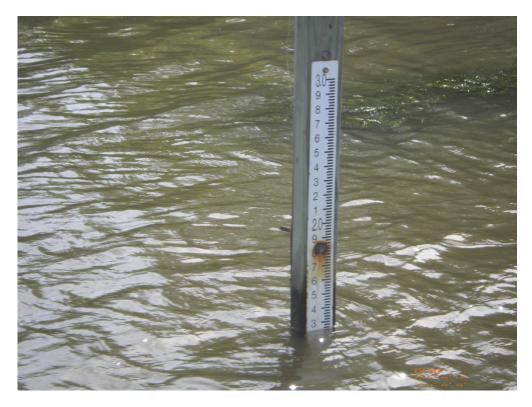
Photo 3: A tide reading of 1.25' NAVD88 was taken near Structure 1 at approximately 10:00am

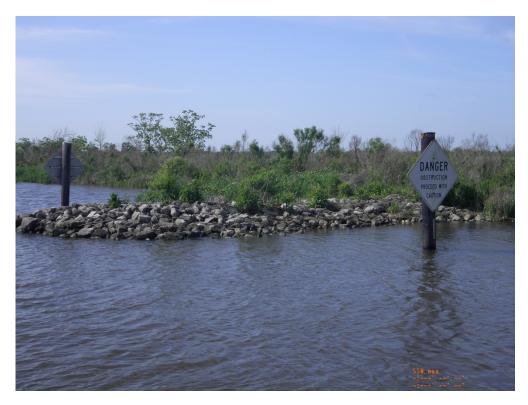
Photo 6: Close up view of the embankment tie-ins on the west side of Structure 1

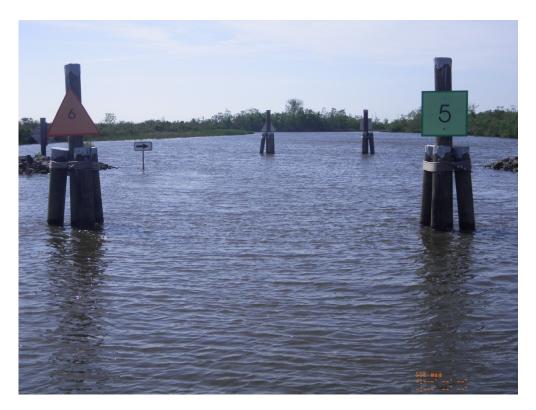
Photo 7: View of the newly installed timber pile clusters and signs on the north side of Structure 1

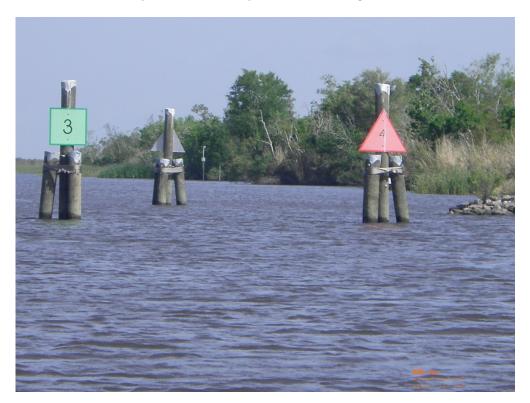
Photo 8: View of the newly installed timber pile clusters and signs on the south side of Structure 1

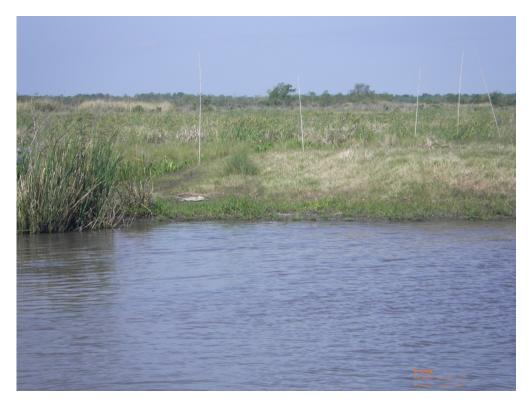
Photo 10: View of Breach Closure No. 5 which was part of the 2012 Maintenance Project

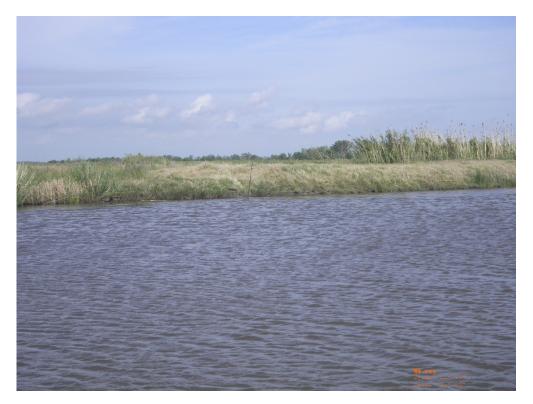
Photo 12: View of Breach Closure No. 4 which was part of the 2012 Maintenance Project

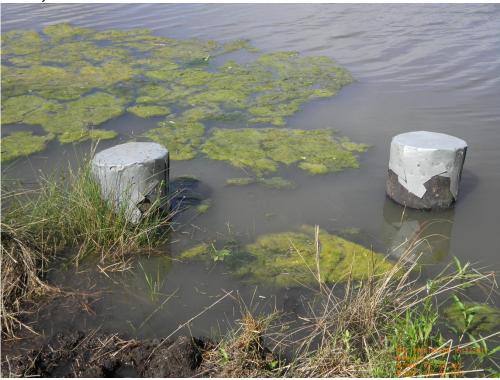
Photo 16: Galvanized pile caps installed on marsh side Structure 91 as part of 2012 Maintenance Project

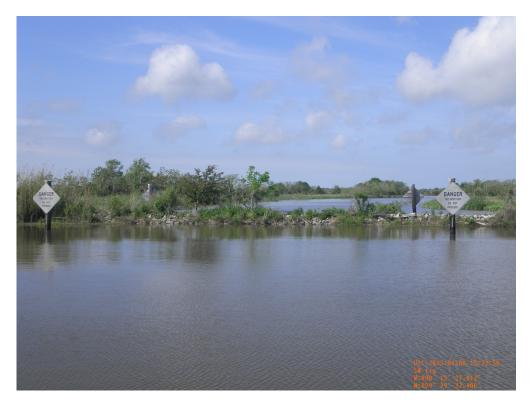
Photo 17: Overall view of Structure 90 rock plug, looking southwest

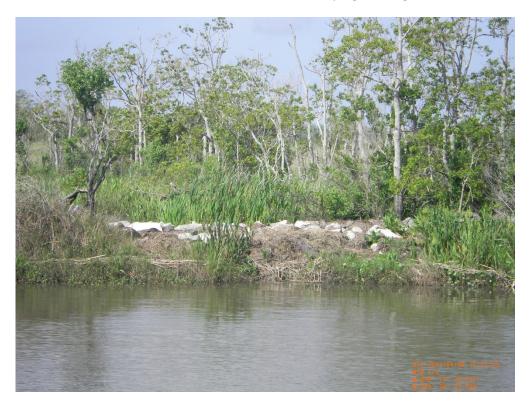
Photo 18: Close up view of the embankment tie-in on the southeast side of Structure 90

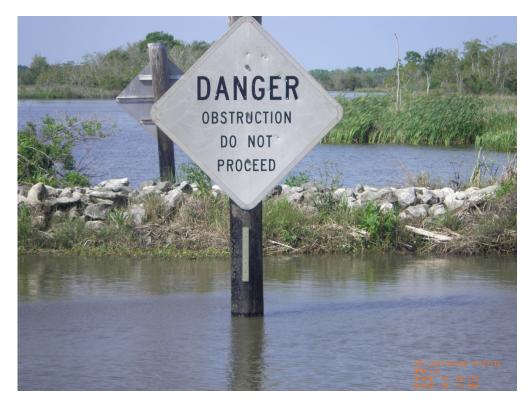
Photo 20: Close of view of the warning signs and supports of Structure 90

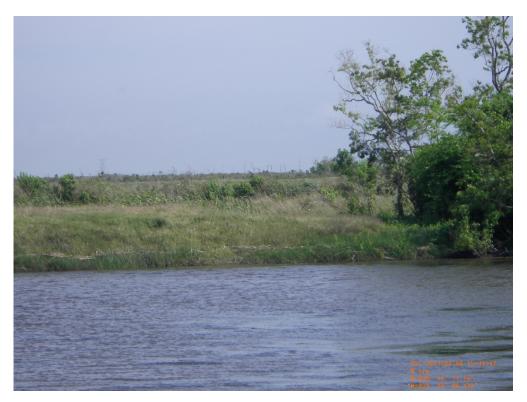
Photo 22: View of Breach Closure No. 2 which was part of the 2012 Maintenance Project

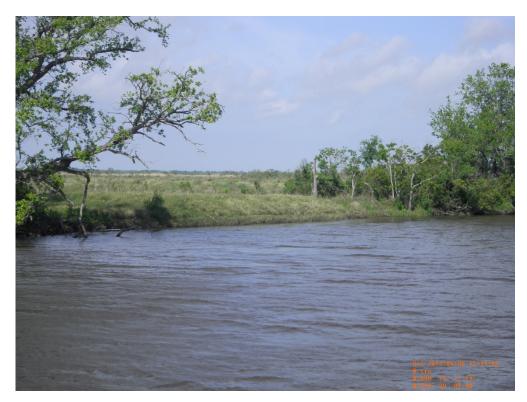
Photo 24: View of Breach Closure No. 3 which was part of the 2012 Maintenance Project

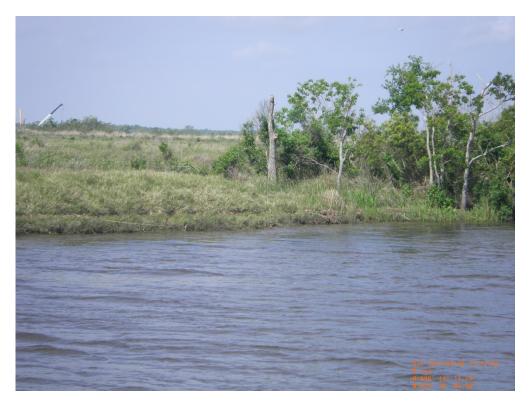
Photo 26: View of Breach Closure No. 3 which was part of the 2012 Maintenance Project

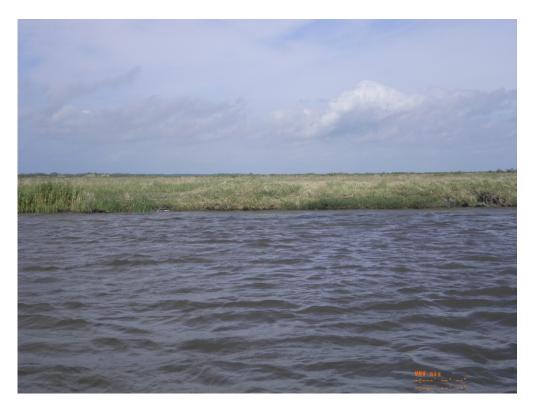
Photo 27: View of Breach Closure No. 1 which was part of the 2012 Maintenance Project

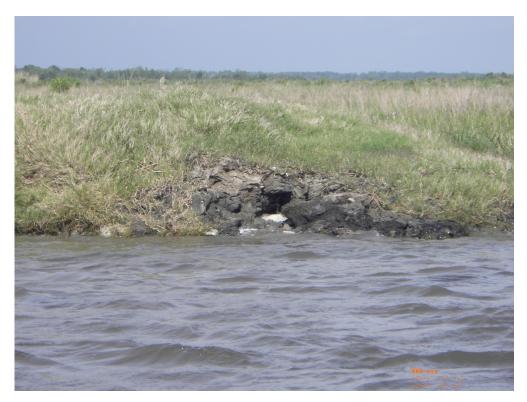
Photo 28: View of Breach Closure No. 1 which was part of the 2012 Maintenance Project

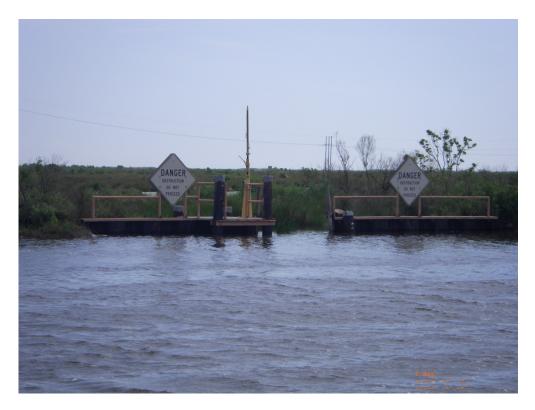
Photo 29: Overall view of Structure 35 variable crest weir, looking northeast

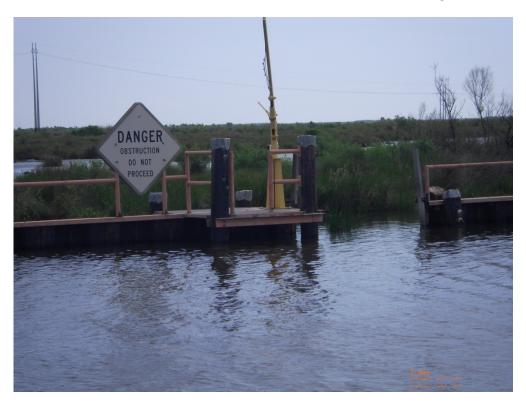
Photo 30: Close up view of Structure 35 warning signs, railings, steel bulkhead, and operating crane

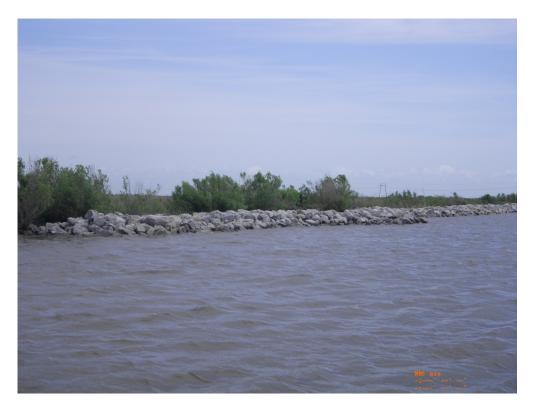
Photo 32: View of the Lake Rim rock dike refurbishment from Breton Canal, looking north

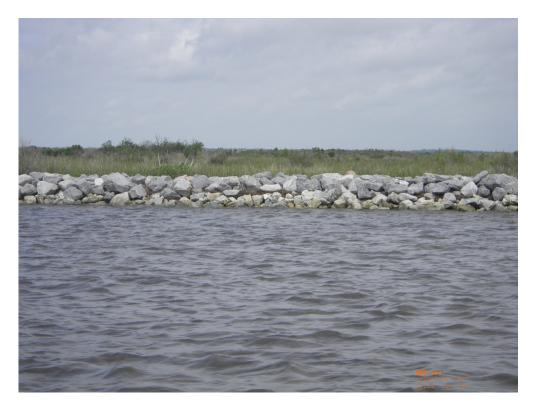
Photo 33: View of the Lake Rim rock dike refurbishment from Breton Canal, looking northwest

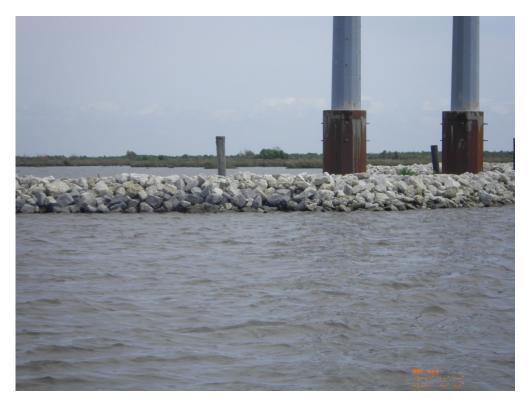
Photo 34: View of the Lake Rim rock dike refurbishment from Breton Canal, looking northwest

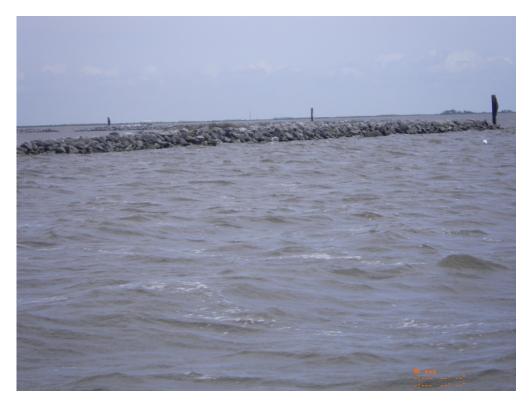
Photo 36: View of the Lake Rim rock dike refurbishment from Breton Canal, looking north

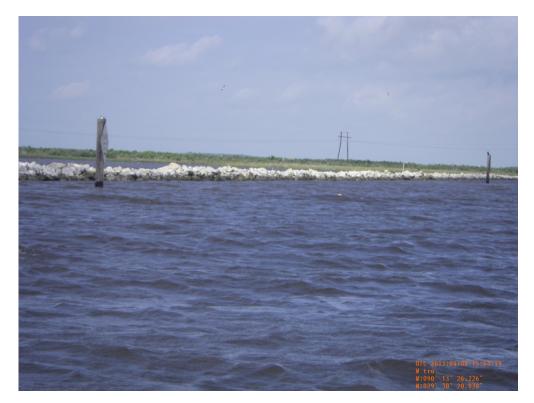
Photo 38: View along the Lake Rim rock dike refurbishment from Little Lake, looking west

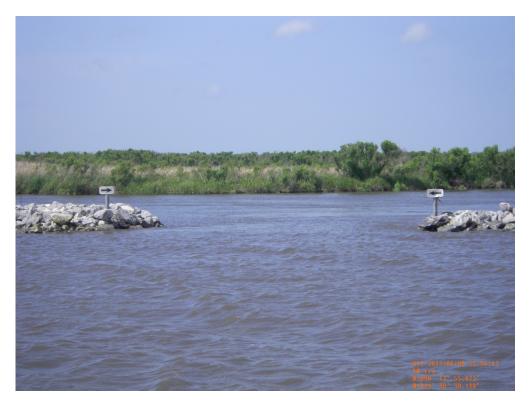
Photo 40: Overall view of Structure 2 fixed crest rock weir with boat bay, looking southwest

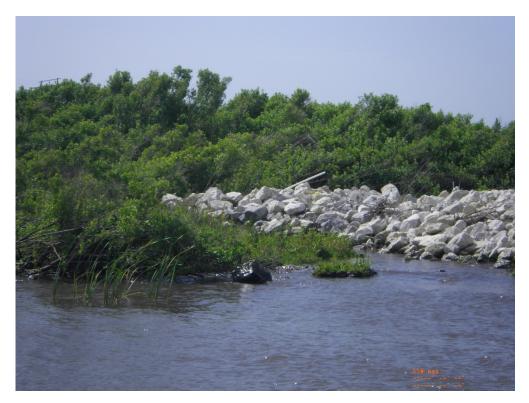
Photo 42: View of the embankment tie-in on the southern side of Structure 2

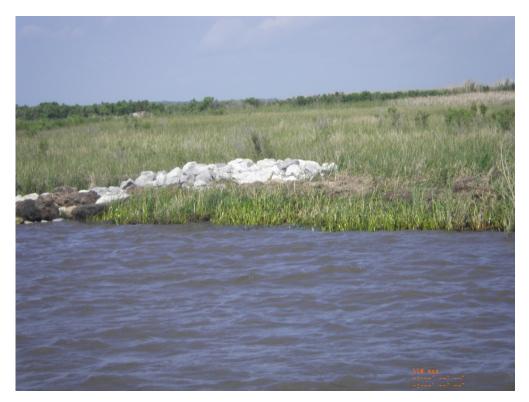
Photo 44: View of the embankment tie-in on the northern side of Structure 2

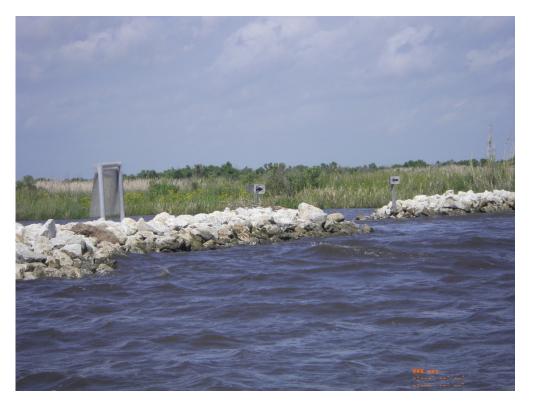
Photo 46: View along the rock recap of Structure 4, looking northwest

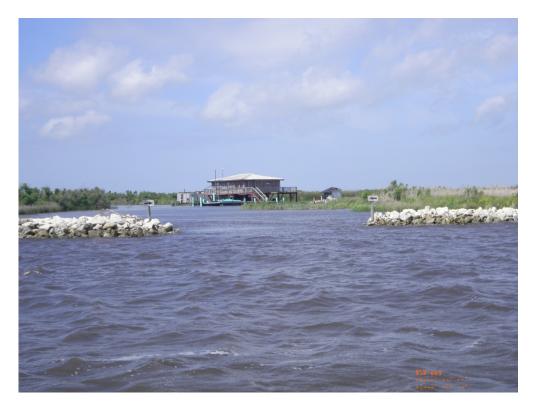
Photo 47: Overall view of Structure 4 fixed crest rock weir with boat bay, looking west

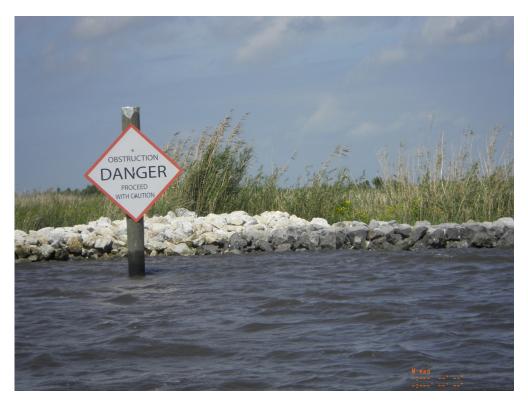
Photo 48: View of new warning sign and transition between Structure 4 and Rock Dike Extension

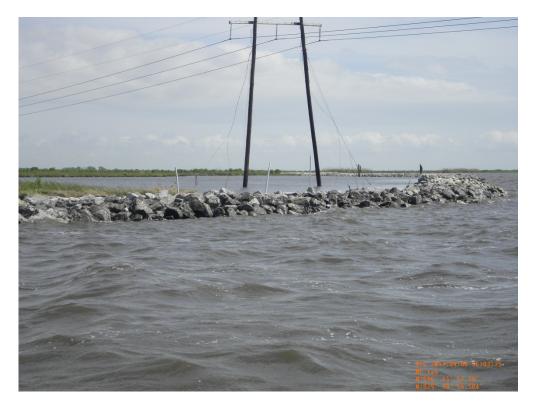
Photo 49: View of Rock Dike Extension from Little Lake, looking north

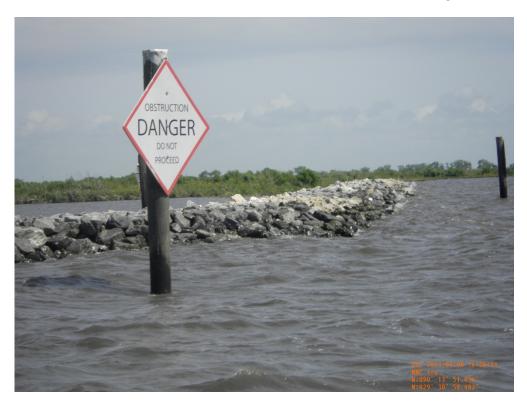
Photo 50: View of new warning sign and transition from Rock Dike Extension to Structure 4A&4B

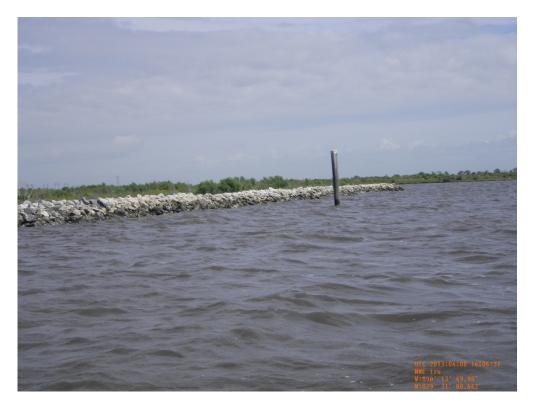
Photo 51: View of Structure 4A&4B rock recap along Little Lake, looking north

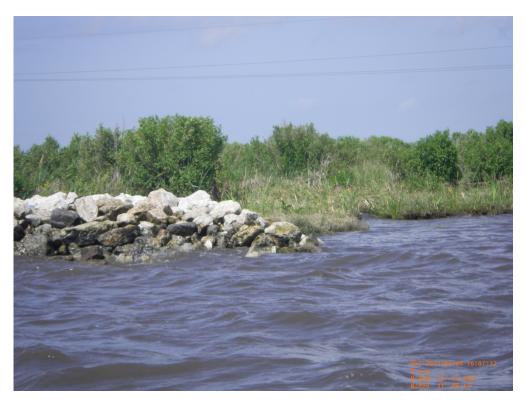
Photo 52: View of the northernmost end of Structure 4A&4B, looking west

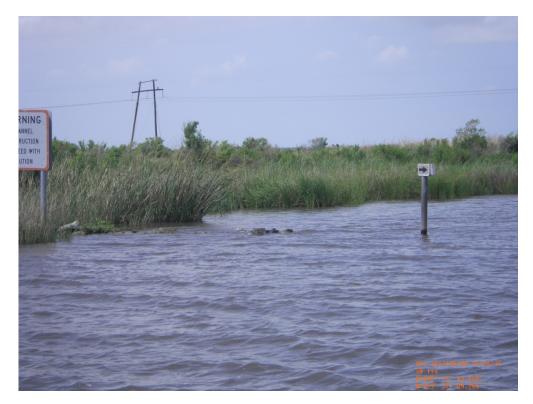
Photo 54: View of the warning sign and embankment tie-in on the southern end of Structure 7

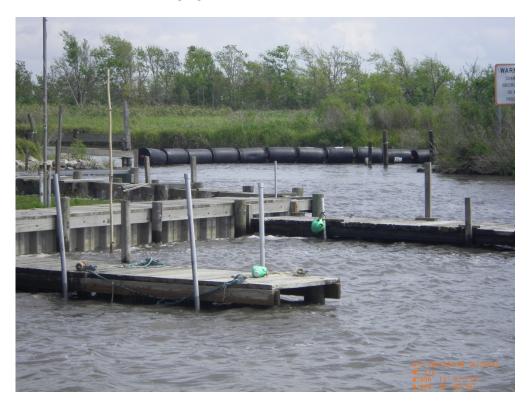
Photo 56: View of Structure 8 rock riprap channel plug, looking north

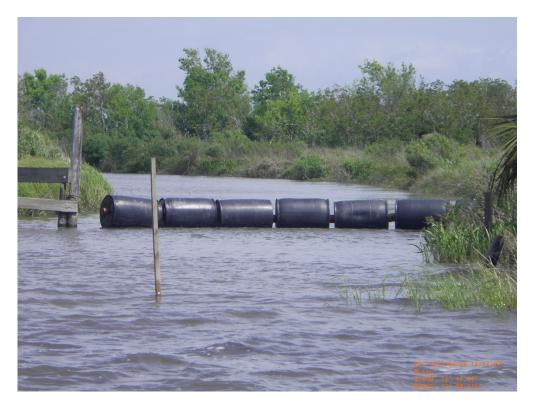
Photo 57: View of Structure 8 rock riprap channel plug, looking north

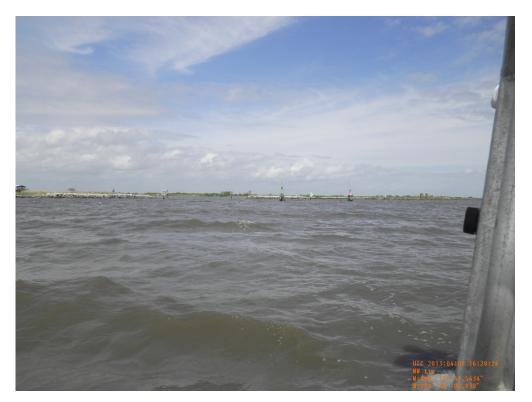
Photo 58: Overall view of Structure 14 fixed crest rock weir with barge bay from Little Lake looking west

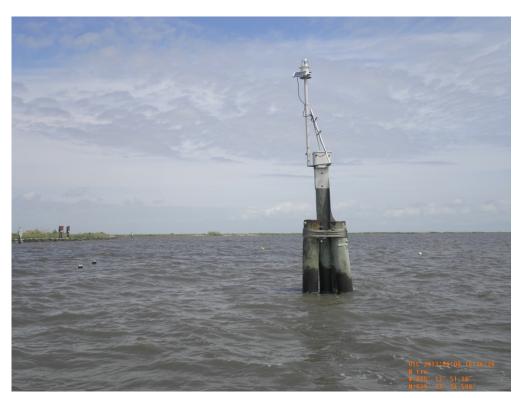
Photo 60: View of navigational light installed on the timber pile cluster at Structure 14

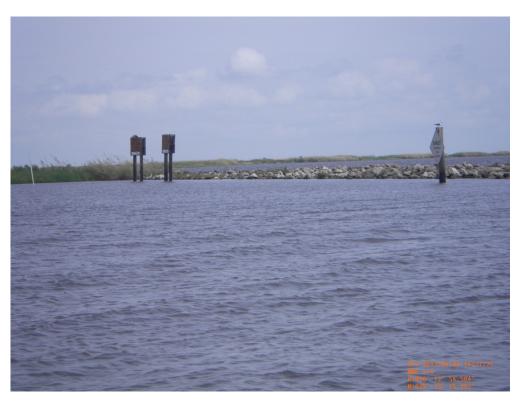
Photo 62: View along the northern side of Structure 14 from Clovelly Canal, looking northeast

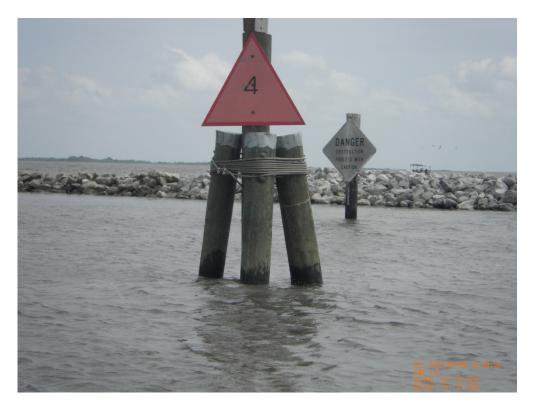
Photo 63: View of newly installed timber pile cluster and sign on northwest side of Structure 14

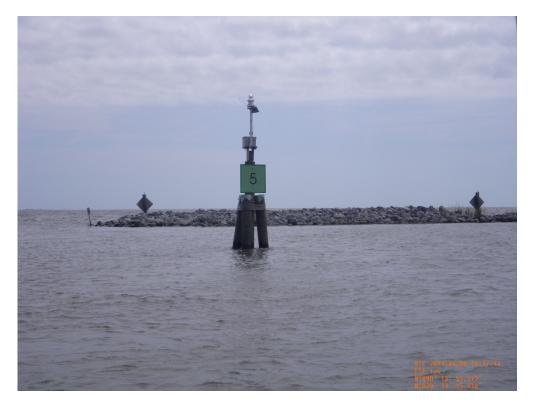
Photo 64: View of the rock recap on the southern side of Structure 14, looking south east

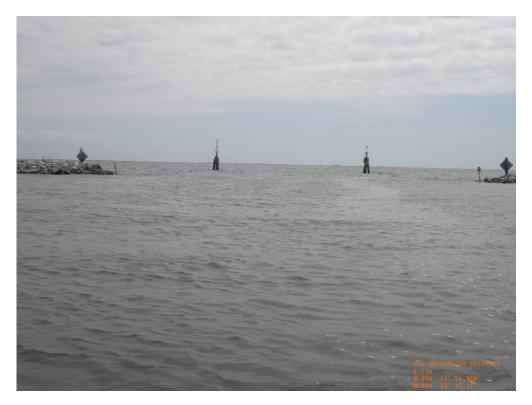
Photo 66: Overall view of Structure 14 fixed crest rock weir with barge bay from Clovelly Canal looking east
