**Coastal Protection and Restoration
Authority of Louisiana (CPRA)**

2023 Operations, Maintenance, and Monitoring Report

Black Bayou Culverts Hydrologic Restoration

State Project Number CS-29
Priority Project List 9

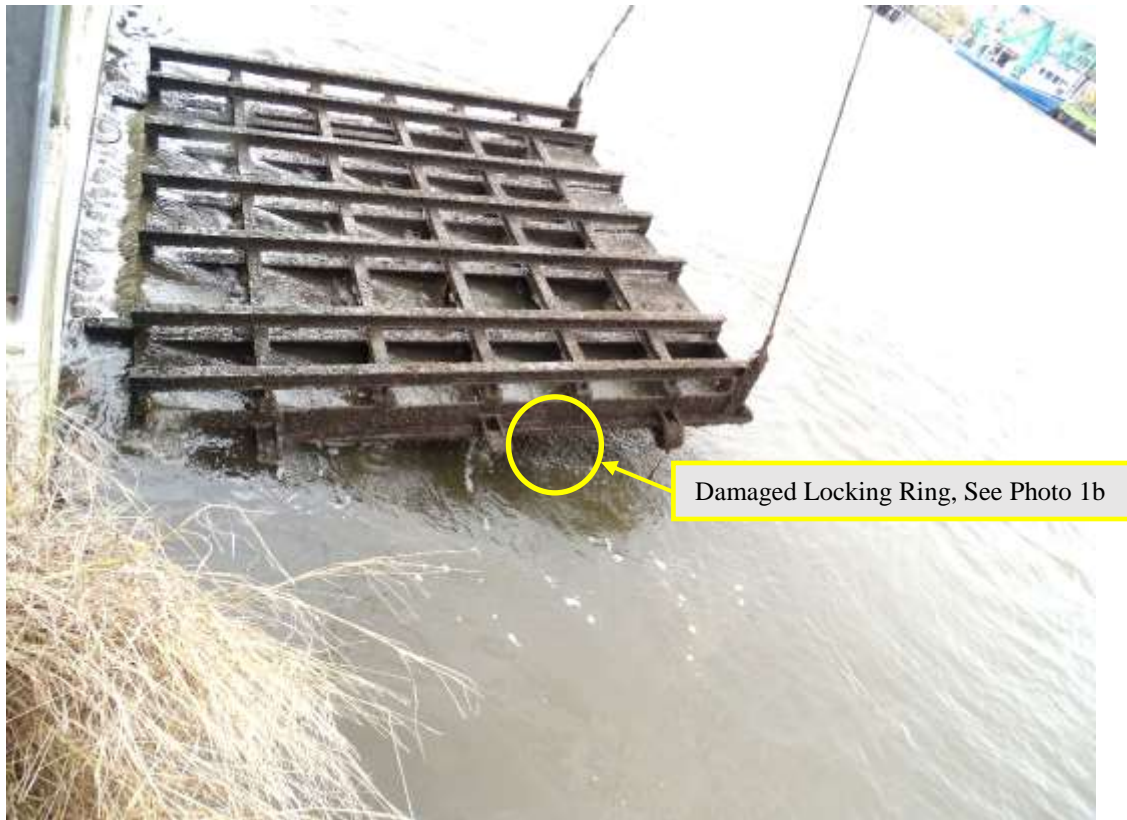
1a. Gate No. 1 – North side of Gate

A	Water levels in the channel did not allow for visual inspection of the locking rings attached to the gate frames.			
B	With all but one locking ring on the gate intact, barring issues with the rings on the receiver gate frame, there should be no problems locking the gate in the closed position. In March of this year, this gate was locked in the closed position with no issues.			
C	A new padlock was installed through the shackle of the lifting cables once the gate was lowered.			
D	Observed an increase in the growth of marine vegetation on the gate surface from that observed during last year's inspection.			
E				
F

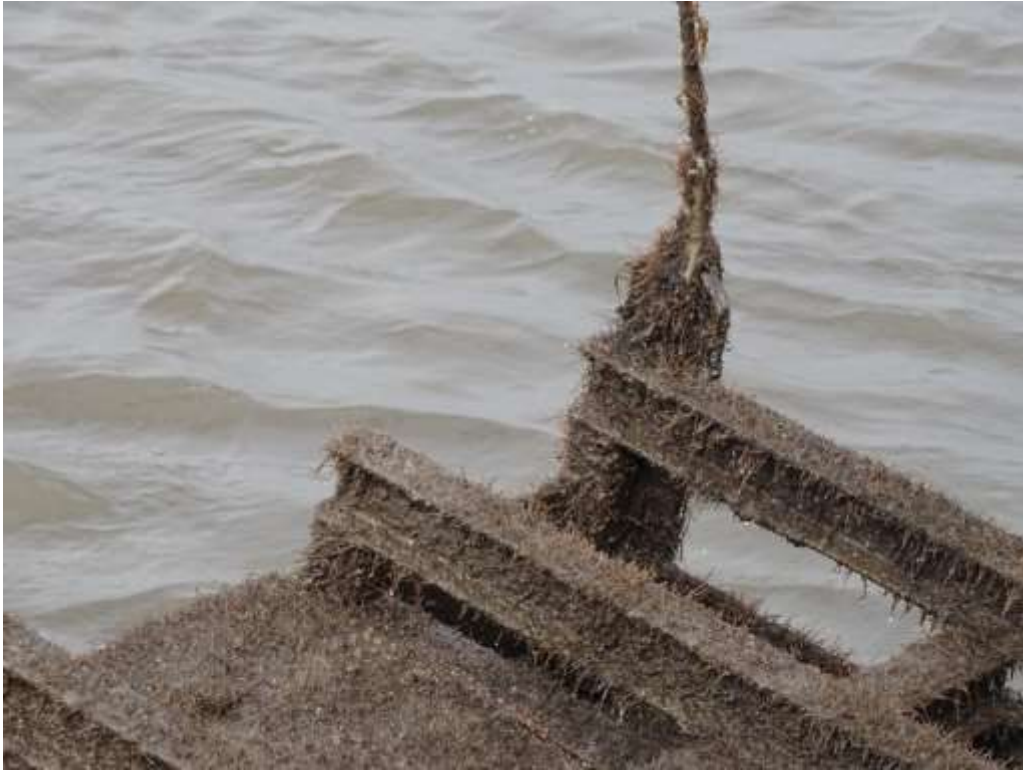
1c. Gate No. 1 – Lifting eye, shackle and cable - North side of Gate

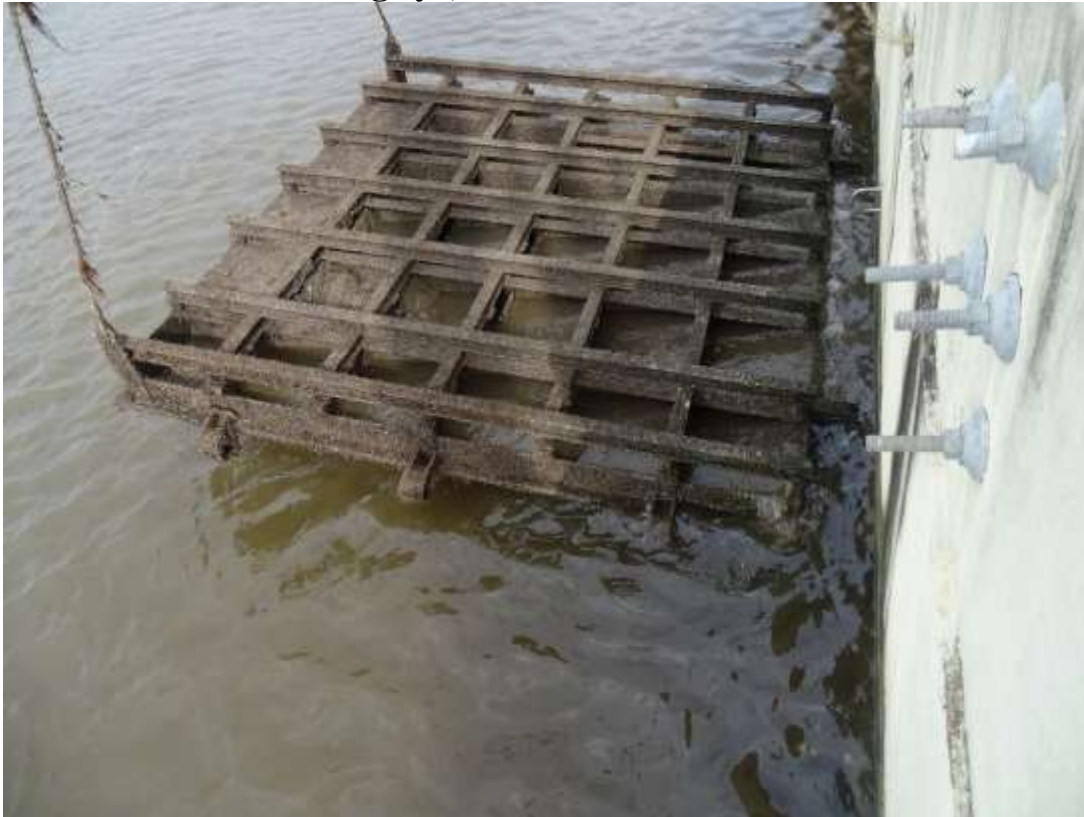
1d. Gate No. 1 – South side of Gate

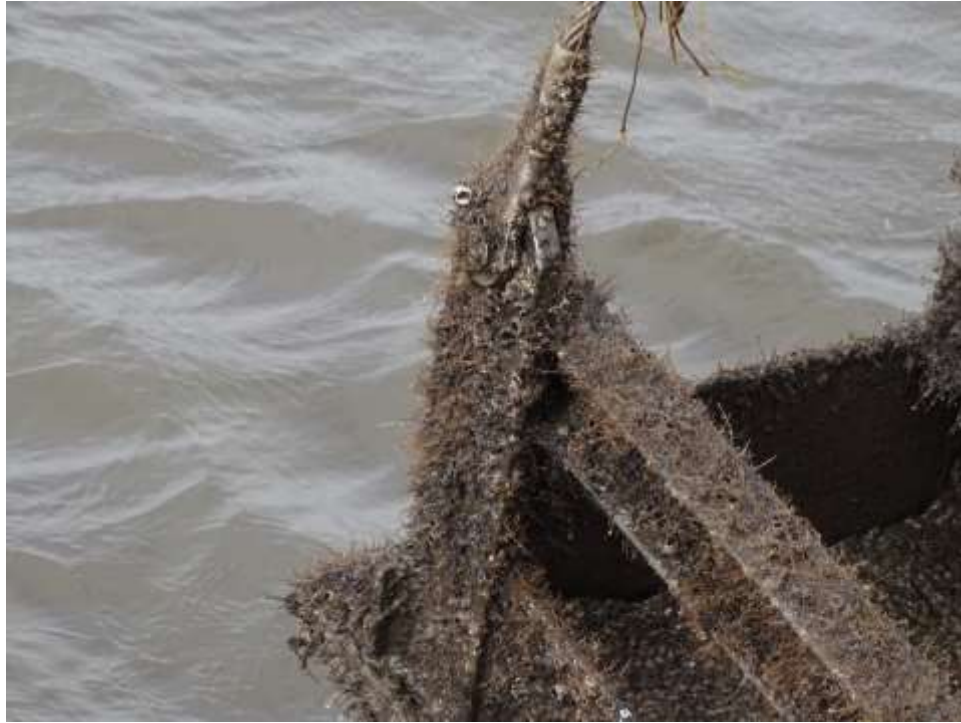
1e. Gate No. 1 – Lifting eye, shackle and cable - South side of

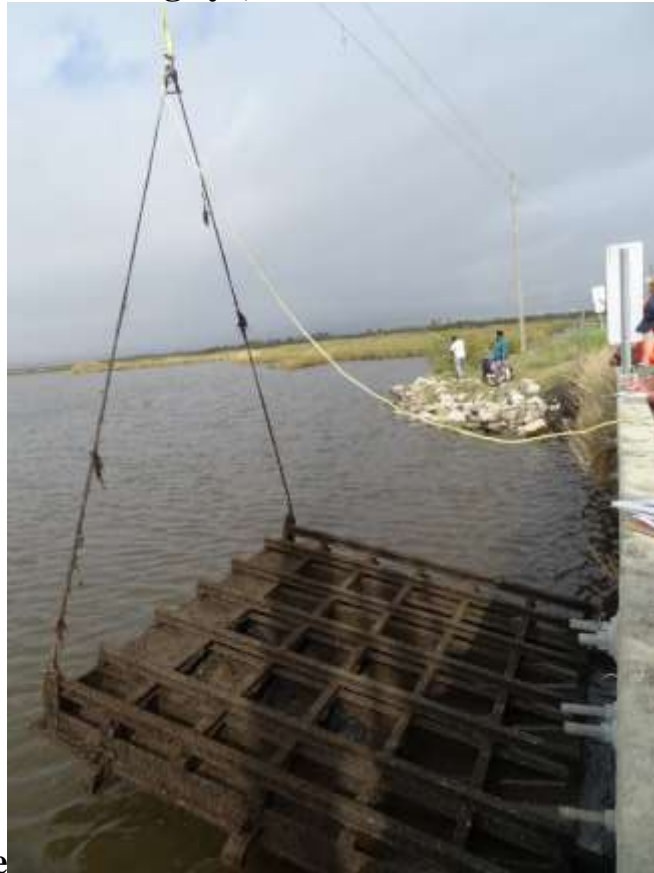
1f. Gate No. 1 – Lifting eyes, shackle and cables- from South side of Gate

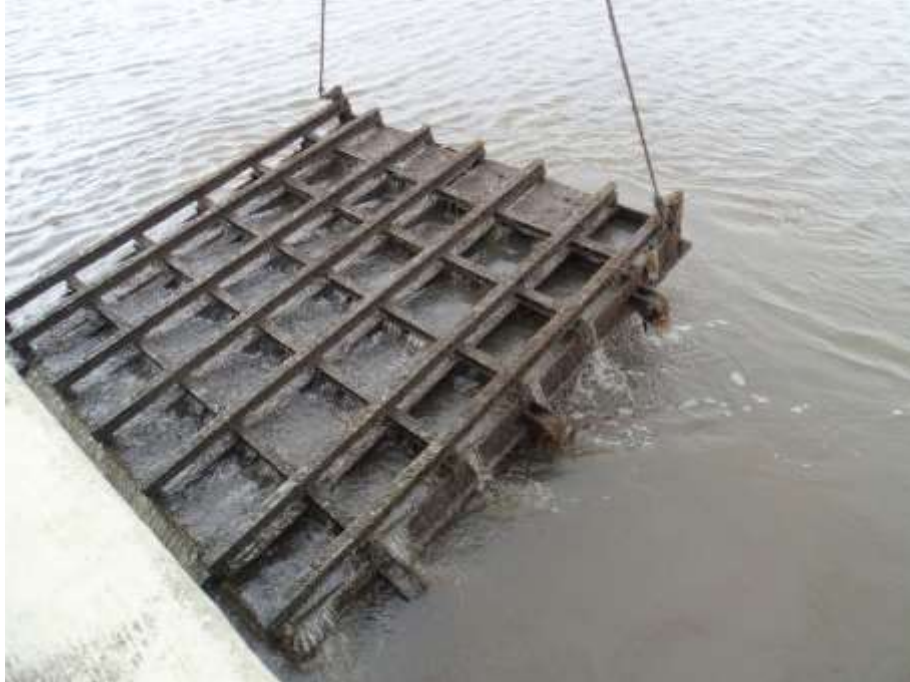
2a. Gate No. 2 – North side of Gate

B	With all the locking rings on the gate intact, barring issues with the rings on the receiving gate frame, there should be no issues locking this gate in the closed position. In March of this year, this gate was locked in the closed position with no issues.			
C	A new padlock was installed through the shackle of the lifting cables once the gate was lowered.			
D	Observed an increase in the growth of marine vegetation on the gate surface from that observed during last year's inspection.			
E				
F

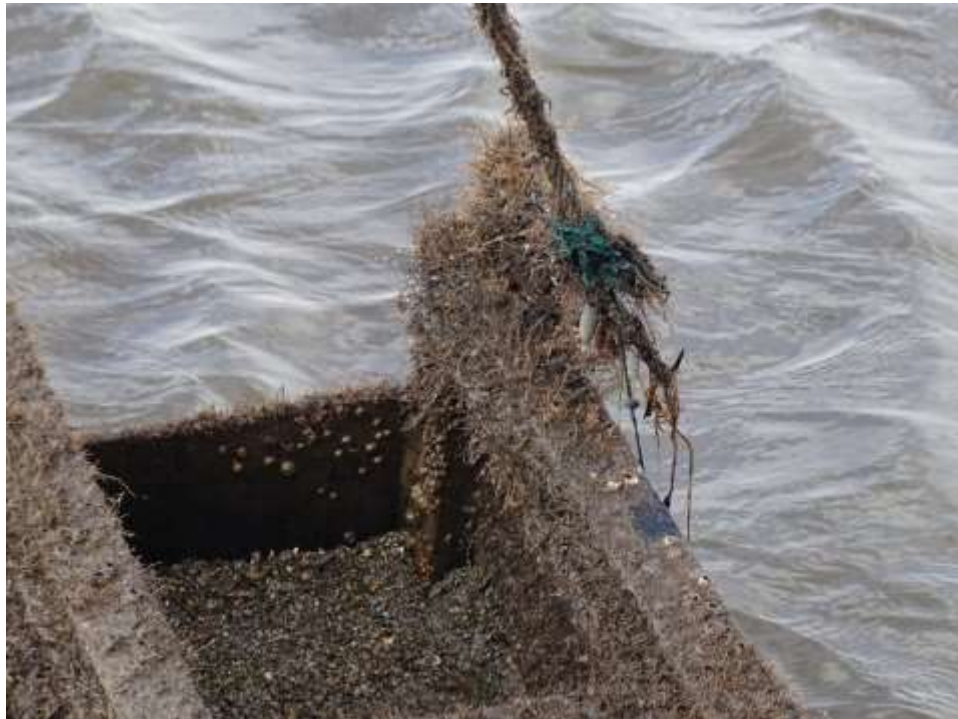
2b. Gate No. 2 – Lifting eye, shackle and cable - North side of Gate

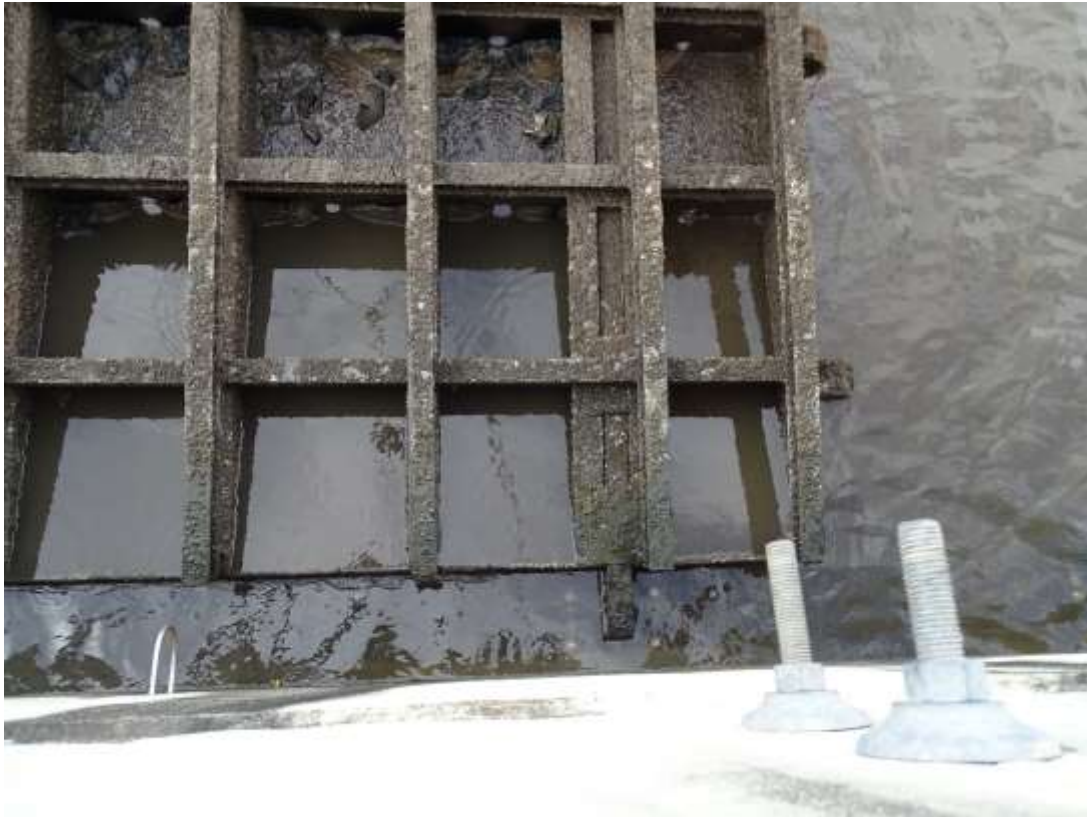
2c. Gate No. 2 – Gate Hinge at Headwall - North side of Gate

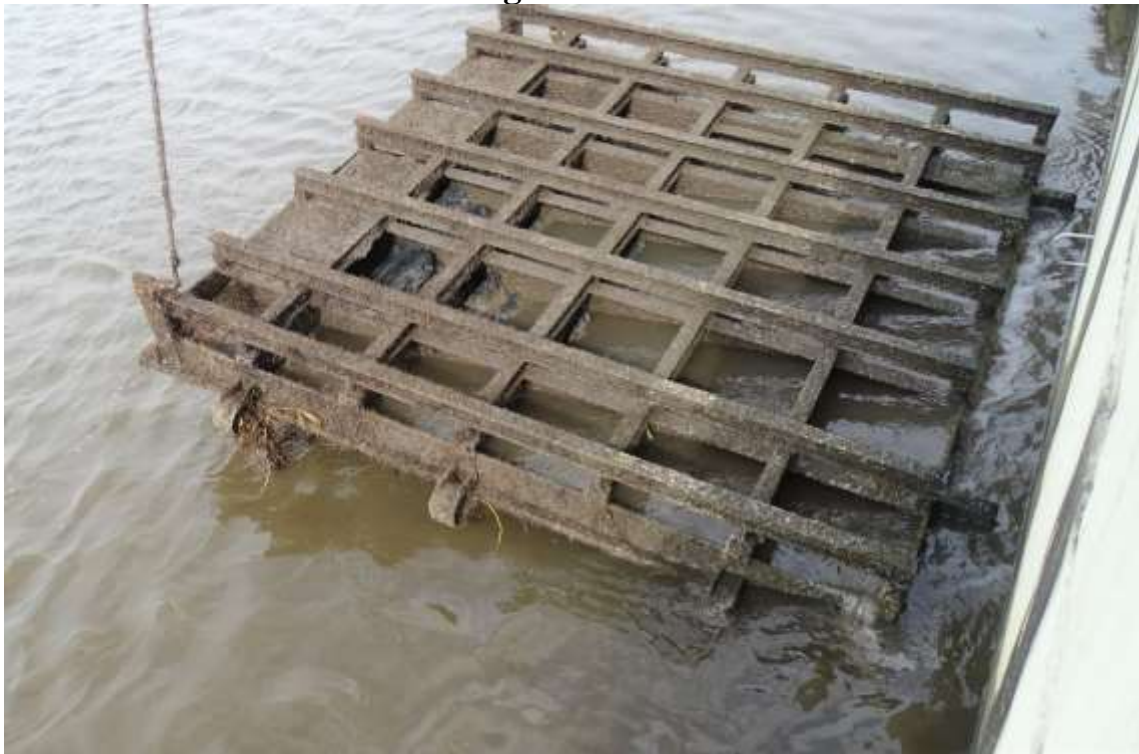
2d. Gate 2 – South side of Gate

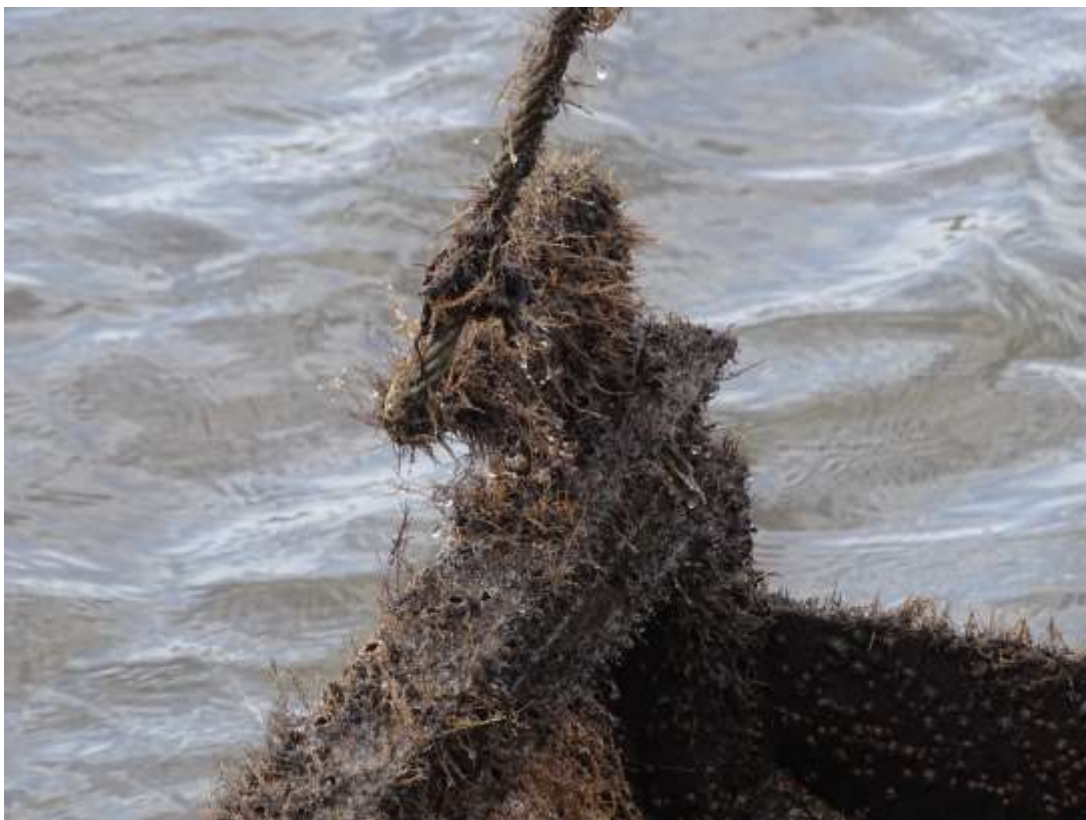
2e. Gate No. 2 – Lifting eye, shackle and cable - South side of Gate

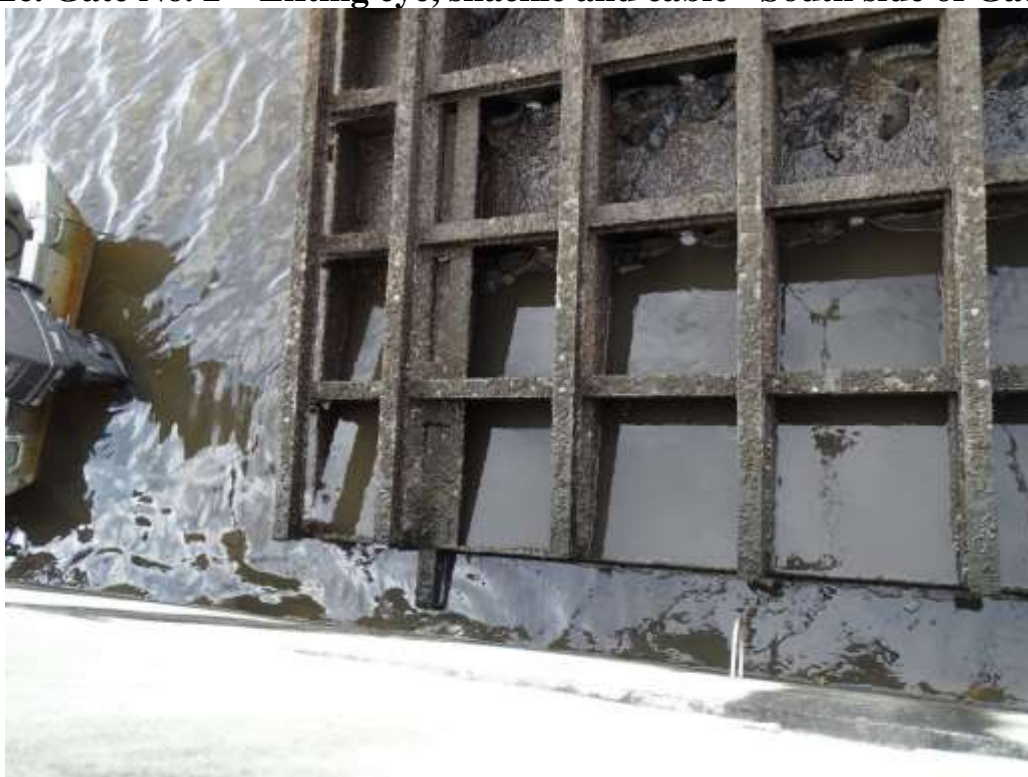
2f. Gate No. 2 – Gate Hinge at Headwall - South side of Gate

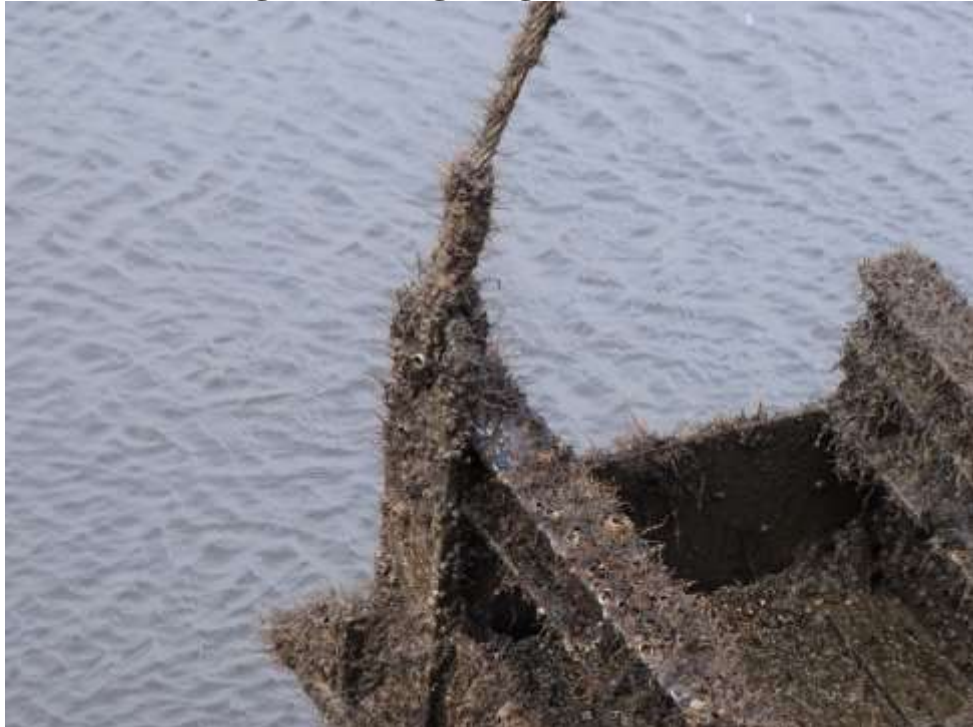
3f. Gate No. 3 – Lifting eye, shackle and cable - South side of Gate

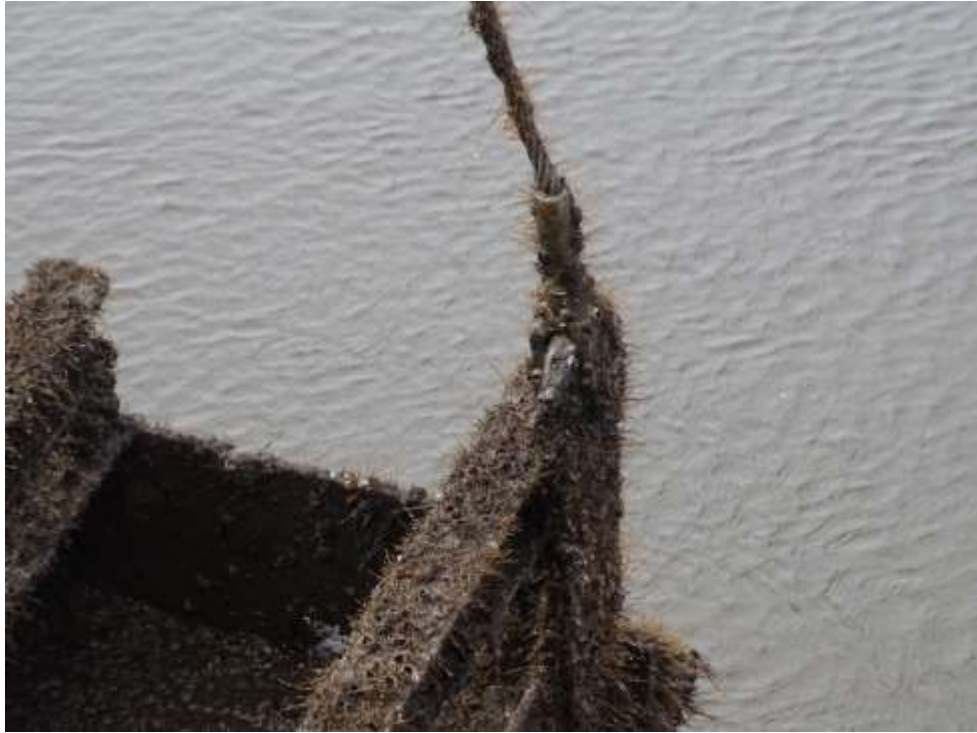
5c. Gate No. 5 – Lifting eye, shackle and cable - North side of Gate

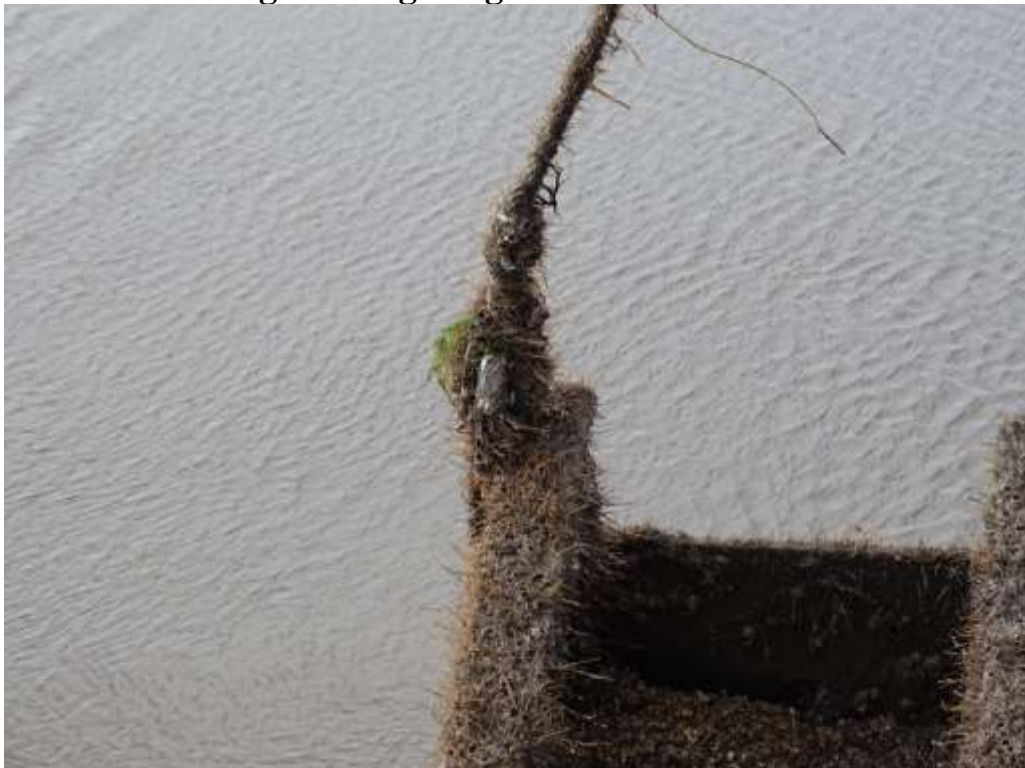
5h. Gate 5 – Lifting eye, shackle and cable - South side of Gate

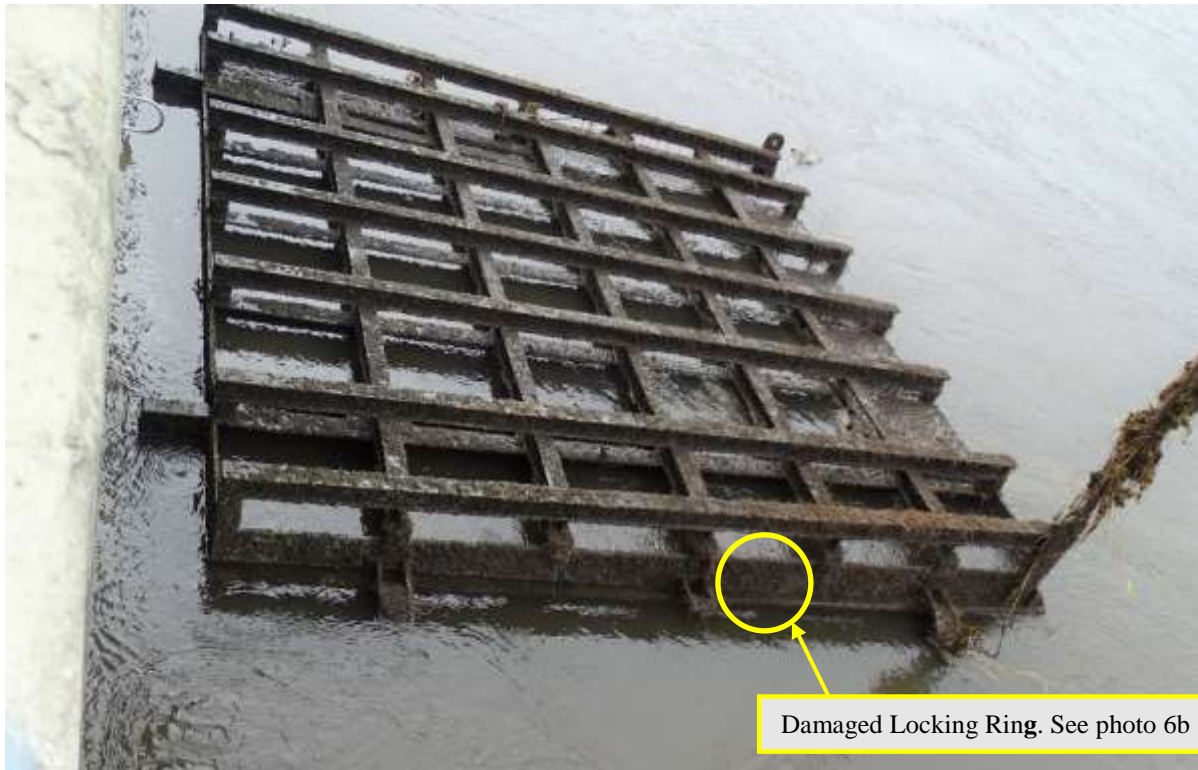
6a. Gate No. 6 – North side of Gate

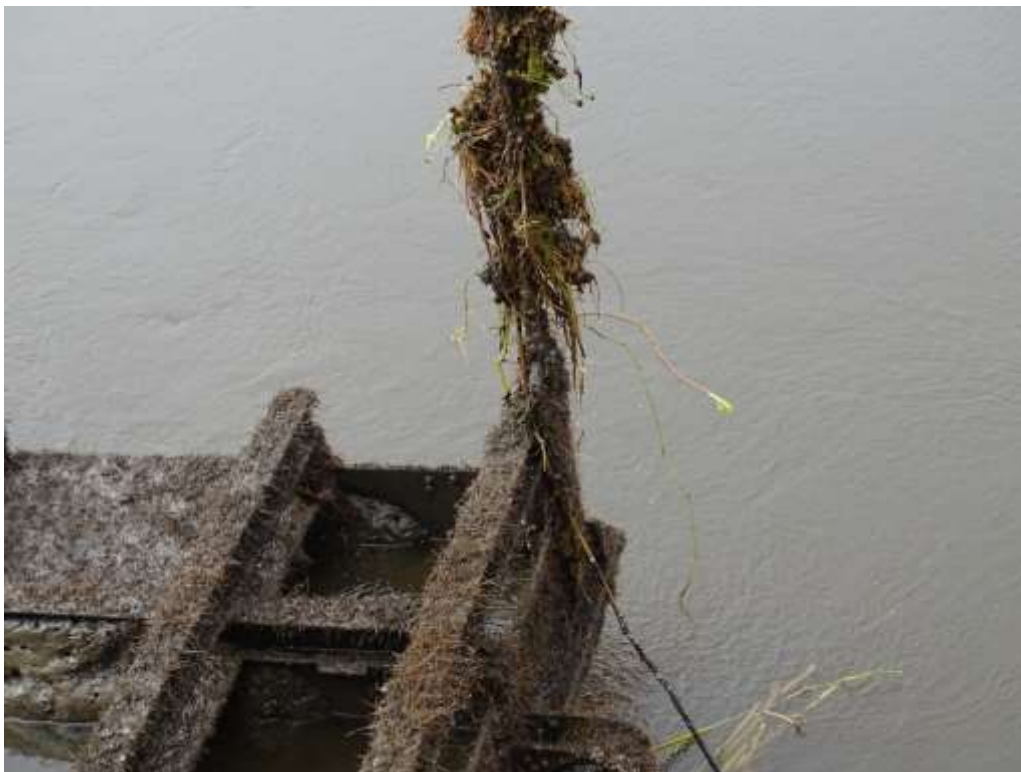
6c. Gate No. 6 – Lifting eye, shackle and cable - North side of Gate

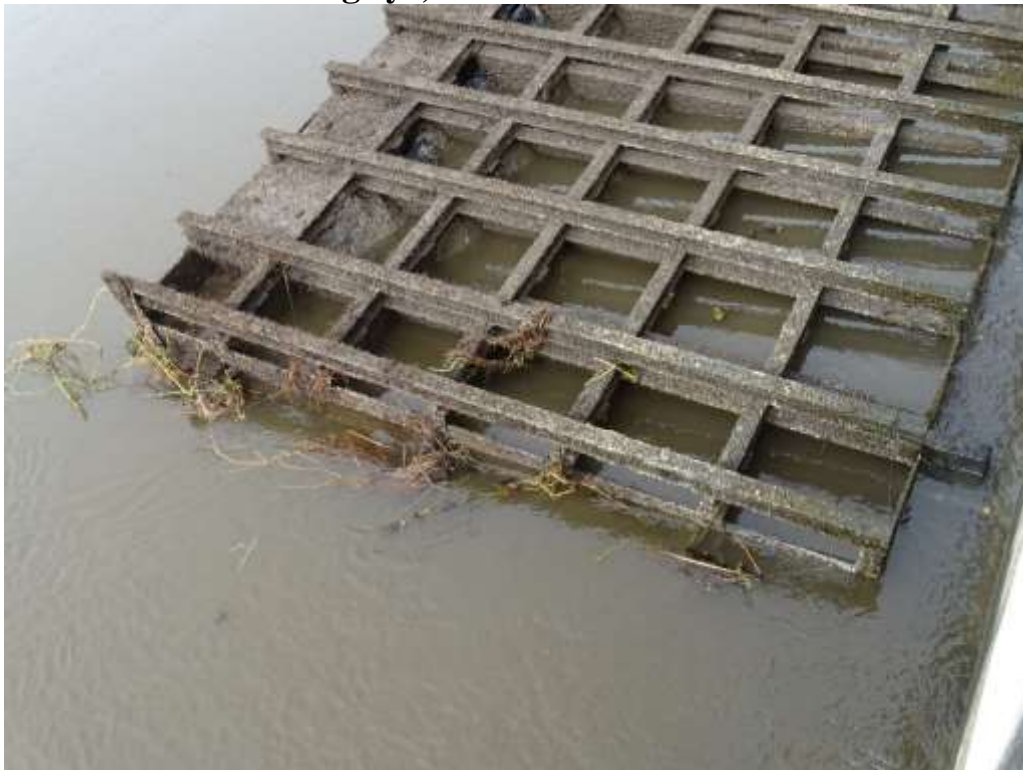
6d. Gate 6 –South side of Gate

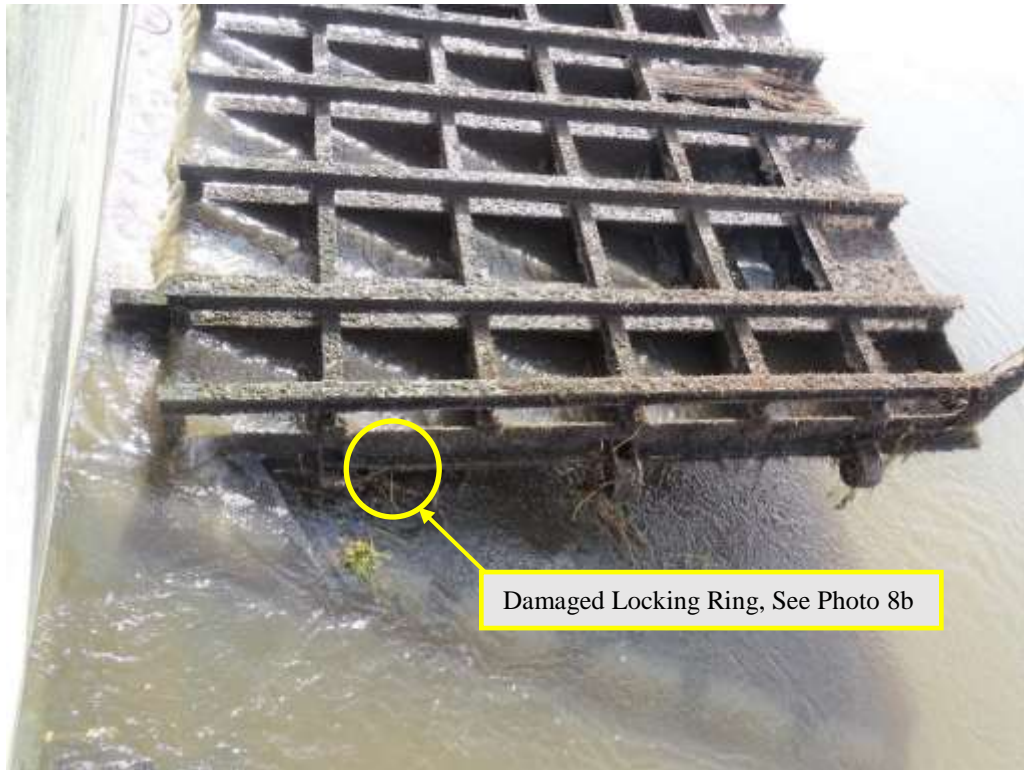
8a. Gate No. 8 – North side of Gate

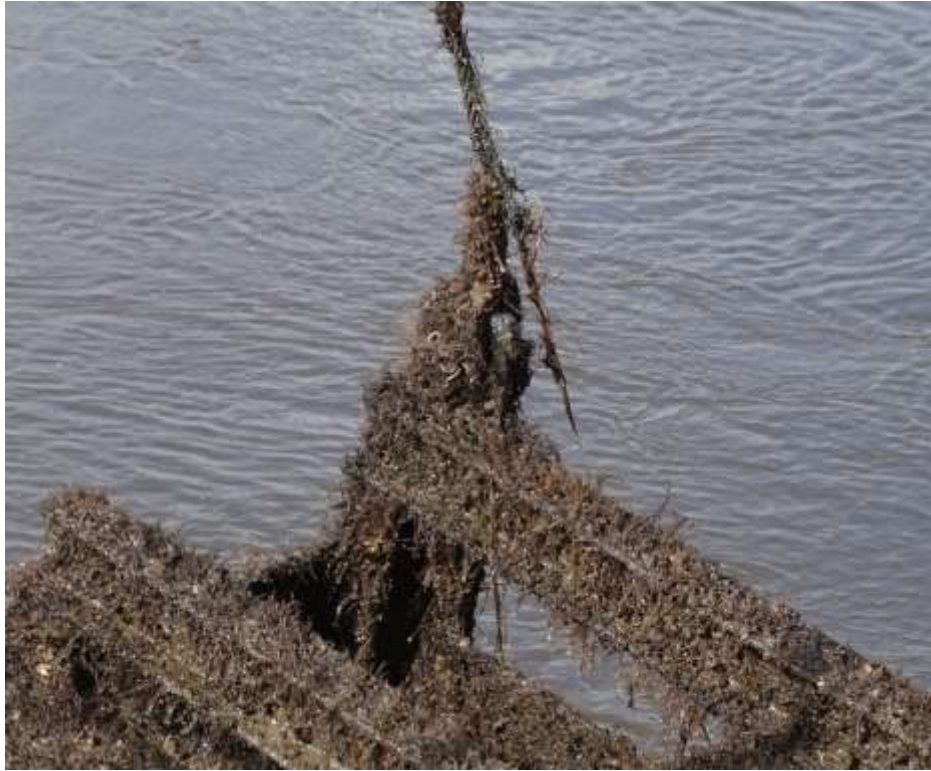
8c. Gate No. 8 – Lifting eye, shackle and cable – North Side of Gate

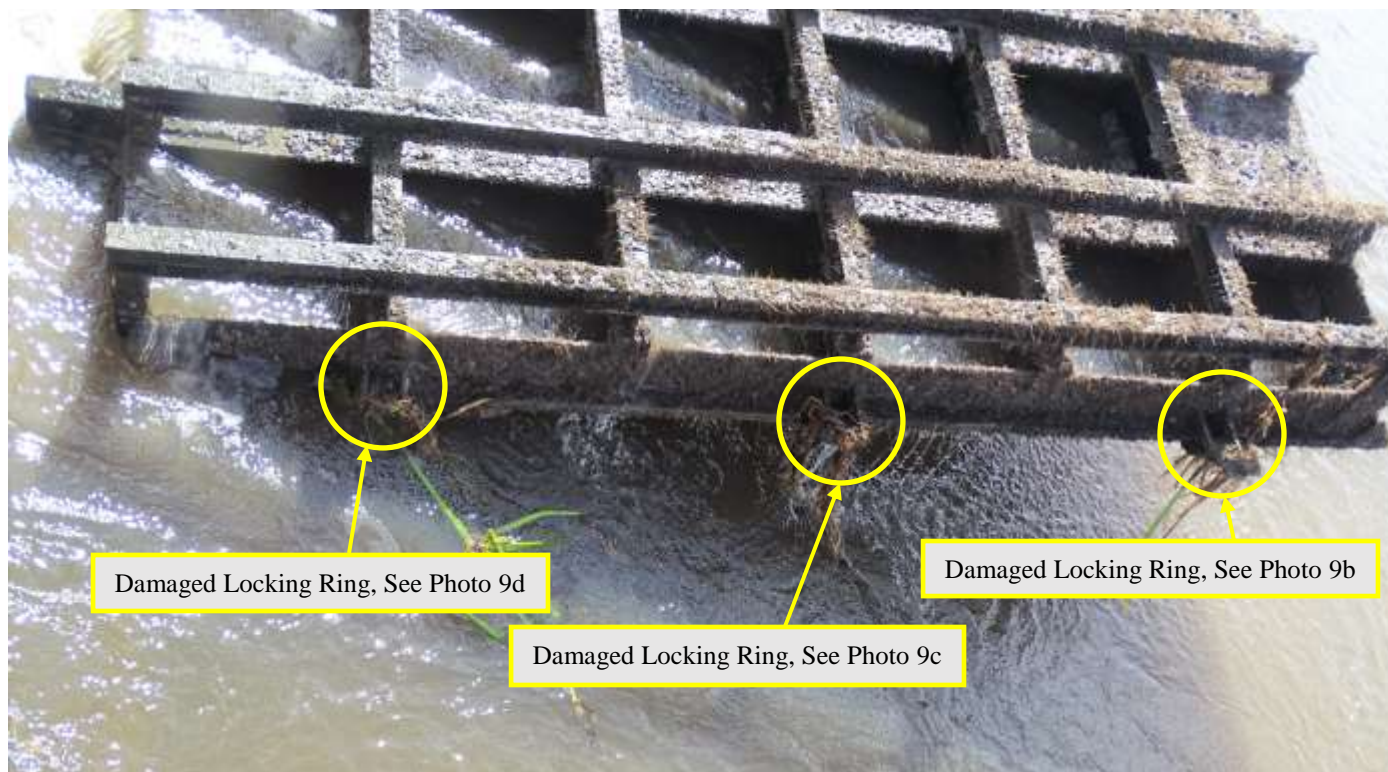
9a. Gate No. 9 – North side of Gate

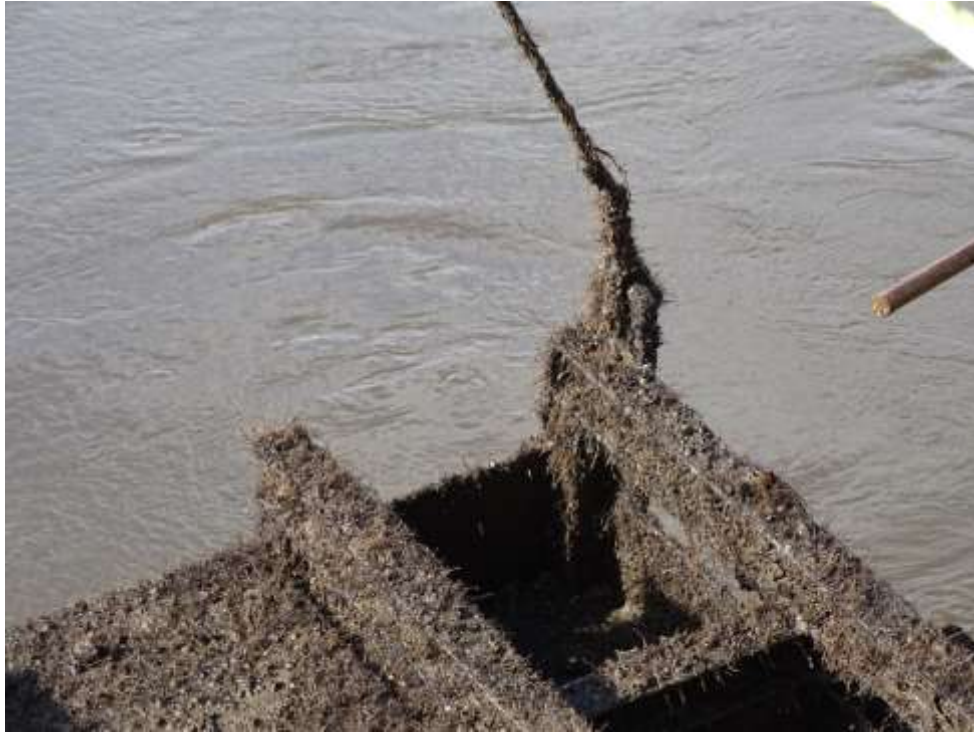
9e. Gate 9 – Lifting eye, shackle and cable – North Side of Gate

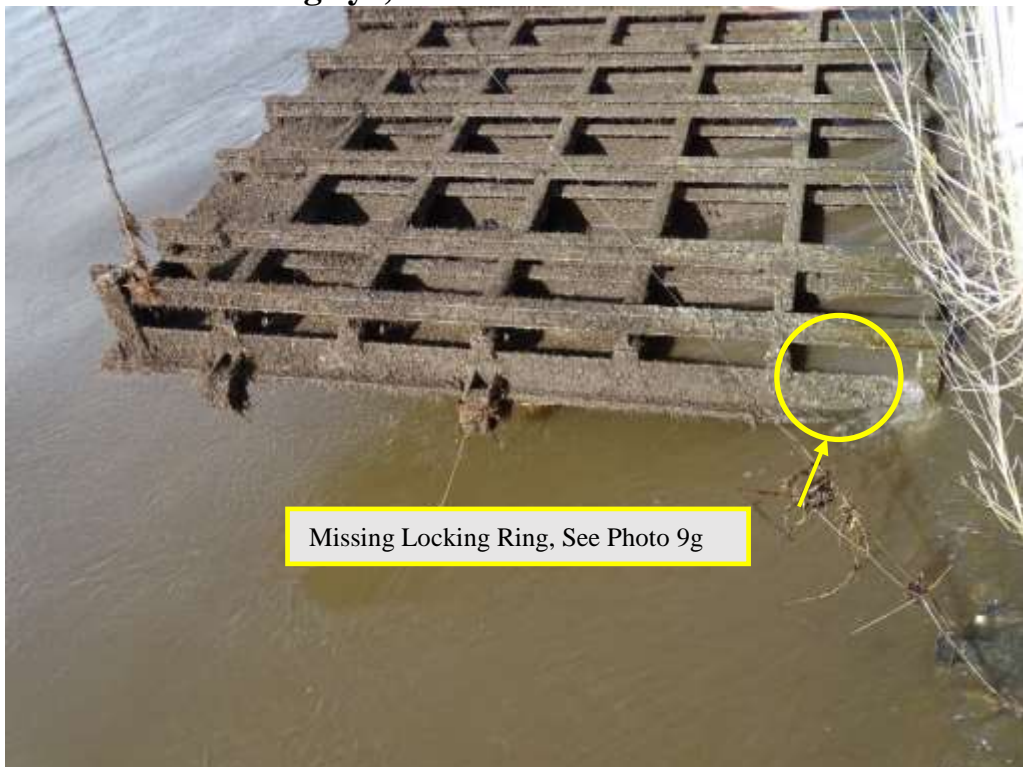
9f. Gate 9 –South Side of Gate

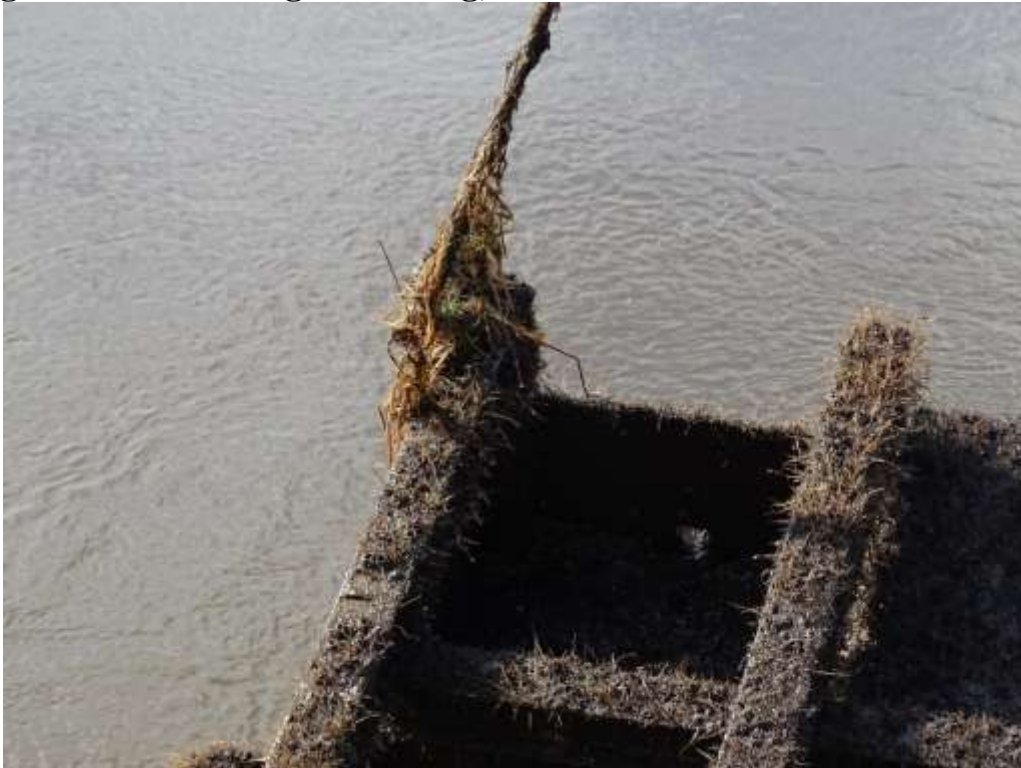
9h. Gate 9 – Lifting eye, shackle and cable – South Side of Gate

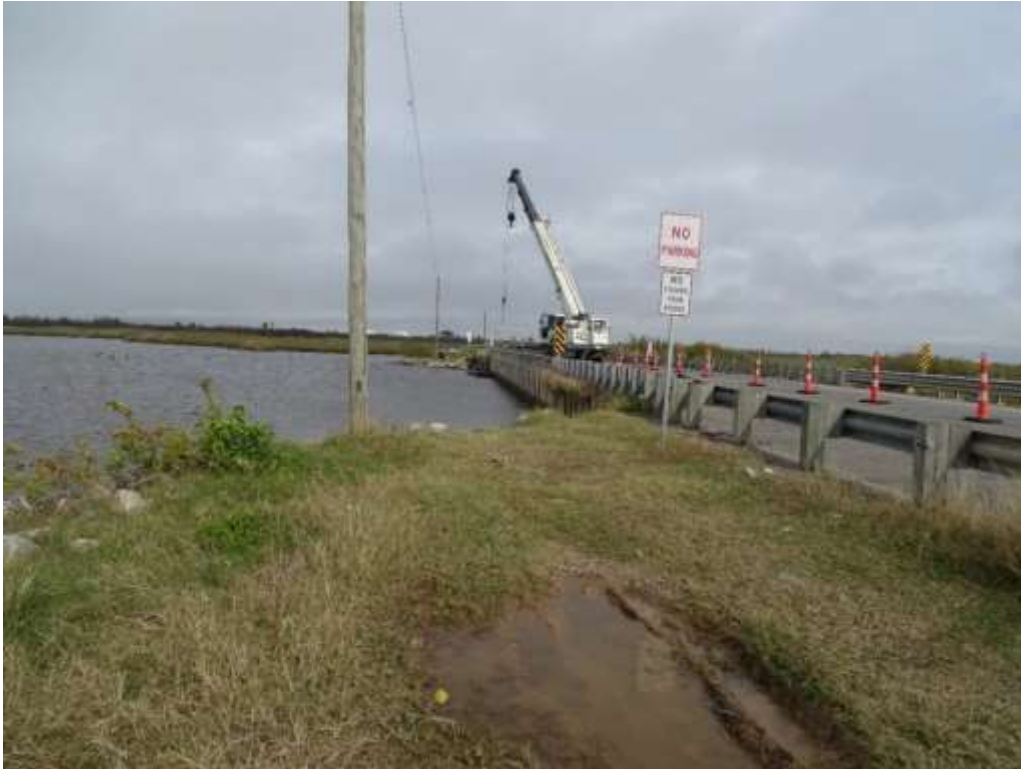
B1. West Side of Structure – Looking North

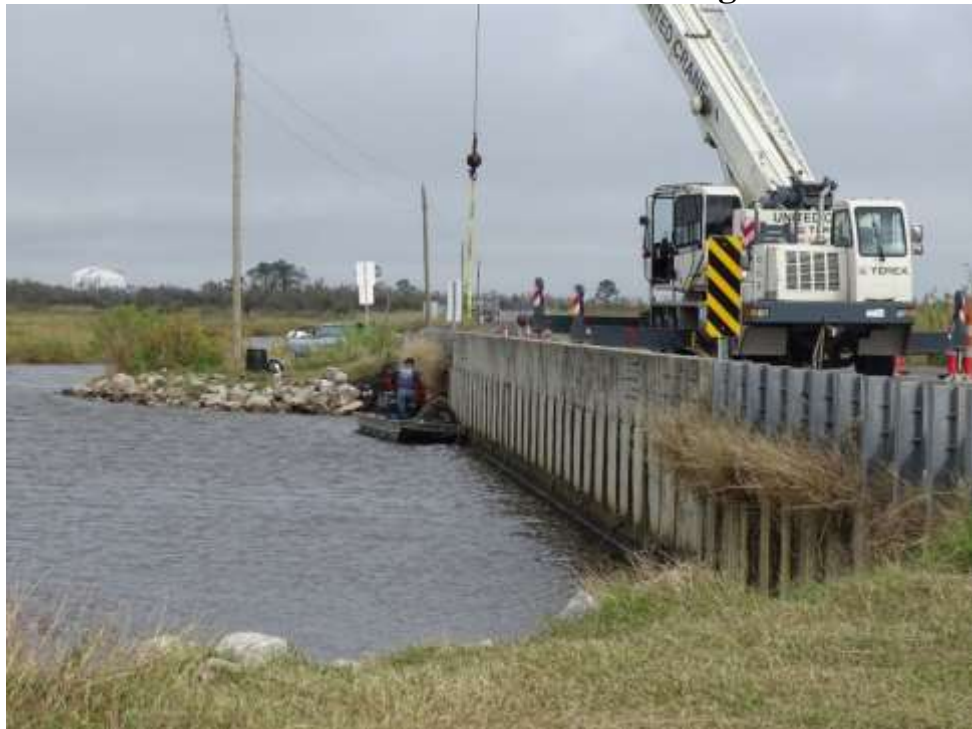
B2. West Side of Structure – Preparing to Lift Gate No. 1

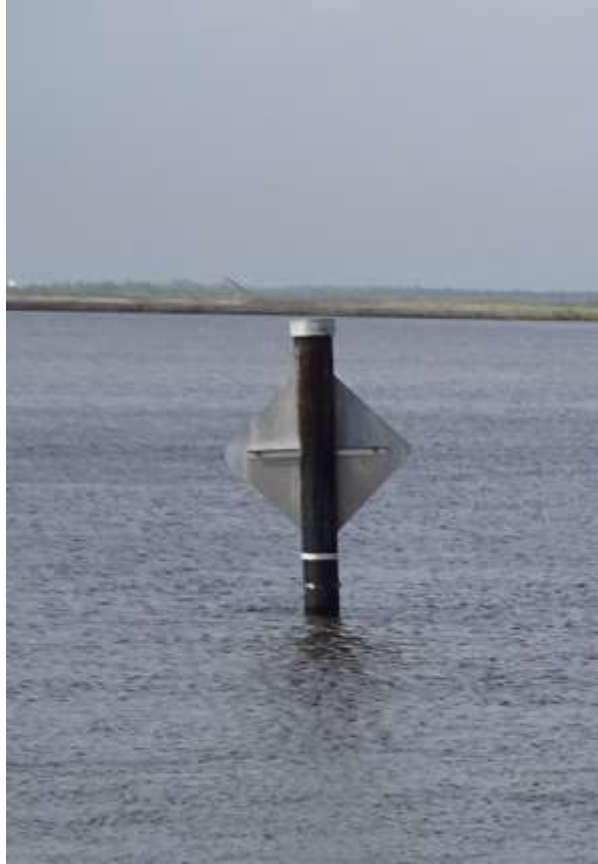
B3. West Side of Structure – Navigation Warning Sign Installation

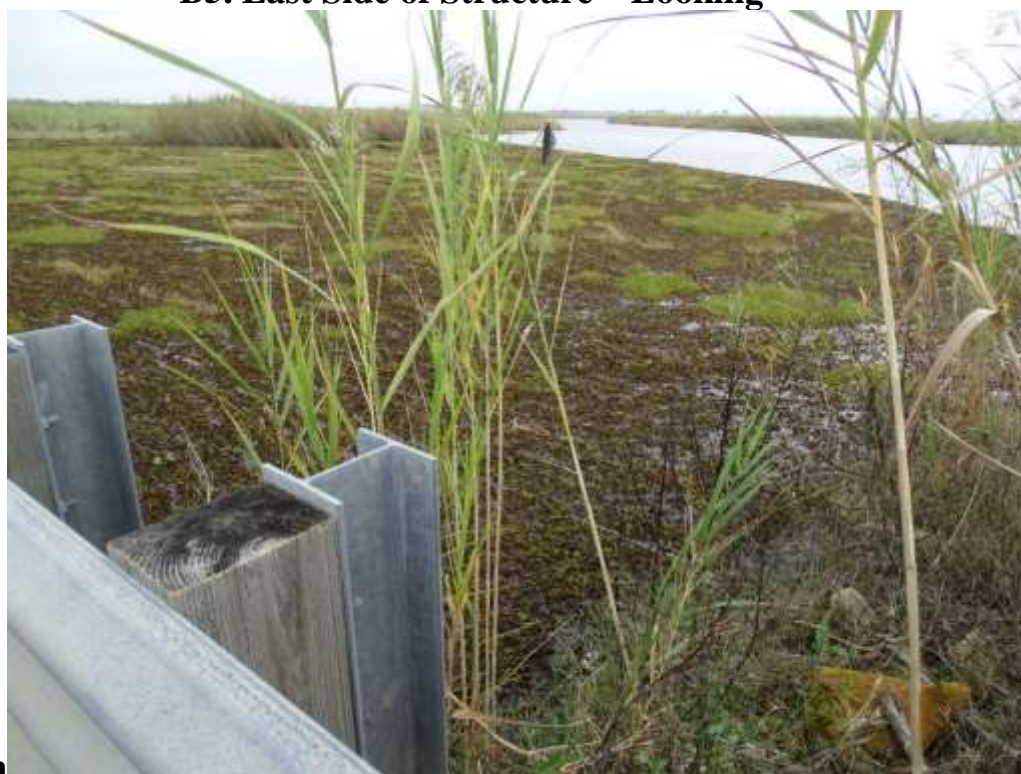
B6. East Side of Structure – Looking Northeast

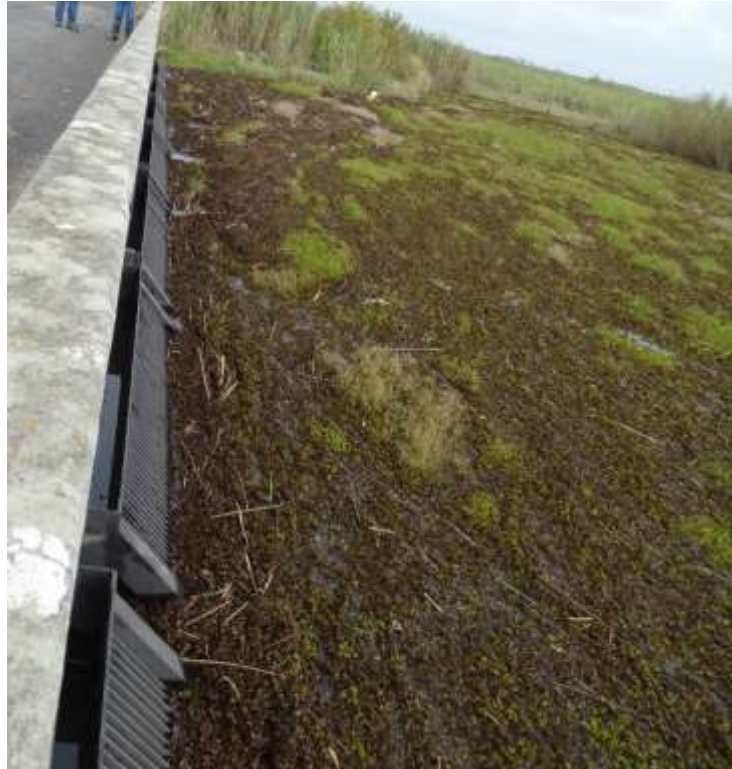
B7. East Side of Structure – Trash Racks -Looking North

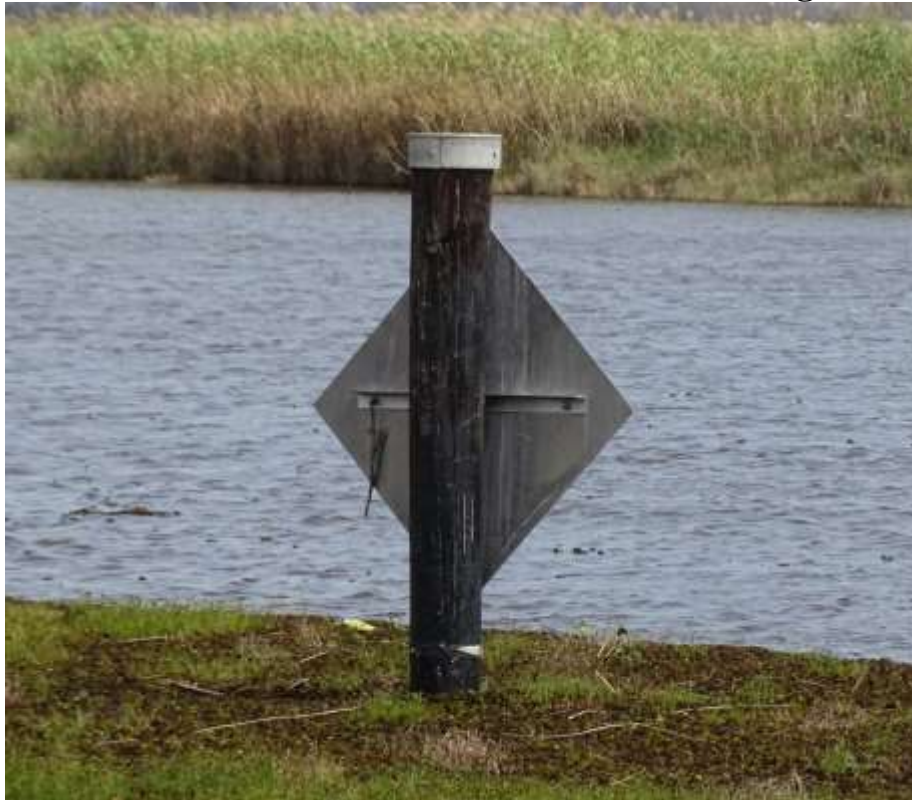
B8. East Side of Structure – Navigation Warning Sign Installation
