## **2018 Operations, Maintenance, and Monitoring Close-out Report**

## **Brady Canal Hydrologic Restoration** (TE-28)

State Project Number TE-28 Priority Project List 3

March 2019 Terrebonne Parish

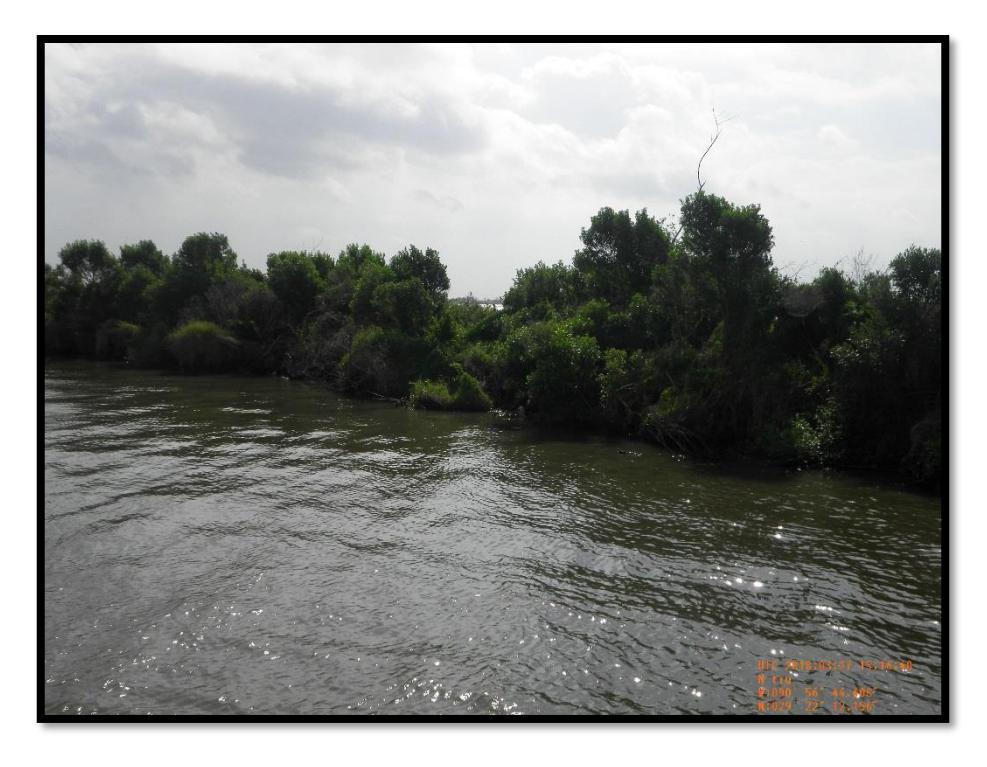
Jug Lake perimeter was in good condition along the south bank of the existing embankment that was refurbished in 2012. The vegetation was thick and the embankment appears to be stable. The north bank of Jug Lake from Structure 23 around the western perimeter to Bayou Decade was is fair to poor condition. There were large areas of the embankment that were very low with a large breach in the bank south of Structure 21. We also noticed areas of the existing south bank along Bayou Decade that were low and thin near the entrance to Voss Canal (Photo 43). The remaining earthen embankments along Voss Canal, Bayou Carencro and Brady Canal were in fair condition with only two (2) small breaches in the bank along Bayou Carencro north of Structure 14. Since the Brady Canal project is approaching the end of its 20-year life, NRCS and CPRA have decided to proceed with a final maintenance event to refurbish the earthen embankments within the project area that are in need of repairs. The repairs include embankment restoration along the northern and eastern perimeter of Jug Lake, breach closures along Bayou Carencro, and refurbishment of existing embankment along the north bank of Bayou Decade near Voss Canal. The plans and specifications are complete and the bid process should begin by the end of March 2019. It is anticipated that construction will begin by June 2019.

Photo No.10 – existing earthen embankment along south bank of Jug Lake near Bayou Decade.

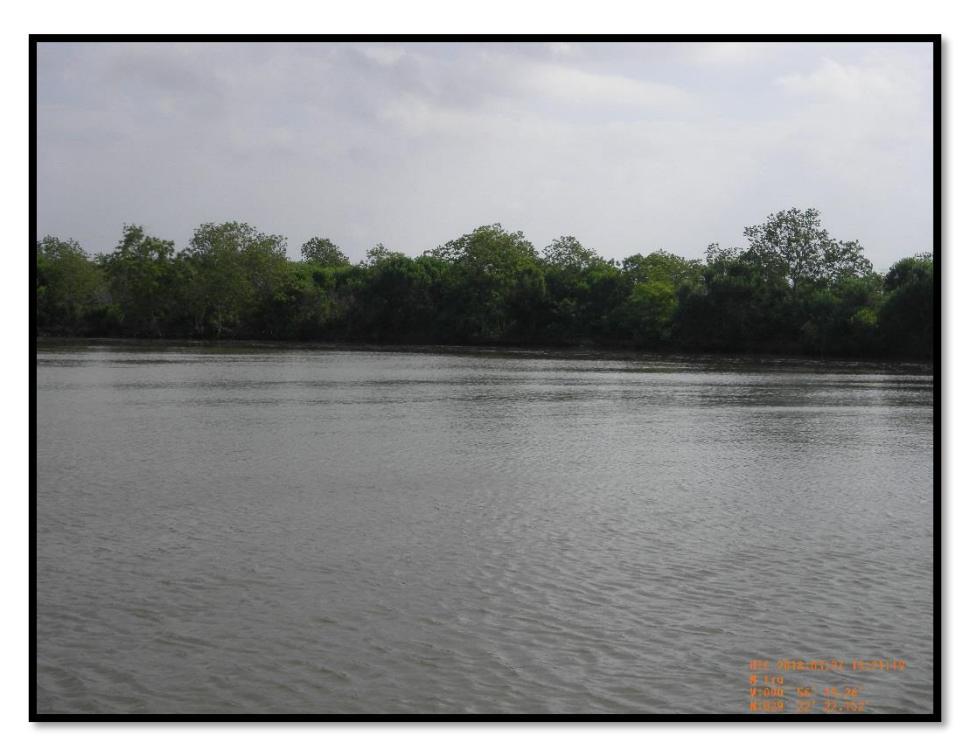
Photo No.11 – existing earthen embankment along south bank of Jug Lake between Bayou Decade and Structure No.24.

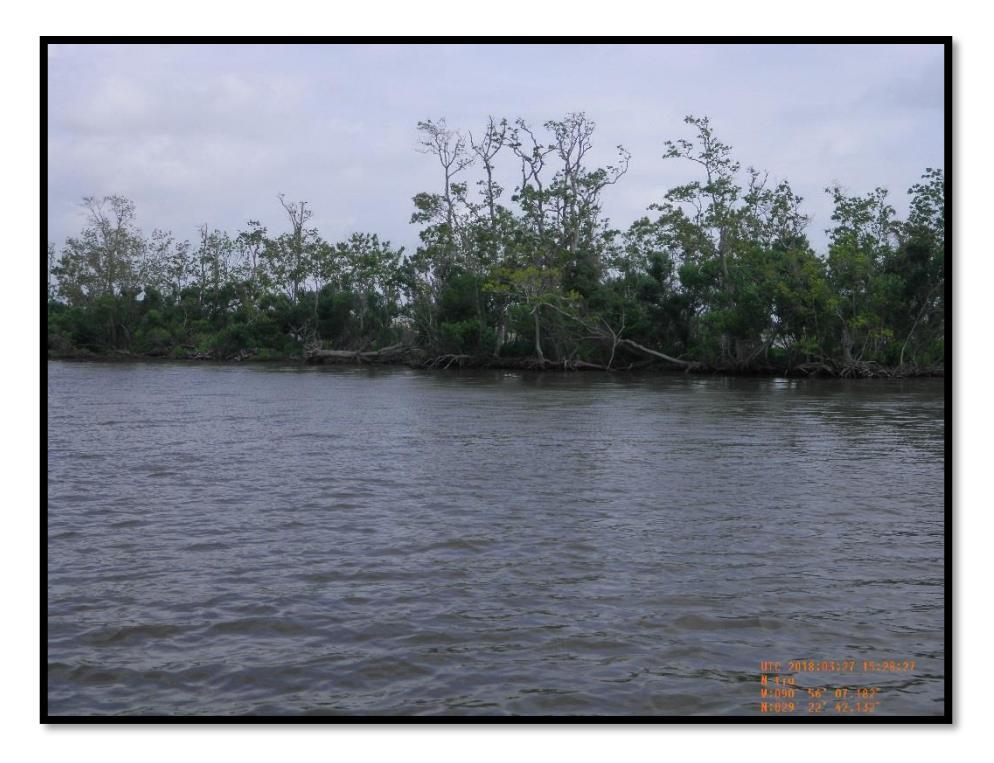
Photo No.17 – existing earthen bank line on the northeast side of Jug Lake just north of Structure No.23.

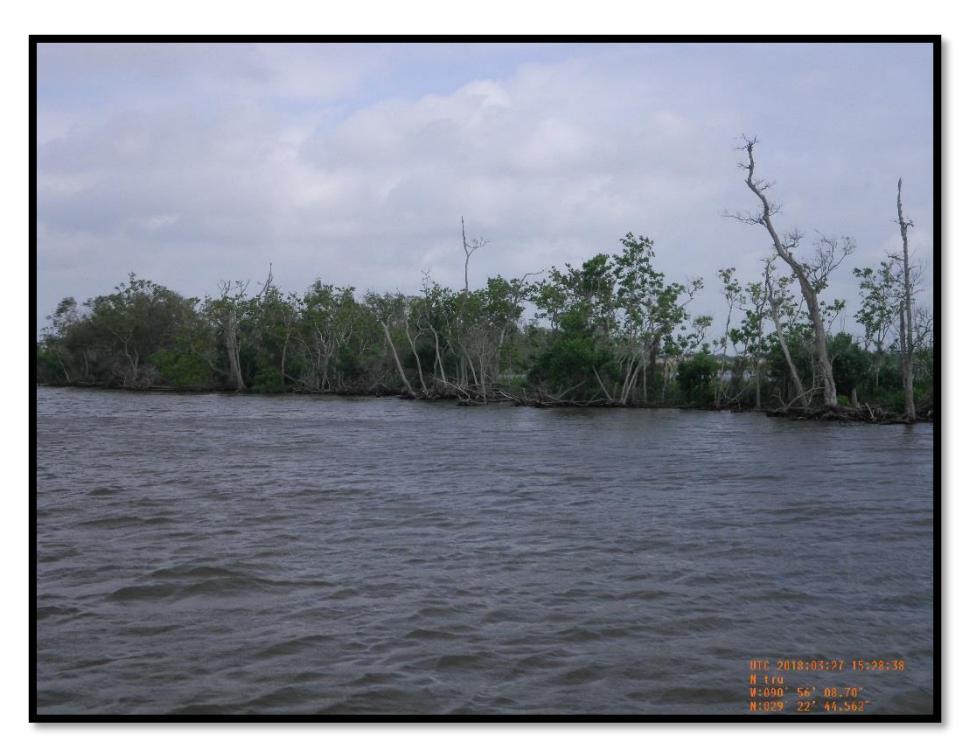
Photo No.18 – existing earthen bank line on the northeast side of Jug Lake north of Structure No.23.

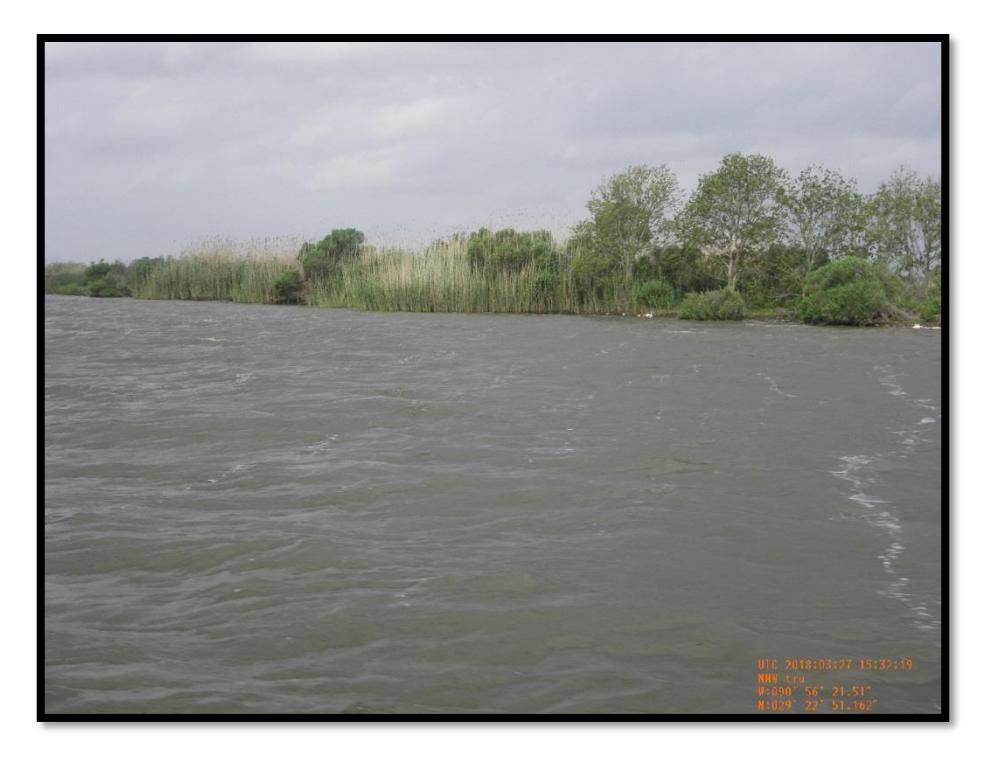
Photo No.20 – existing earthen bank line on the north side of Jug Lake northeast of Structure No.21.

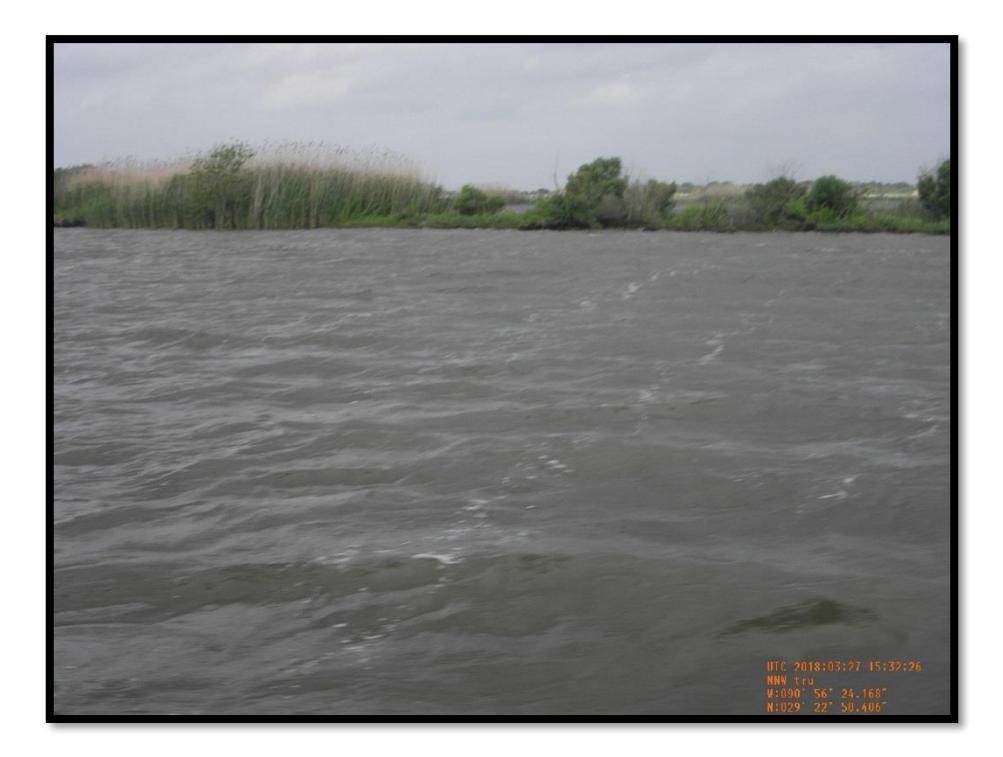
Photo No.21 – existing earthen bank line on the north side of Jug Lake northeast of Structure No.21.

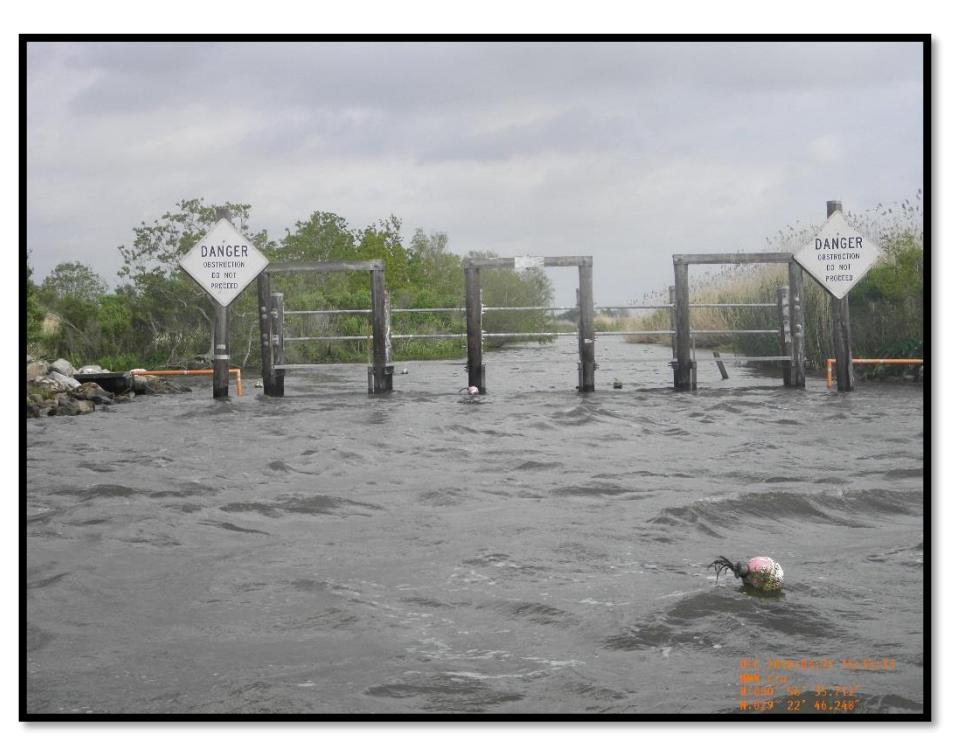
Overall, Structure 21 is in good condition. There was no visible damage to the steel bulkhead, railings, platform or the warning signs and their timber supports. The rock armored embankments was also in good condition with no signs of settlement since refurbished in 2012. Structure 21 will not require maintenance at this time. (See Appendix A, Photos 22 - 23)

Photo No.23 – variable crest weir (Structure No.21) located along the north bank of Jug Lake.

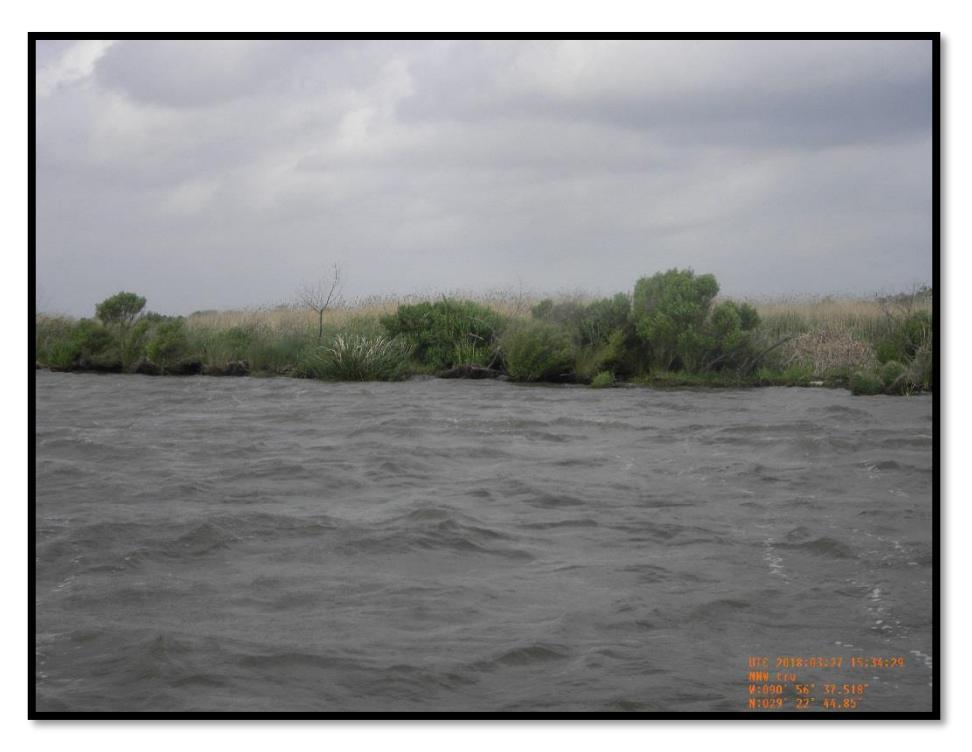
Photo No.24 – existing bank line on the northwest side of Jug Lake south of Structure No.21.

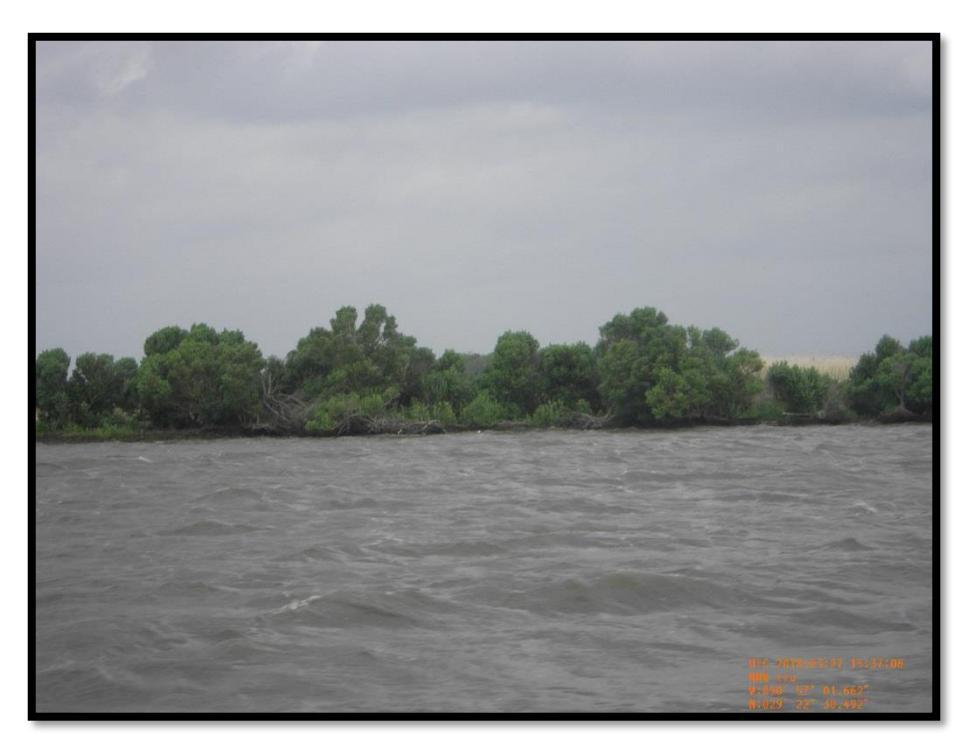
Photo No.26 – existing bank line on the northwest side of Jug Lake between Structure No.21 and Structure No.20.

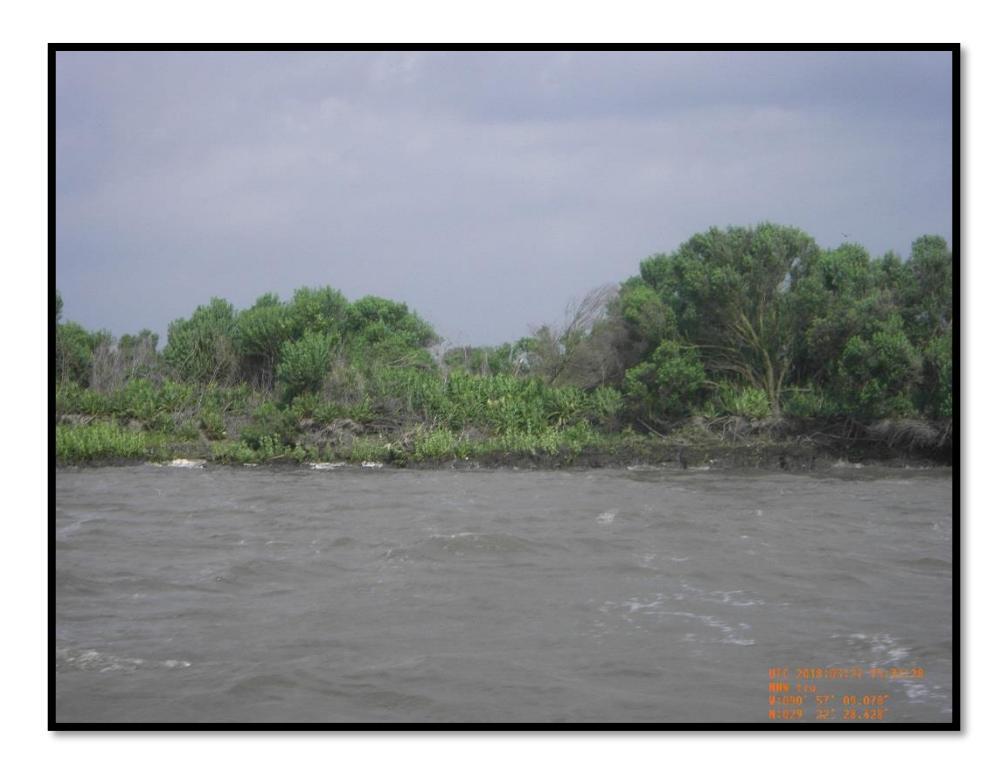
Photo No.27 – existing bank line on the northwest side of Jug Lake between Structure No.21 and Structure No.20.

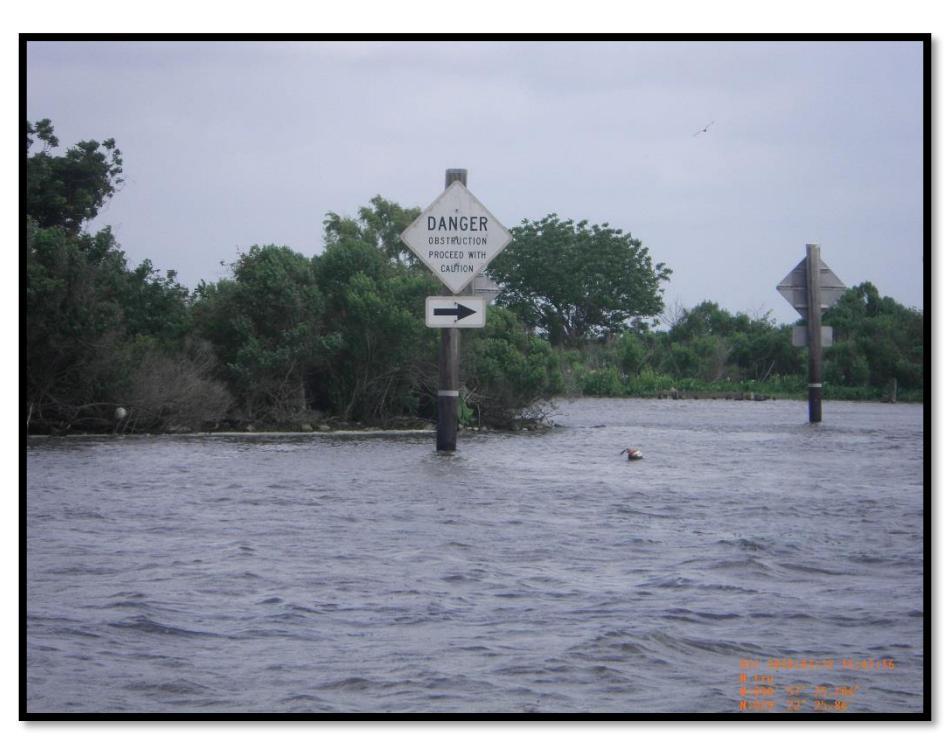
Structure 20 is in fair to good overall condition. There appears to be some settlement of the rock riprap on the bank tie-ins and submerged crest of the structure based on elevation depths collected along the crest of the channel liner. Depths along the channel liner crest were approximately 7.7' at the time of this inspection with water levels at 1.7' NAVD. The calculated elevation of the channel liner crest in the center of the opening was approximately -6.0' NAVD with a settlement of approximately 1.2' to 1.5' since the structure was installed. The warning signs and timber supports were also in good condition. At this time, Structure 20 is in good condition and no maintenance will be required. (See Appendix A, Photo 28 - 30)

Photo No.30 – south side rock lined channel (Structure No.20) located along the northwest bank of Jug Lake.

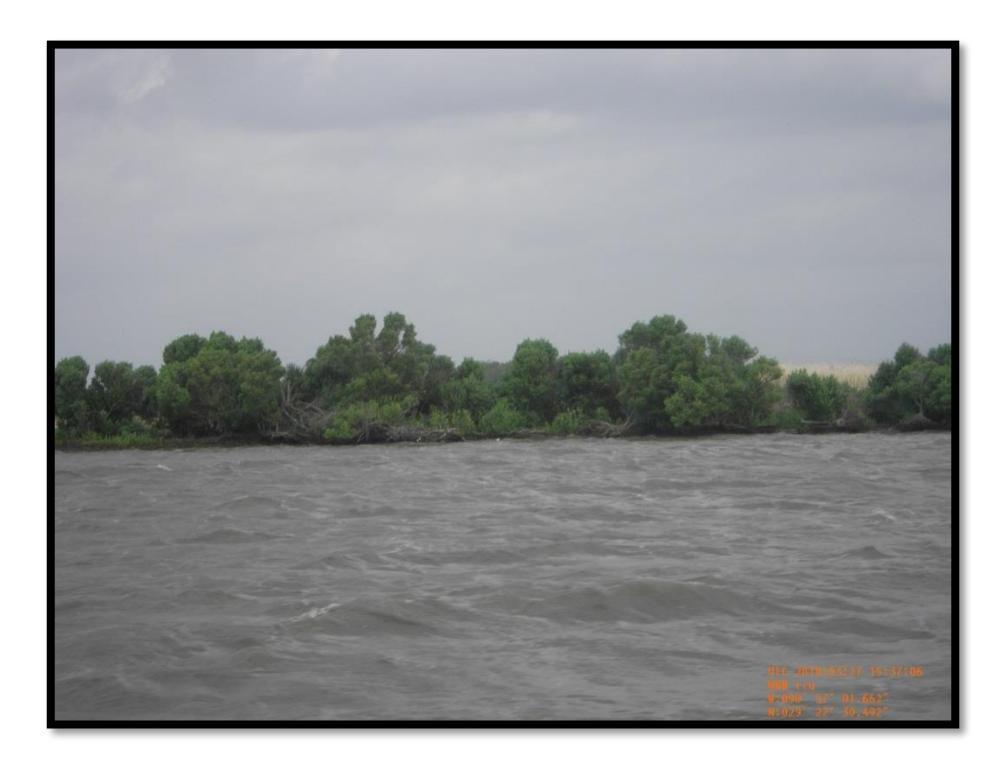
Photo No.31 – earthen bank along northwest side of Jug Lake south of Structure No.20.

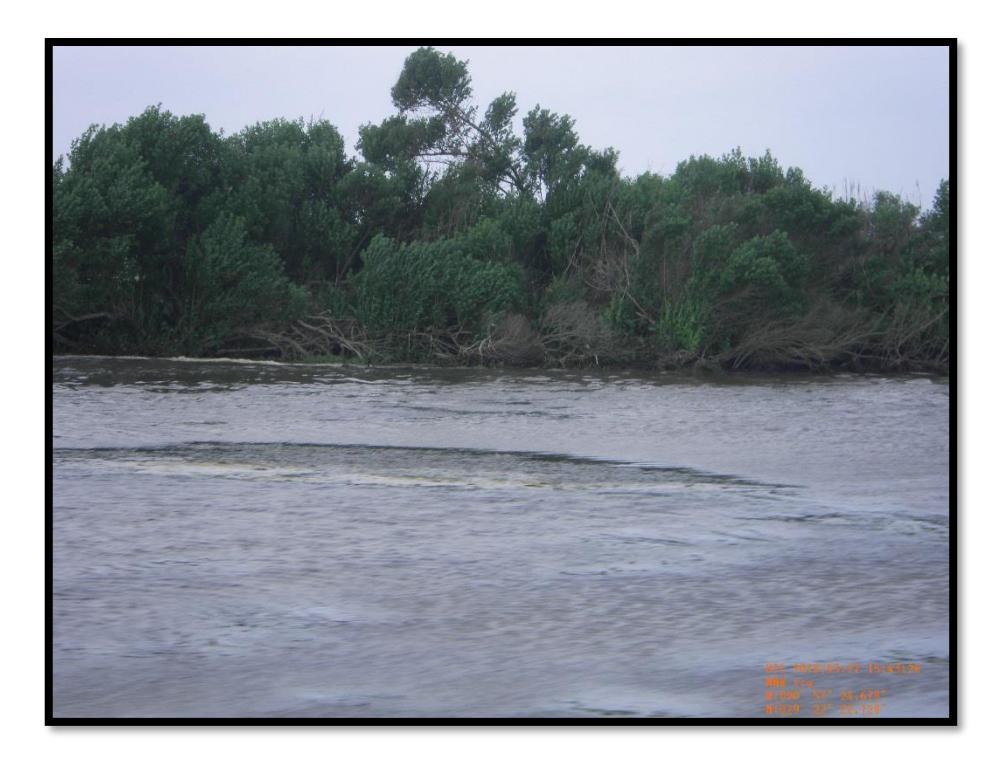
Photo No.32 – earthen bank along northwest side of Jug Lake near Bayou Decade.

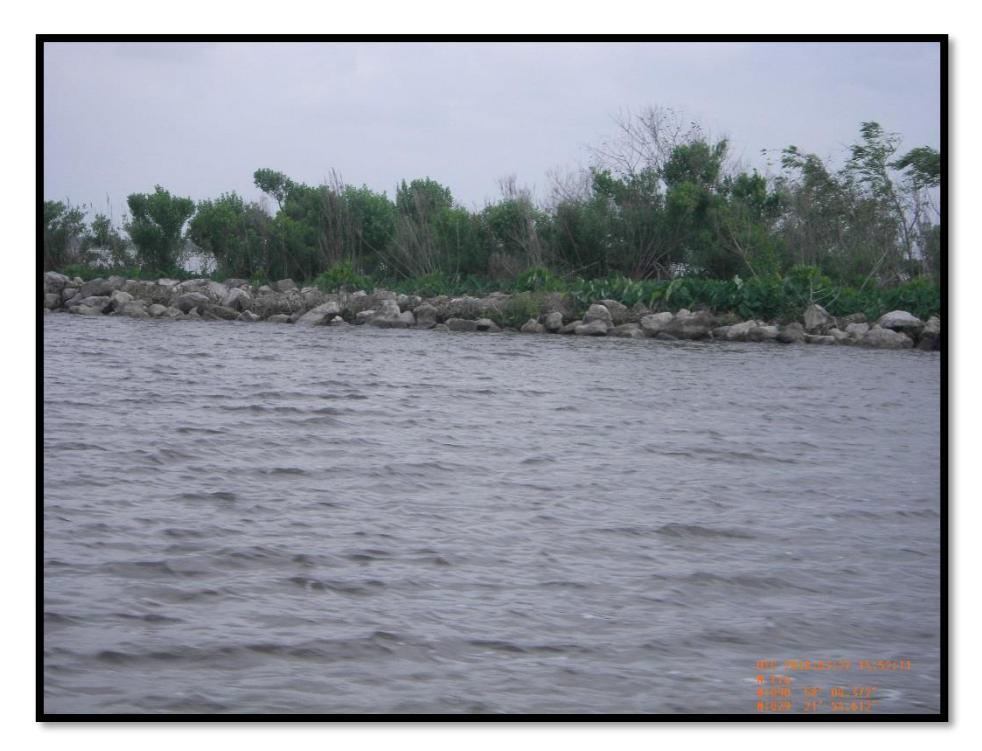
The rock armored embankments and rock dikes along the north bank of Bayou Decade (Appendix A, Photos 6-9, 38, 42) and Voss Canal (Appendix A, Photo 44) are in good condition. The rock dike along Bayou Decade between Jug Lake and Turtle Bayou appears to be in fair condition with isolated low areas and moderate displacement of rock riprap. The earthen embankment with rock revetment west of Structure 7 along Bayou Decade appears to be in good condition with no apparent settlement. The earthen embankment with rock revetment beginning at the intersection of Bayou Decade and Voss Canal had some initial settlement after construction but has experienced little change since previous inspections. Despite some minor deficiencies, the rock armored embankments appear to be functioning as intended and no maintenance will be required at this time.

Photo No.38 – rock dike along north bank of Bayou Decade just west of Structure No.6.

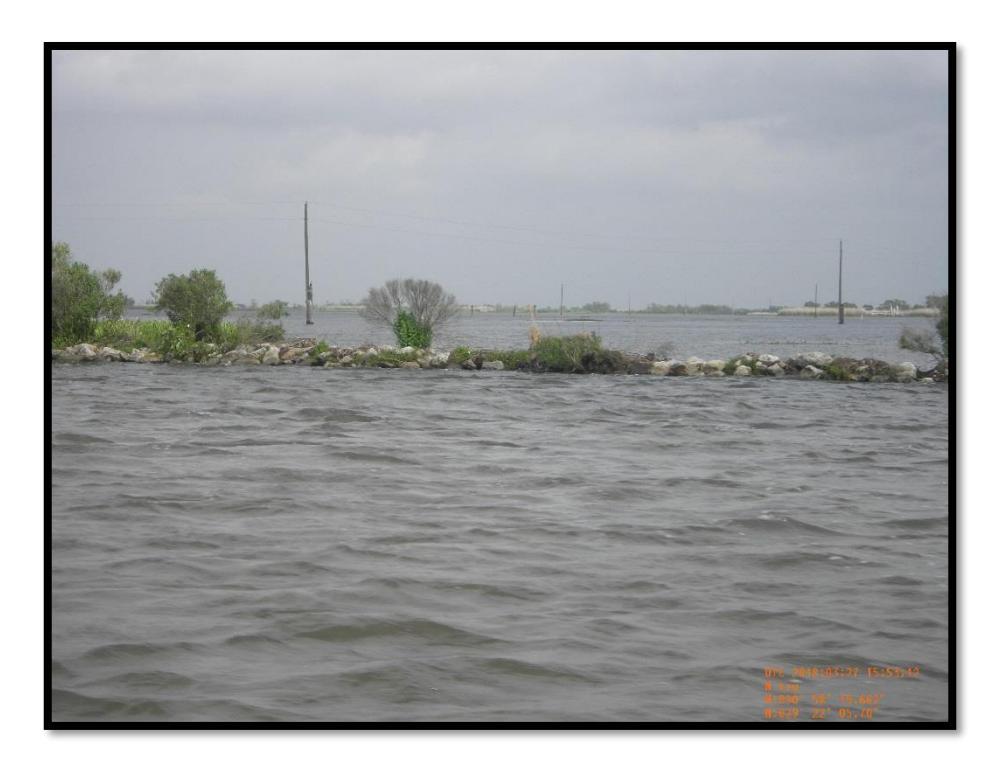
Photo No.39 – rock dike along north bank of Bayou Decade just east of rock plug (Structure No.7)

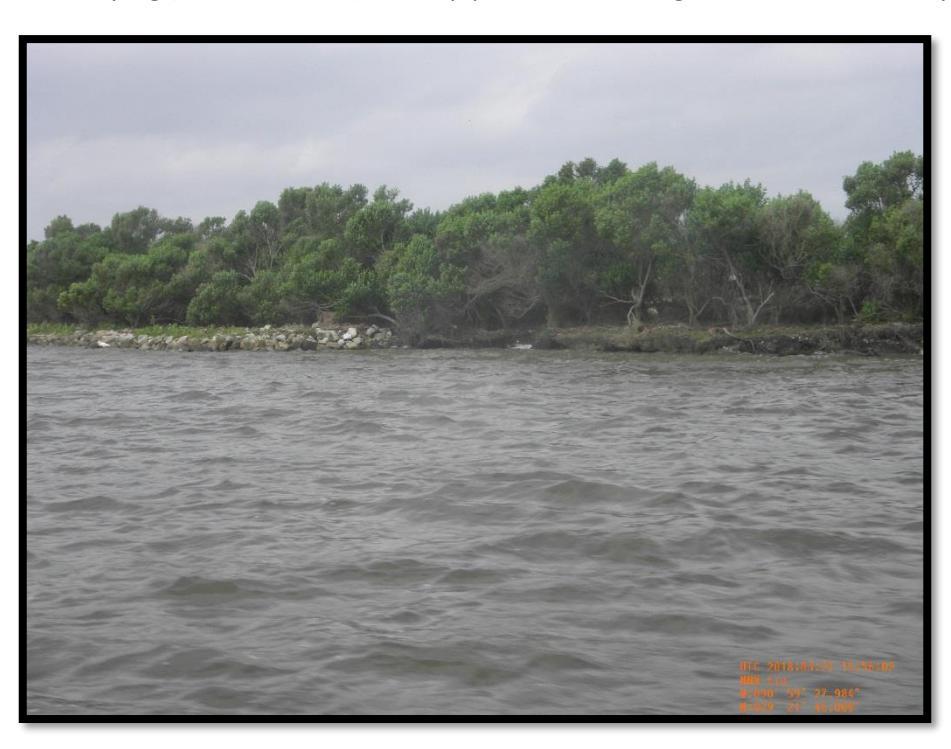
Photo No.42 – beginning of a rock dike section west of Structure No.7 along Bayou Decade.

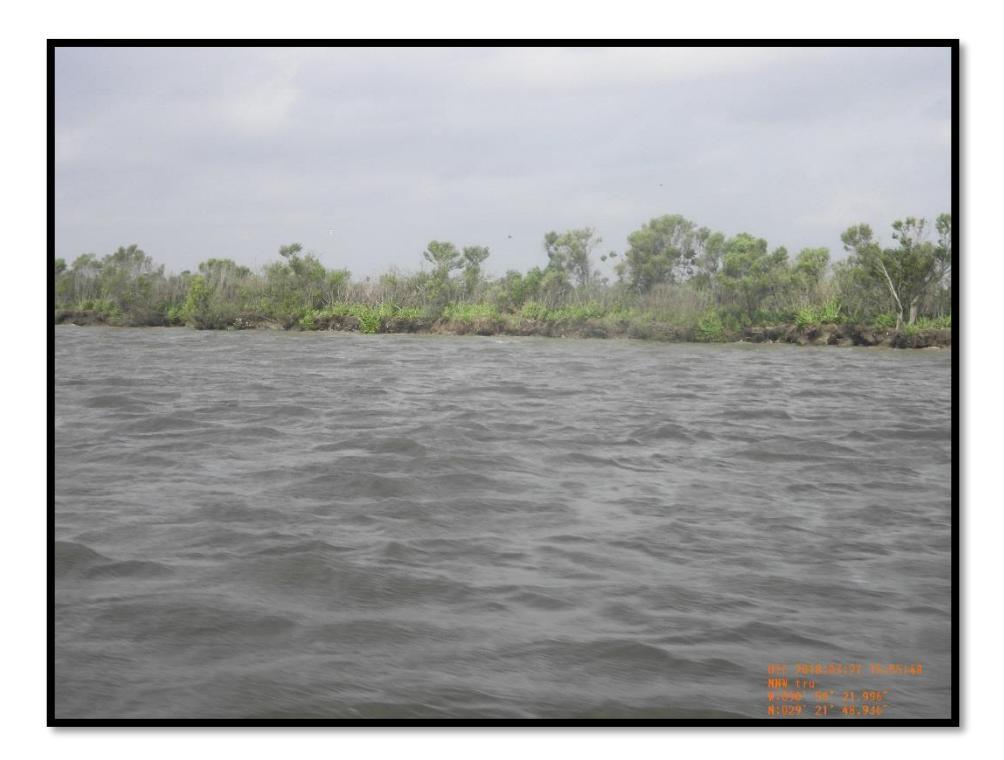
The inspection of the earthen embankments included the west bank of Turtle Bayou to Superior Canal (Appendix A, Photos 1, 4-5), the dead end canal connected to Superior Canal, the Jug Lake perimeter (Appendix A, Photos 10-11, 17-21, 24-27 and 31-31), Bayou Decade from Jug Lake to Voss Canal (Appendix A, Photo 43), Voss Canal to Bayou Carencro (Appendix A, Photos 46-49), and Bayou Carencro to Brady Canal (Appendix A, Photos 53-54). The earthen embankments along Turtle Bayou and Superior Canal are in good condition with a couple of recent repairs made by the landowner along Superior Canal (Photos 4-5). The

Photo No.43 – earthen embankment along north bank of Bayou Decade between Structure No.7 and Voss Canal.

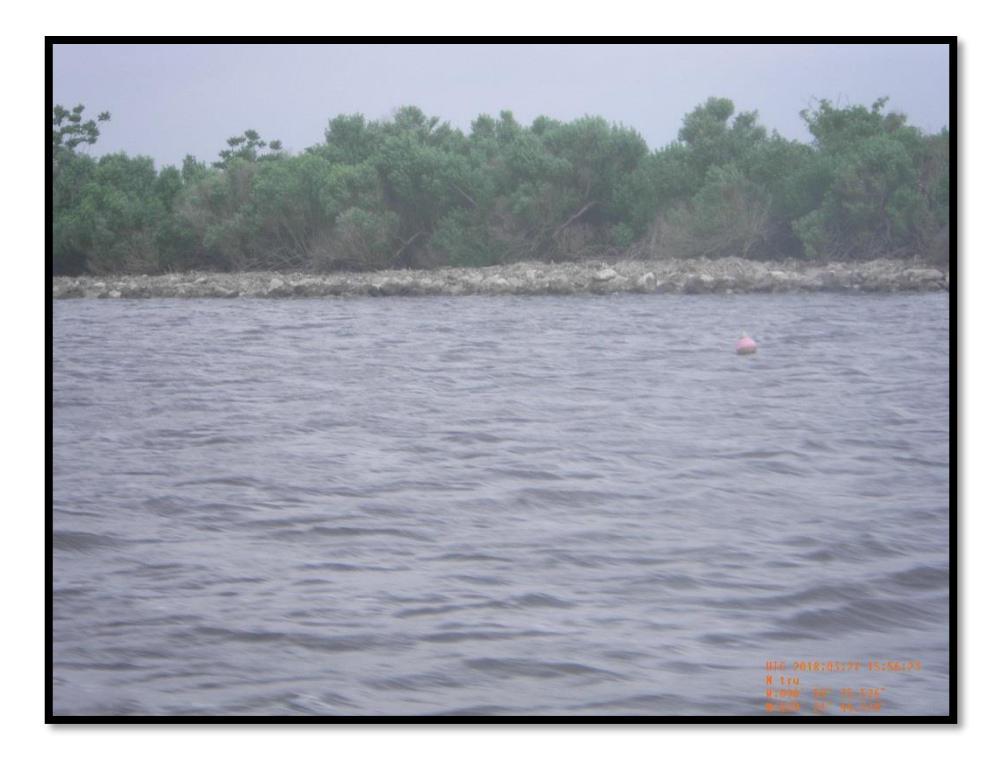
Photo No.44 – rock revetment along north bank of Bayou Decade at Voss Canal.

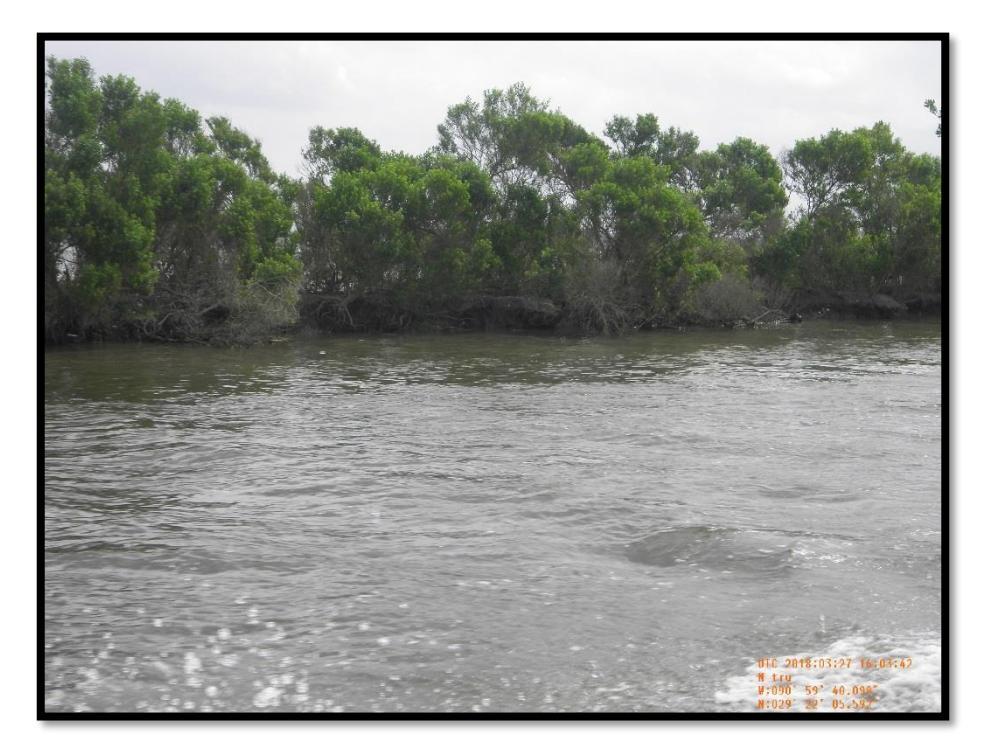
Photo No.46 – earthen embankment along the east bank of Voss Canal.

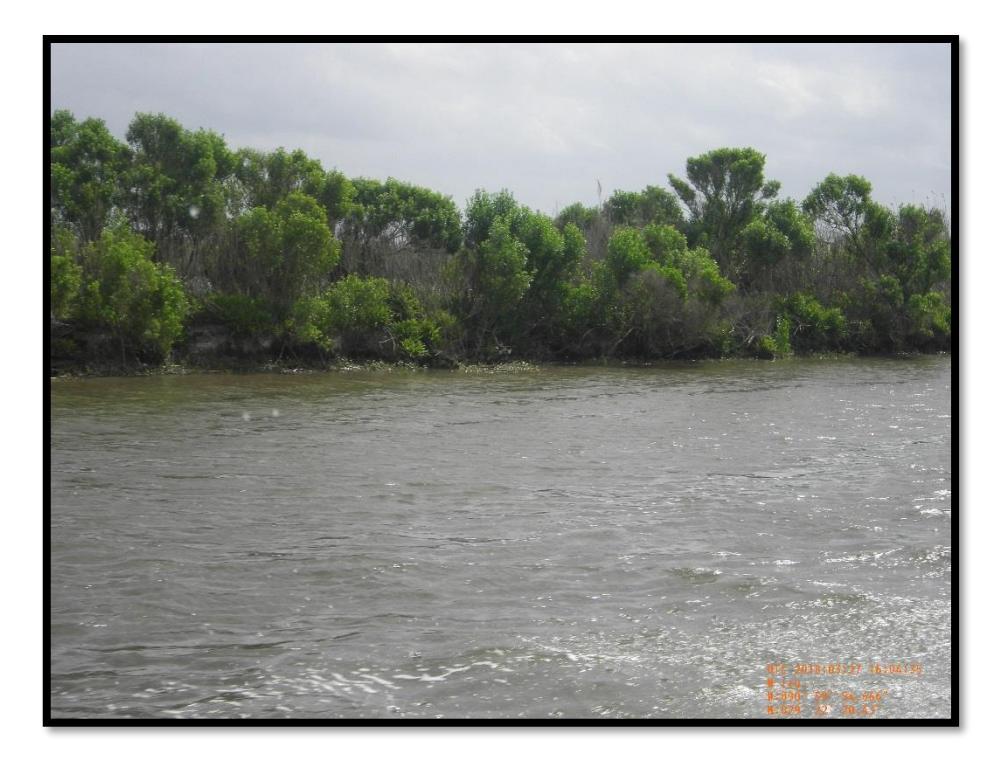
Photo No.47 – earthen embankment along the east bank of Voss Canal.

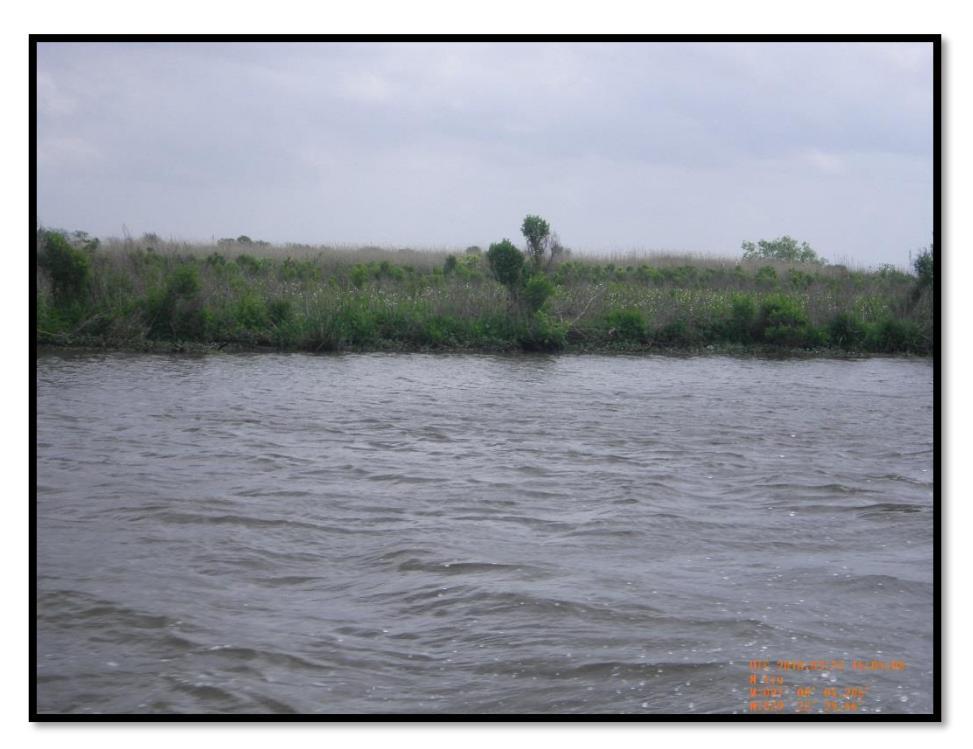
Photo No.48 – existing bank line along the northern reach of Voss Canal along the east bank.

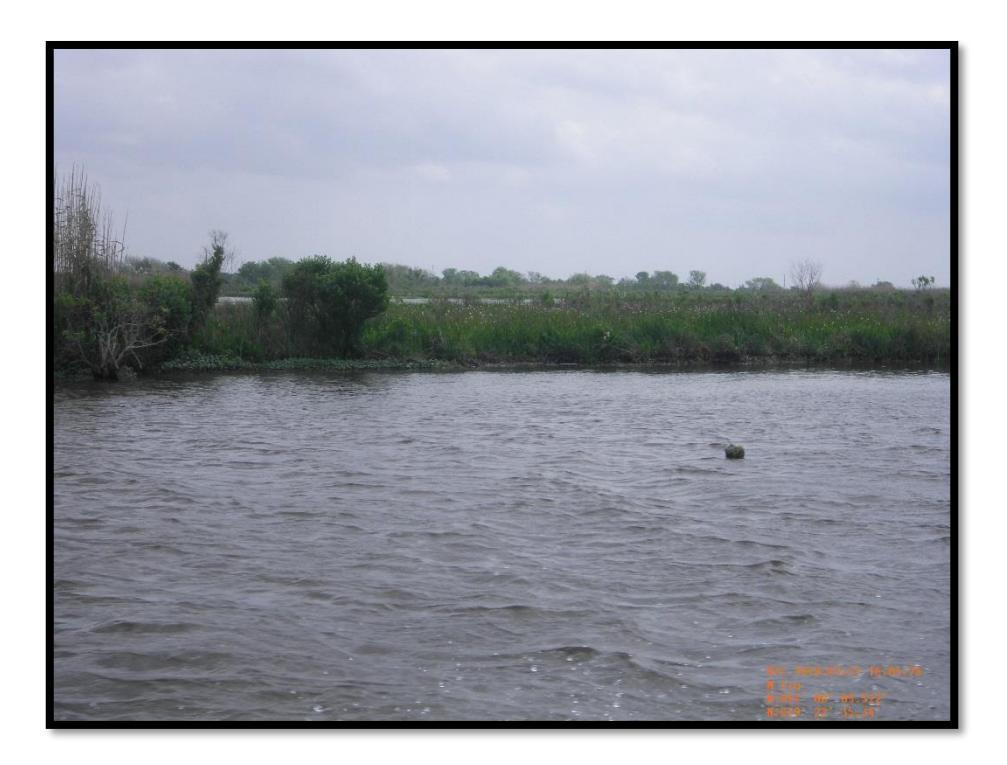
Photo No.49 – existing bank line along the northern reach of Voss Canal along the east bank.
